**Application, Appendix,
DEQ Supplement, Direct
Testimony and Exhibits of
Virginia Electric and Power
Company**

**Cirrus-Keyser 230 kV Loop and
Related Projects**

Case No. PUR-2022-00198

DEQ Supplement

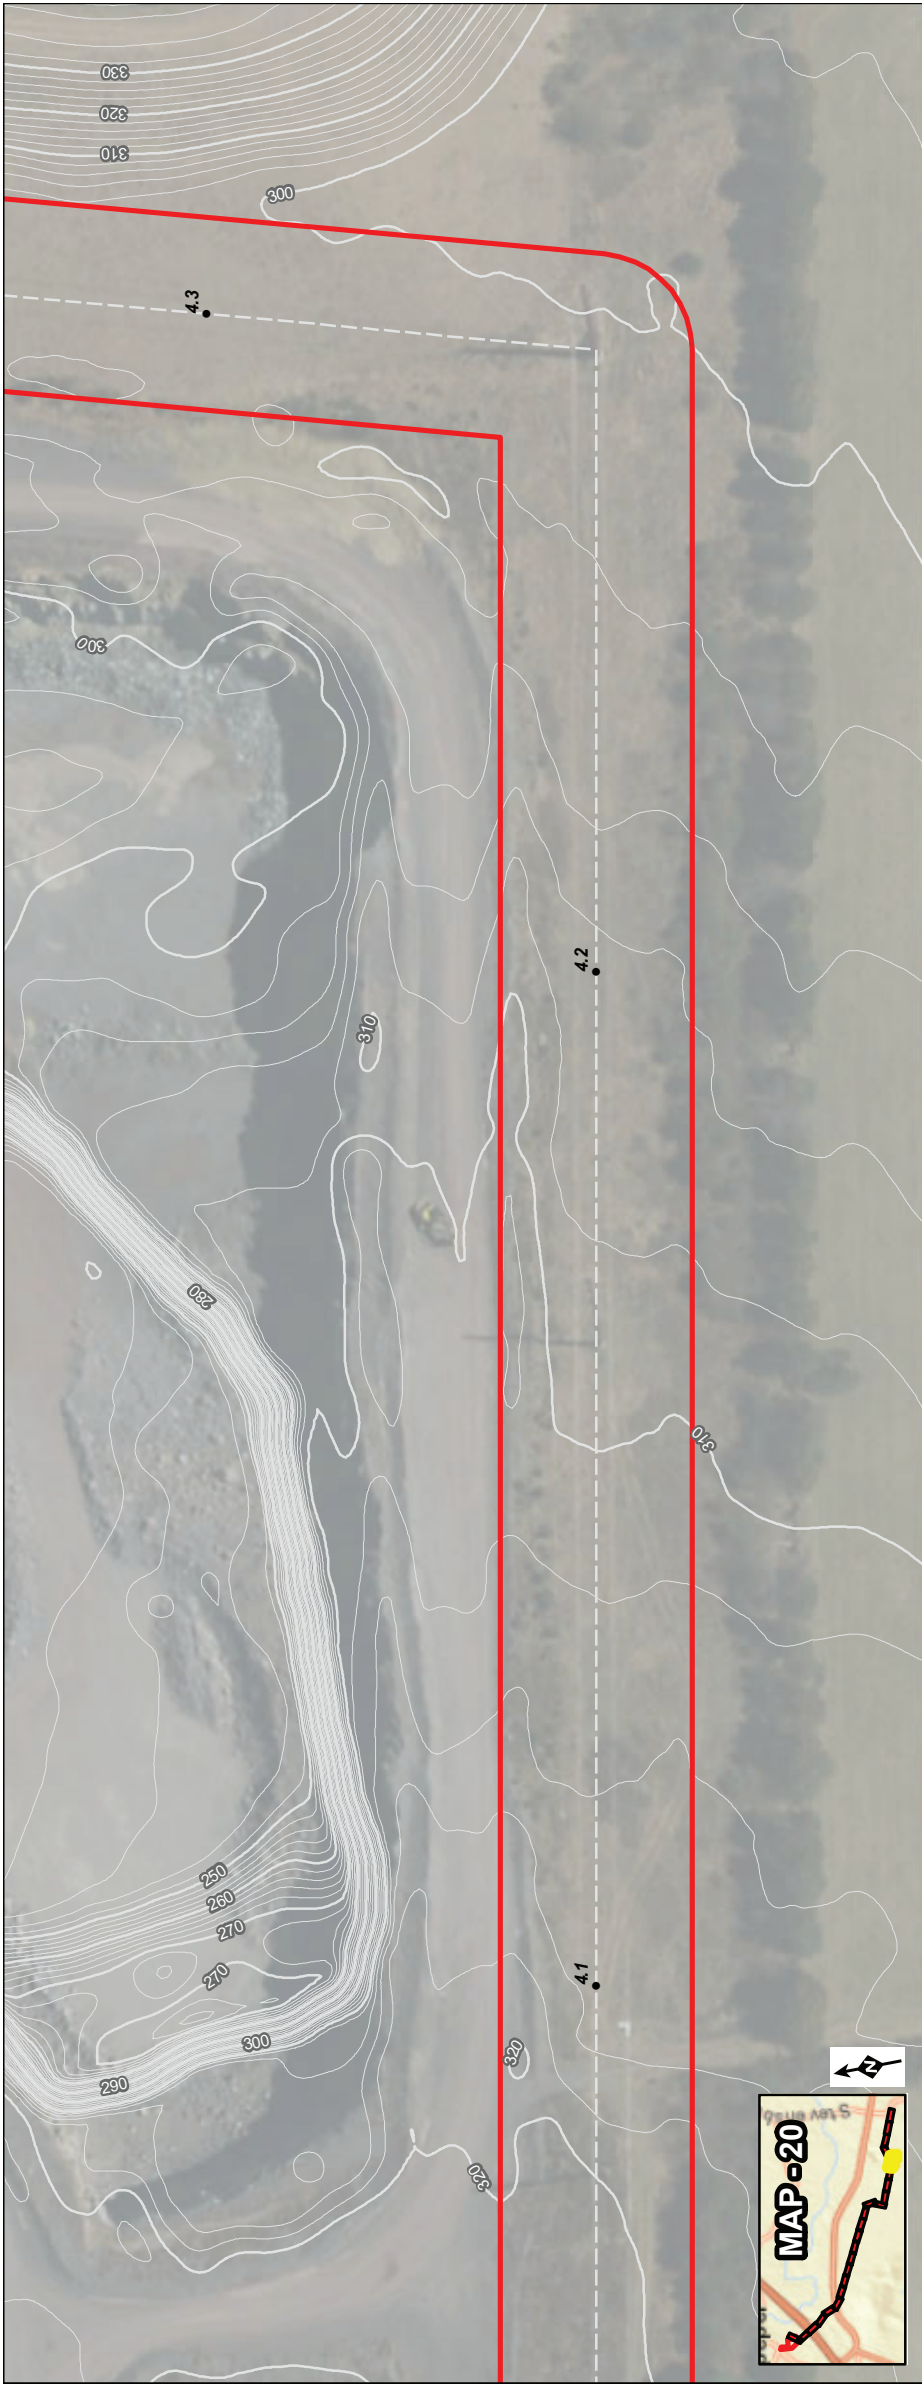
FIGURE 6-10.
Waters of the U.S., including Wetlands
Delineation Map

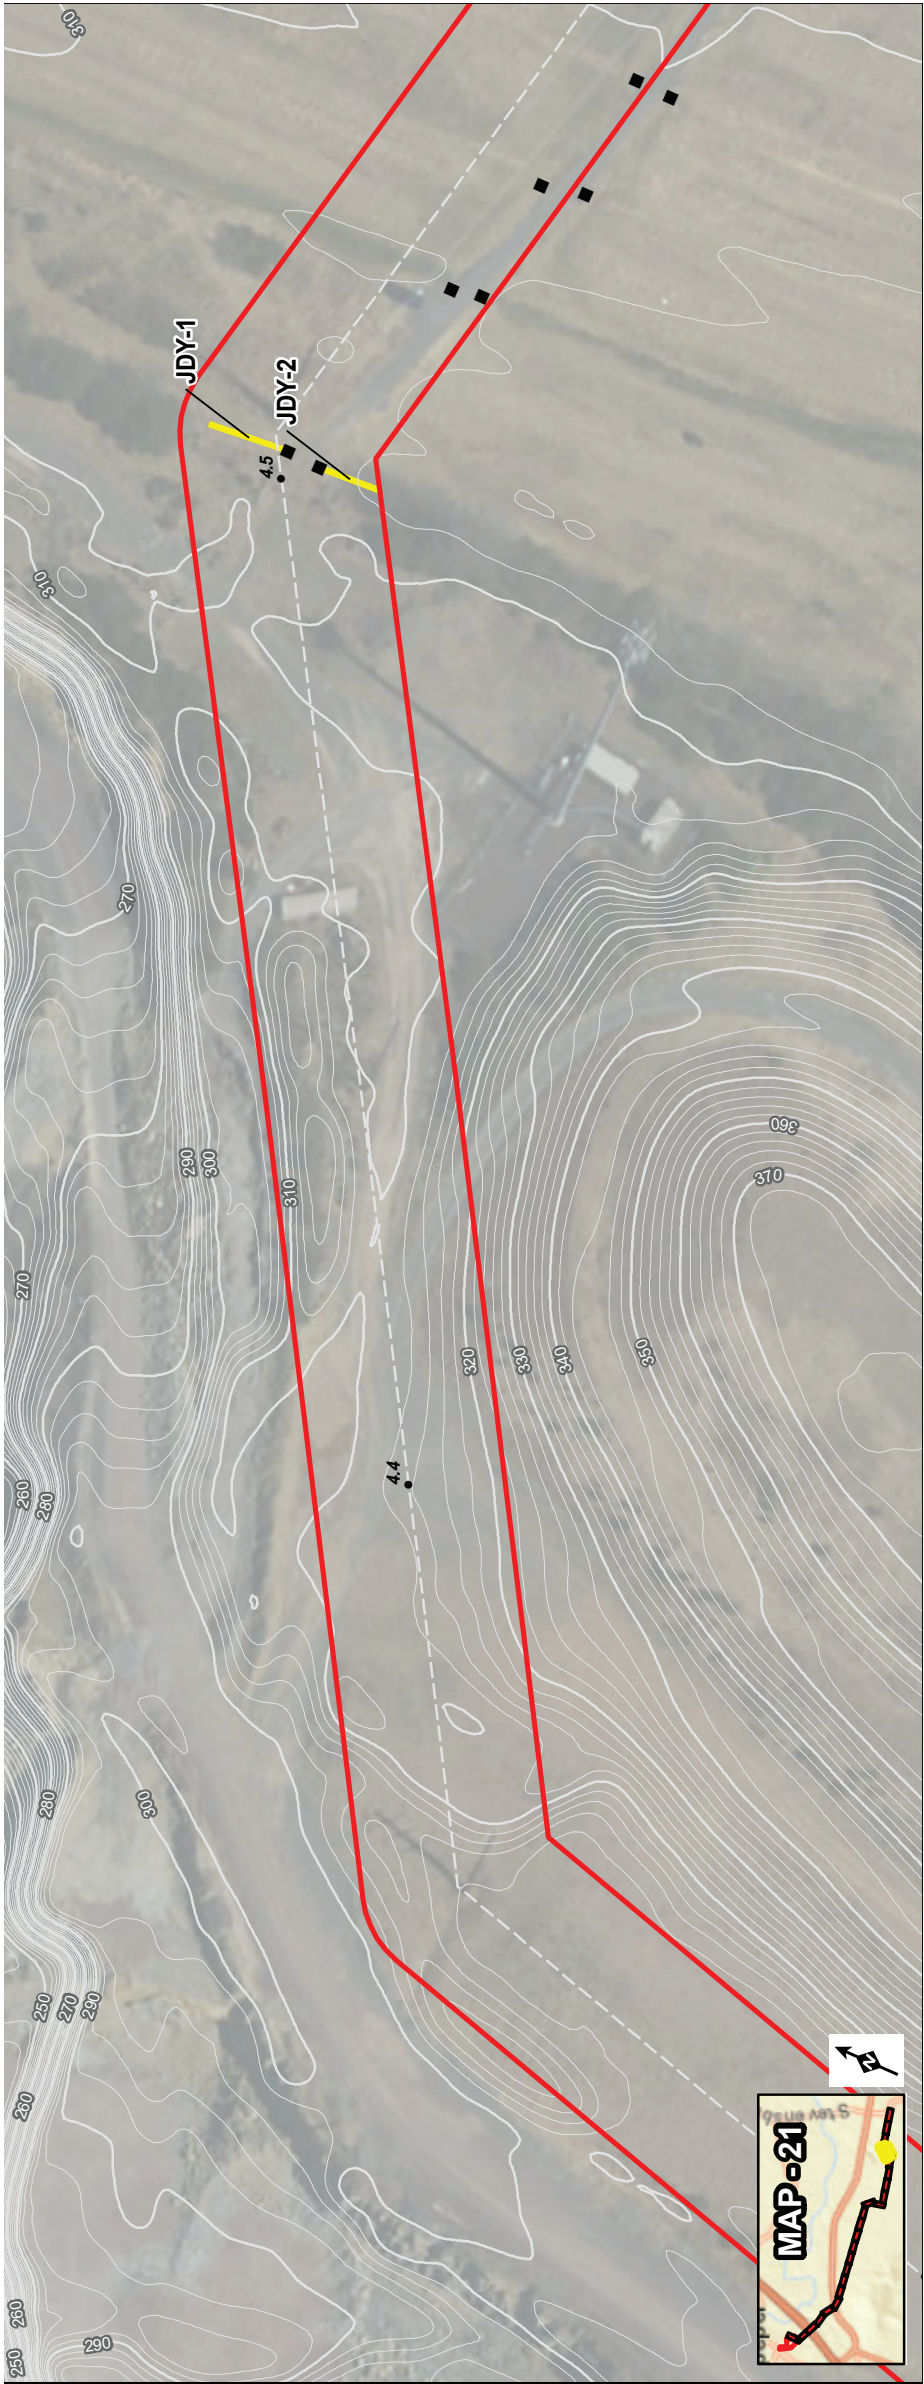
FIGURE 6-11.
Waters of the U.S., including Wetlands
Delineation Map
Cirrus – Keyser 230 kV Loop and
Related Projects
Culpeper County, Virginia

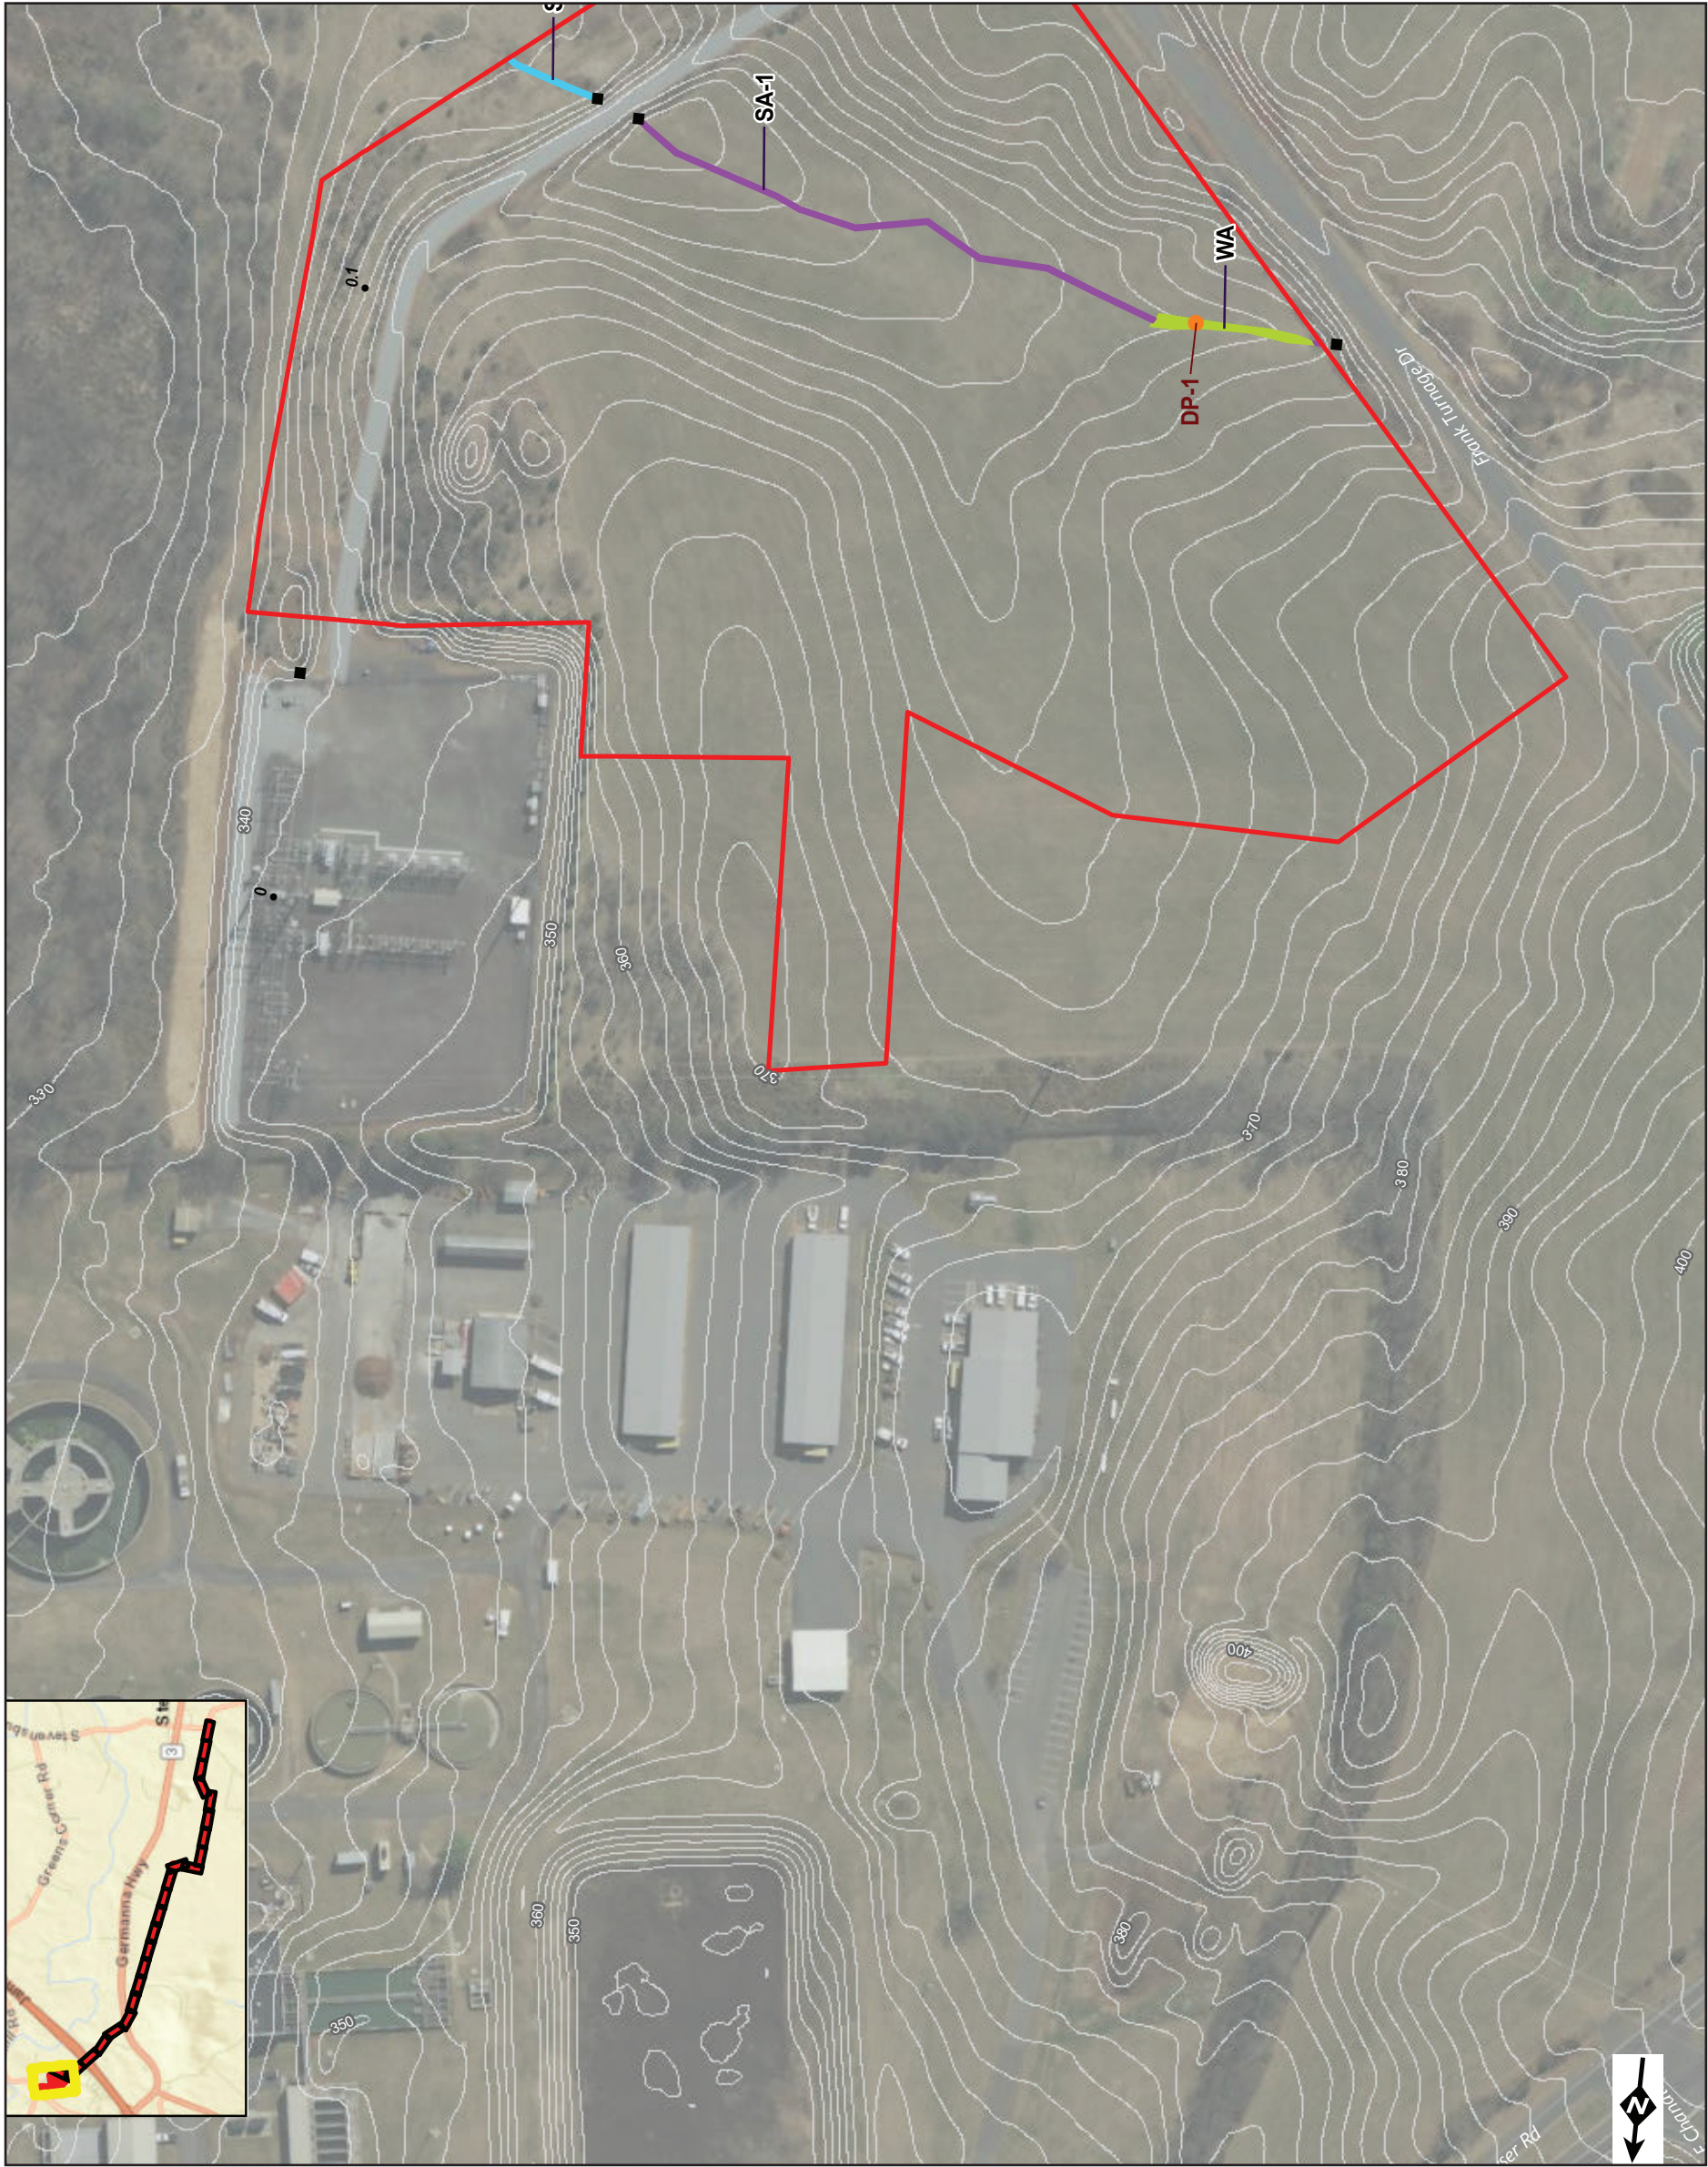
FIGURE 6-13.
Waters of the U.S., including Wetlands
Delineation Map

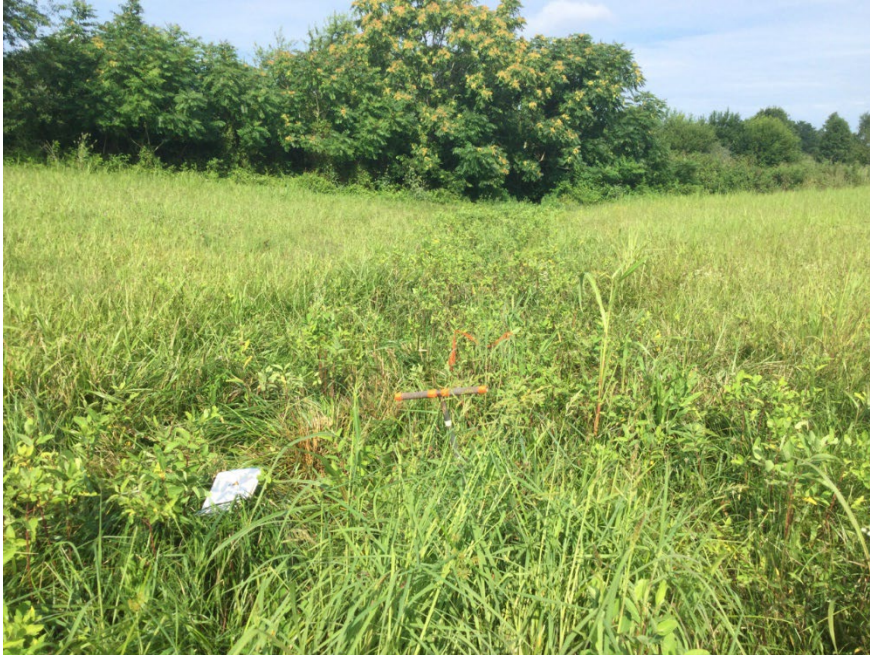
NO. 1

Photo of DP-1 showing linear emergent wetland.

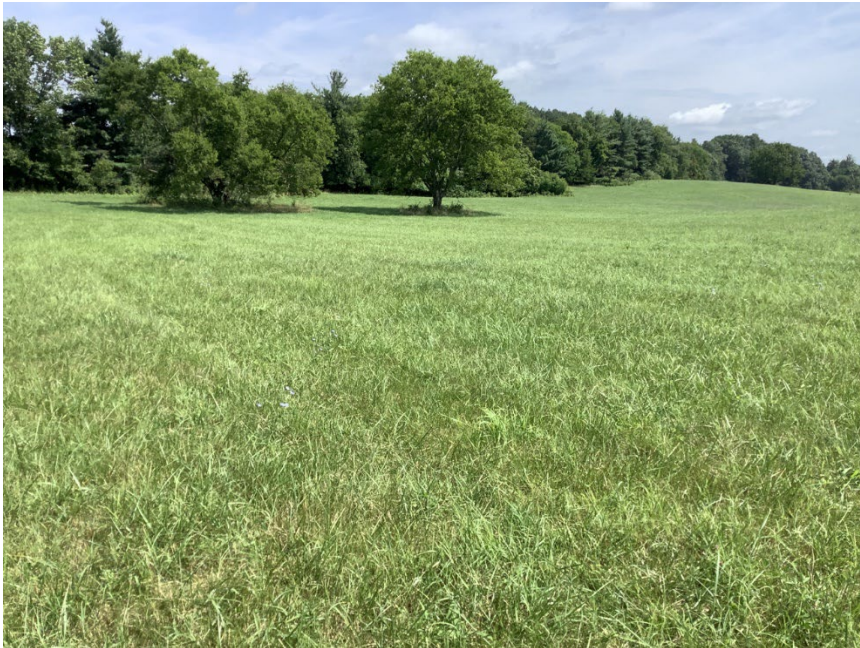
NO. 2

Photo of DP-2, taken in upland swale located in NWI mapped feature

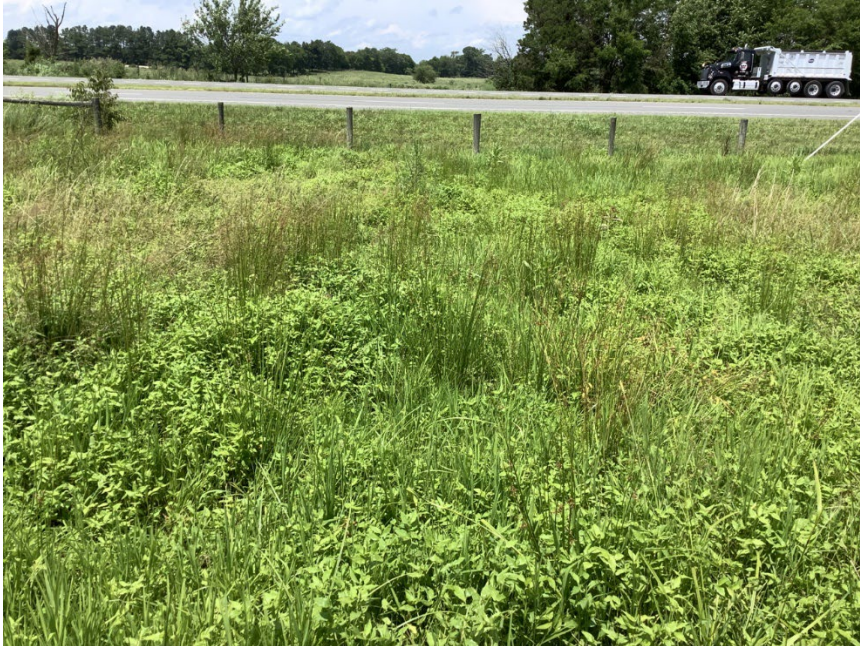
NO. 3

Photo of DP-3, showing
emergent wetland along
Germanna Highway

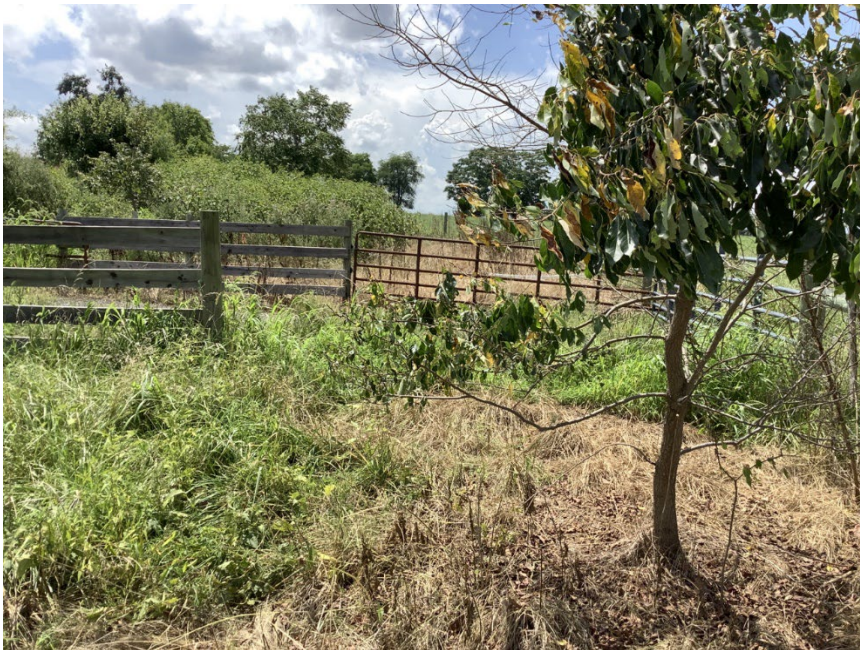
NO. 4

Photo of DP-4 showing upland
floodplain along stream channel

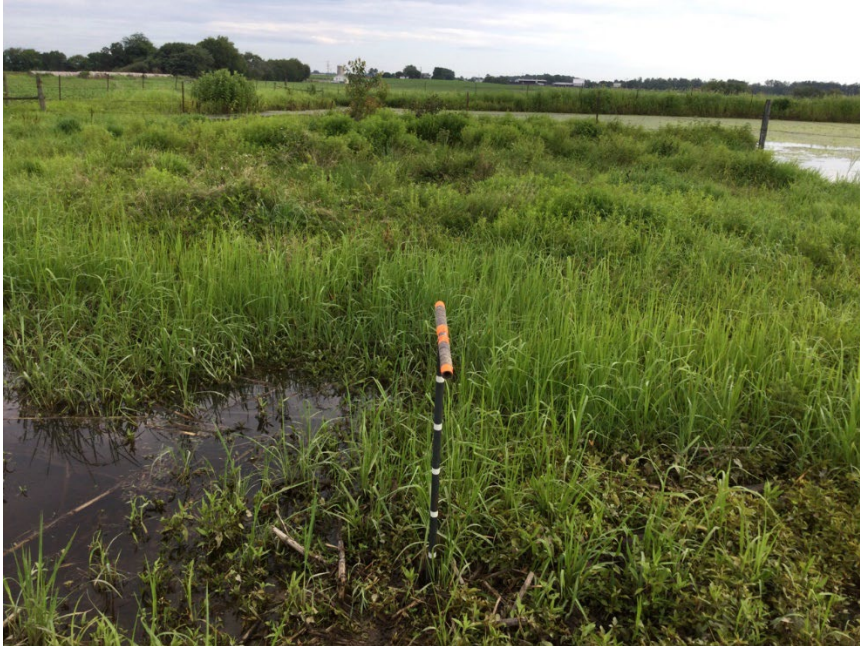
NO. 5

Photo of DP-5 showing farm field wetland associated with farm pond

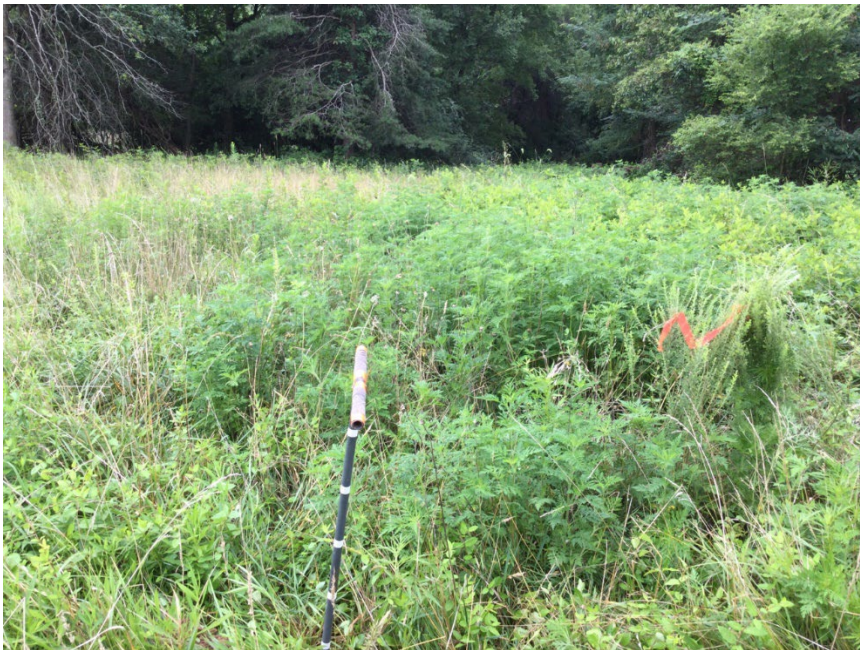
NO. 6

Photo of DP-6, showing upland swale associated with wetland WS

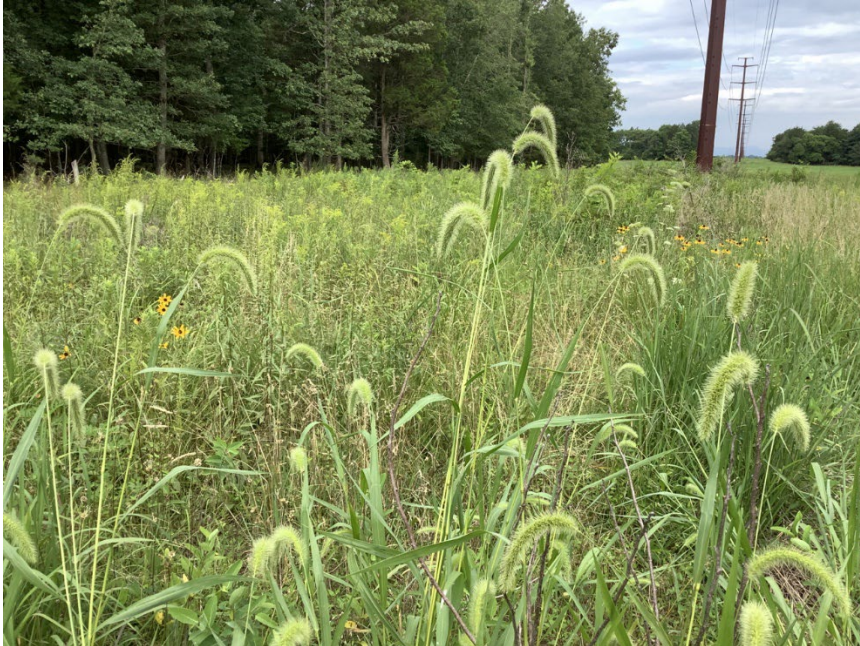
NO. 7

Photo of DP-7, showing upland community between wetlands WS and WT

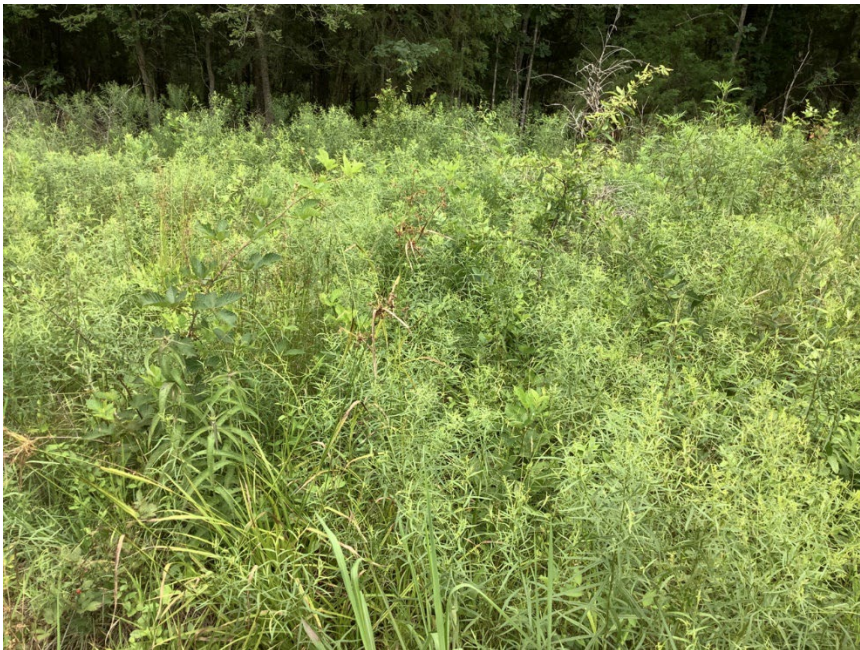
NO. 8

Photo of DP-8, showing emergent wetland WU

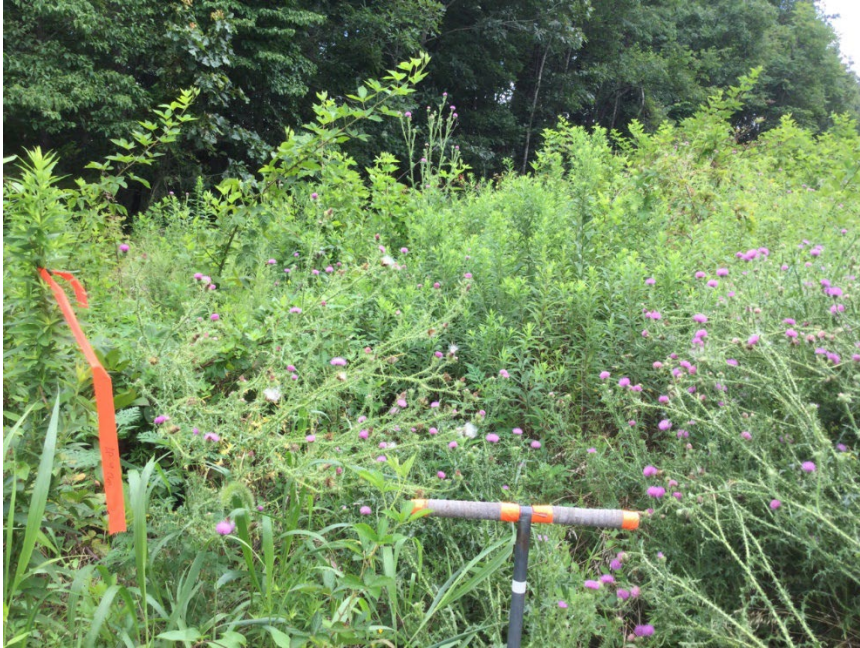
NO. 9

View of DP-9, showing upland
hillslope associated with wetland
WU

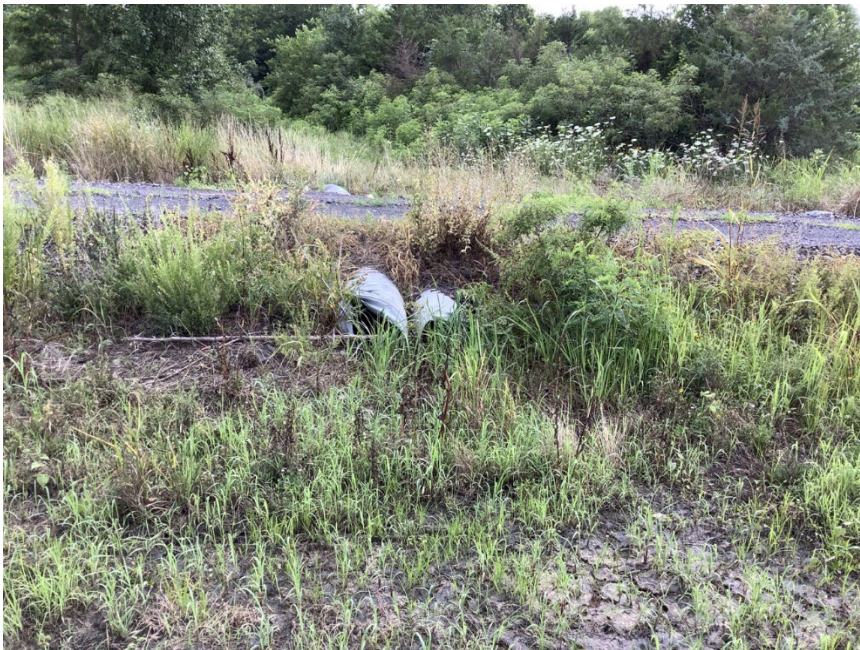
NO. 10

Photo of DP-10, showing culverts
associated with upland
drainageway

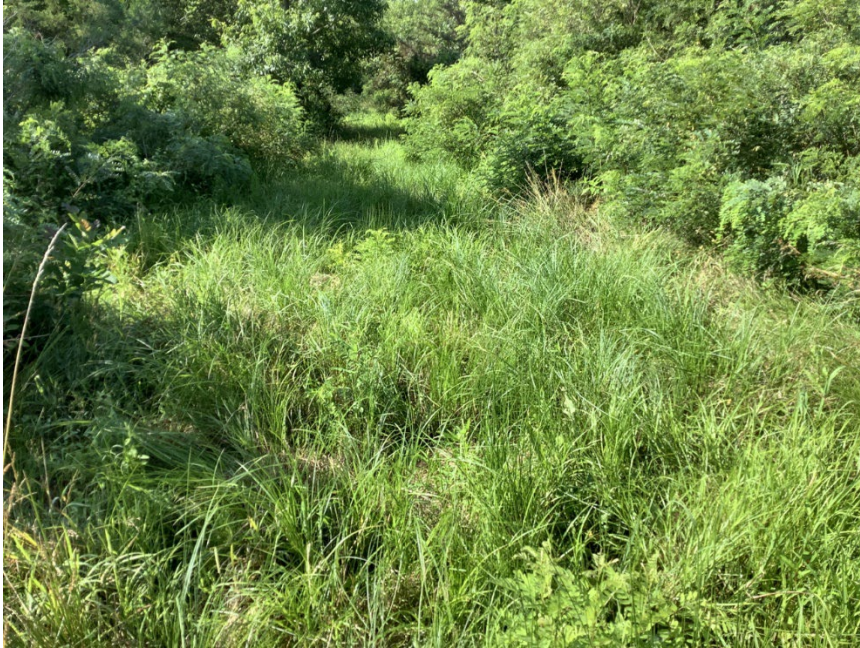
NO. 11

Photo of DP-11, showing linear wetland below culverted crossing

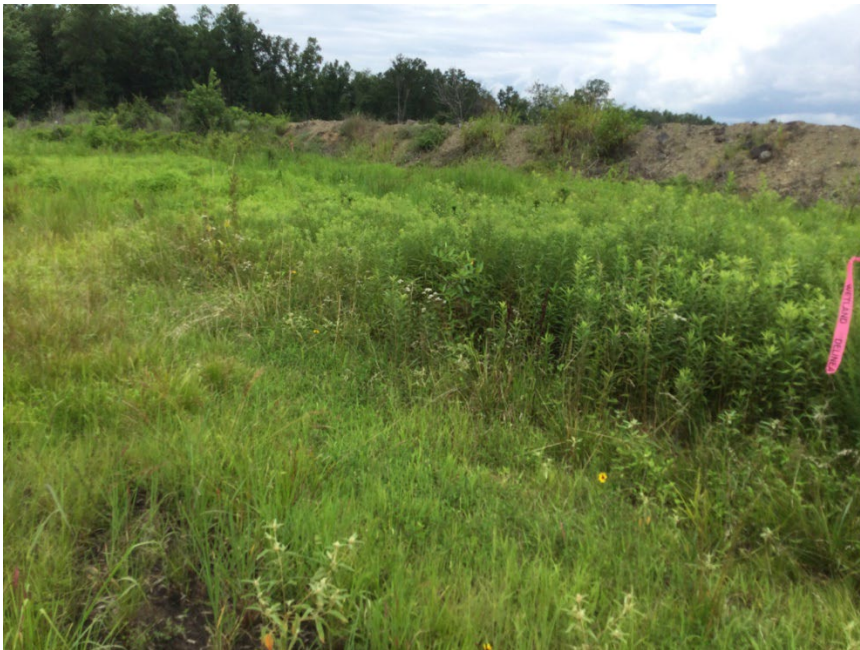
NO. 12

Representative photo showing isolated wetlands behind mining facilities berm

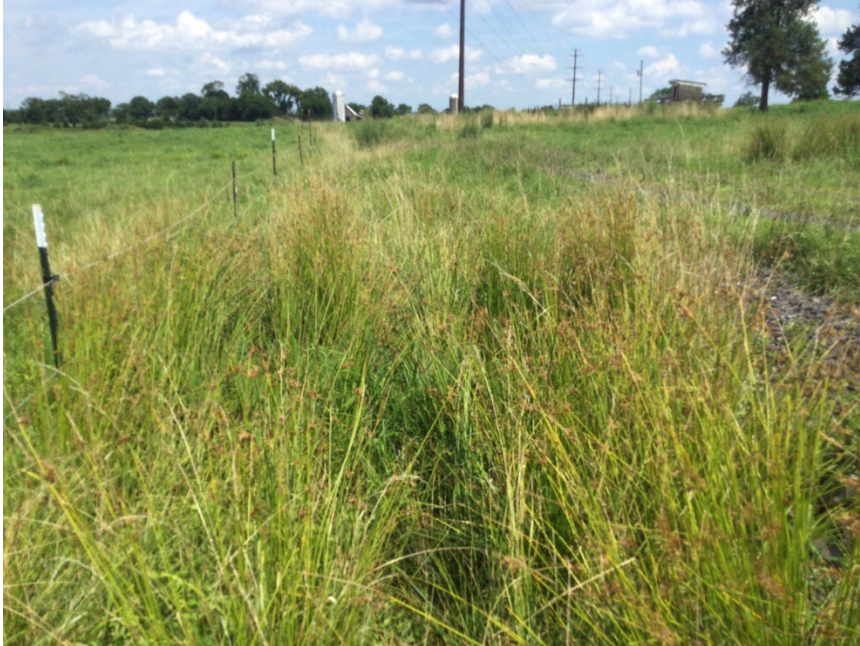
NO. 13

Representative photo showing
linear wetland WK in farm field

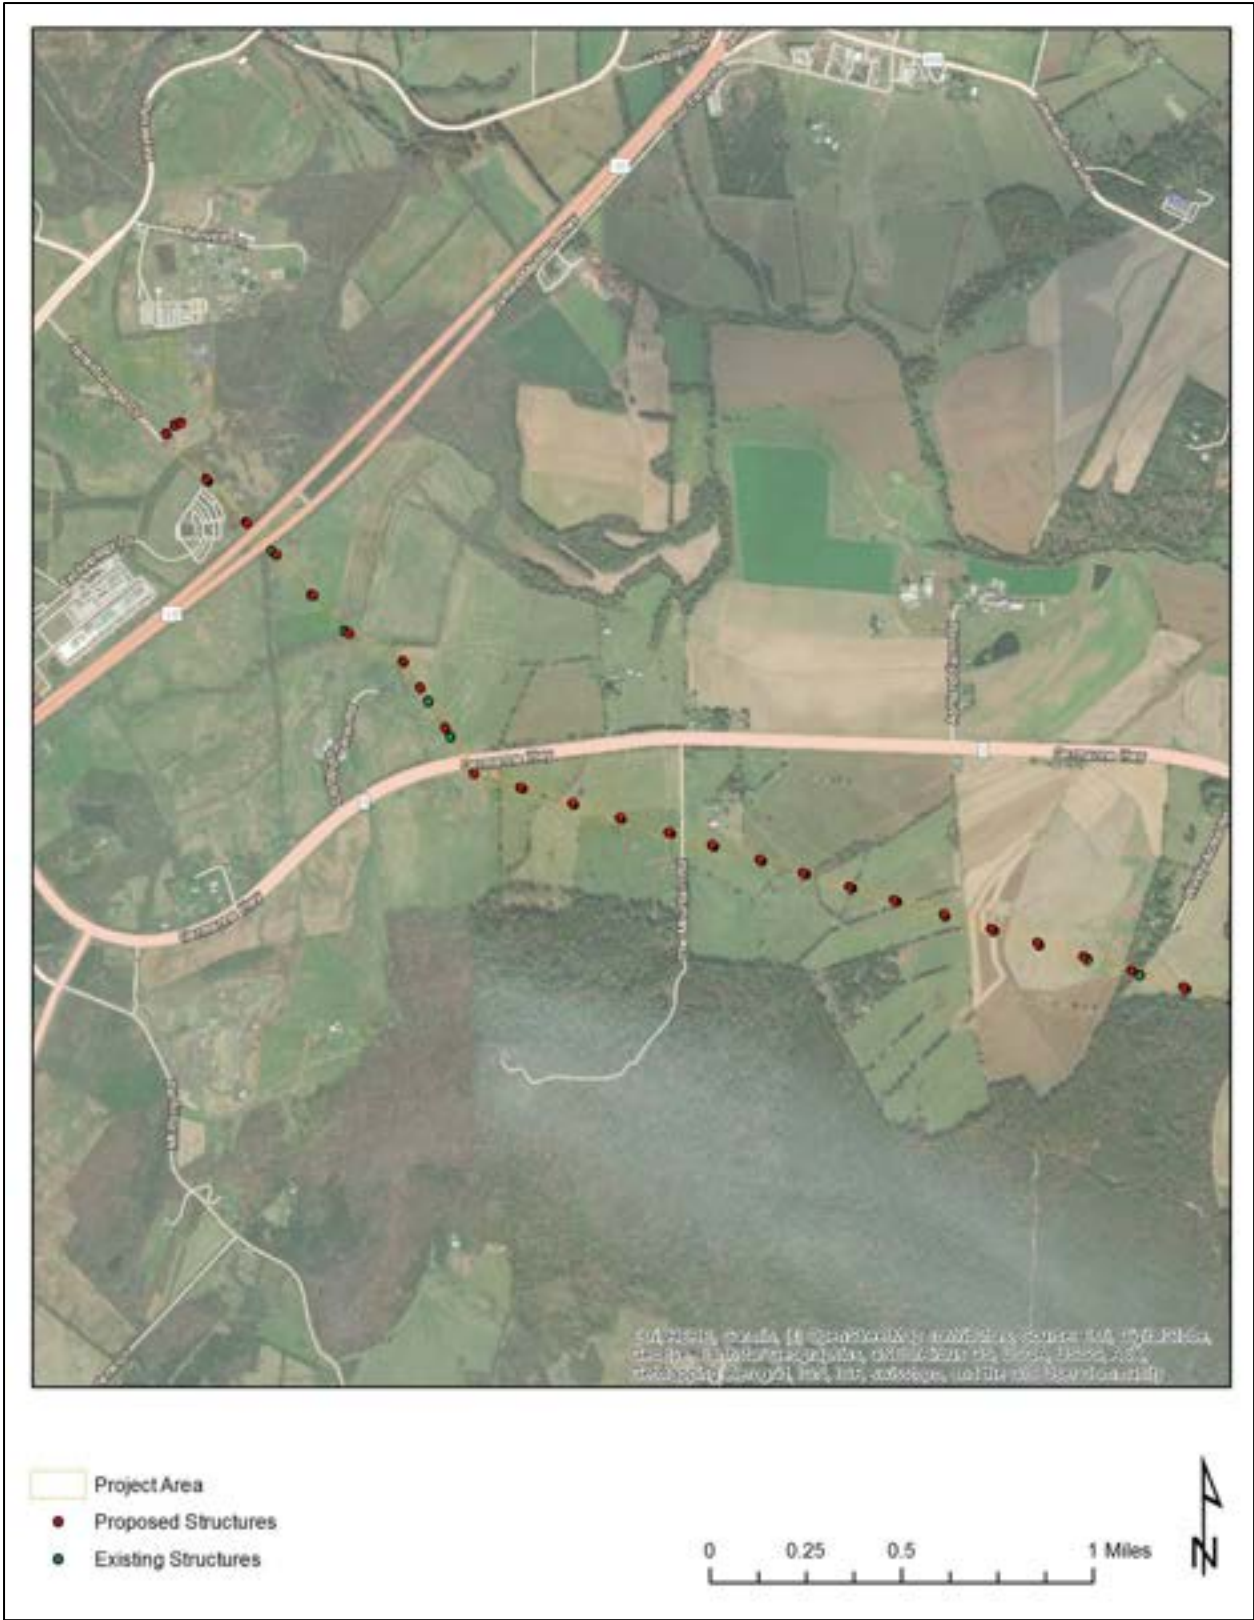
Figure 2-2: Detail of Cirrus – Keyser 230 kV Loop and Related Projects (West)

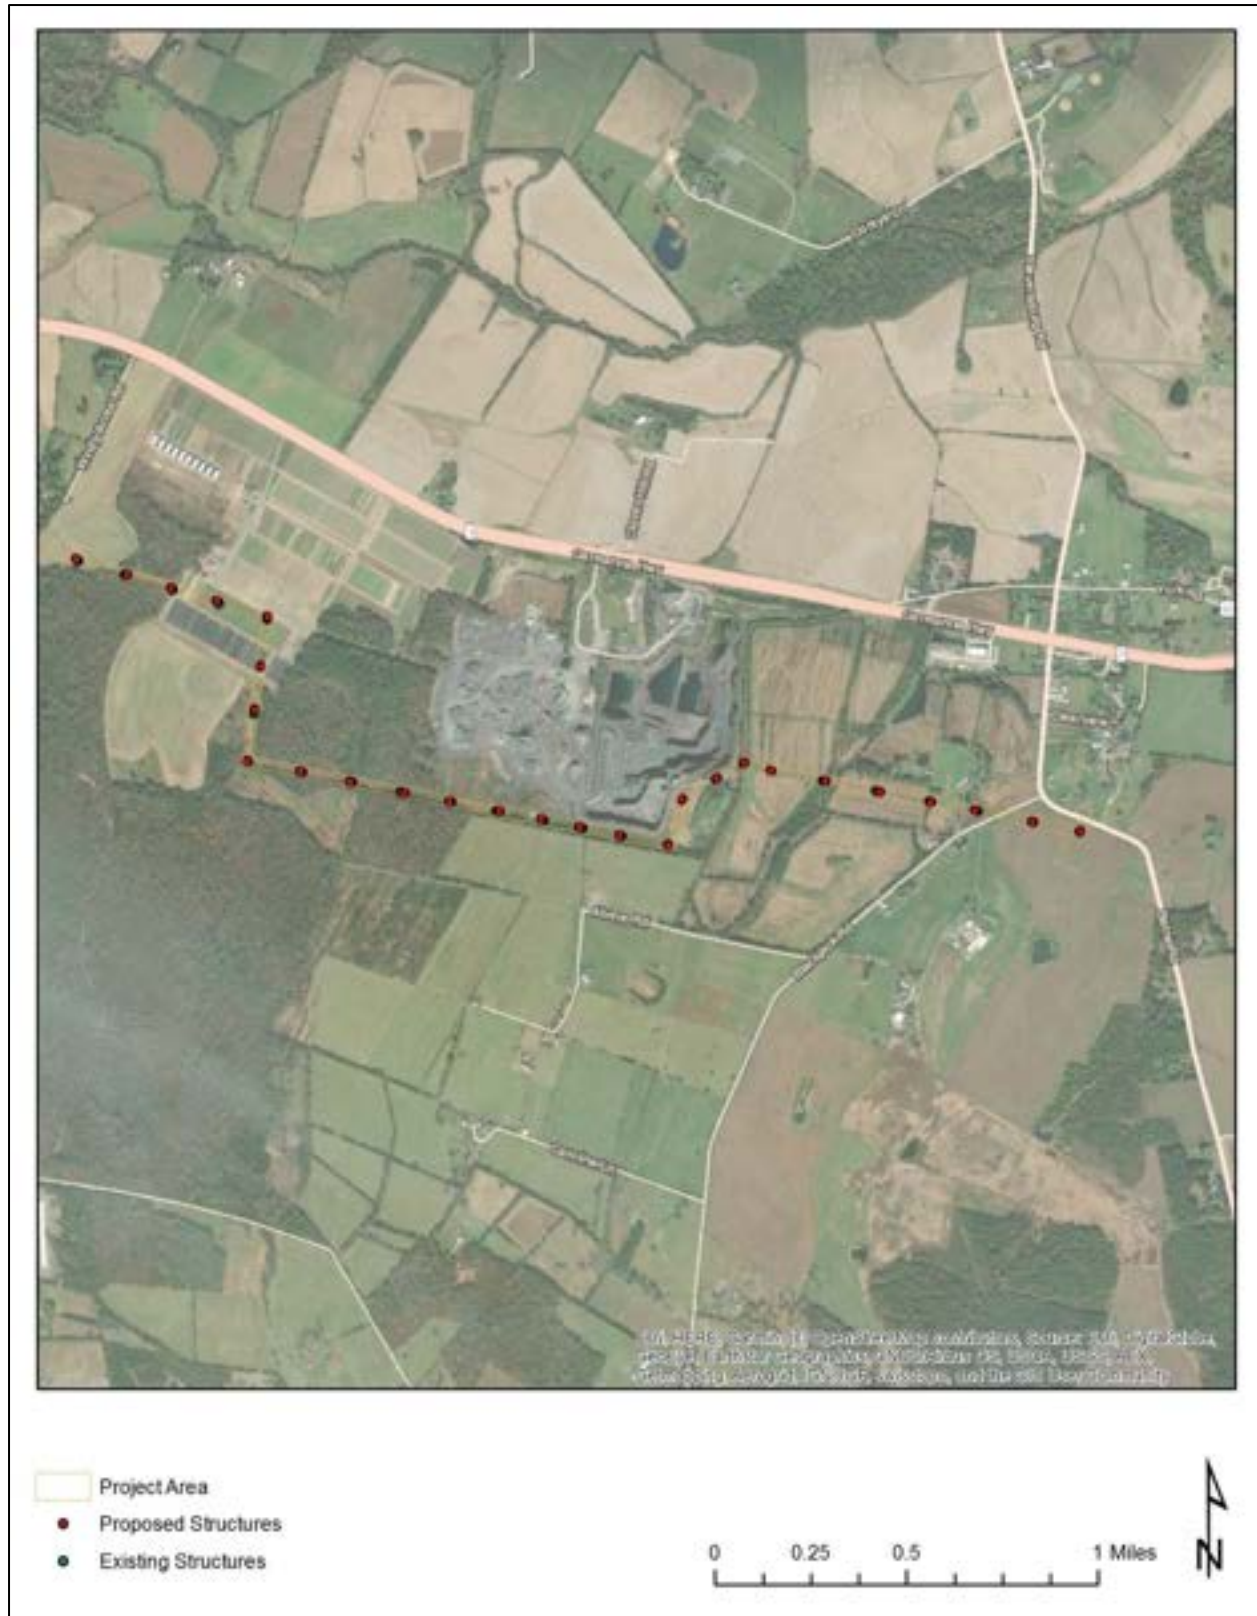
Figure 2-3: Detail of Cirrus – Keyser 230 kV Loop and Related Projects (East)

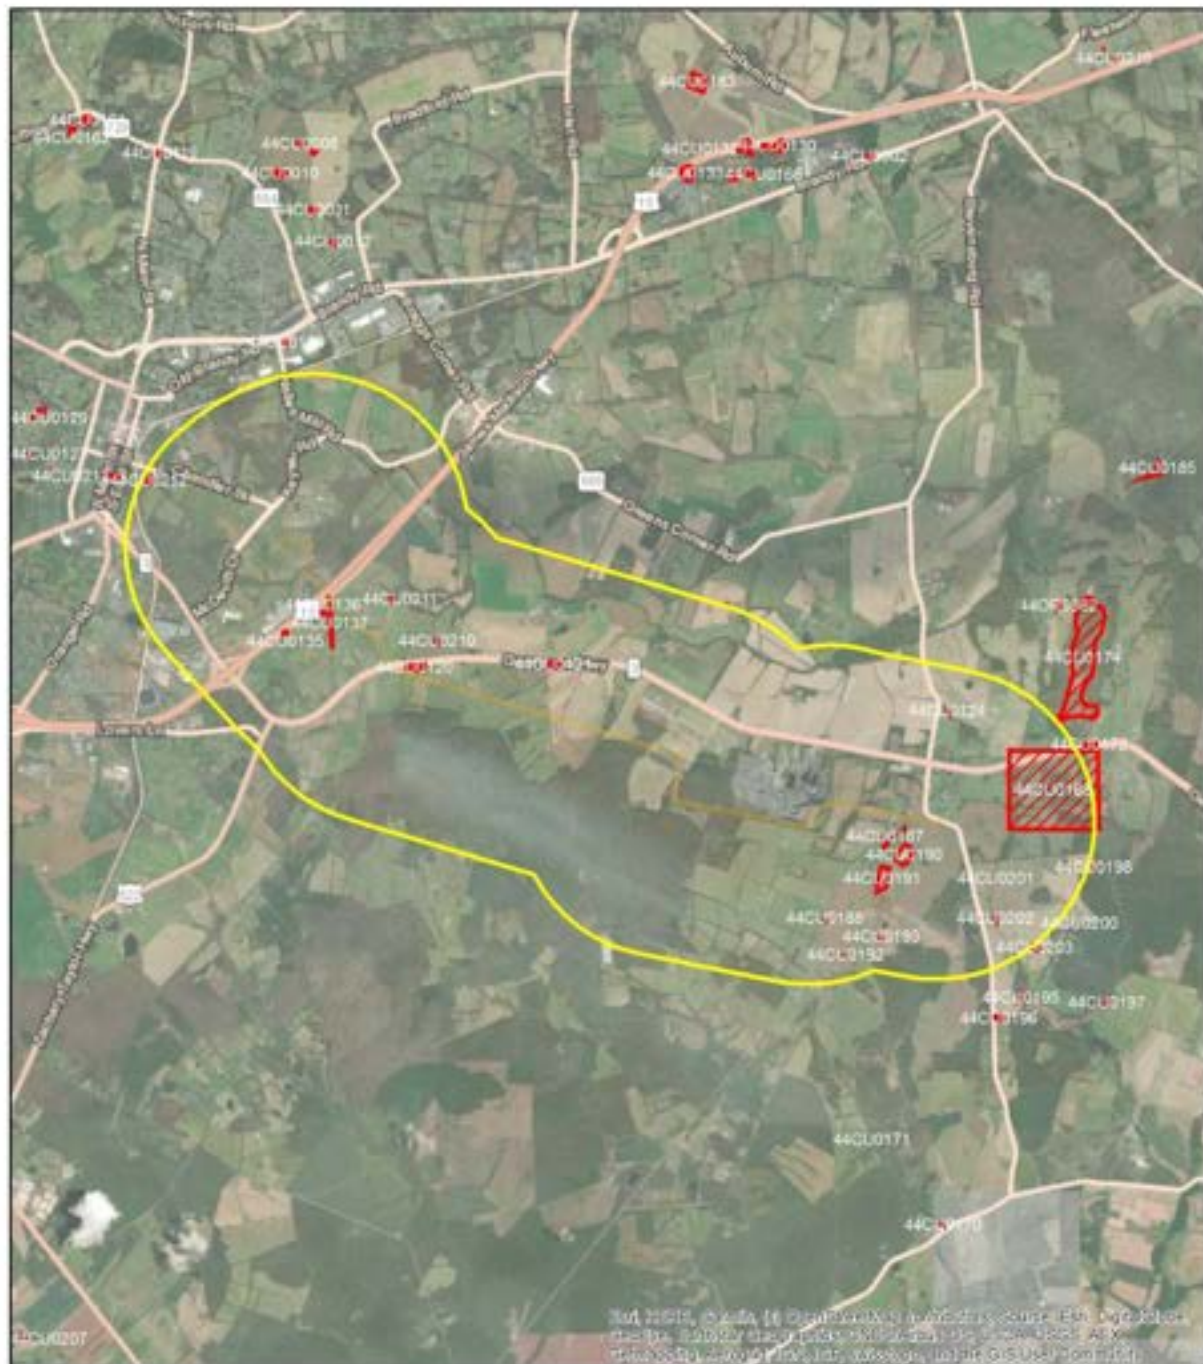
Figure 4-2: Previously recorded archaeological resources located within 1- mile of project area. Source: VCRIS

Table 4-2 lists the previously recorded archaeological resources within one-mile of the project area. Figure 4-2 illustrates the locations of the previously recorded sites within one mile of the project study area and Figure 4-3 details the location of the site within the project ROW.
