**Application, Appendix,
DEQ Supplement, Direct
Testimony and Exhibits of
Virginia Electric and Power
Company**

**Cirrus-Keyser 230 kV Loop and
Related Projects**

Case No. PUR-2022-00198

DEQ Supplement

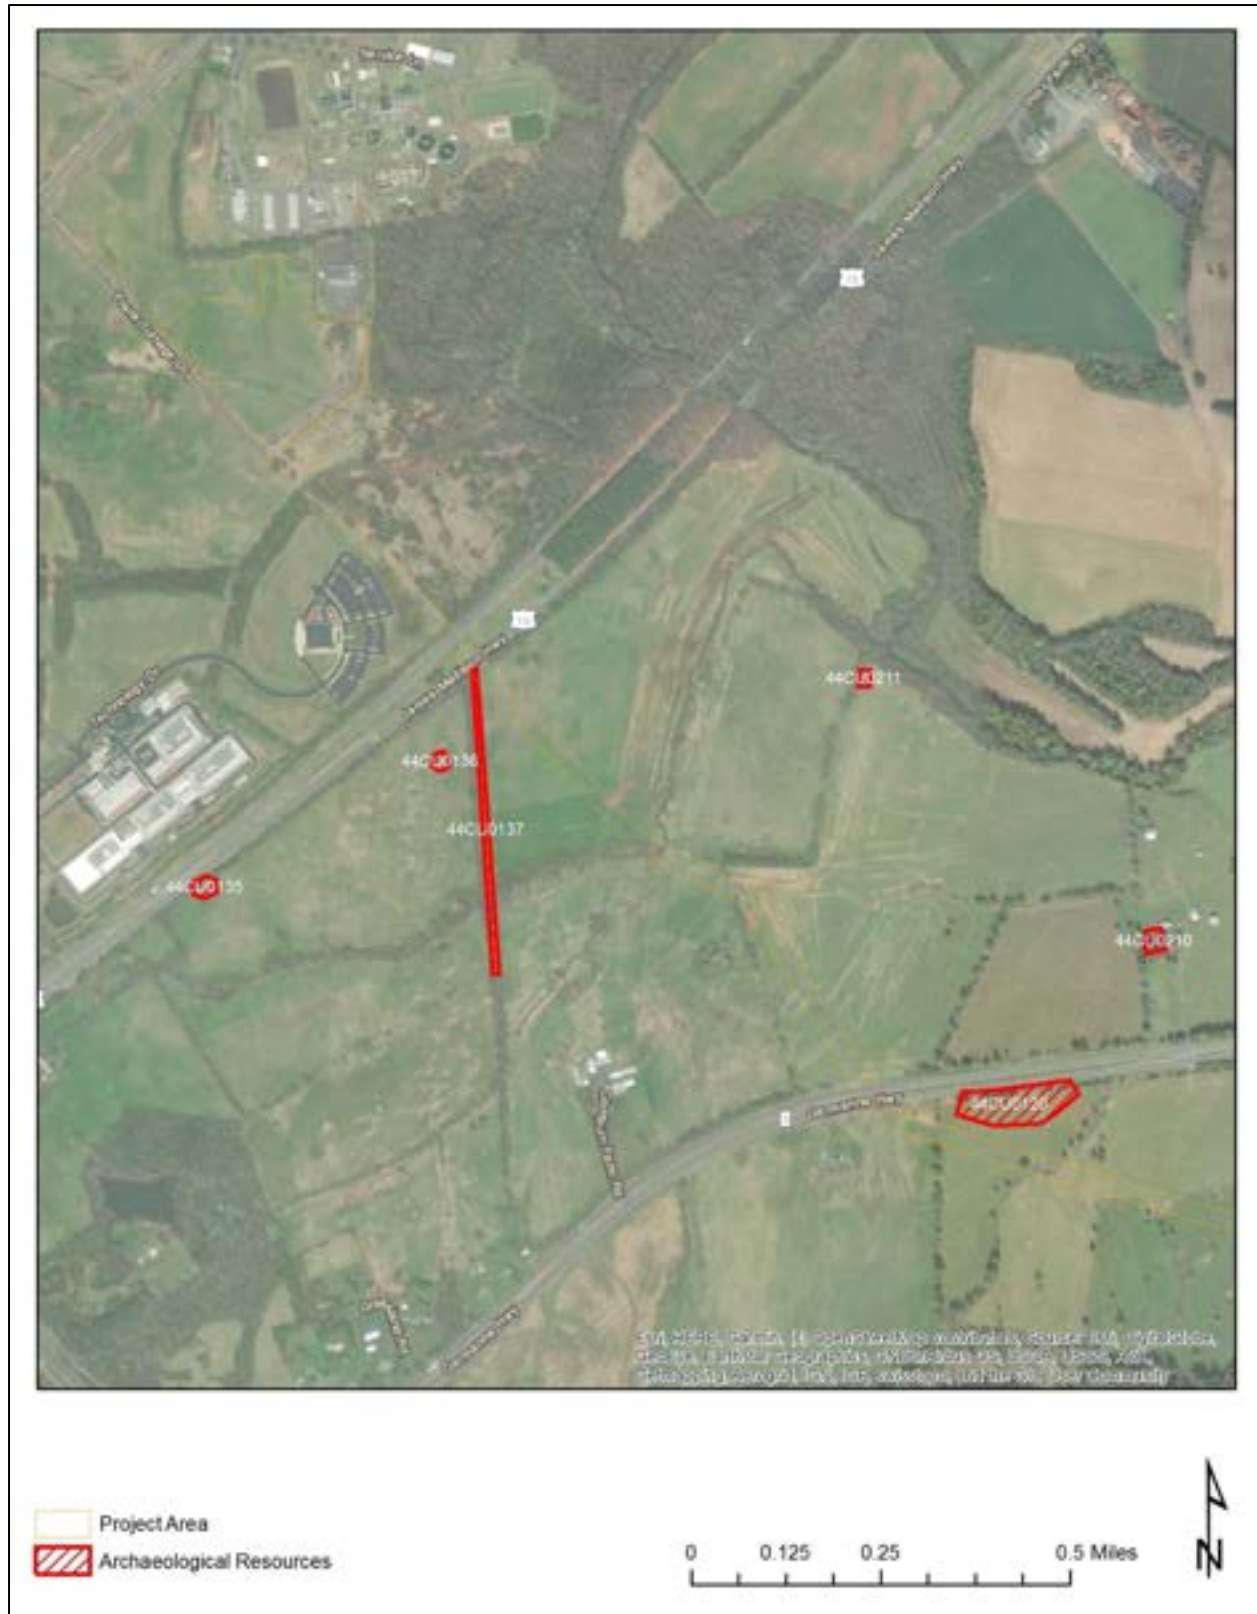
Figure 4-3: Detail of previously recorded archaeological resource crossed by the project ROW. Source: VCRIS

Table 4-2 lists the previously recorded archaeological resources within one-mile of the project area. Figure 4-2 illustrates the locations of the previously recorded sites within one mile of the project study area and Figure 4-3 details the location of the site within the project ROW.

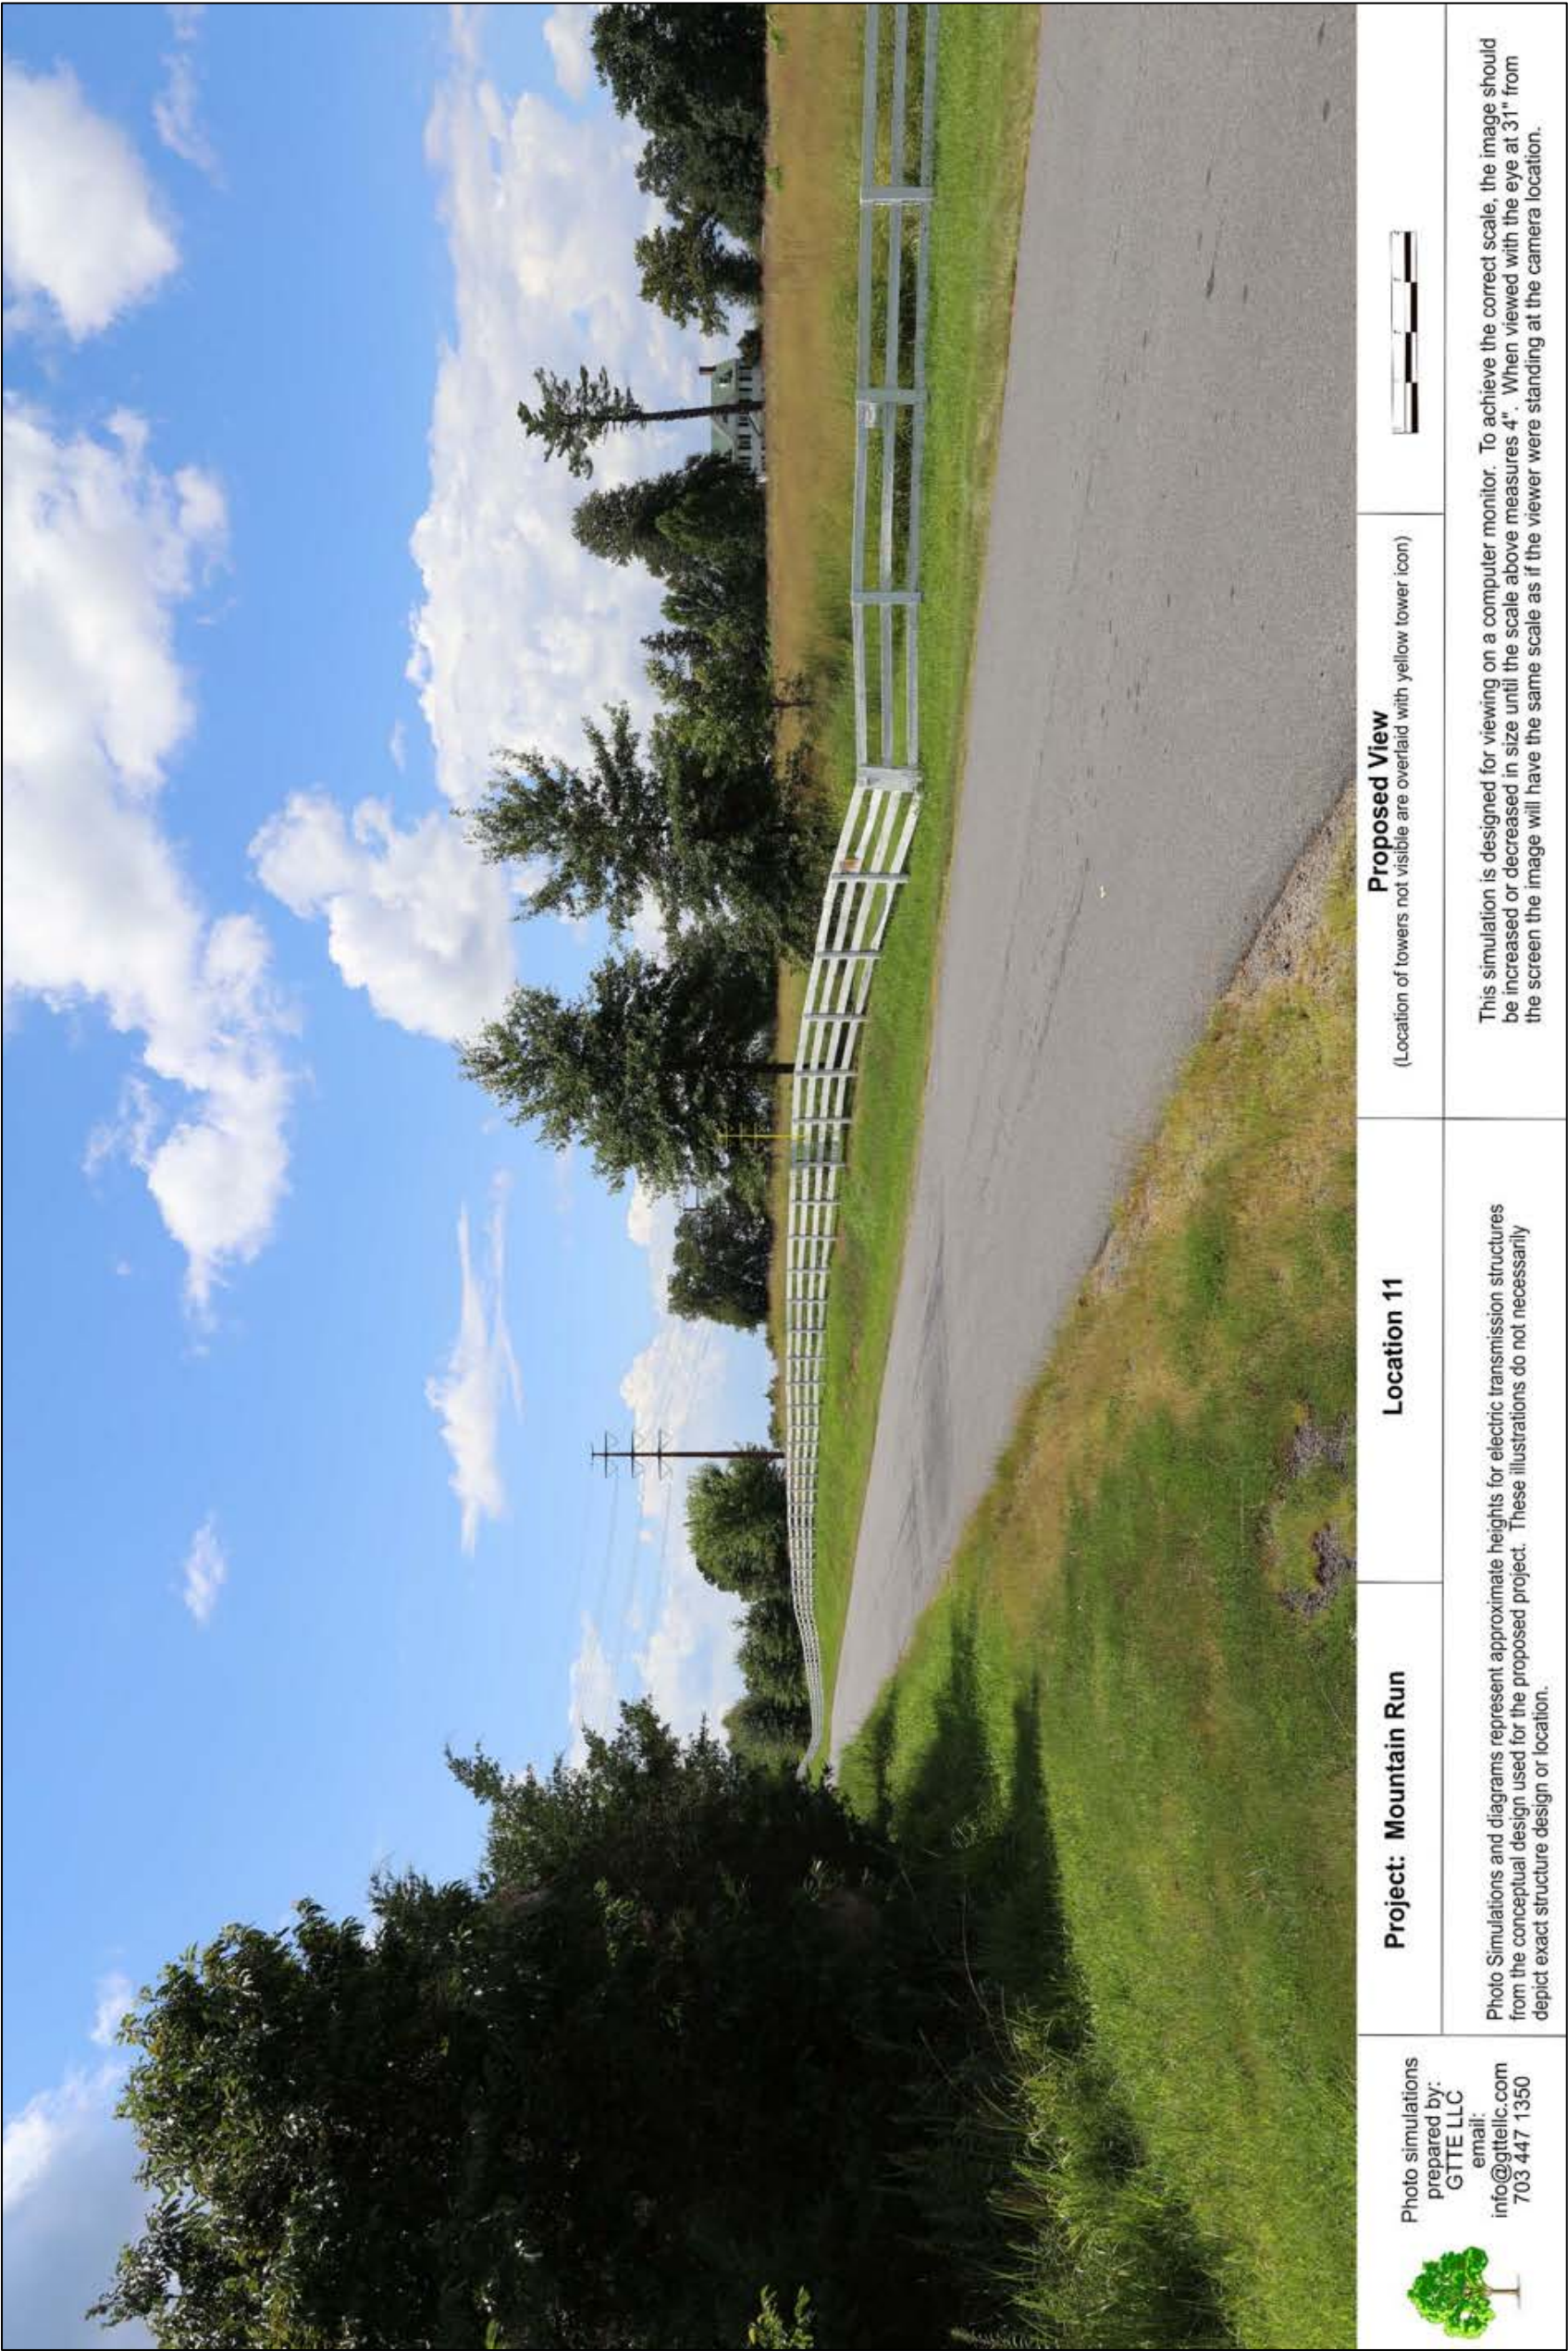
Figure 5-16: Rose Hill Simulation 1 – Proposed view from Batna Road – (Visible structures shown as they would appear. Structures not visible shown in yellow). Source: GTTE, LLC

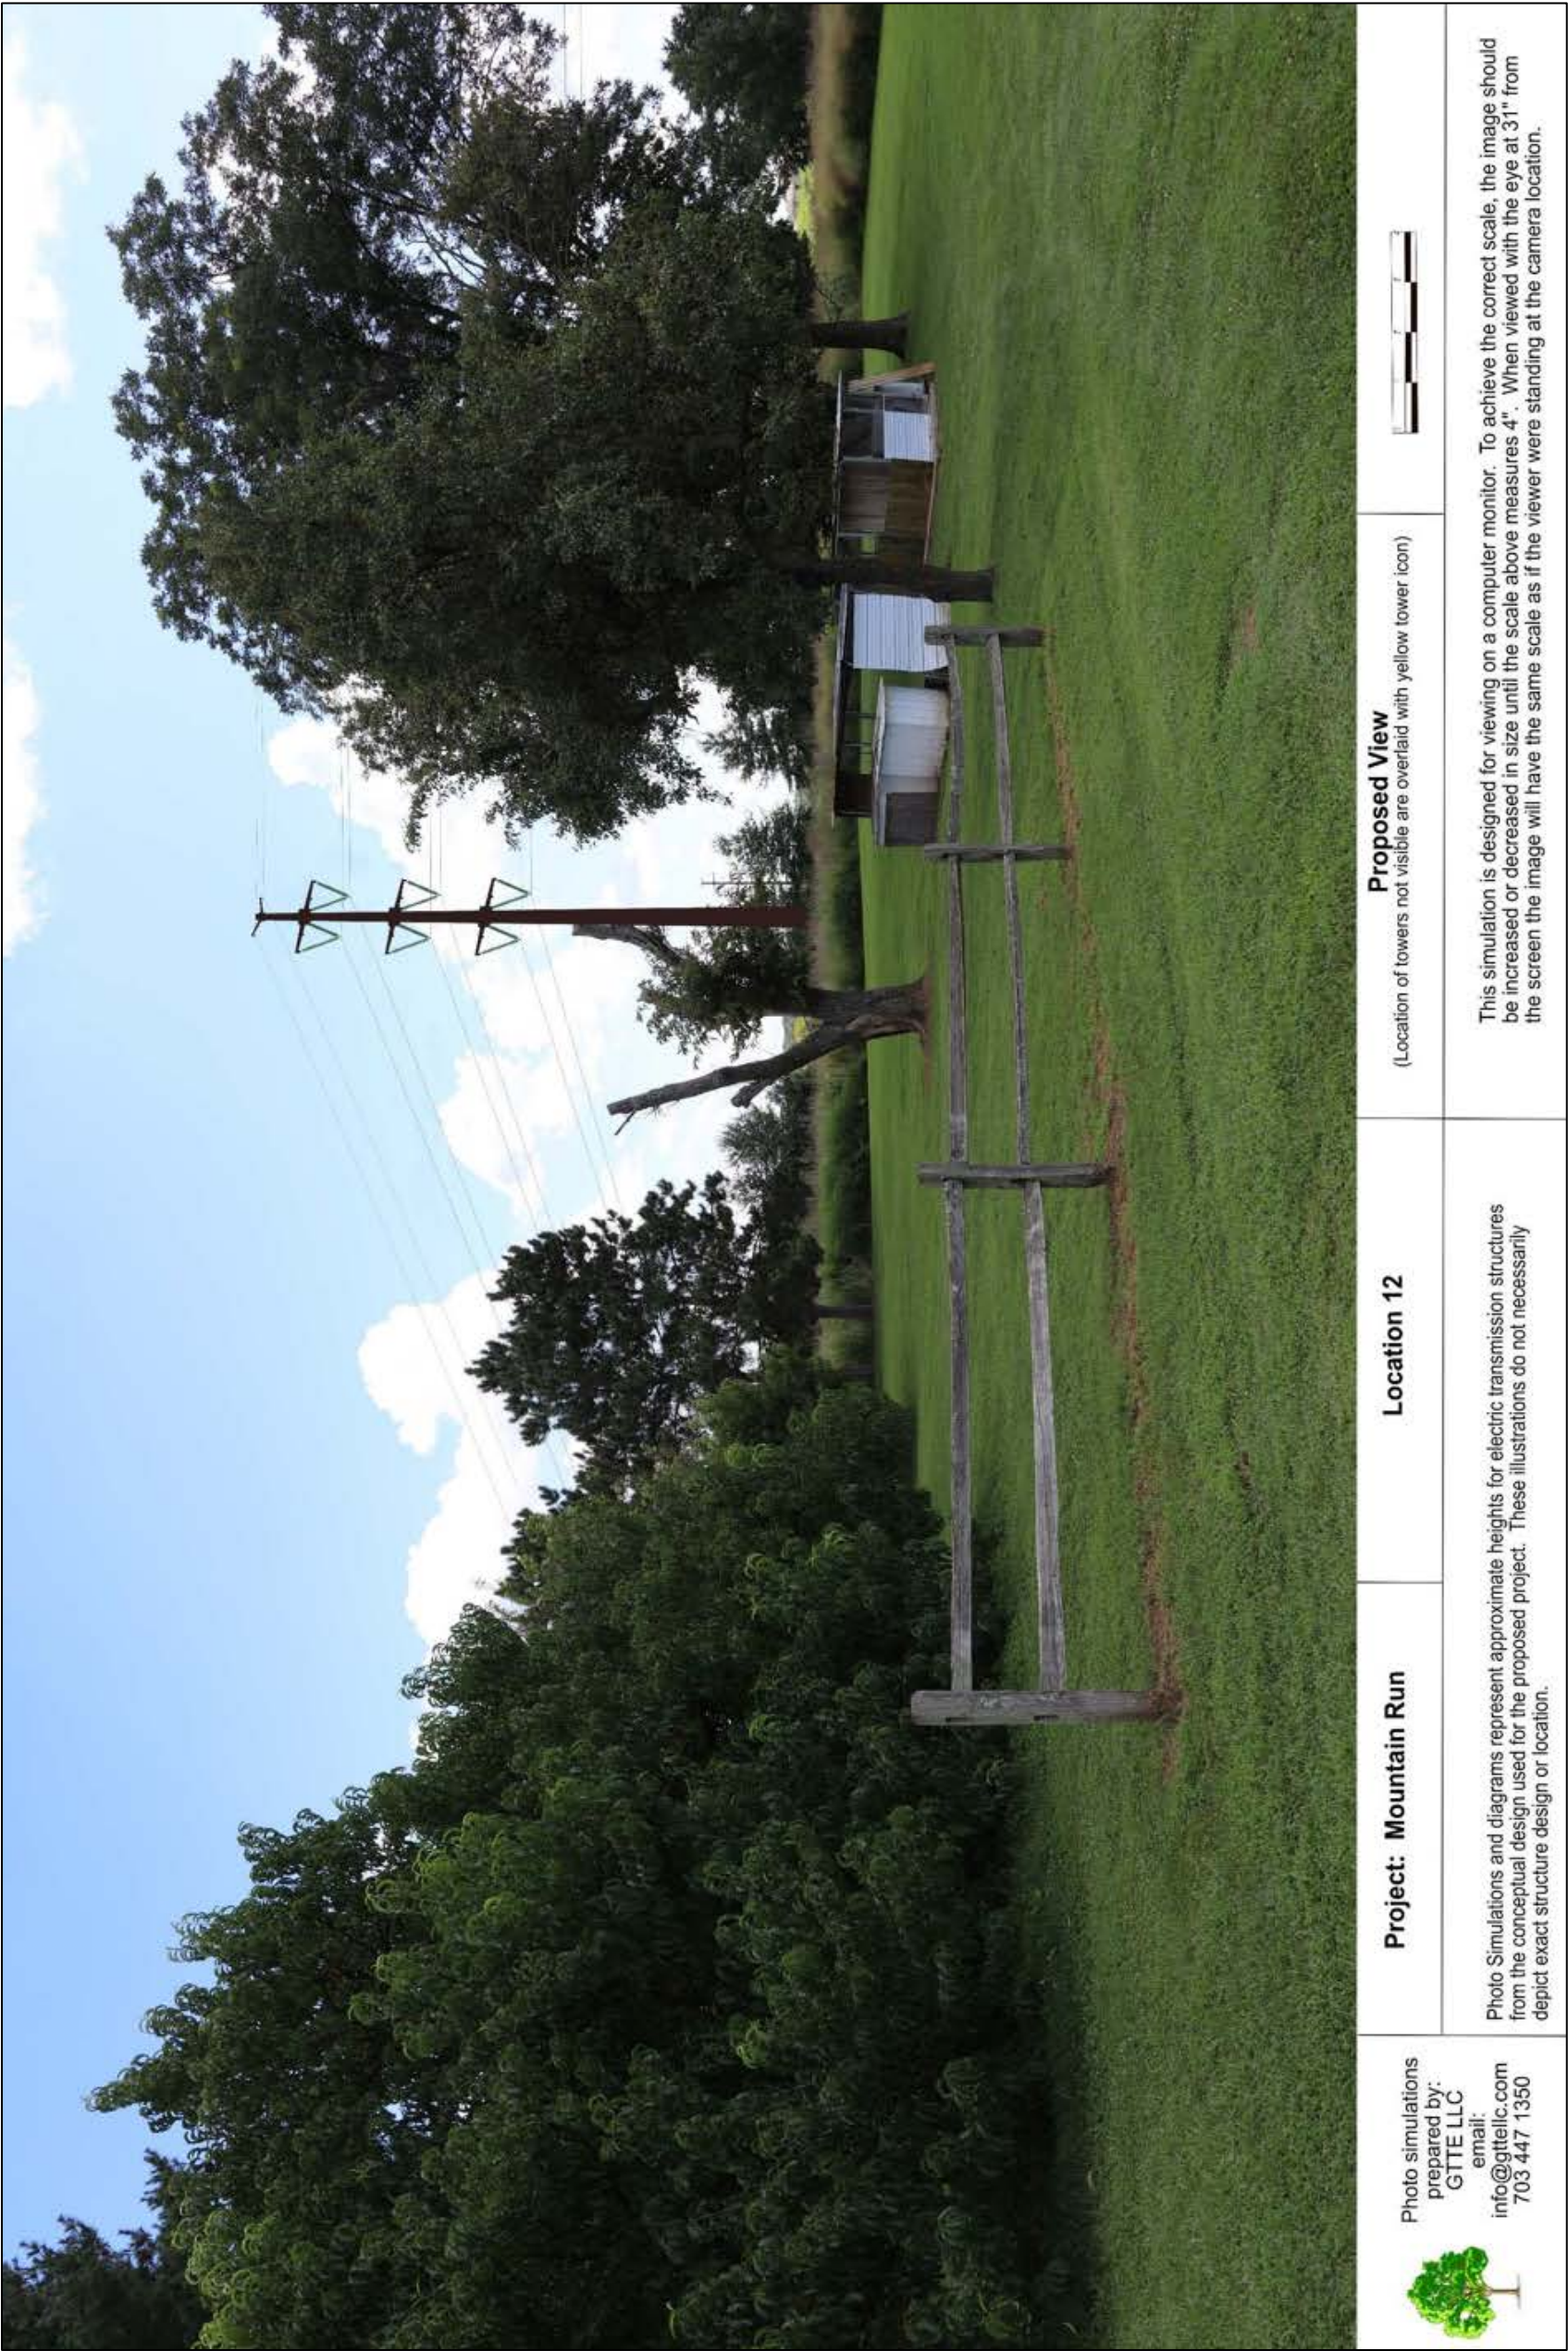
Figure 5-19: Rose Hill Simulation 2 – Proposed view from driveway looking southeast – (Visible structure shown as it would appear). Source: GTTE, LLC

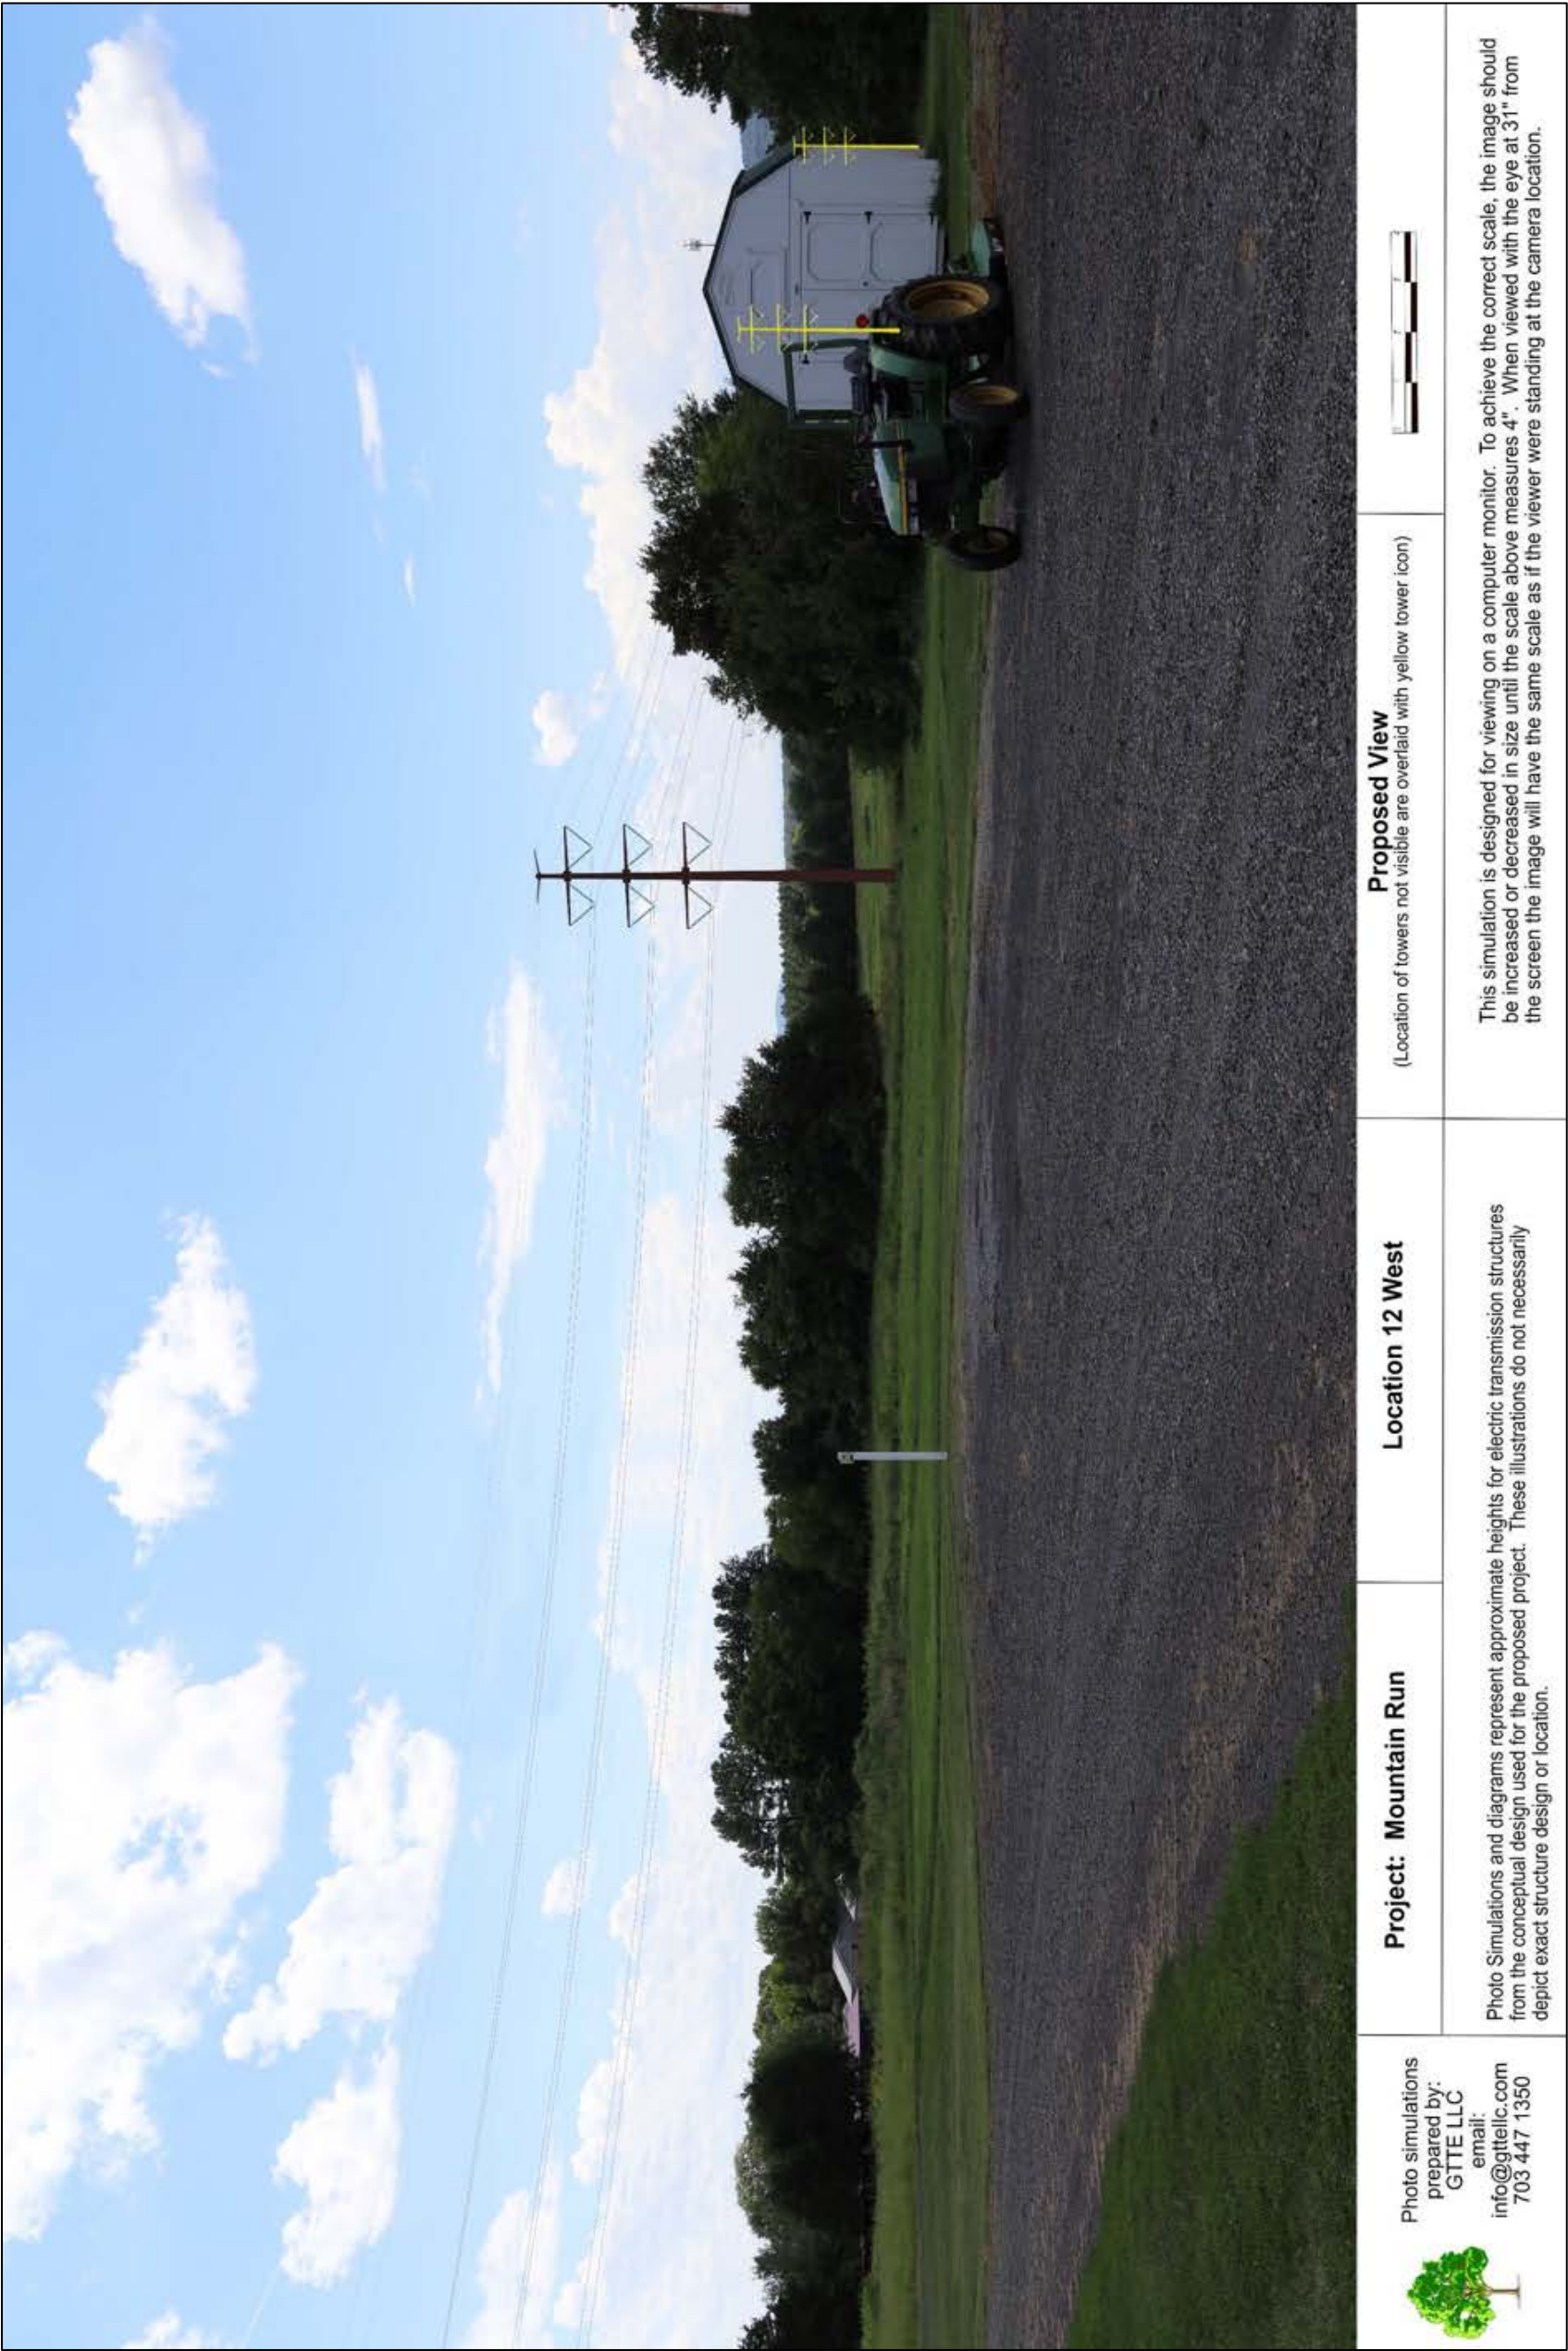
Figure 5-22: Rose Hill Simulation 3 – Proposed view from driveway looking southwest – (Visible structure shown as it would appear). Source: GTTE, LLC

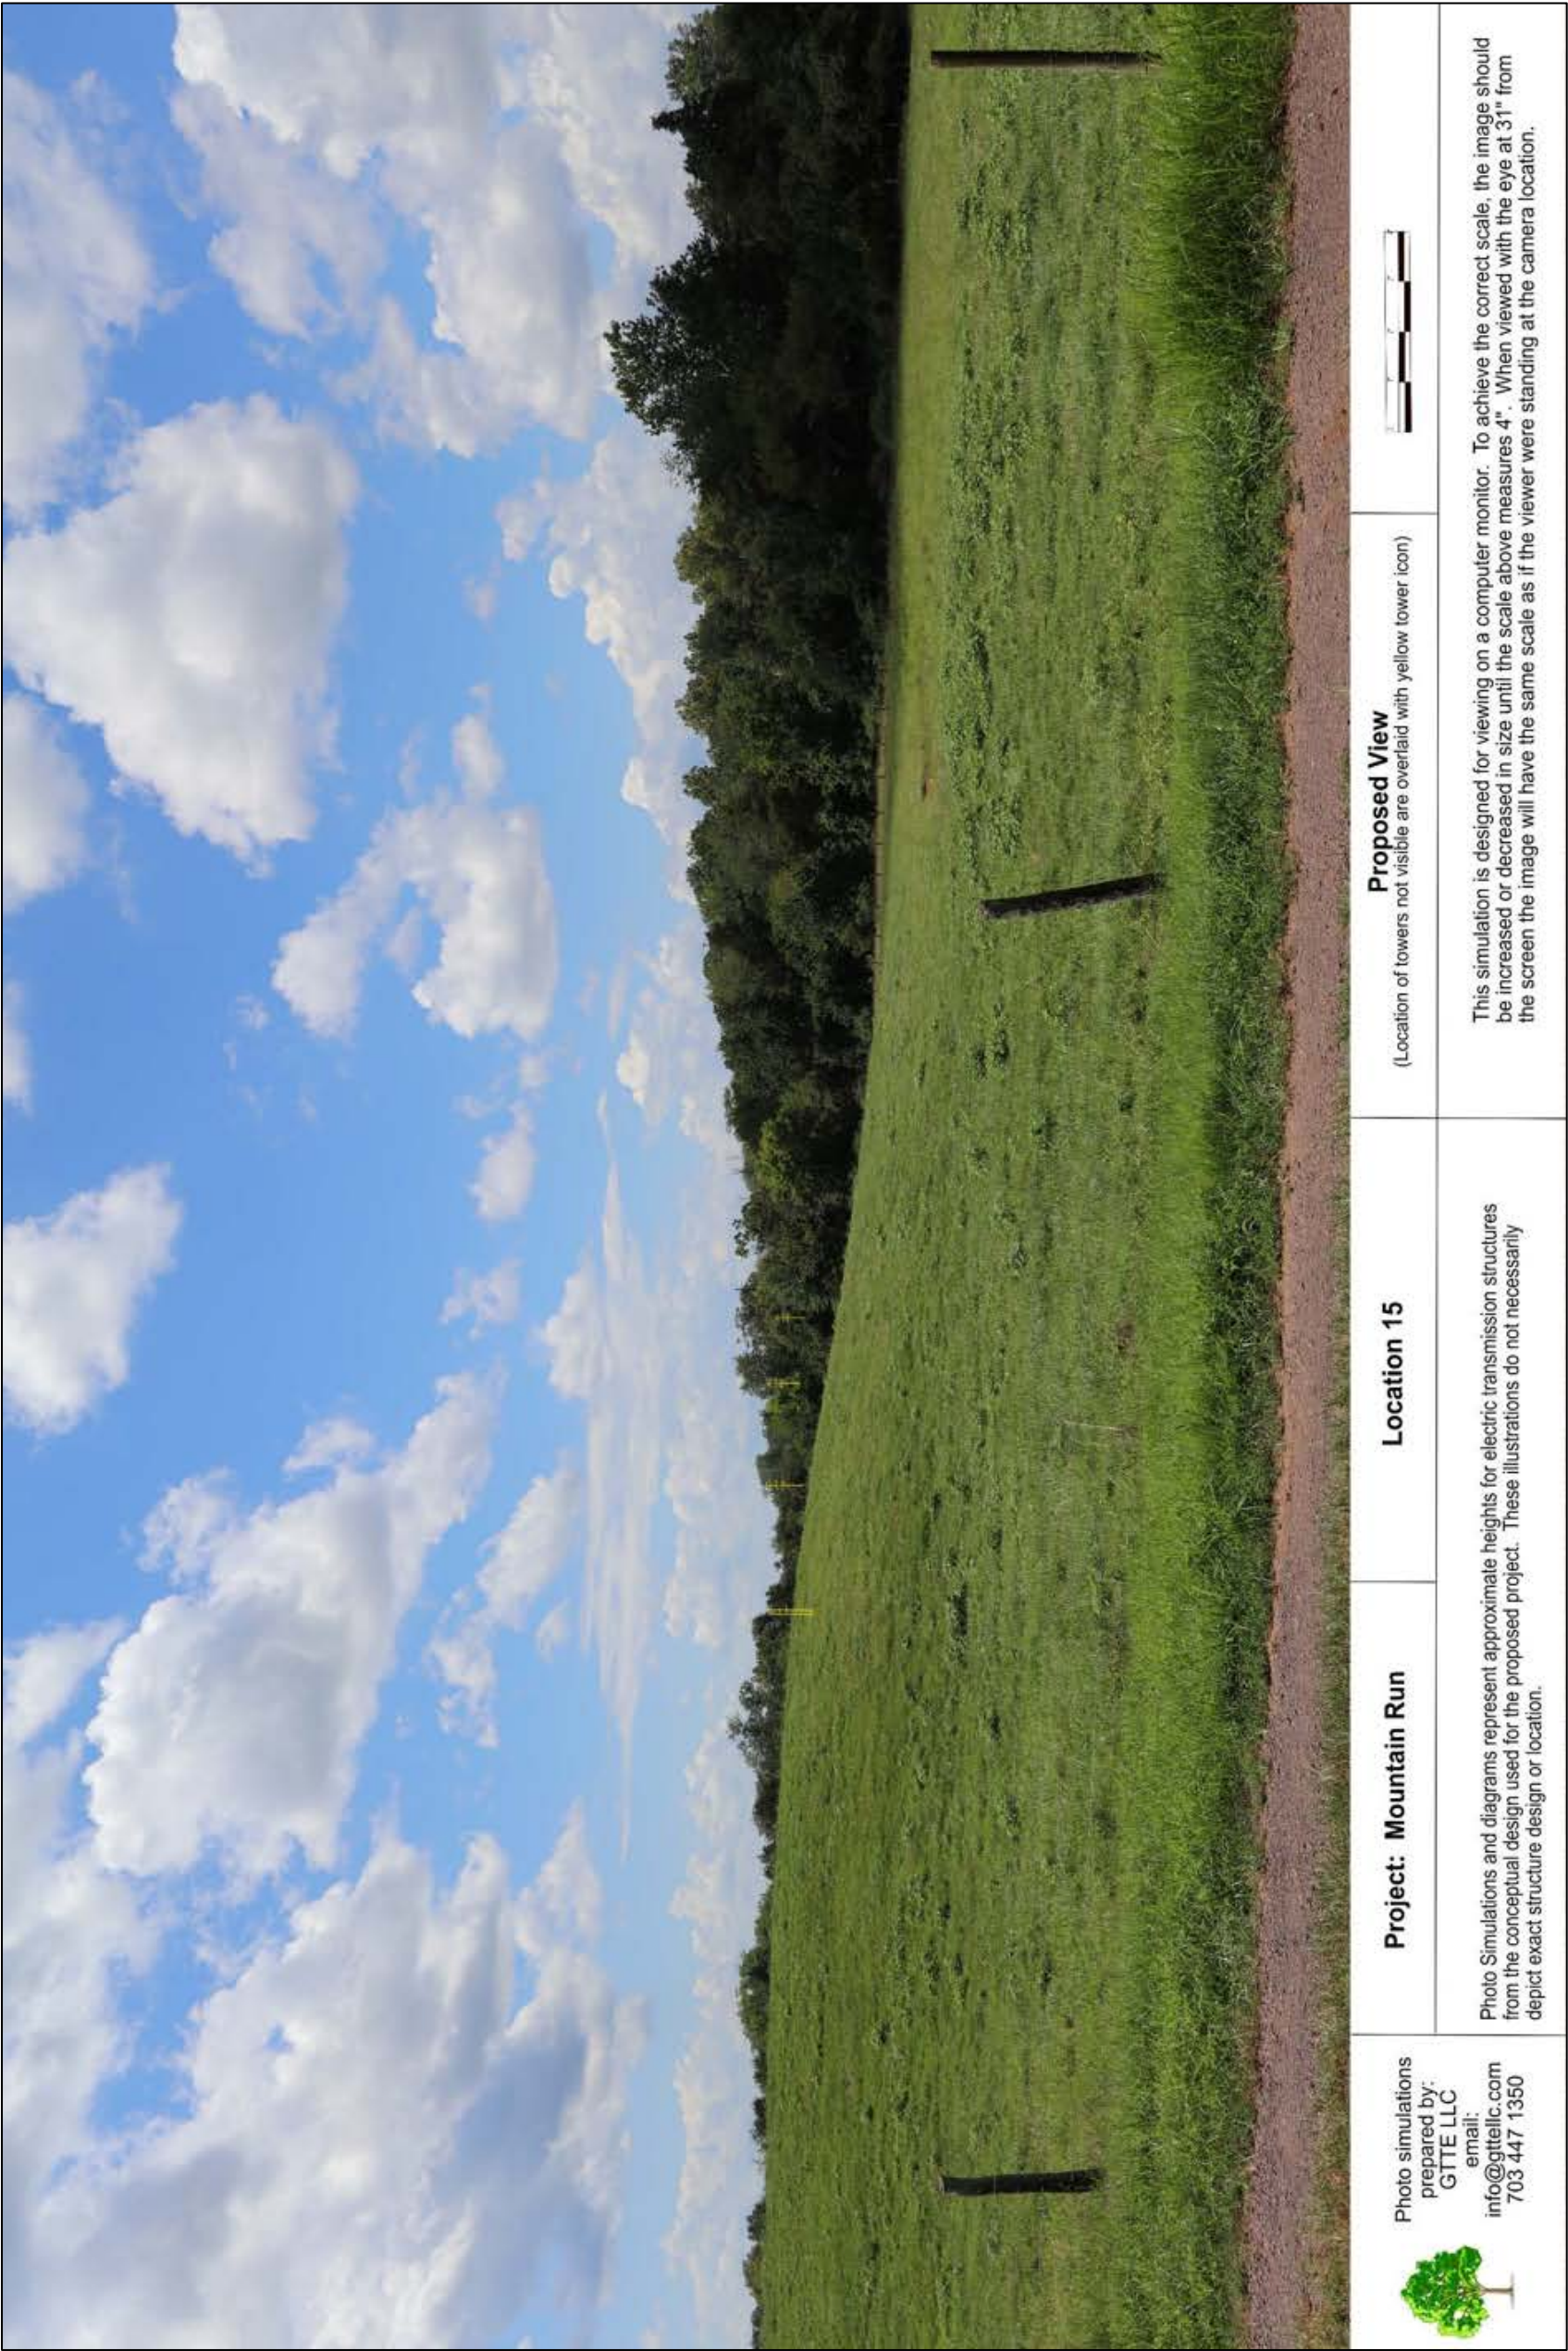
Figure 5-32: Salubria Simulation 1 – Proposed view from gate to property – (Structures not visible shown in yellow). Source: GTTE, LLC

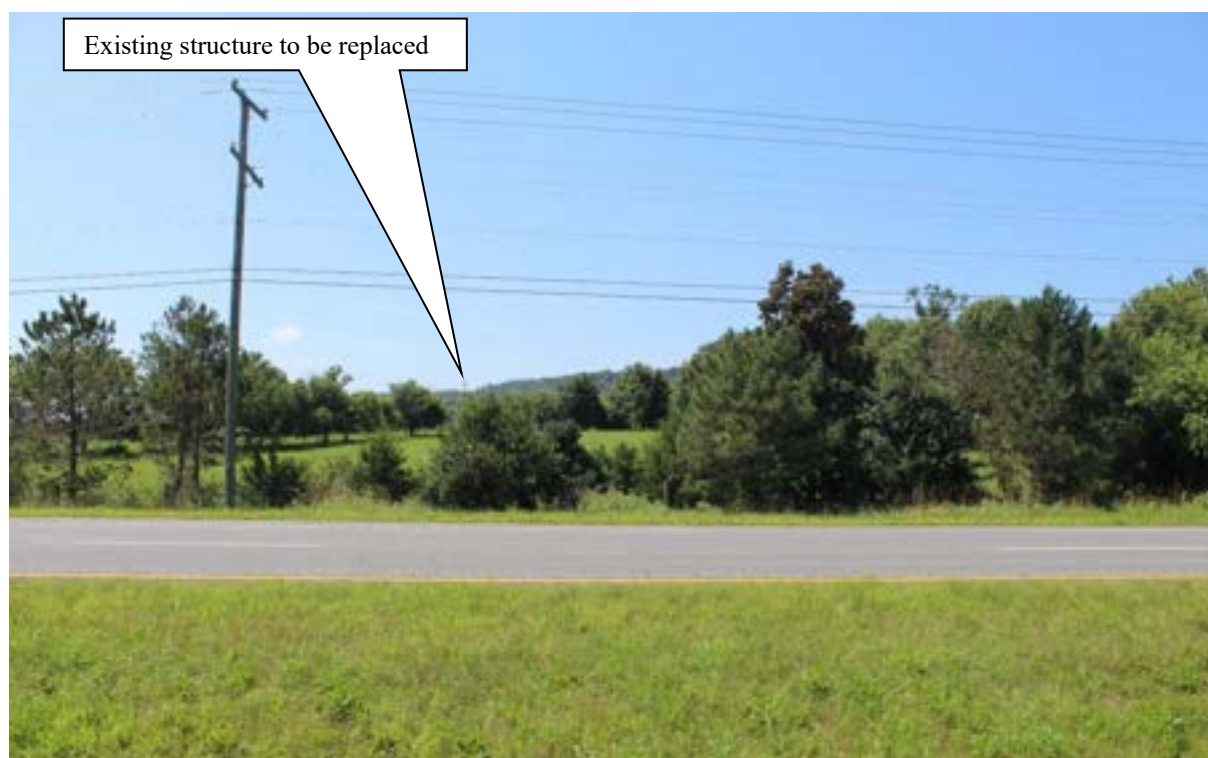
Figure 5-35: Photo location 2- View from front of Signal Hill along Route 3 (One project structure visible), facing south.

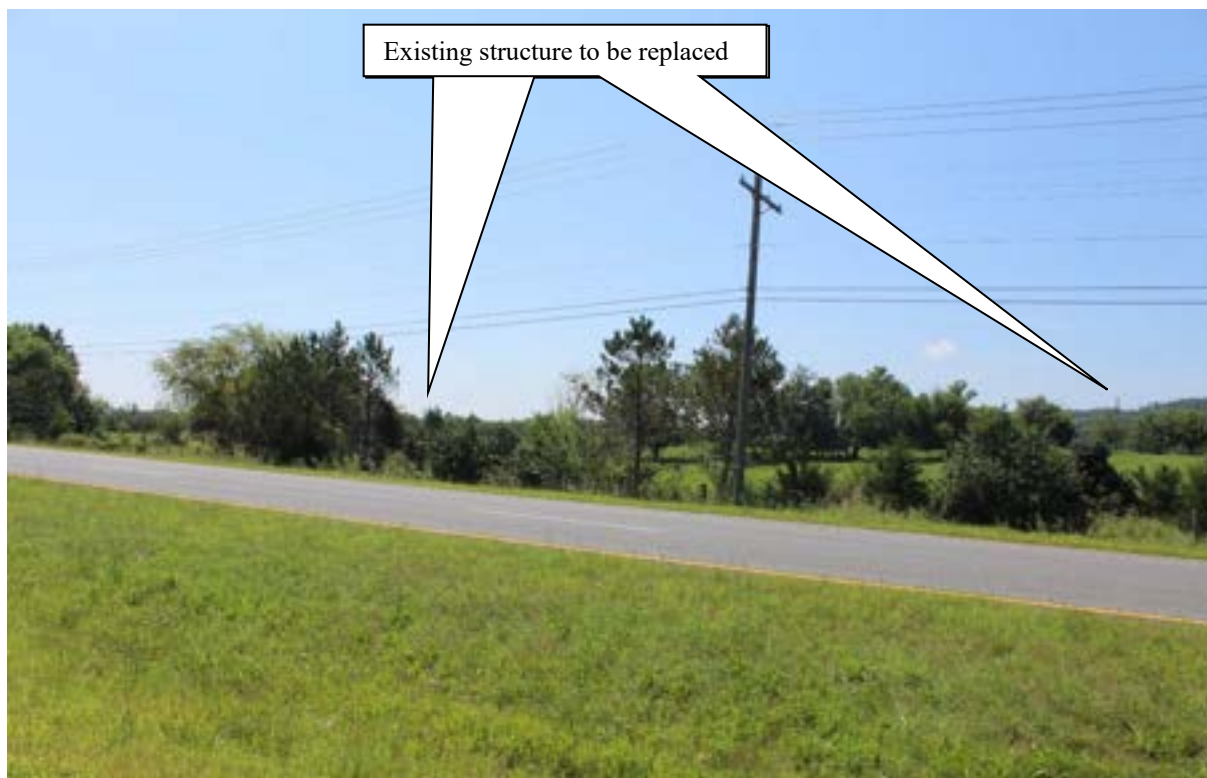
Figure 5-36: Photo location 3- View from front of Signal Hill along Route 3 (Multiple project structures visible), facing southeast.

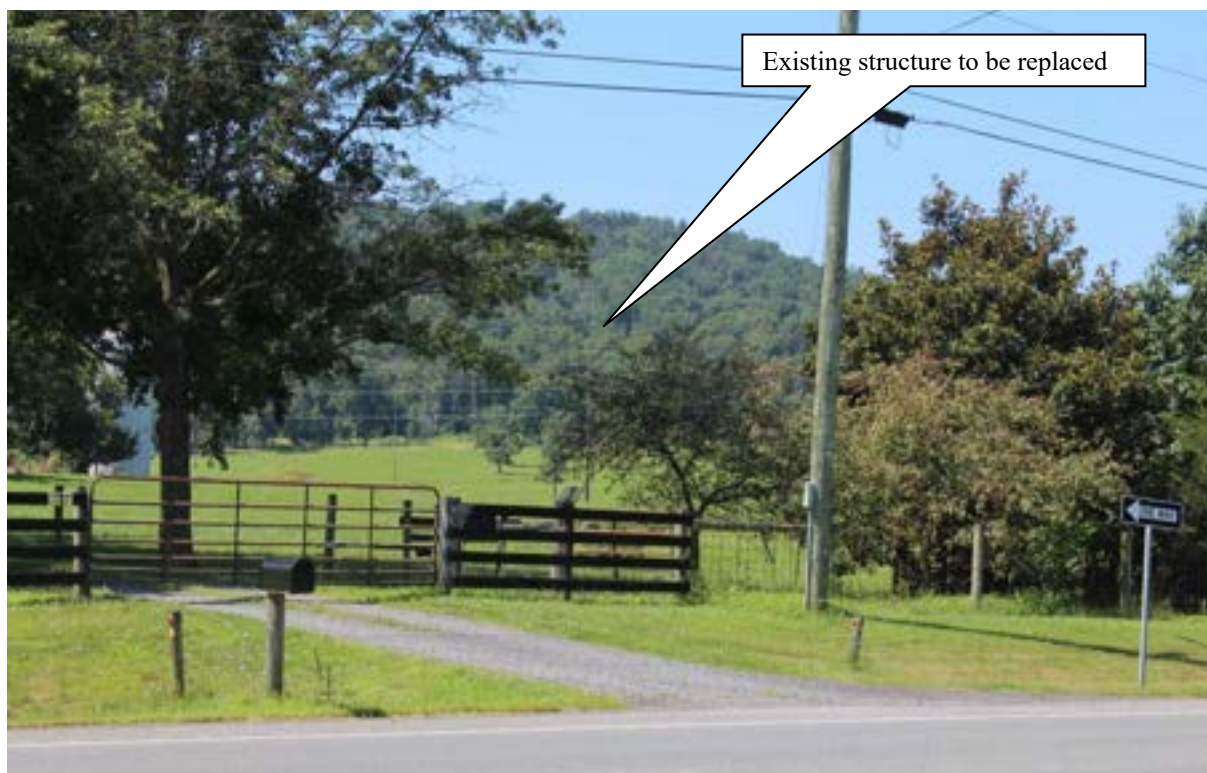
Figure 5-37: Photo location 4- View from driveway to Signal Hill off Route 3 (One project structure visible), facing southwest.

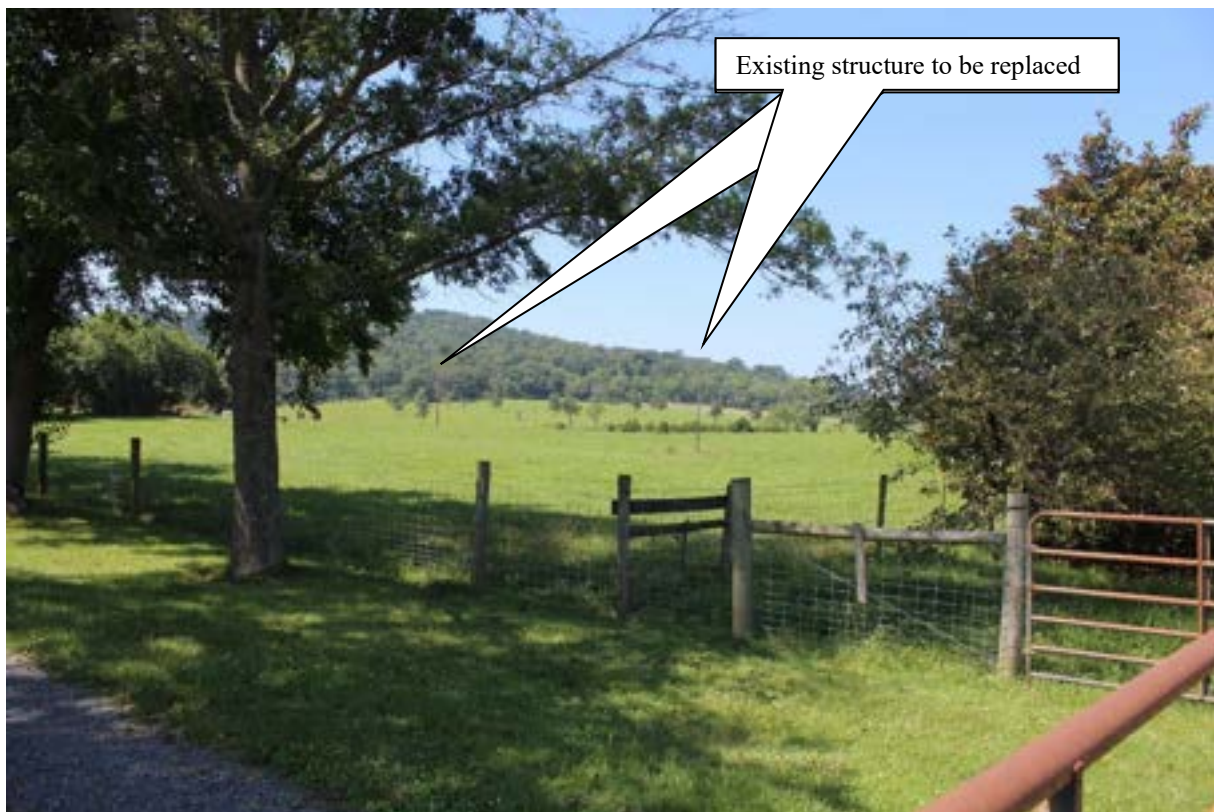
Figure 5-39: Photo location 6- View from driveway to Signal Hill (Multiple project structures visible), facing southwest.

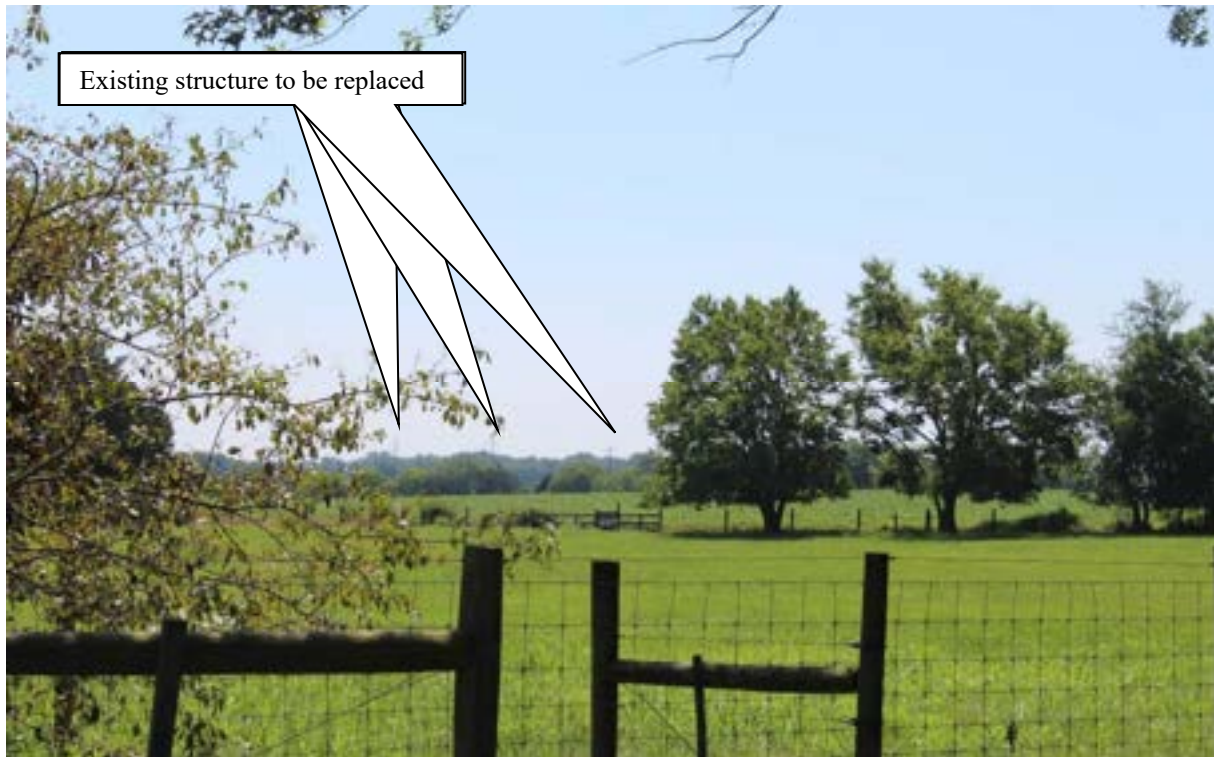
Figure 5-40: Photo location 7- View from front of Signal Hill along Route 3 (Multiple project structures visible), facing southeast.
