**Application, Appendix,
DEQ Supplement, Direct
Testimony and Exhibits of
Virginia Electric and Power
Company**

**Cirrus-Keyser 230 kV Loop and
Related Projects**

Case No. PUR-2022-00198

DEQ Supplement

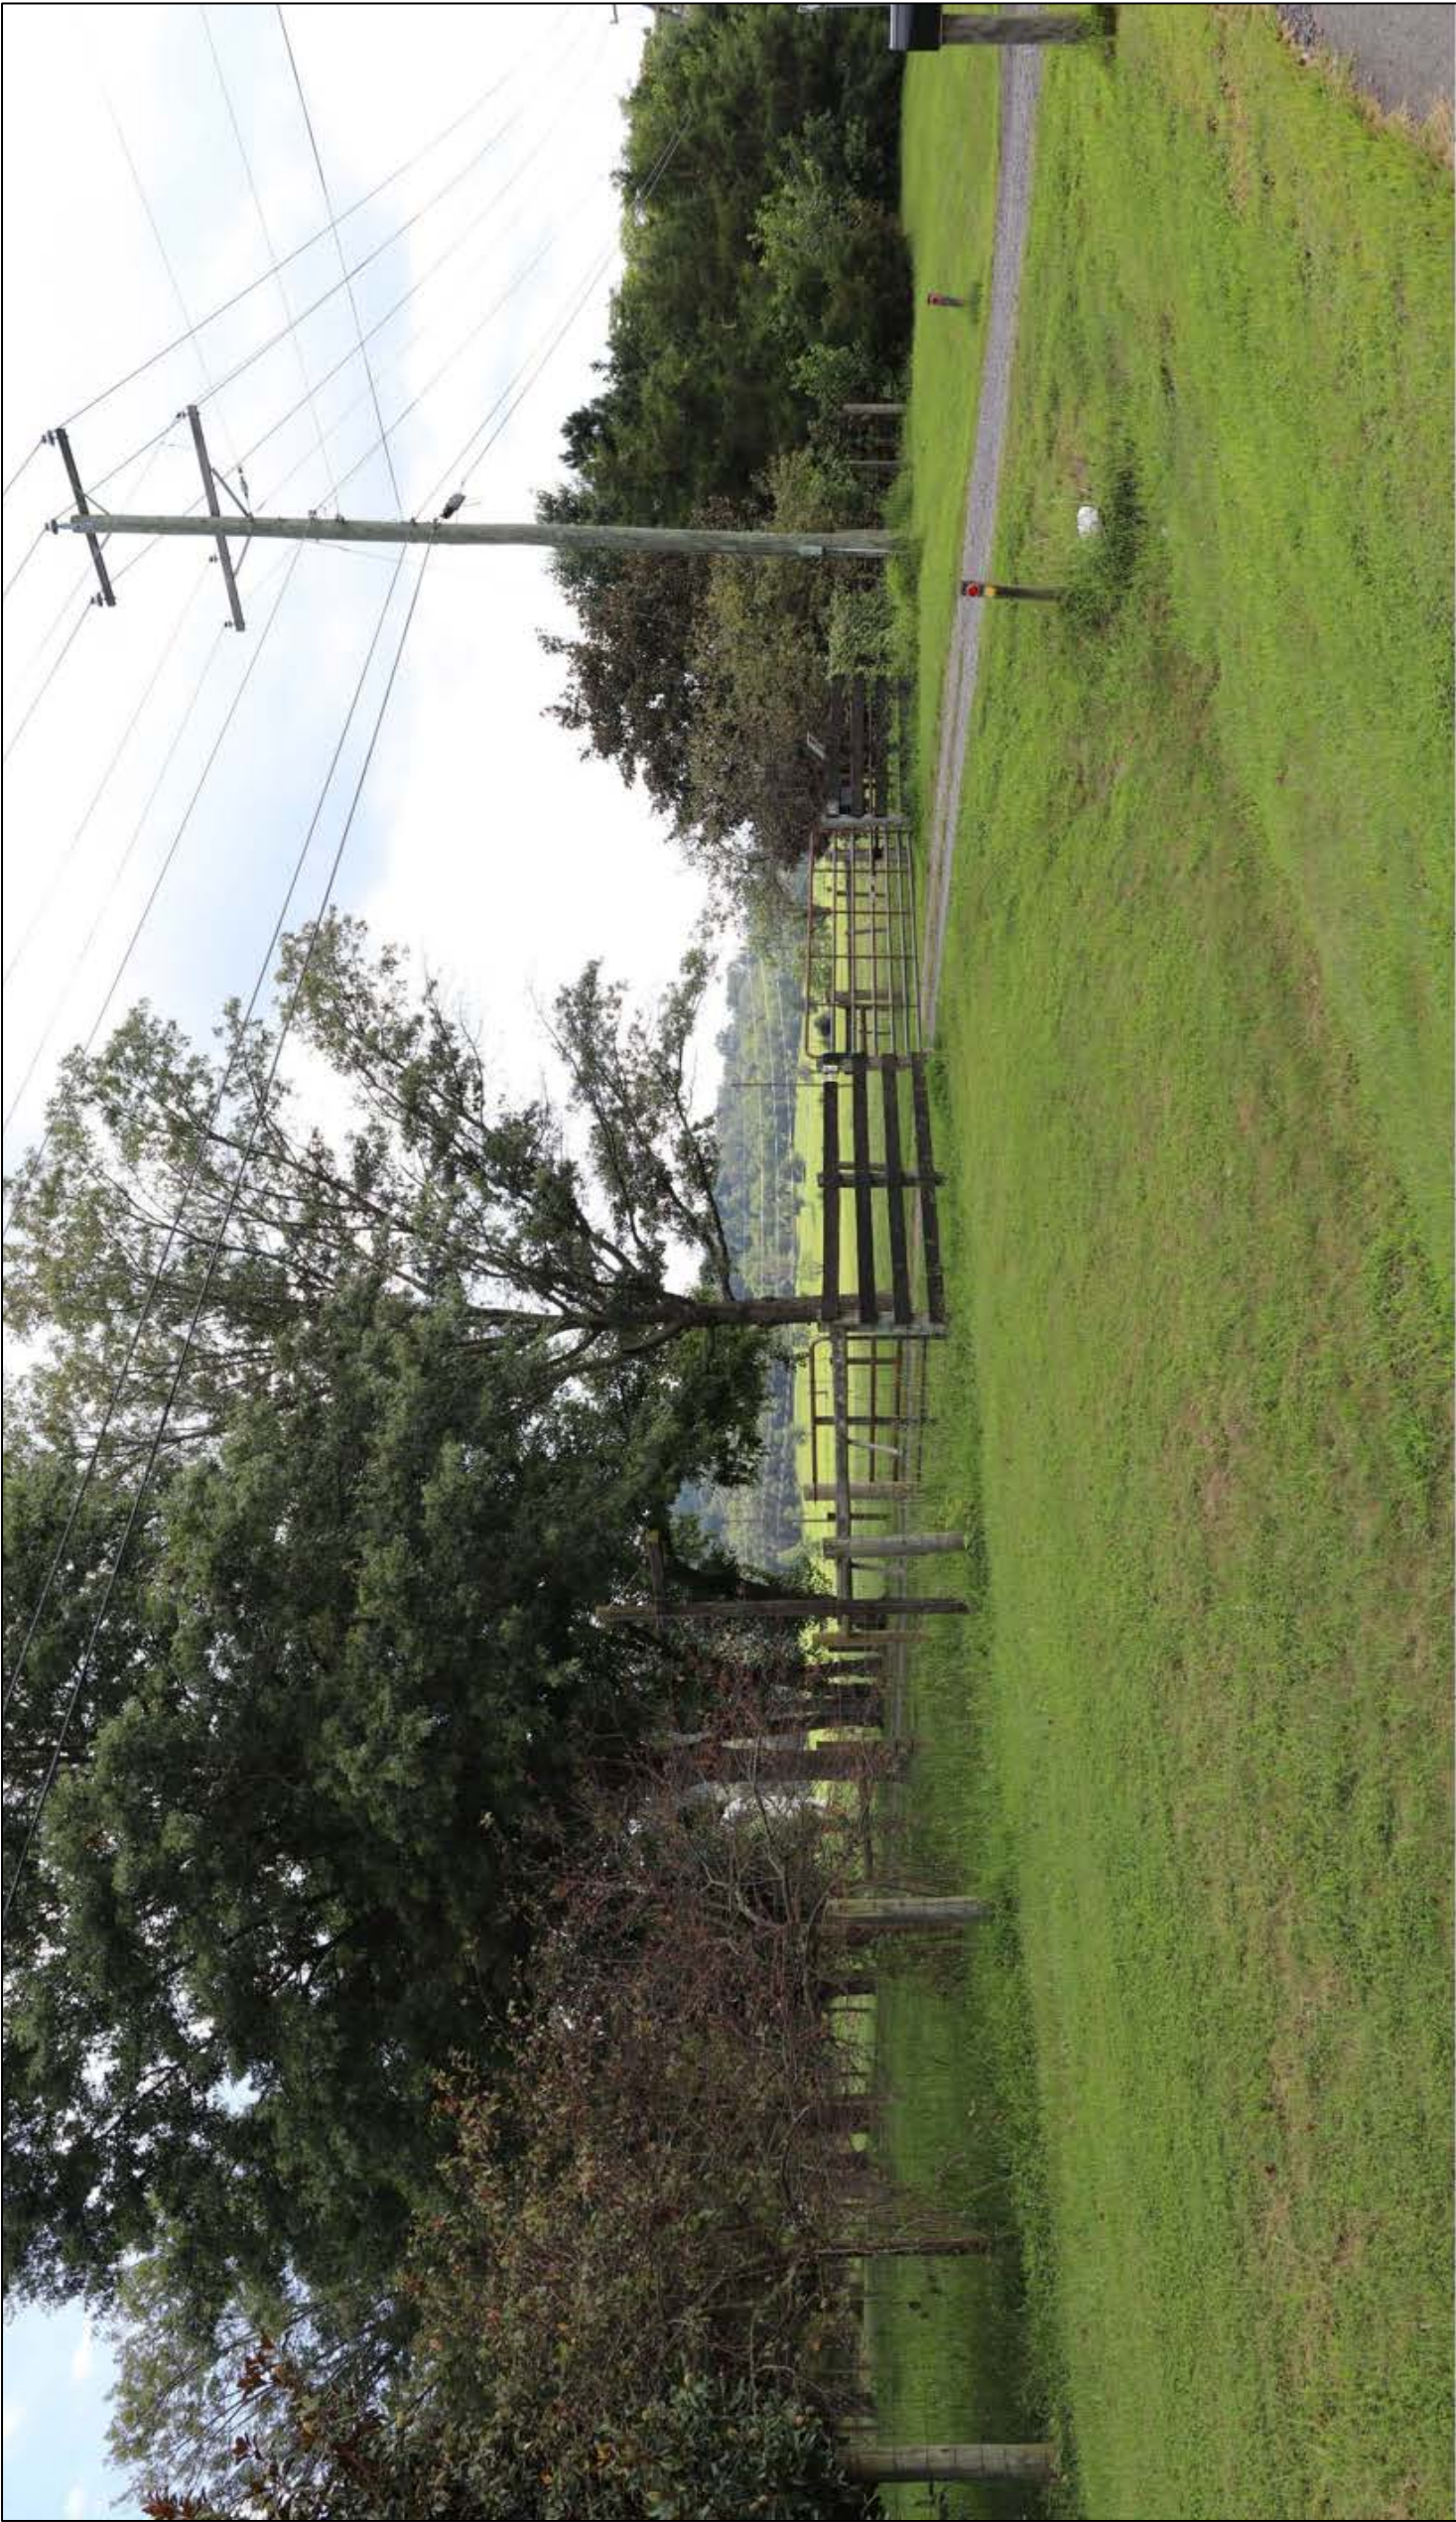
Figure 5-43: Signal Hill Simulation 1 – Existing view from front of driveway. Source: GTTE, LLC

The existing structures on the property are each 80-feet in height and the proposed replacement structures will generally average 100-feet in height. Structures will be replaced on a one-to-one basis near the existing locations with new structures of a similar design, material, and overall appearance. As such, it is anticipated that visibility of the replacement structures will remain similar to the views of existing structures from vantage points within and in the vicinity of the property. Although the structures will be increased in height, they will be replaced by structures of similar finish and configuration. Visibility of structures partially screened by vegetation may increase, although the change in height will be less noticeable for those visible across open field without the backdrop of vegetation. This was confirmed by photo simulation from the public ROW along the front of the property that revealed an increase in height of visible structures within the field to the side of the house but no additional visibility of currently screened structures. Therefore, the increase in height may be perceptible, but will not introduce any substantially new or cumulative impacts to the viewshed or setting of the resources that already includes multiple transmission structures and wide views of the transmission line. Nor will the project detract from or compromise those qualities and characteristics that make the property eligible for listing in the NRHP. It is therefore D+A's opinion that the Cirrus – Keyser 230 kV Loop and Related Projects will pose no more than a *minimal impact* on Signal Hill.

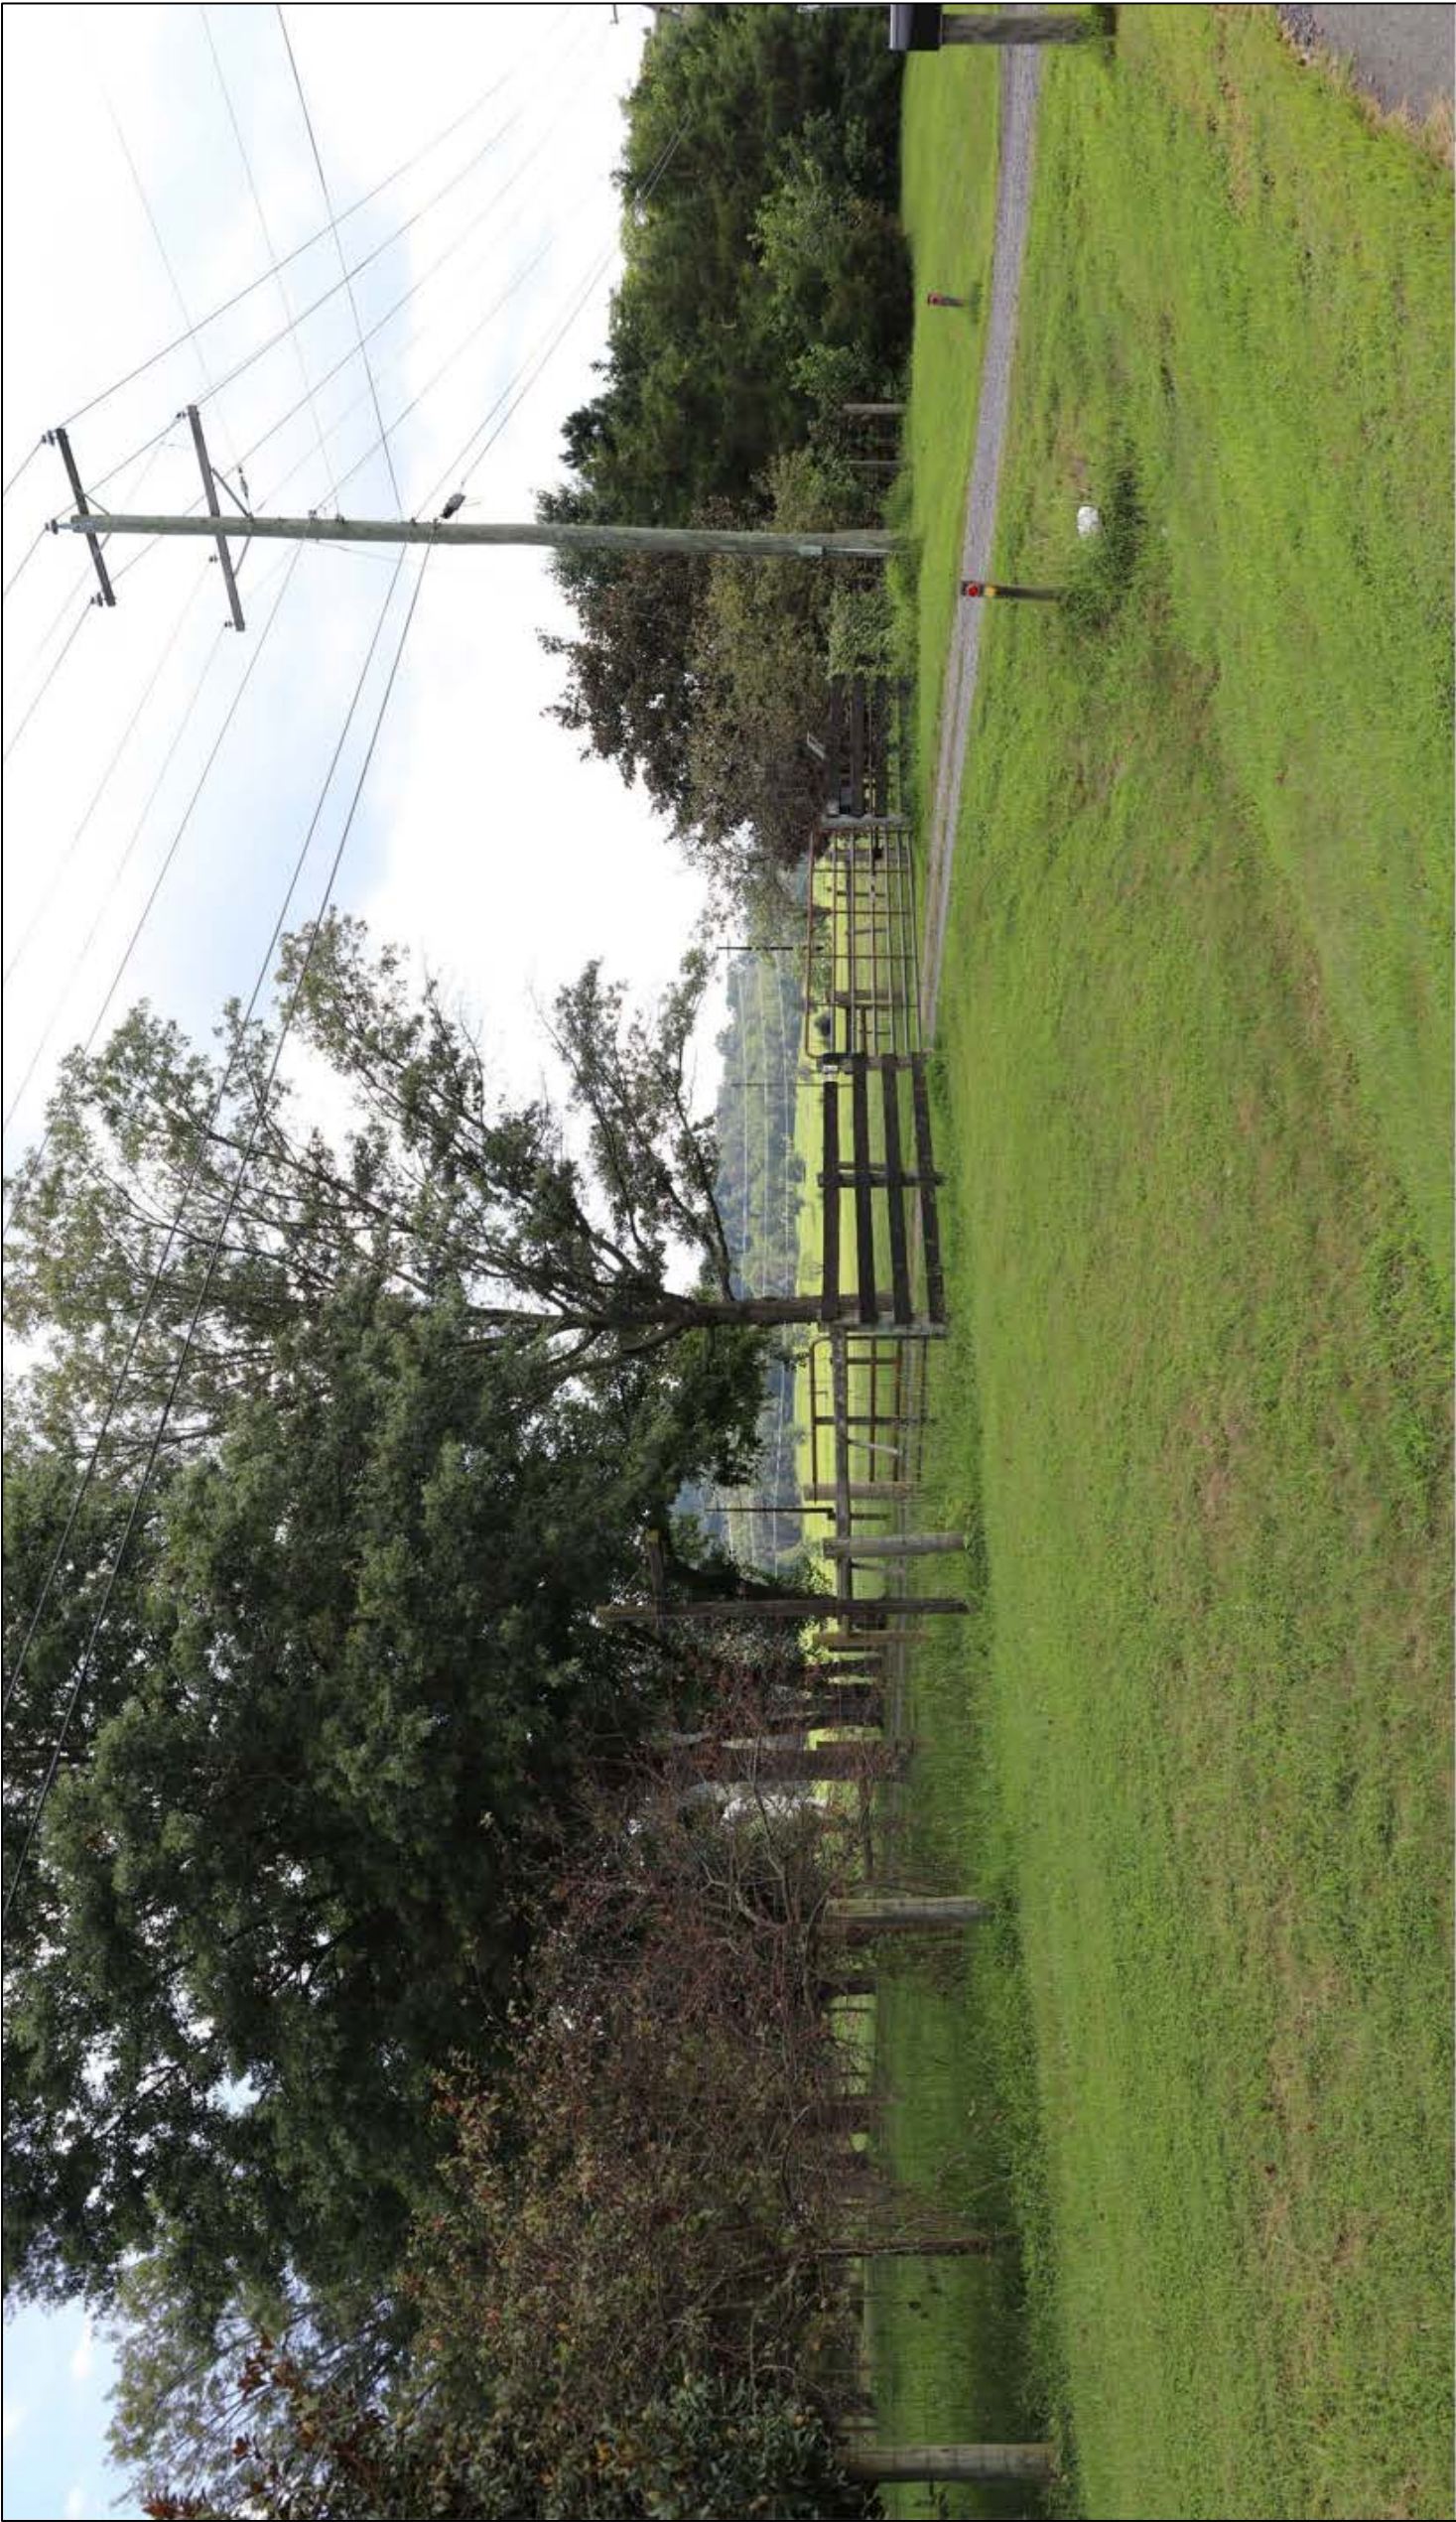
Proposed View (Location of towers not visible are overlaid with yellow tower icon)

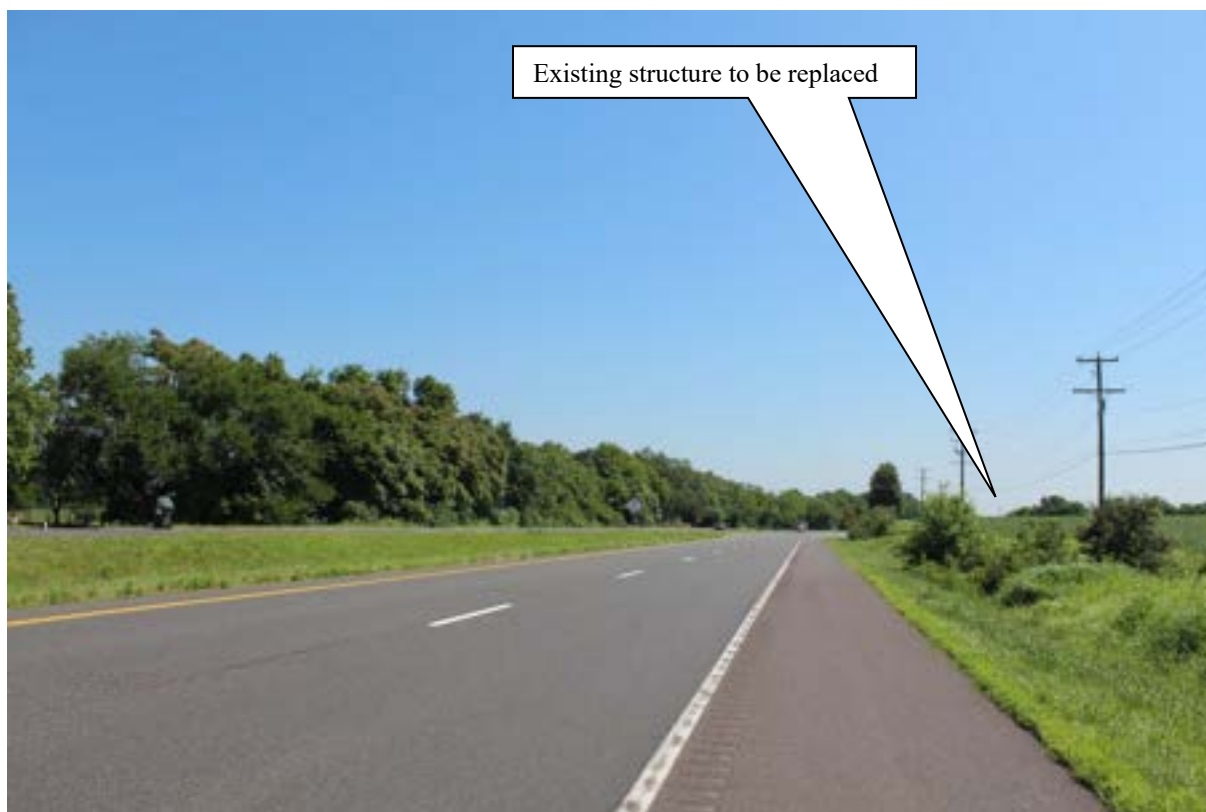
Figure 5-47: Photo location 2- View from front of Croftburn Farm along Route 3 (One project structure visible), facing east.

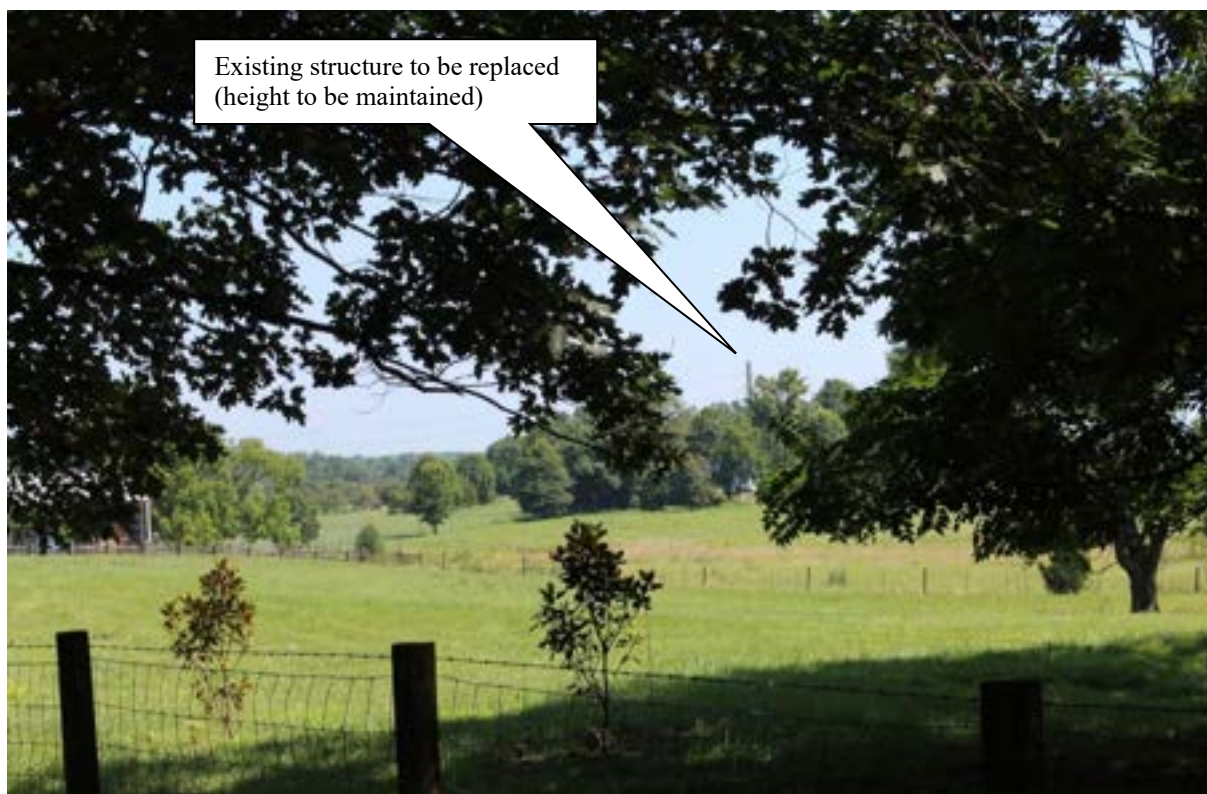
Figure 5-49: Photo location 4- View from driveway to Croftburn Farm (One project structure visible), facing northeast.

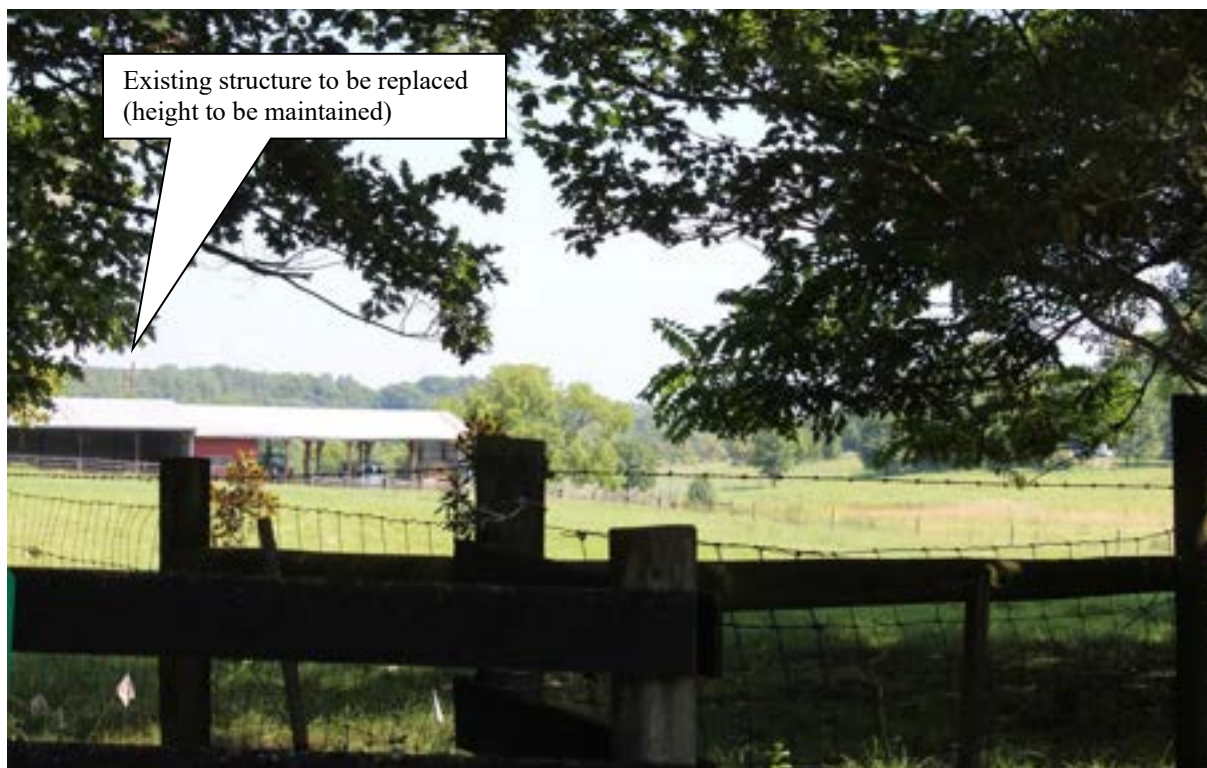
Figure 5-50: Photo location 5- View from driveway to Croftburn Farm (One project structure visible), facing northeast.

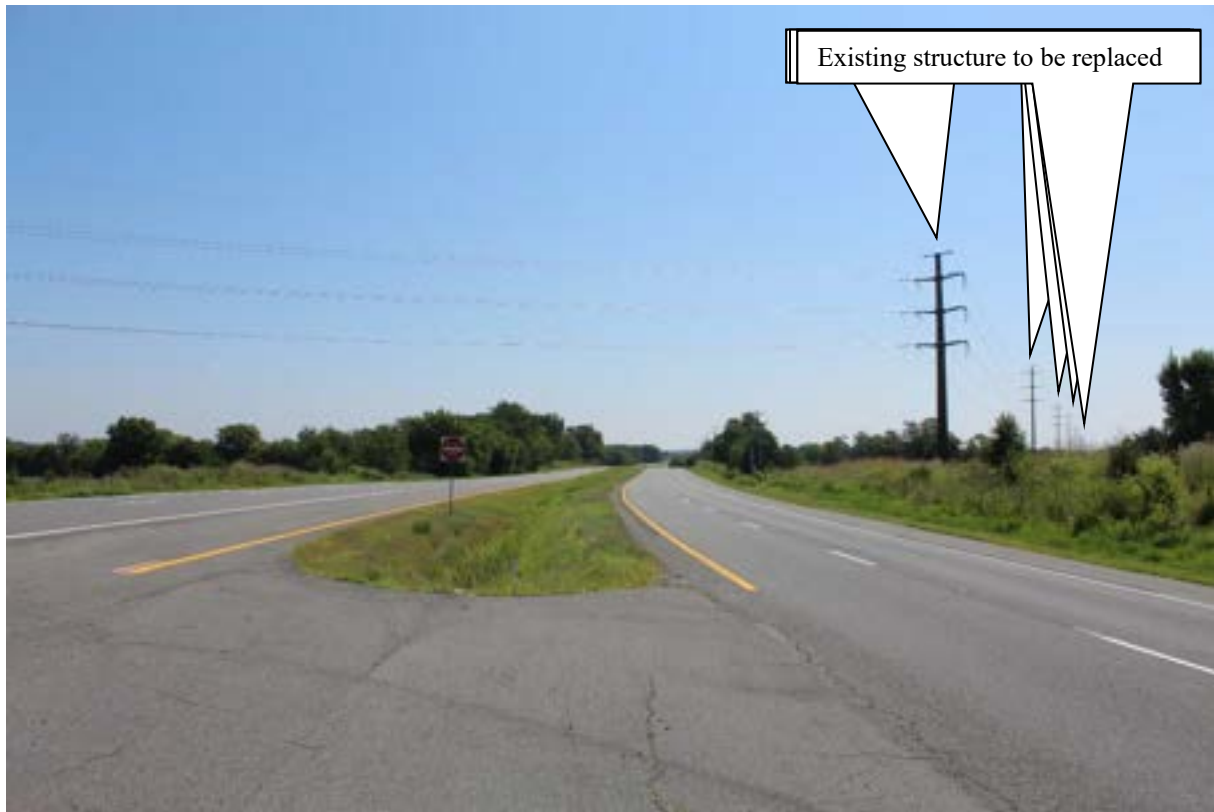
Figure 5-54: Photo location 9- View from eastern edge of Croftburn Farm property (multiple project structures visible), facing east.

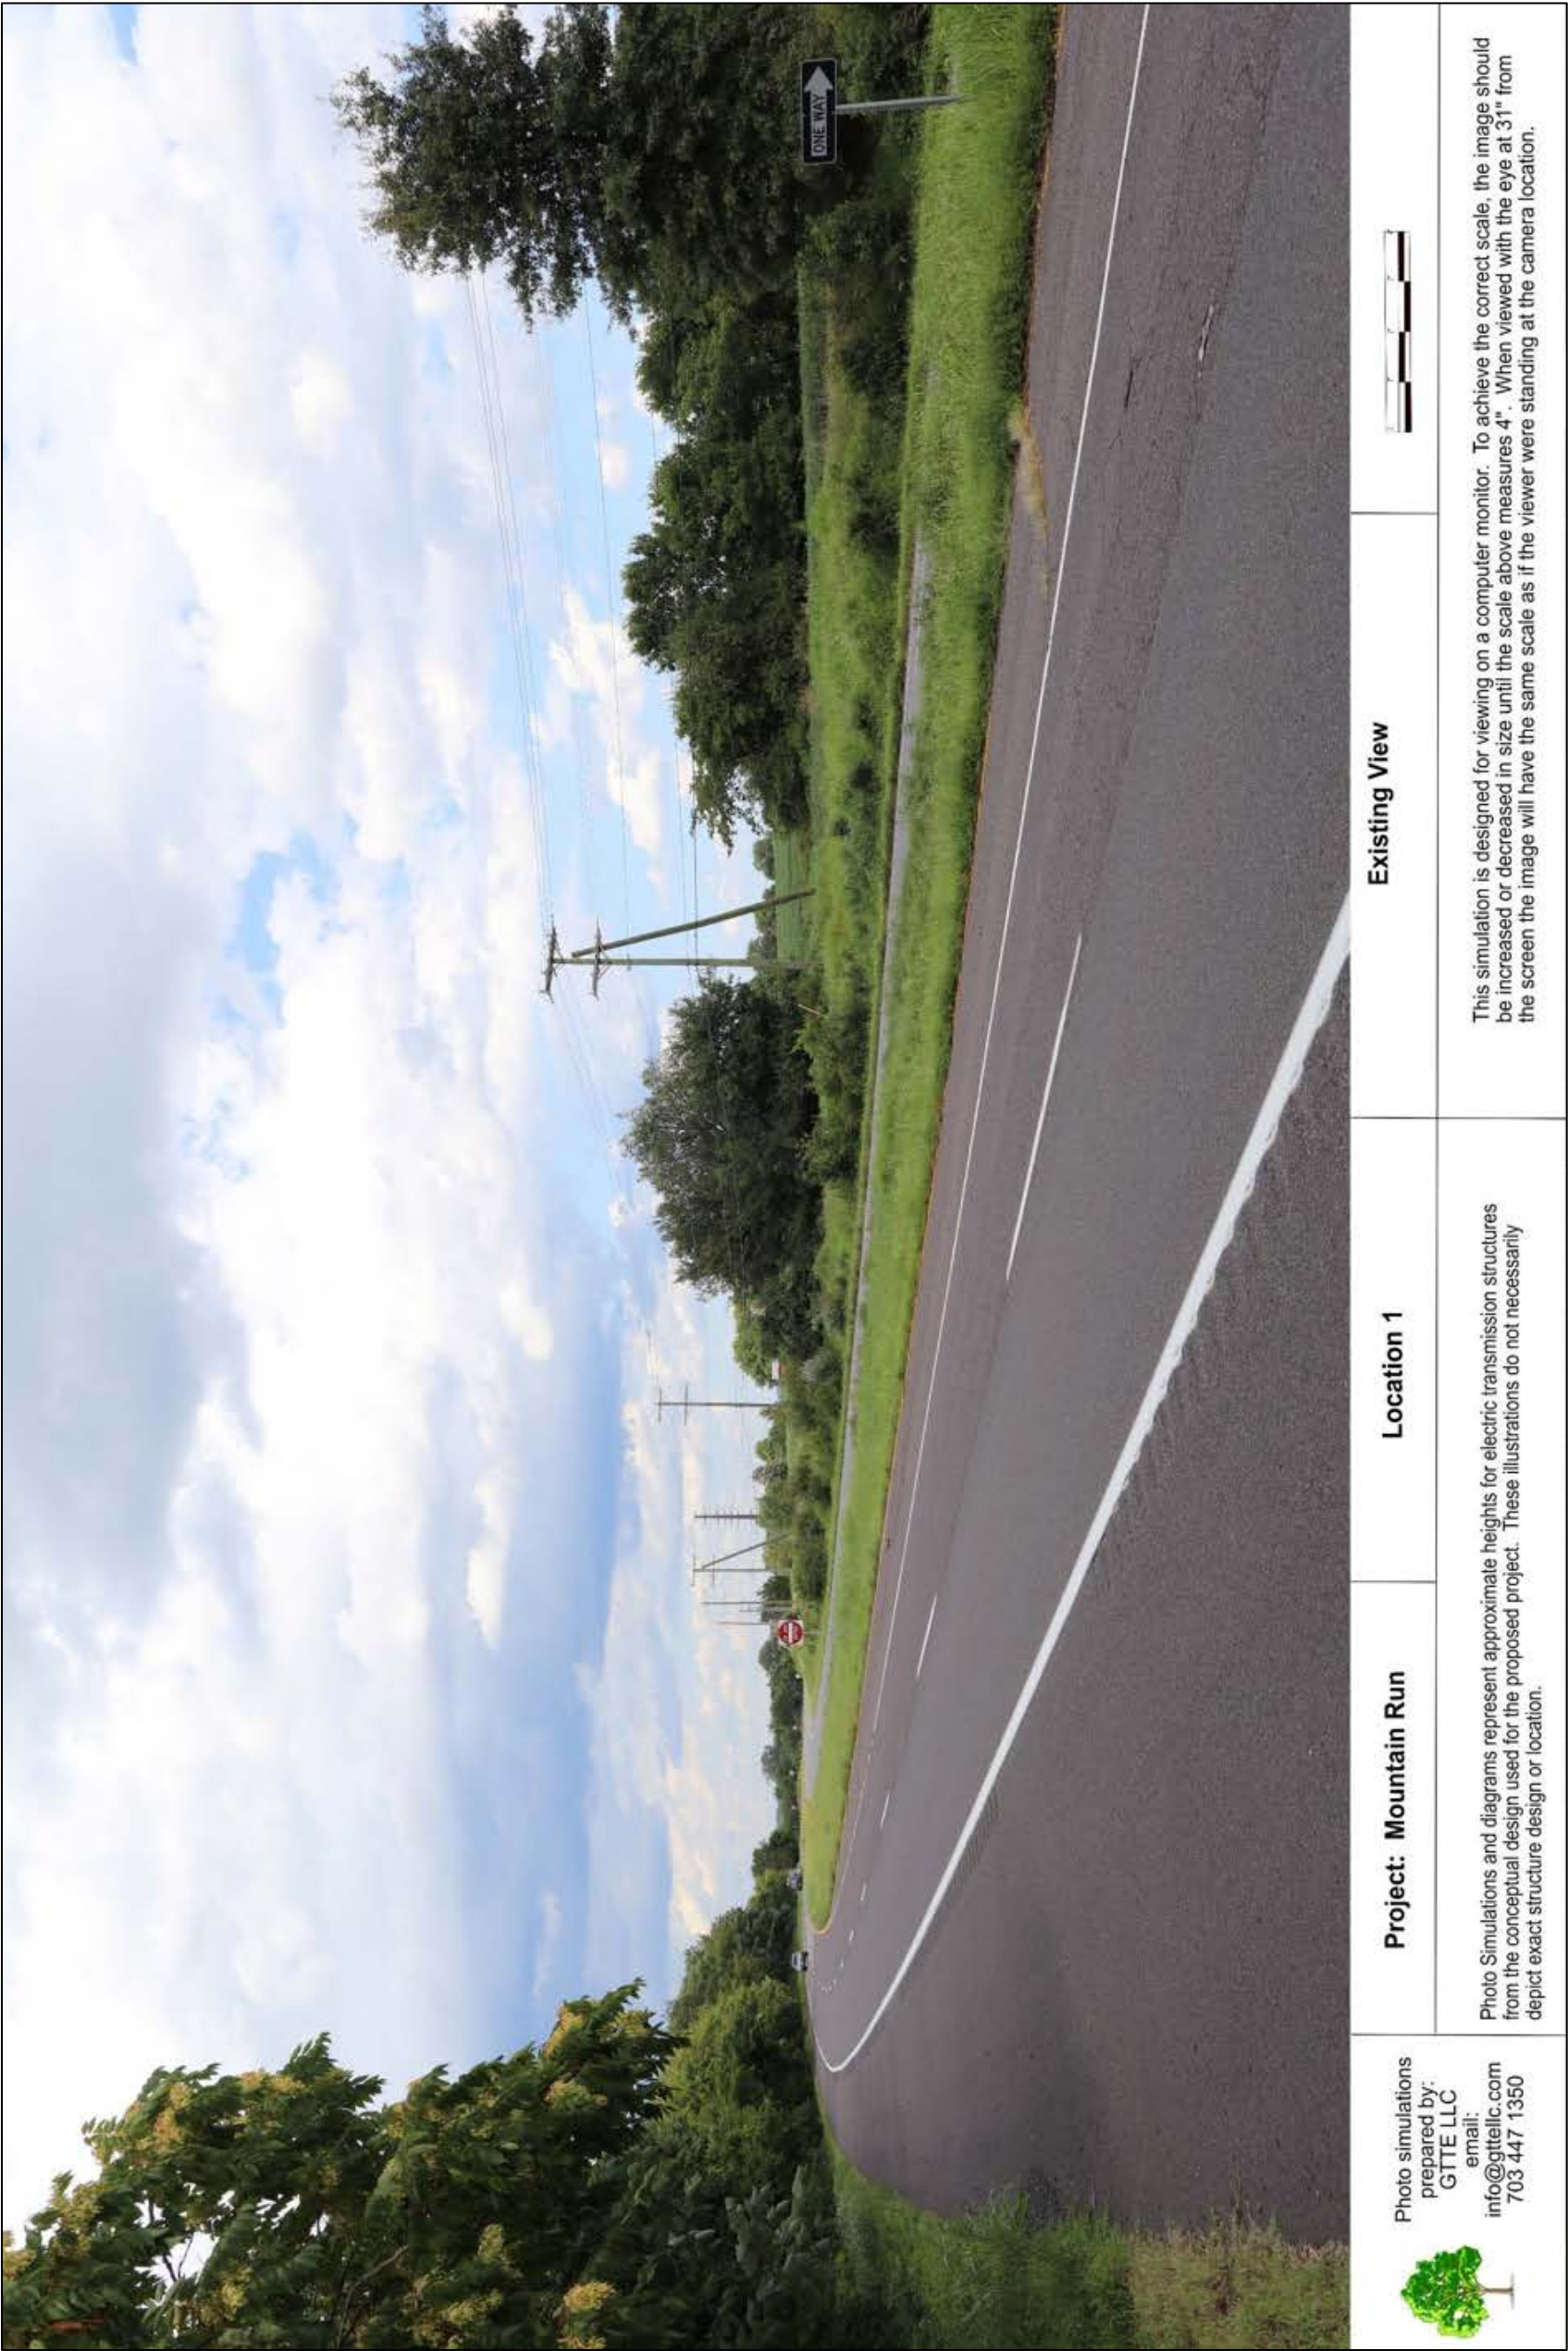
Figure 5-56: Croftburn Simulation 1 – Existing view from front of driveway. Source: GTTE, LLC

The existing structures on the property are each 80-feet in height and the proposed replacement structures will generally average 100-feet in height, although the three structures nearest to the house will remain 80-feet. While structures further away will be replaced on a one-to-one basis near the existing locations, the three nearest the house will be shifted along the centerline slightly and be replaced with structures of identical height and design to the existing. As such, it is anticipated that visibility of the replacement structures will remain similar to the views of existing structures from vantage points within and in the vicinity of the property. The three structures currently not visible from the house itself will be shifted but no taller, while other structures to the rear and extending away from the property to the east will be taller. Although the structures will be increased in height, they will be replaced by structures of similar finish and configuration and as they are currently visible across open landscape across the road from the house, visibility as a result of the change in height is not anticipated to be substantial. This was confirmed by photo simulation from the front of the property and the nearby public ROW. Views from the front of the driveway currently include just one structure, and while that structure will increase in height, it will continue to be seen amongst other structures in the foreground. Simulation also showed the views towards the structures set adjacent to the side of the property will shift on the landscape as a result of the shift, but there will be no noticeable increase in height. Views of the structures across the road from this location will still include multiple structures seen down the ROW and the increase in height is minimally noticeable due to retention of the same structure configuration. Therefore, the increase in height may be perceptible from discrete publicly-accessible locations, however, no change in height will be observed from the house itself. As such, the project is not anticipated to introduce any substantially new or cumulative impacts to the viewshed or setting of the resources that already includes multiple transmission structures and wide views of the transmission line, nor will it detract from or compromise those qualities and characteristics that make the property eligible for the NRHP. It is therefore D+A's opinion that the Cirrus – Keyser 230 kV Loop and Related Projects will pose no more than a *minimal impact* on Croftburn Farm.

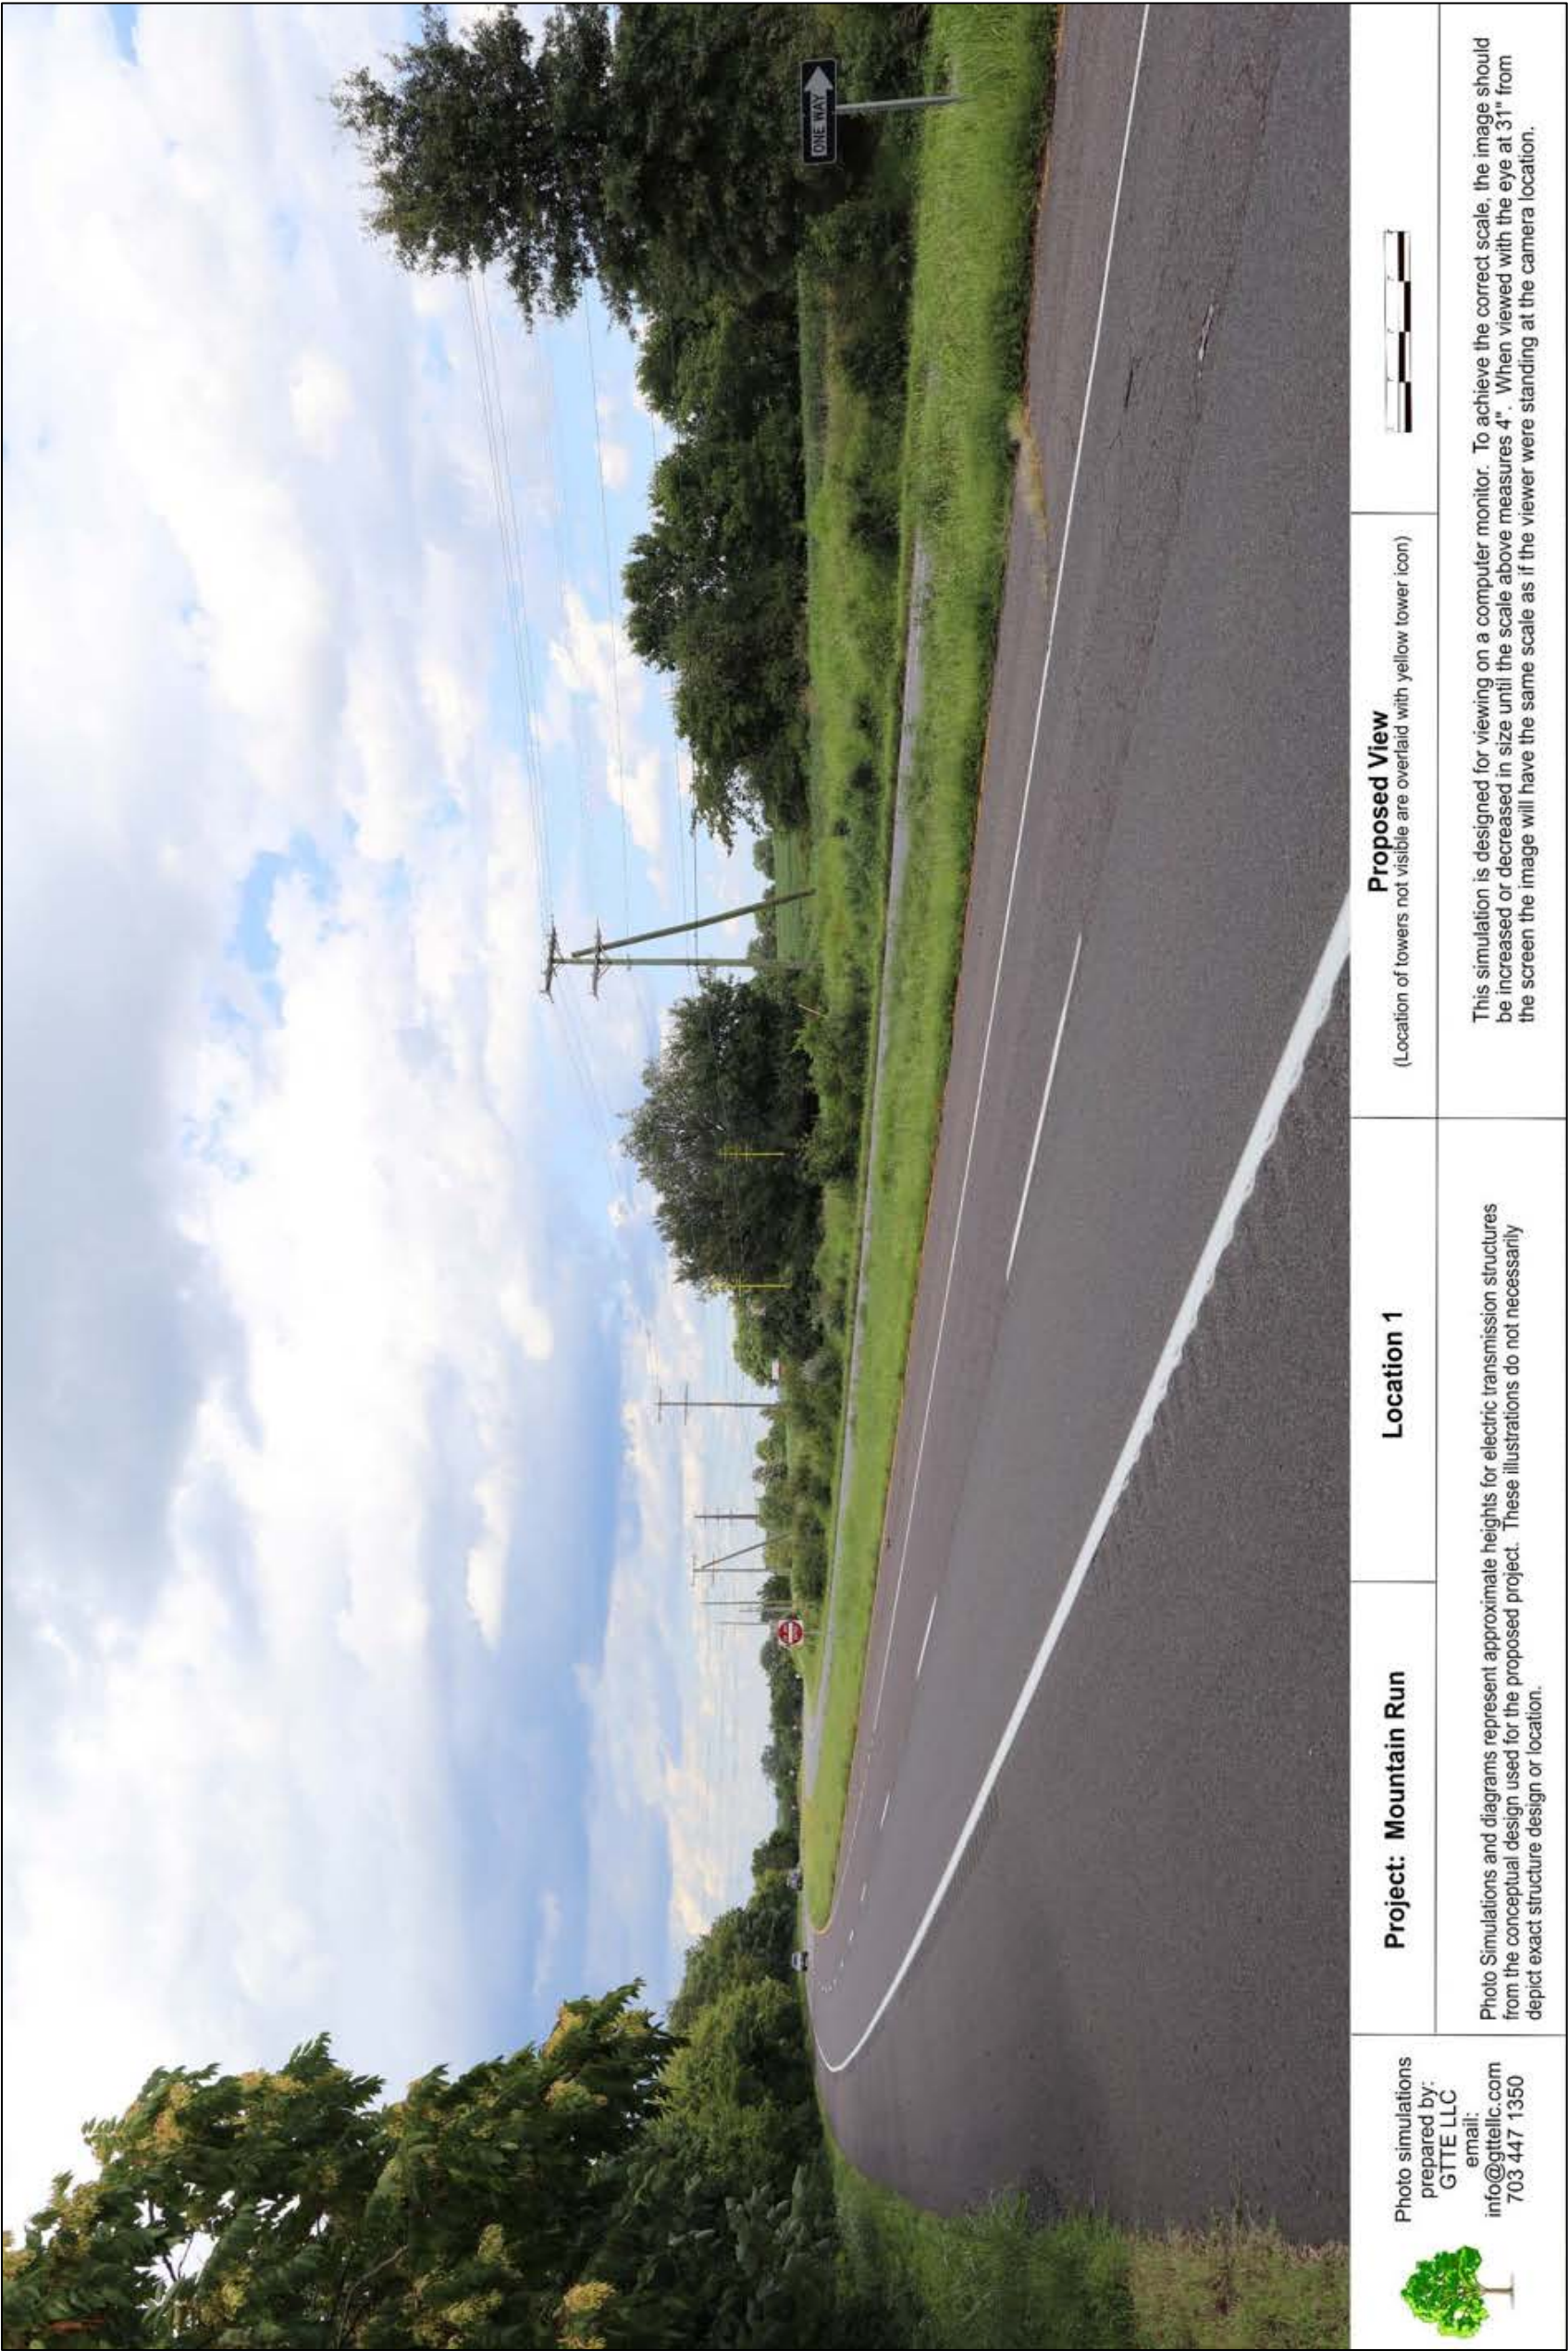
Figure 5-57: Croftburn Simulation 1 – Proposed view from front of driveway – (Visible structure shown as it would appear. Structures not visible shown in yellow). Source: GTTE, LLC
