**Application, Appendix,
DEQ Supplement, Direct
Testimony and Exhibits of
Virginia Electric and Power
Company**

**Cirrus-Keyser 230 kV Loop and
Related Projects**

Case No. PUR-2022-00198

DEQ Supplement

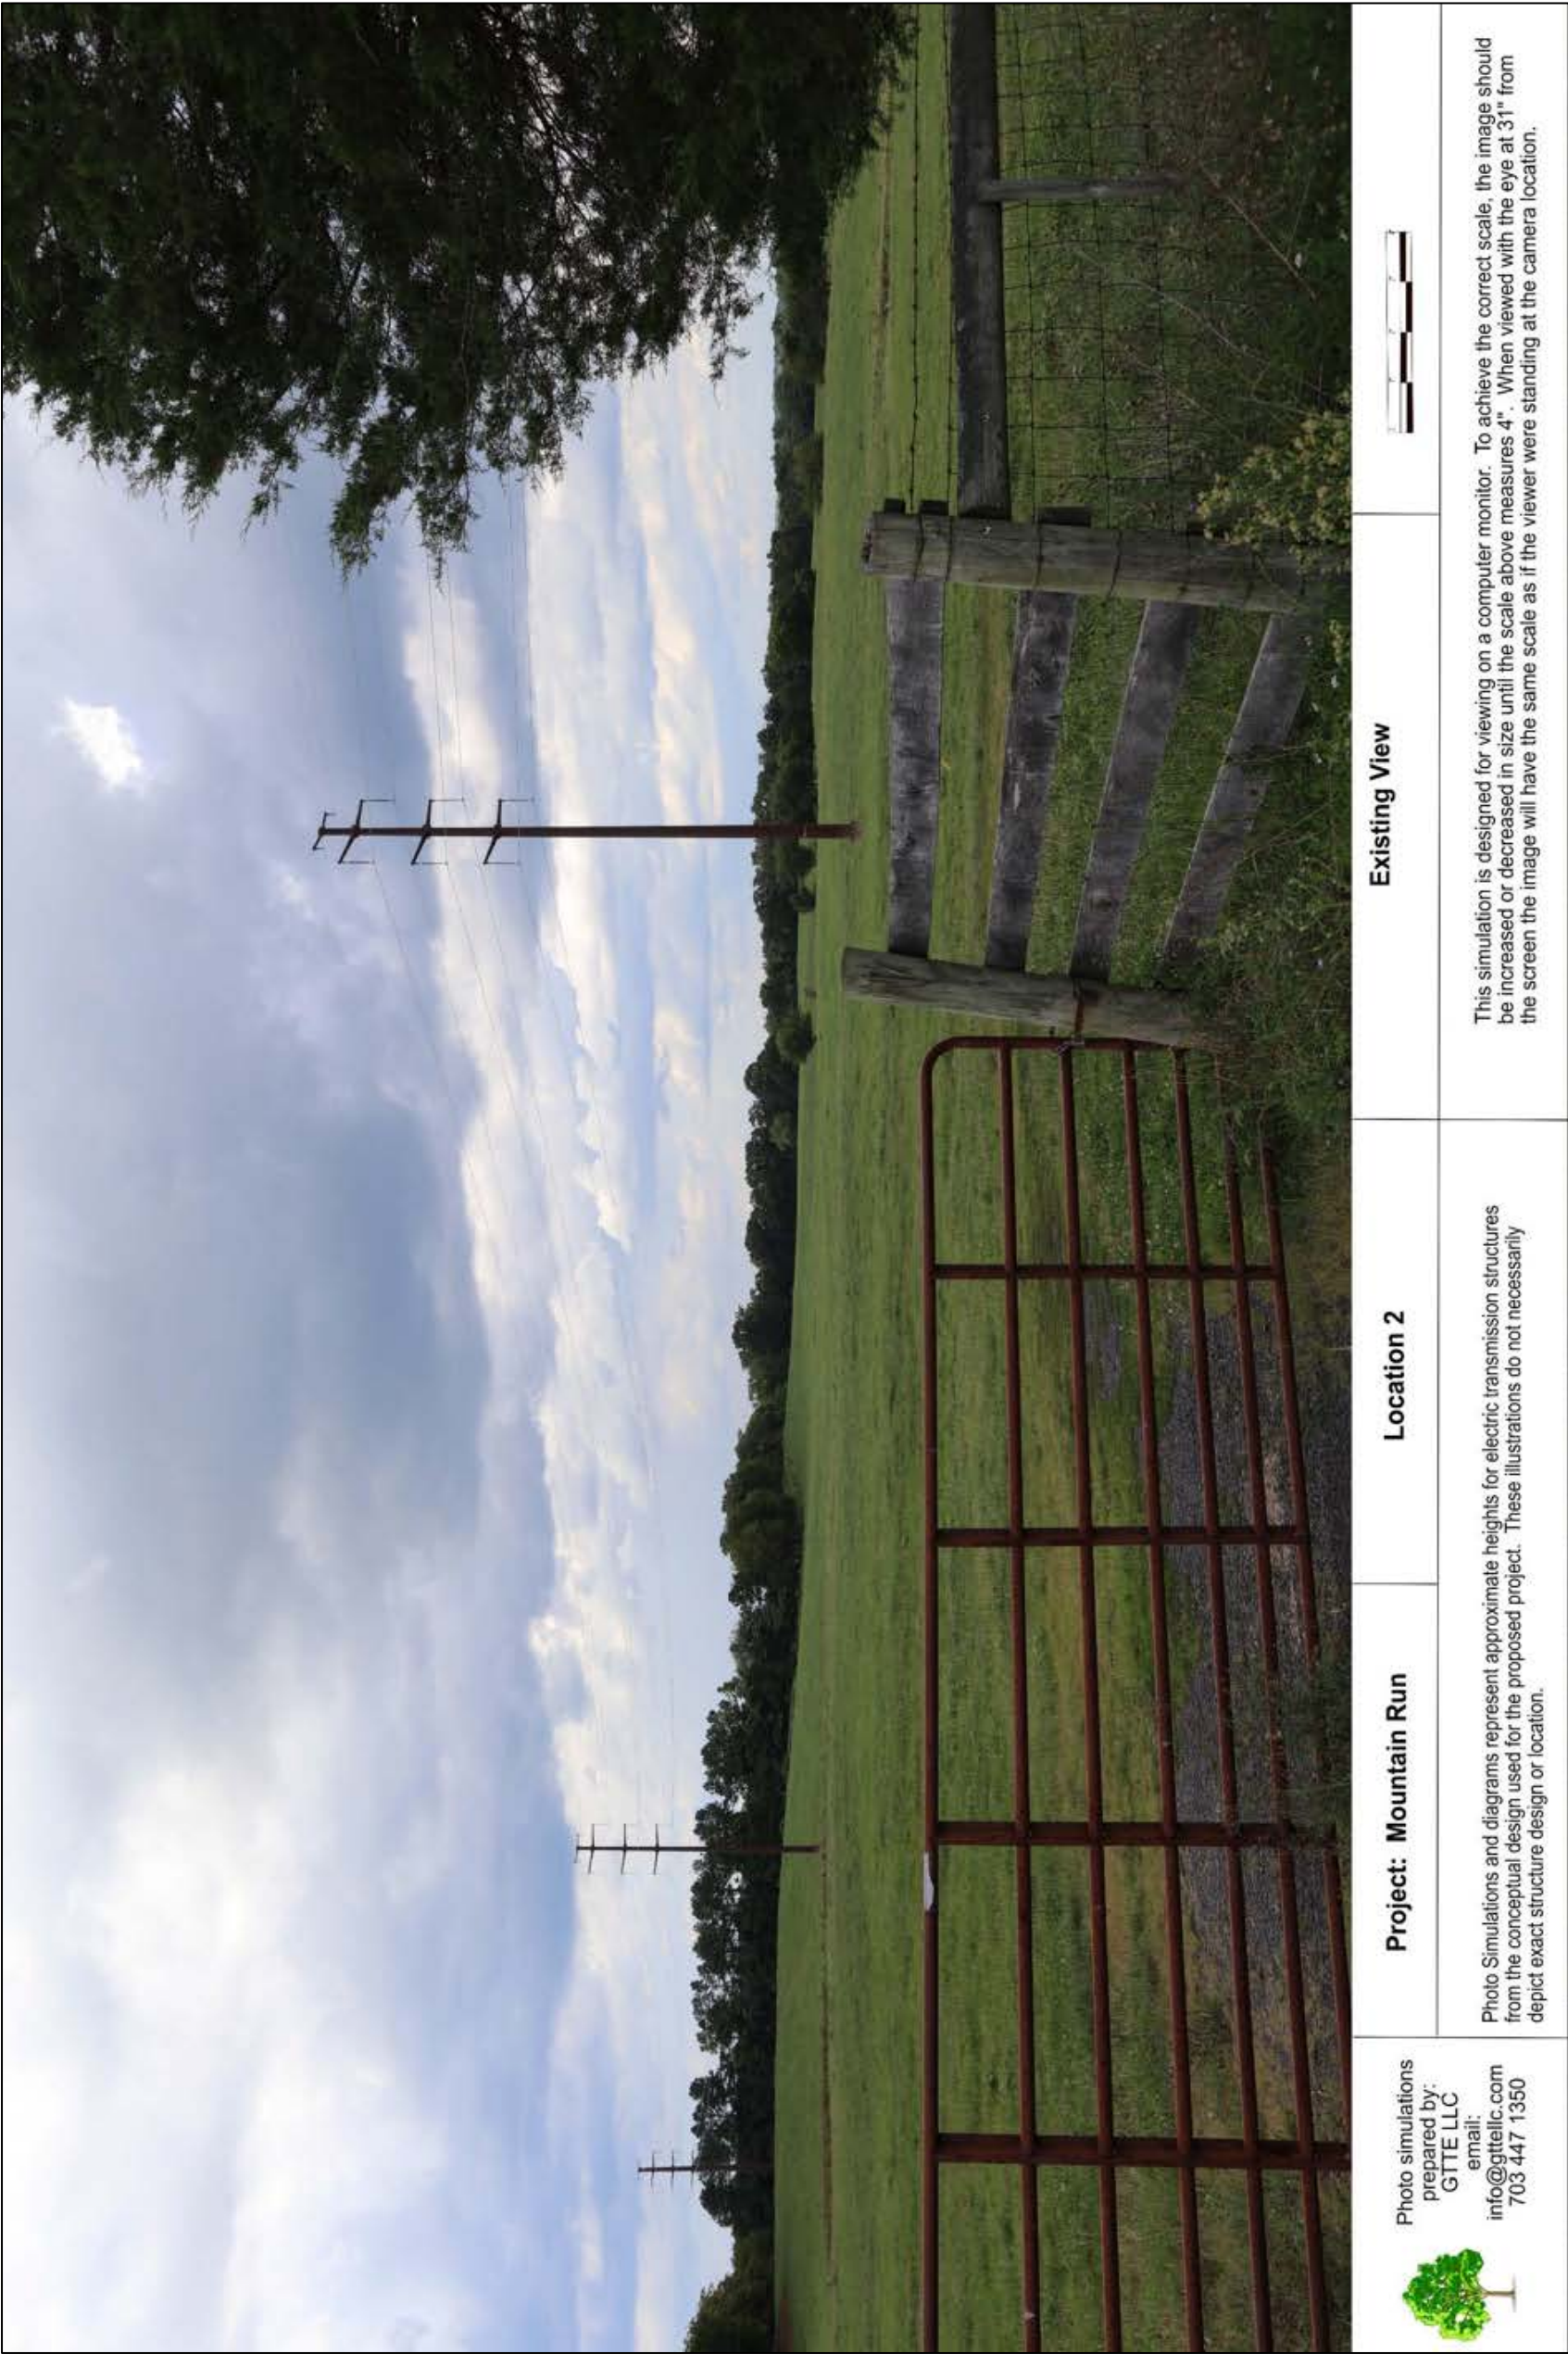
Figure 5-59: Croftburn Simulation 2 – Existing view from southeastern corner of property. Source: GTTE, LLC

The existing structures on the property are each 80-feet in height and the proposed replacement structures will generally average 100-feet in height, although the three structures nearest to the house will remain 80-feet. While structures further away will be replaced on a one-to-one basis near the existing locations, the three nearest the house will be shifted along the centerline slightly and be replaced with structures of identical height and design to the existing. As such, it is anticipated that visibility of the replacement structures will remain similar to the views of existing structures from vantage points within and in the vicinity of the property. The three structures currently not visible from the house itself will be shifted but no taller, while other structures to the rear and extending away from the property to the east will be taller. Although the structures will be increased in height, they will be replaced by structures of similar finish and configuration and as they are currently visible across open landscape across the road from the house, visibility as a result of the change in height is not anticipated to be substantial. This was confirmed by photo simulation from the front of the property and the nearby public ROW. Views from the front of the driveway currently include just one structure, and while that structure will increase in height, it will continue to be seen amongst other structures in the foreground. Simulation also showed the views towards the structures set adjacent to the side of the property will shift on the landscape as a result of the shift, but there will be no noticeable increase in height. Views of the structures across the road from this location will still include multiple structures seen down the ROW and the increase in height is minimally noticeable due to retention of the same structure configuration. Therefore, the increase in height may be perceptible from discrete publicly-accessible locations, however, no change in height will be observed from the house itself. As such, the project is not anticipated to introduce any substantially new or cumulative impacts to the viewshed or setting of the resources that already includes multiple transmission structures and wide views of the transmission line, nor will it detract from or compromise those qualities and characteristics that make the property eligible for the NRHP. It is therefore D+A's opinion that the Cirrus – Keyser 230 kV Loop and Related Projects will pose no more than a *minimal impact* on Croftburn Farm.

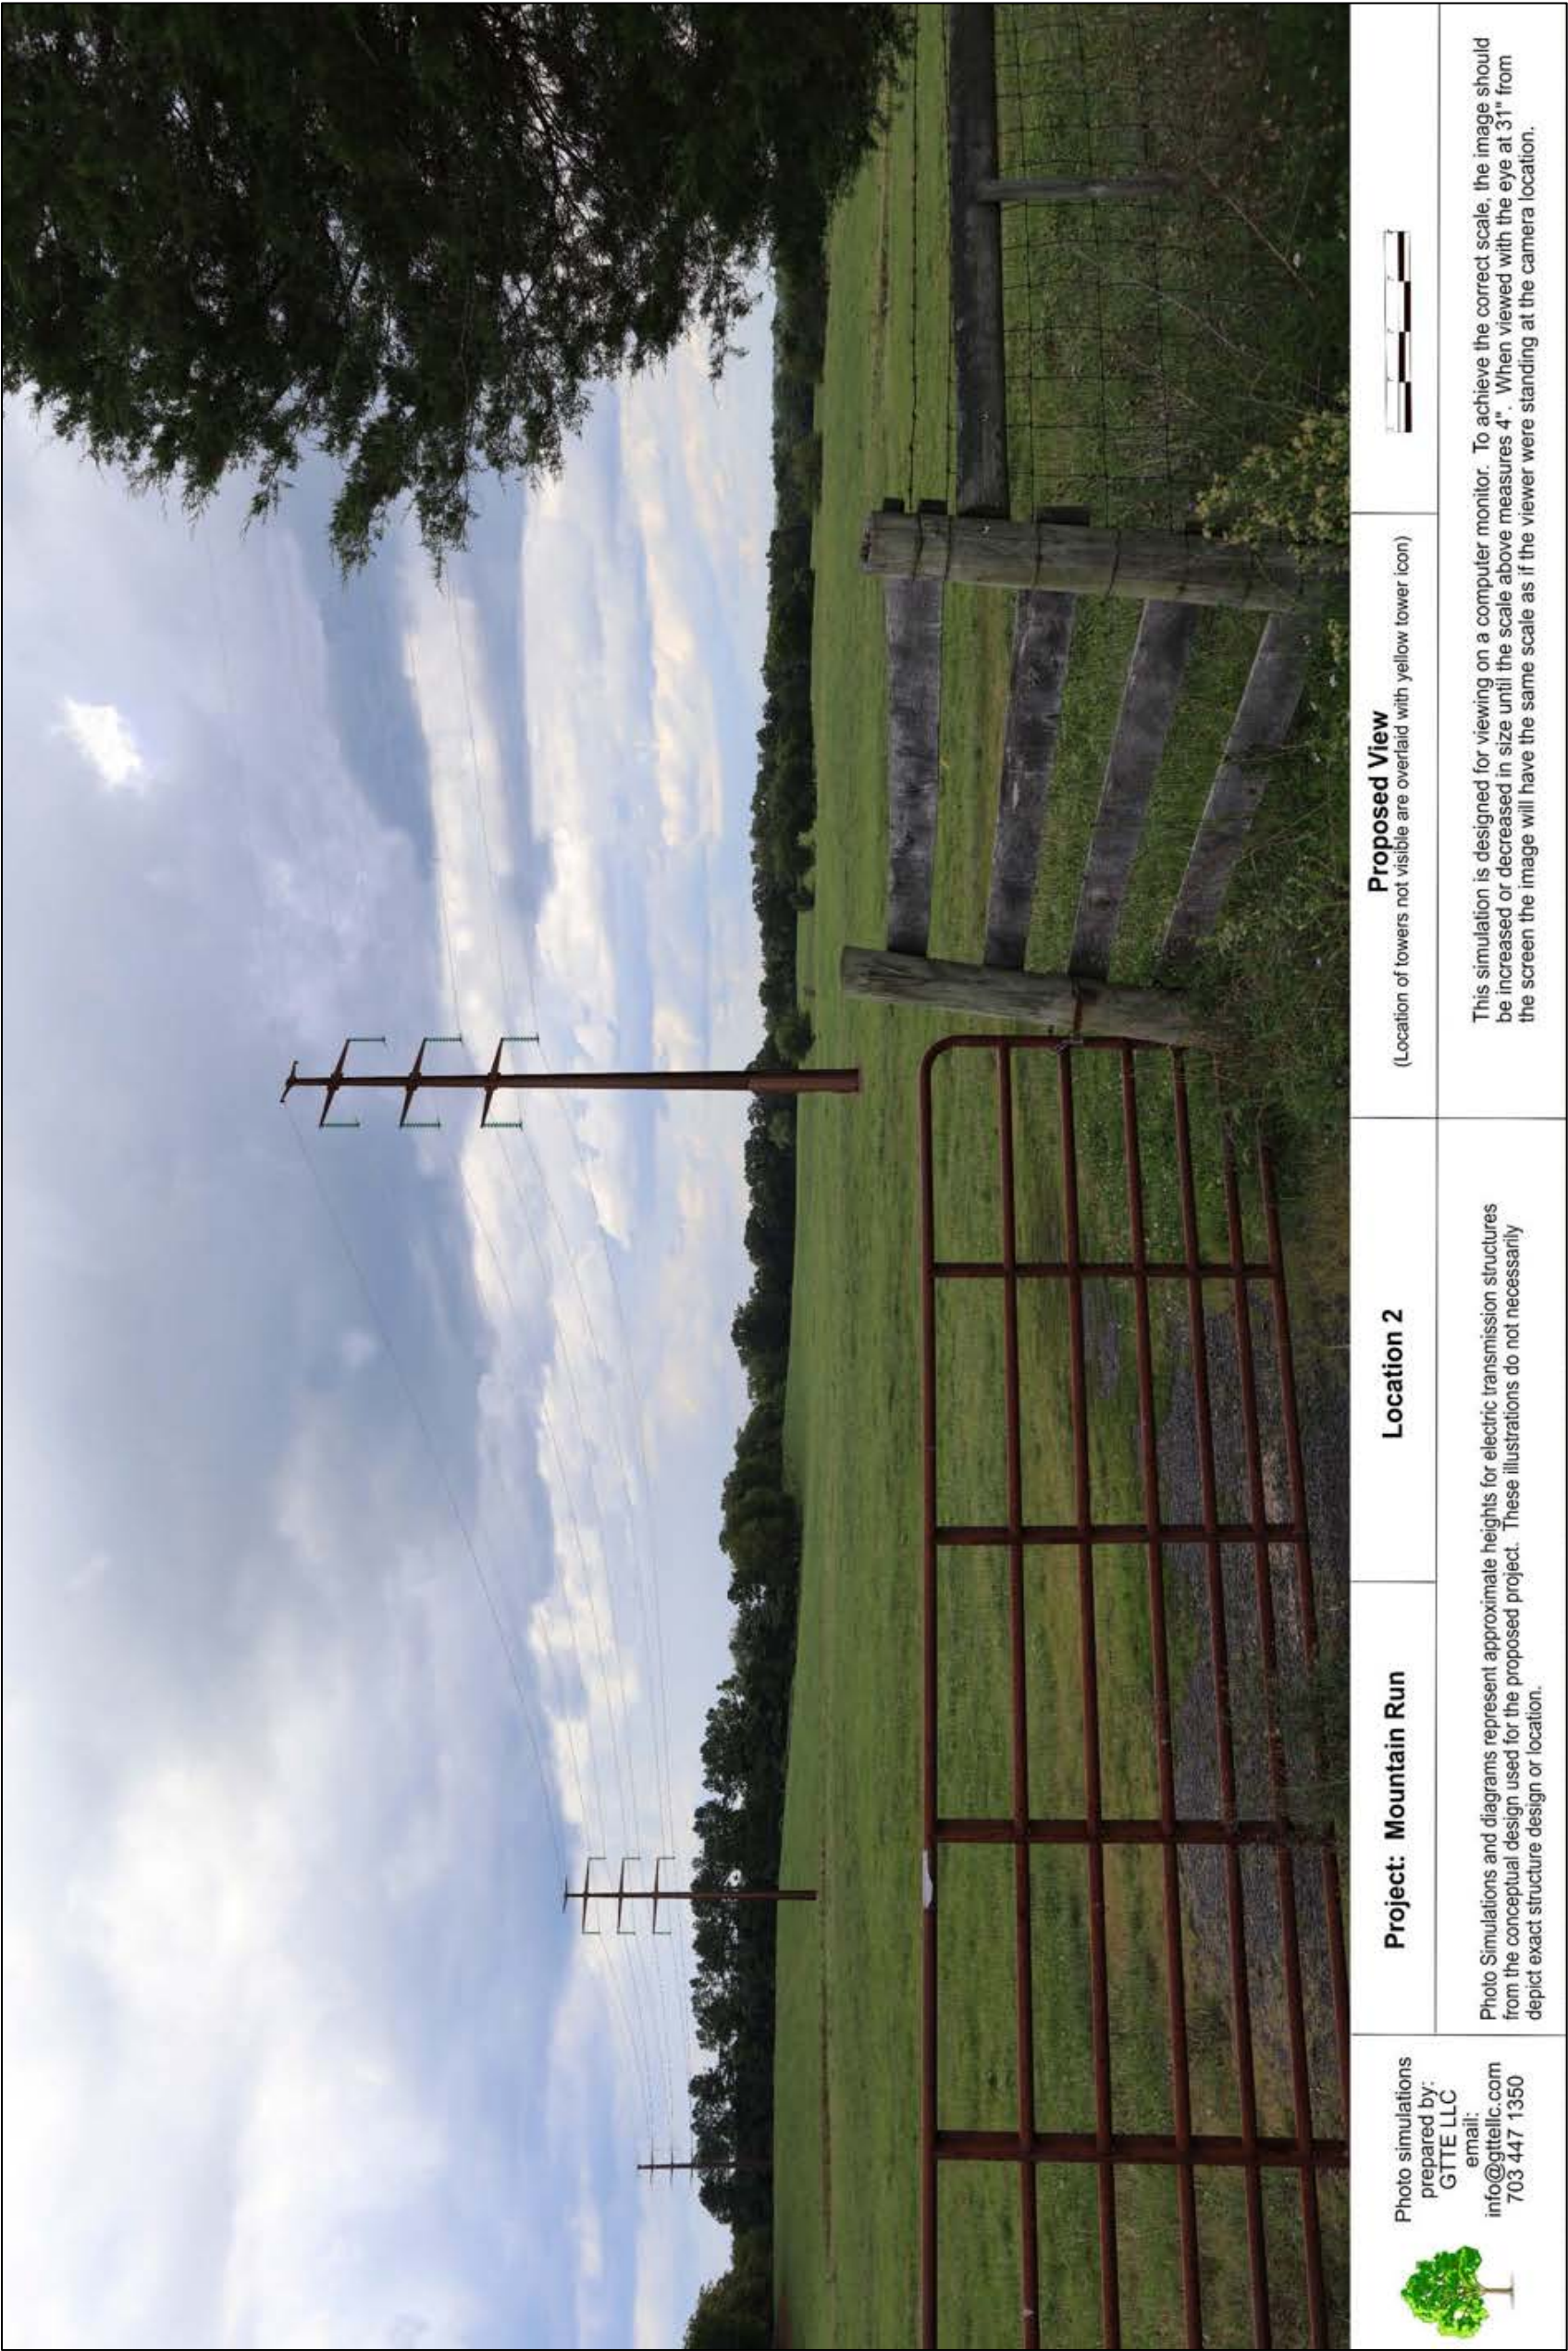
Figure 5-60: Croftburn Simulation 2 – Proposed view from southeastern corner of property – (Visible structure shown as it would appear). Source: GTTE, LLC

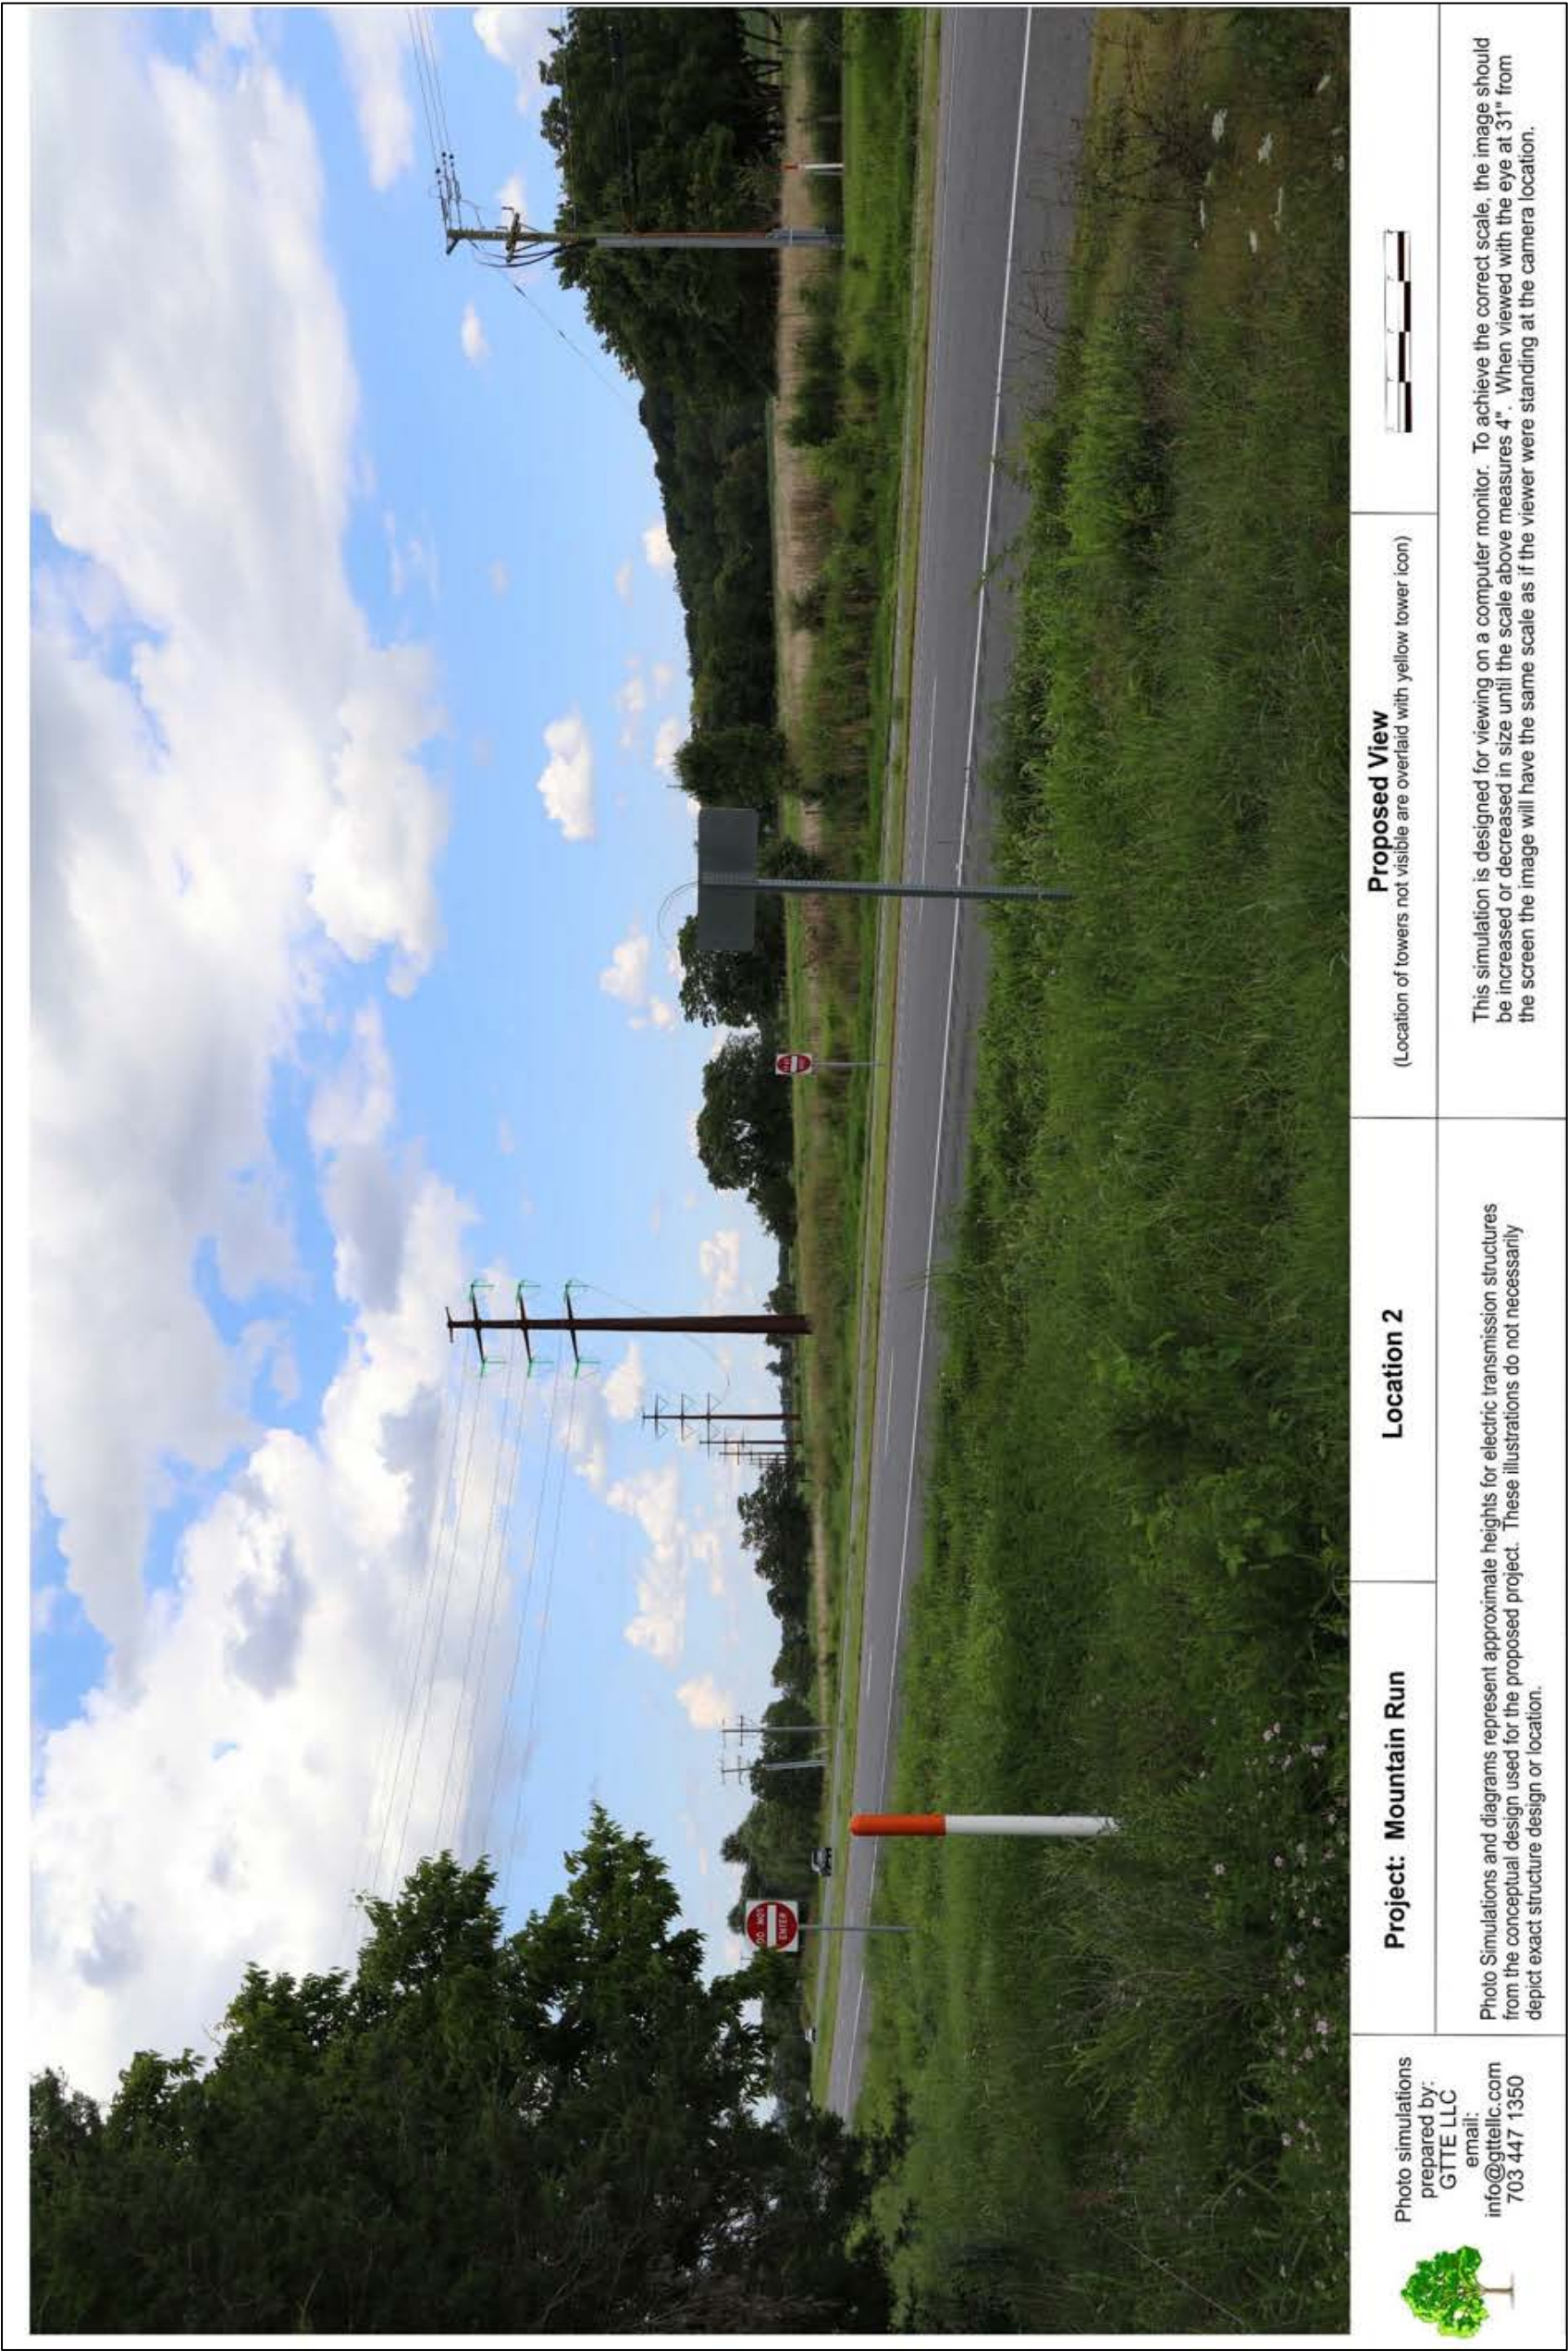
Figure 5-63: Croftburn Simulation 3 – Proposed view across road from southeastern corner of property – (Visible structures shown as they would appear). Source: GTTE, LLC

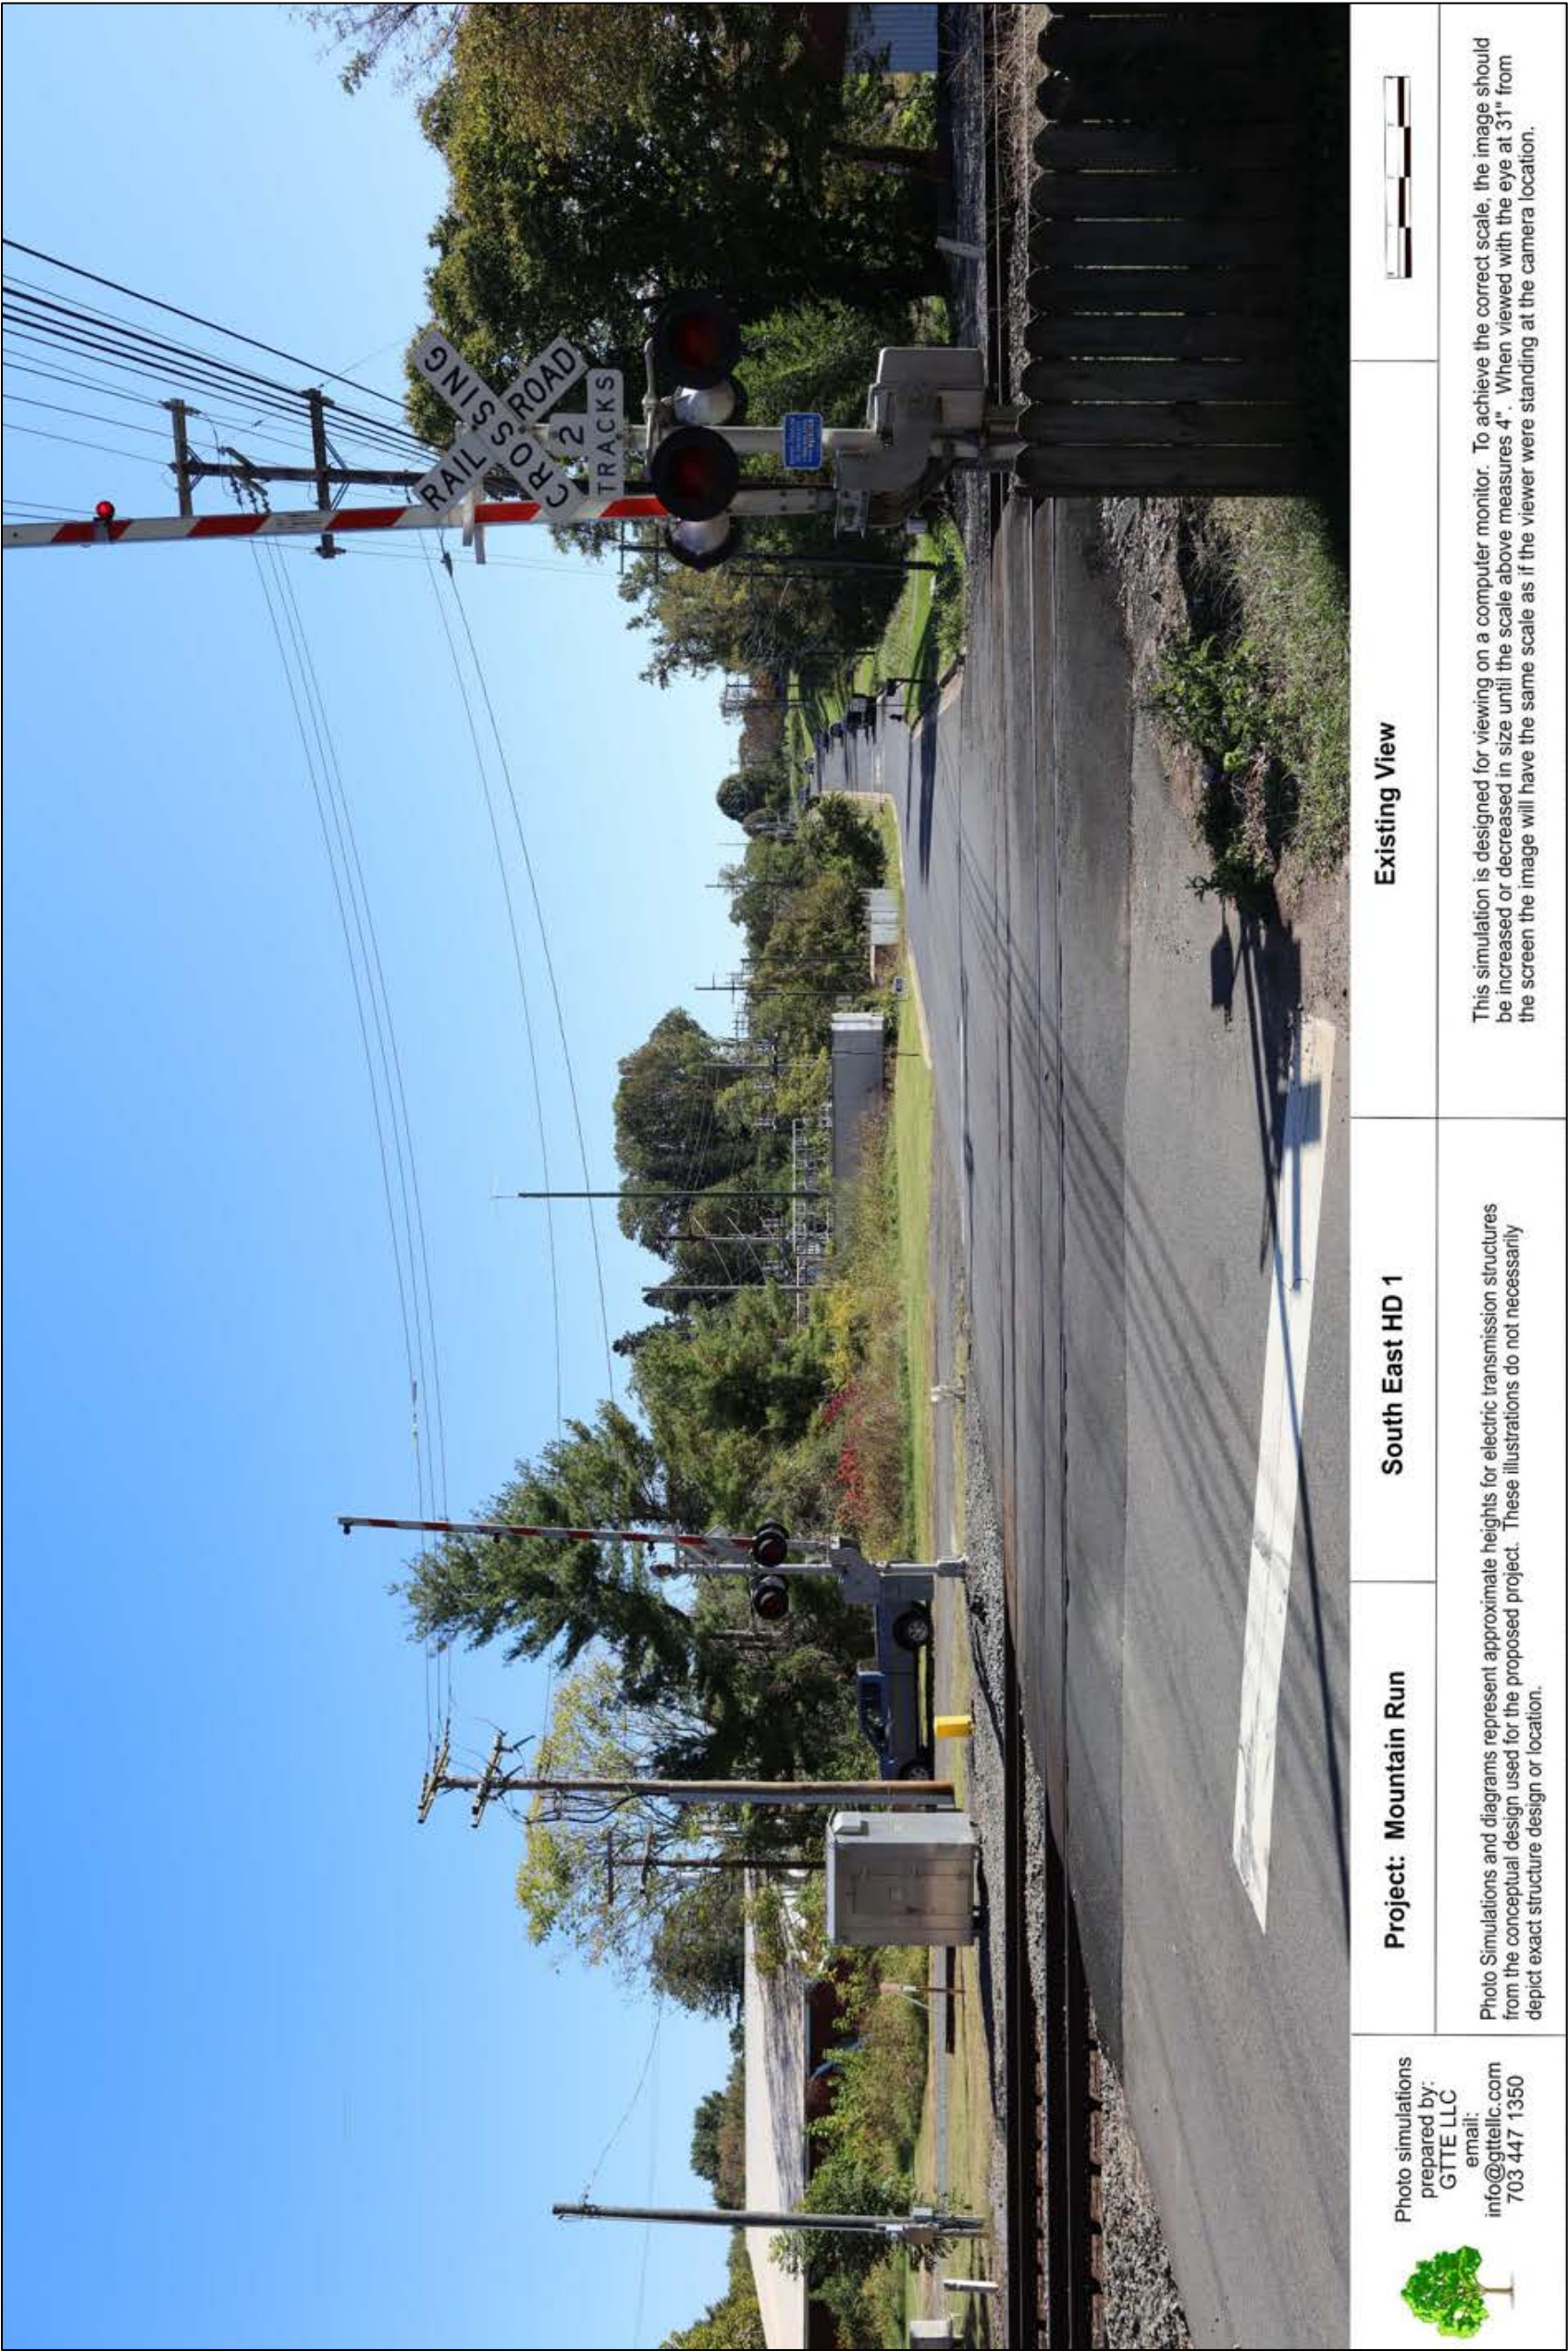
Figure 5-72: South East Street Historic District Simulation 1 – Existing view from Chandler Street. Source: GTTE, LLC

Inspection from publicly-accessible vantage points throughout the district found that none of the existing structures on the project alignment are visible. However, a number of structures and a substation on other transmission lines not included in the project, but in closer proximity to the district are visible from a number of locations. The existing structures to be replaced as part of this project are each 80-feet in height and the proposed replacement structures will generally average 100-feet in height. The tallest structures within the proposed substation in closer proximity to the district will be no more than 90 feet tall with an average structure height of 77 feet tall. As such, it is anticipated that the intervening topography, vegetation, and urban development patterns that currently screen views of the project alignment will continue to screen the replacement structures and substation from publicly-accessible locations throughout the district. This was confirmed by photo simulation from representative vantage points that depict all structures remaining screened beneath the intervening terrain and vegetation. Therefore, the project will not introduce any noticeable change in setting or viewshed of or from the district which does not include any of the existing project structures, nor will it include views of any replacement structures, and it is therefore D+A's opinion that the Cirrus – Keyser 230 kV Loop and Related Projects will pose ***no impact*** on the South East Street Historic District.

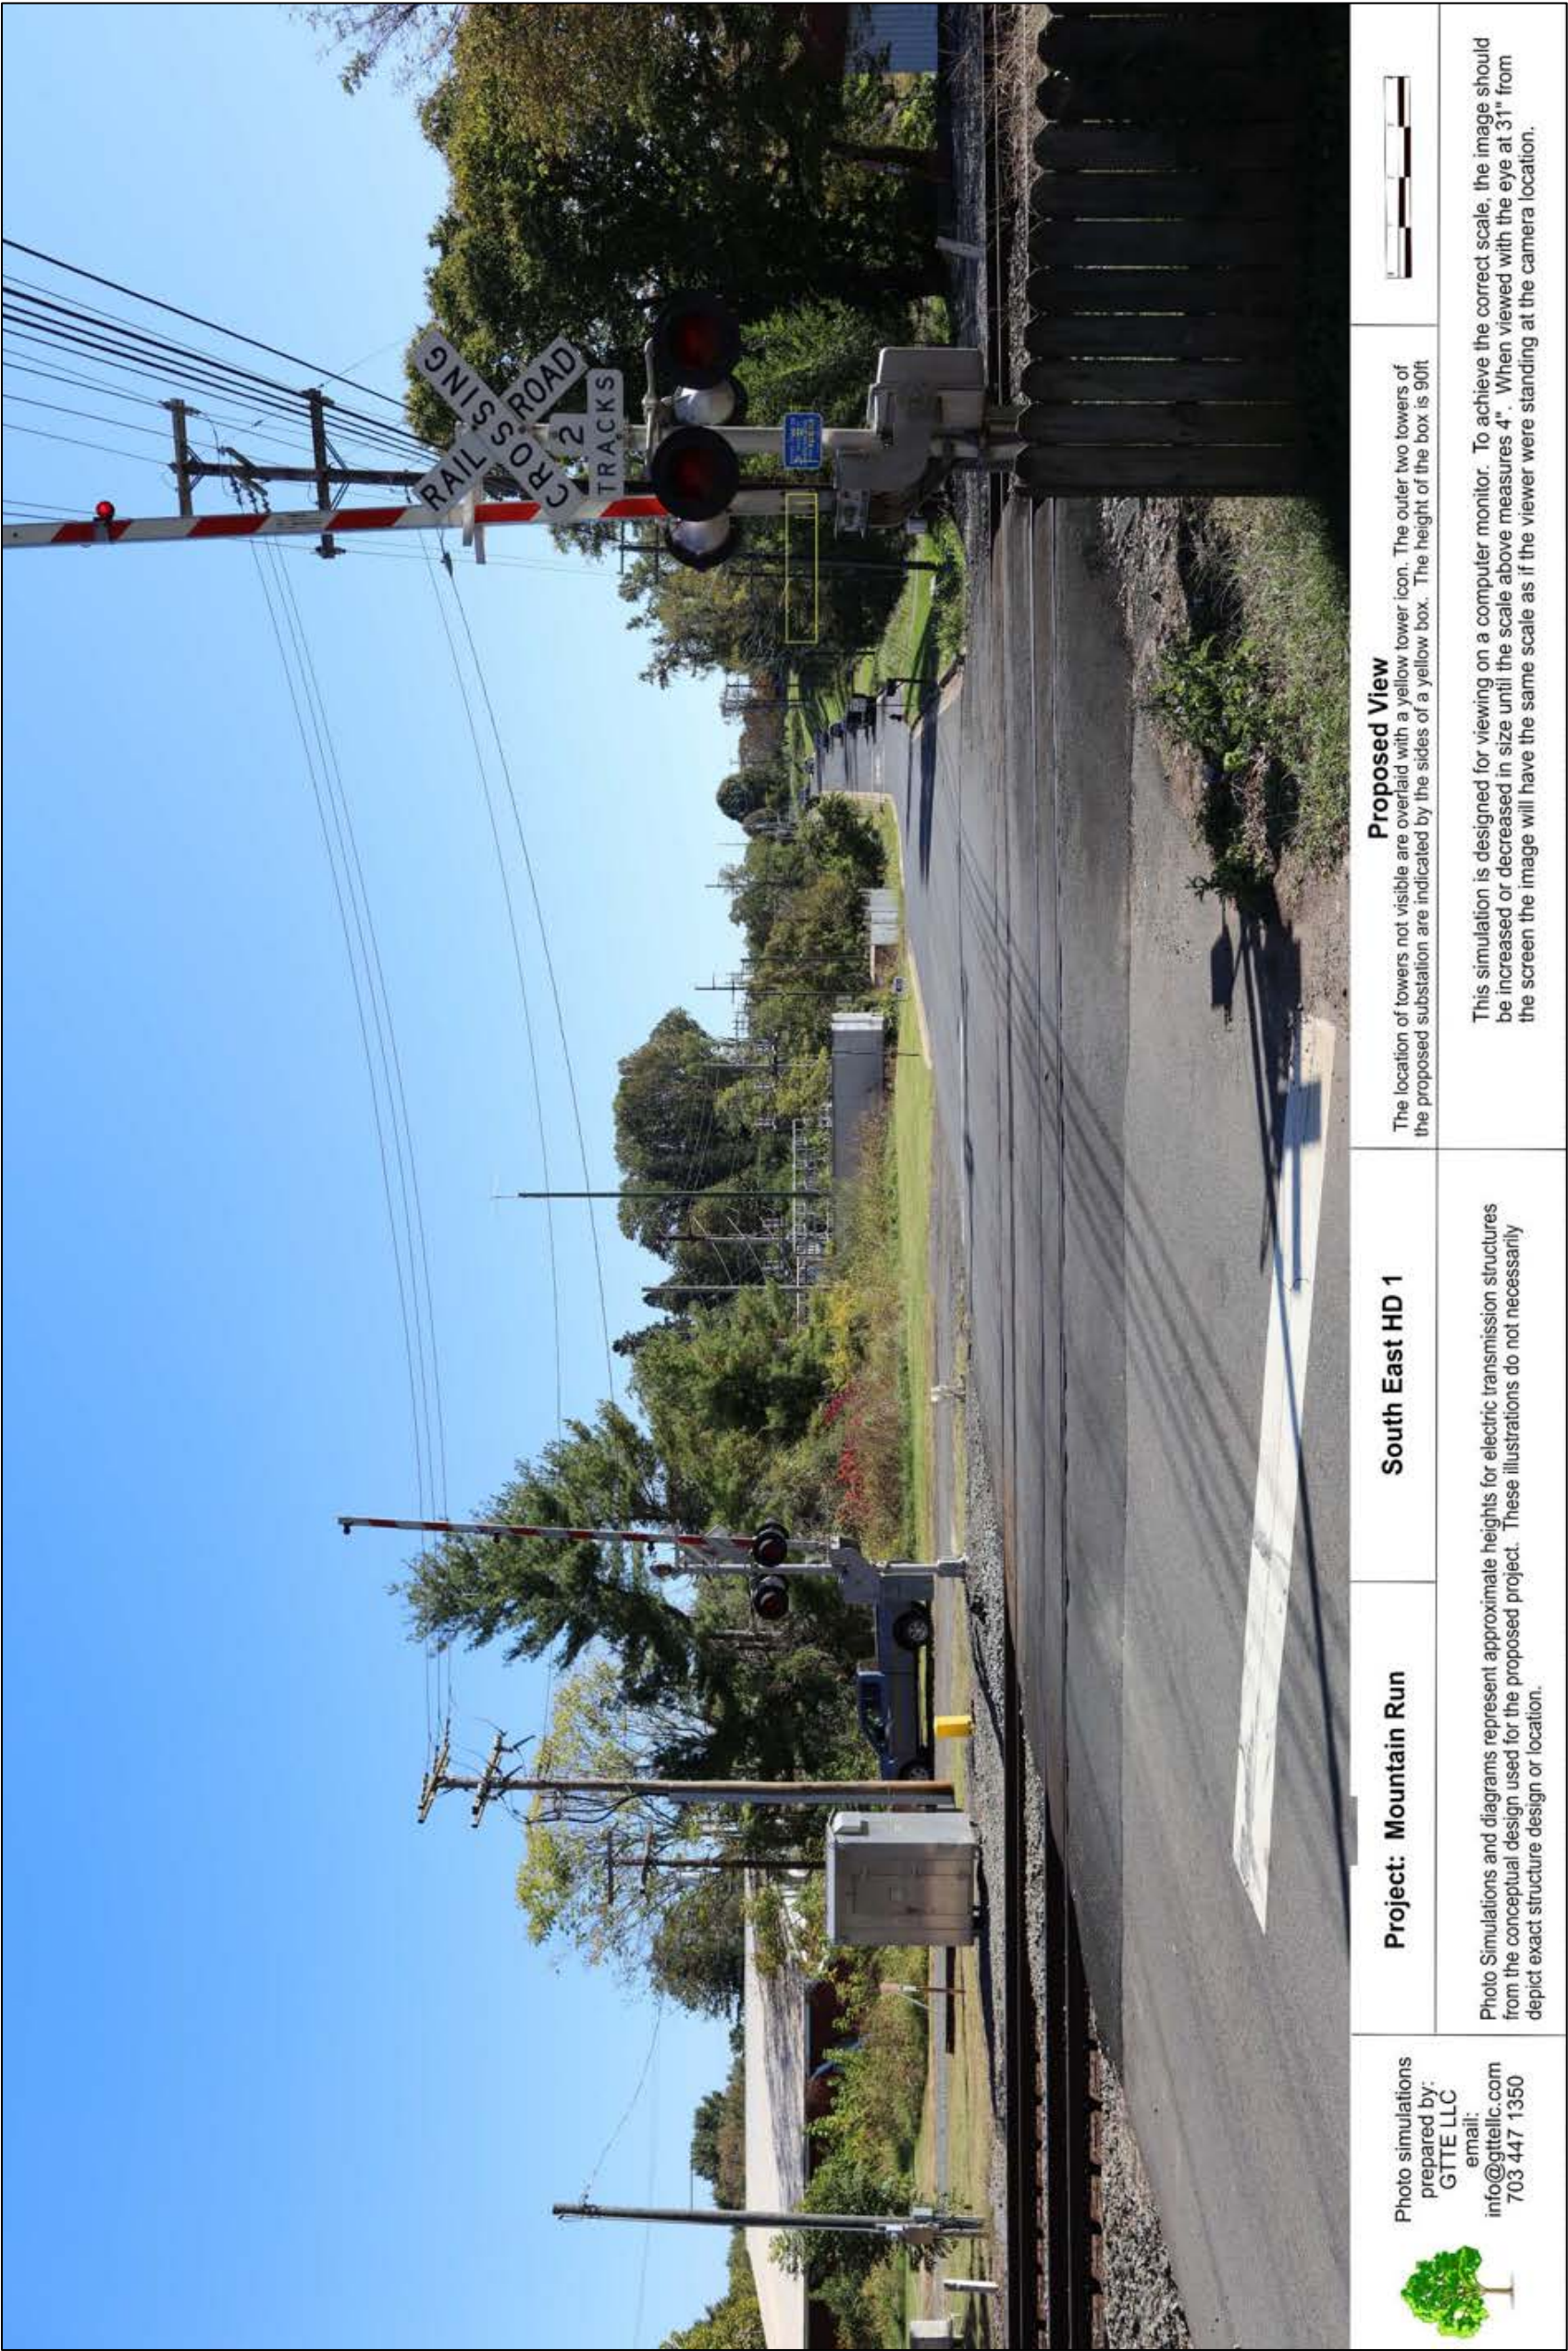
Figure 5-73: South East Street Historic District Simulation 1 – Proposed view from Chandler Street – (Structures not visible shown in yellow). Source: GTTE, LLC
