**Application, Appendix,
DEQ Supplement, Direct
Testimony and Exhibits of
Virginia Electric and Power
Company**

**Cirrus-Keyser 230 kV Loop and
Related Projects**

Case No. PUR-2022-00198

DEQ Supplement

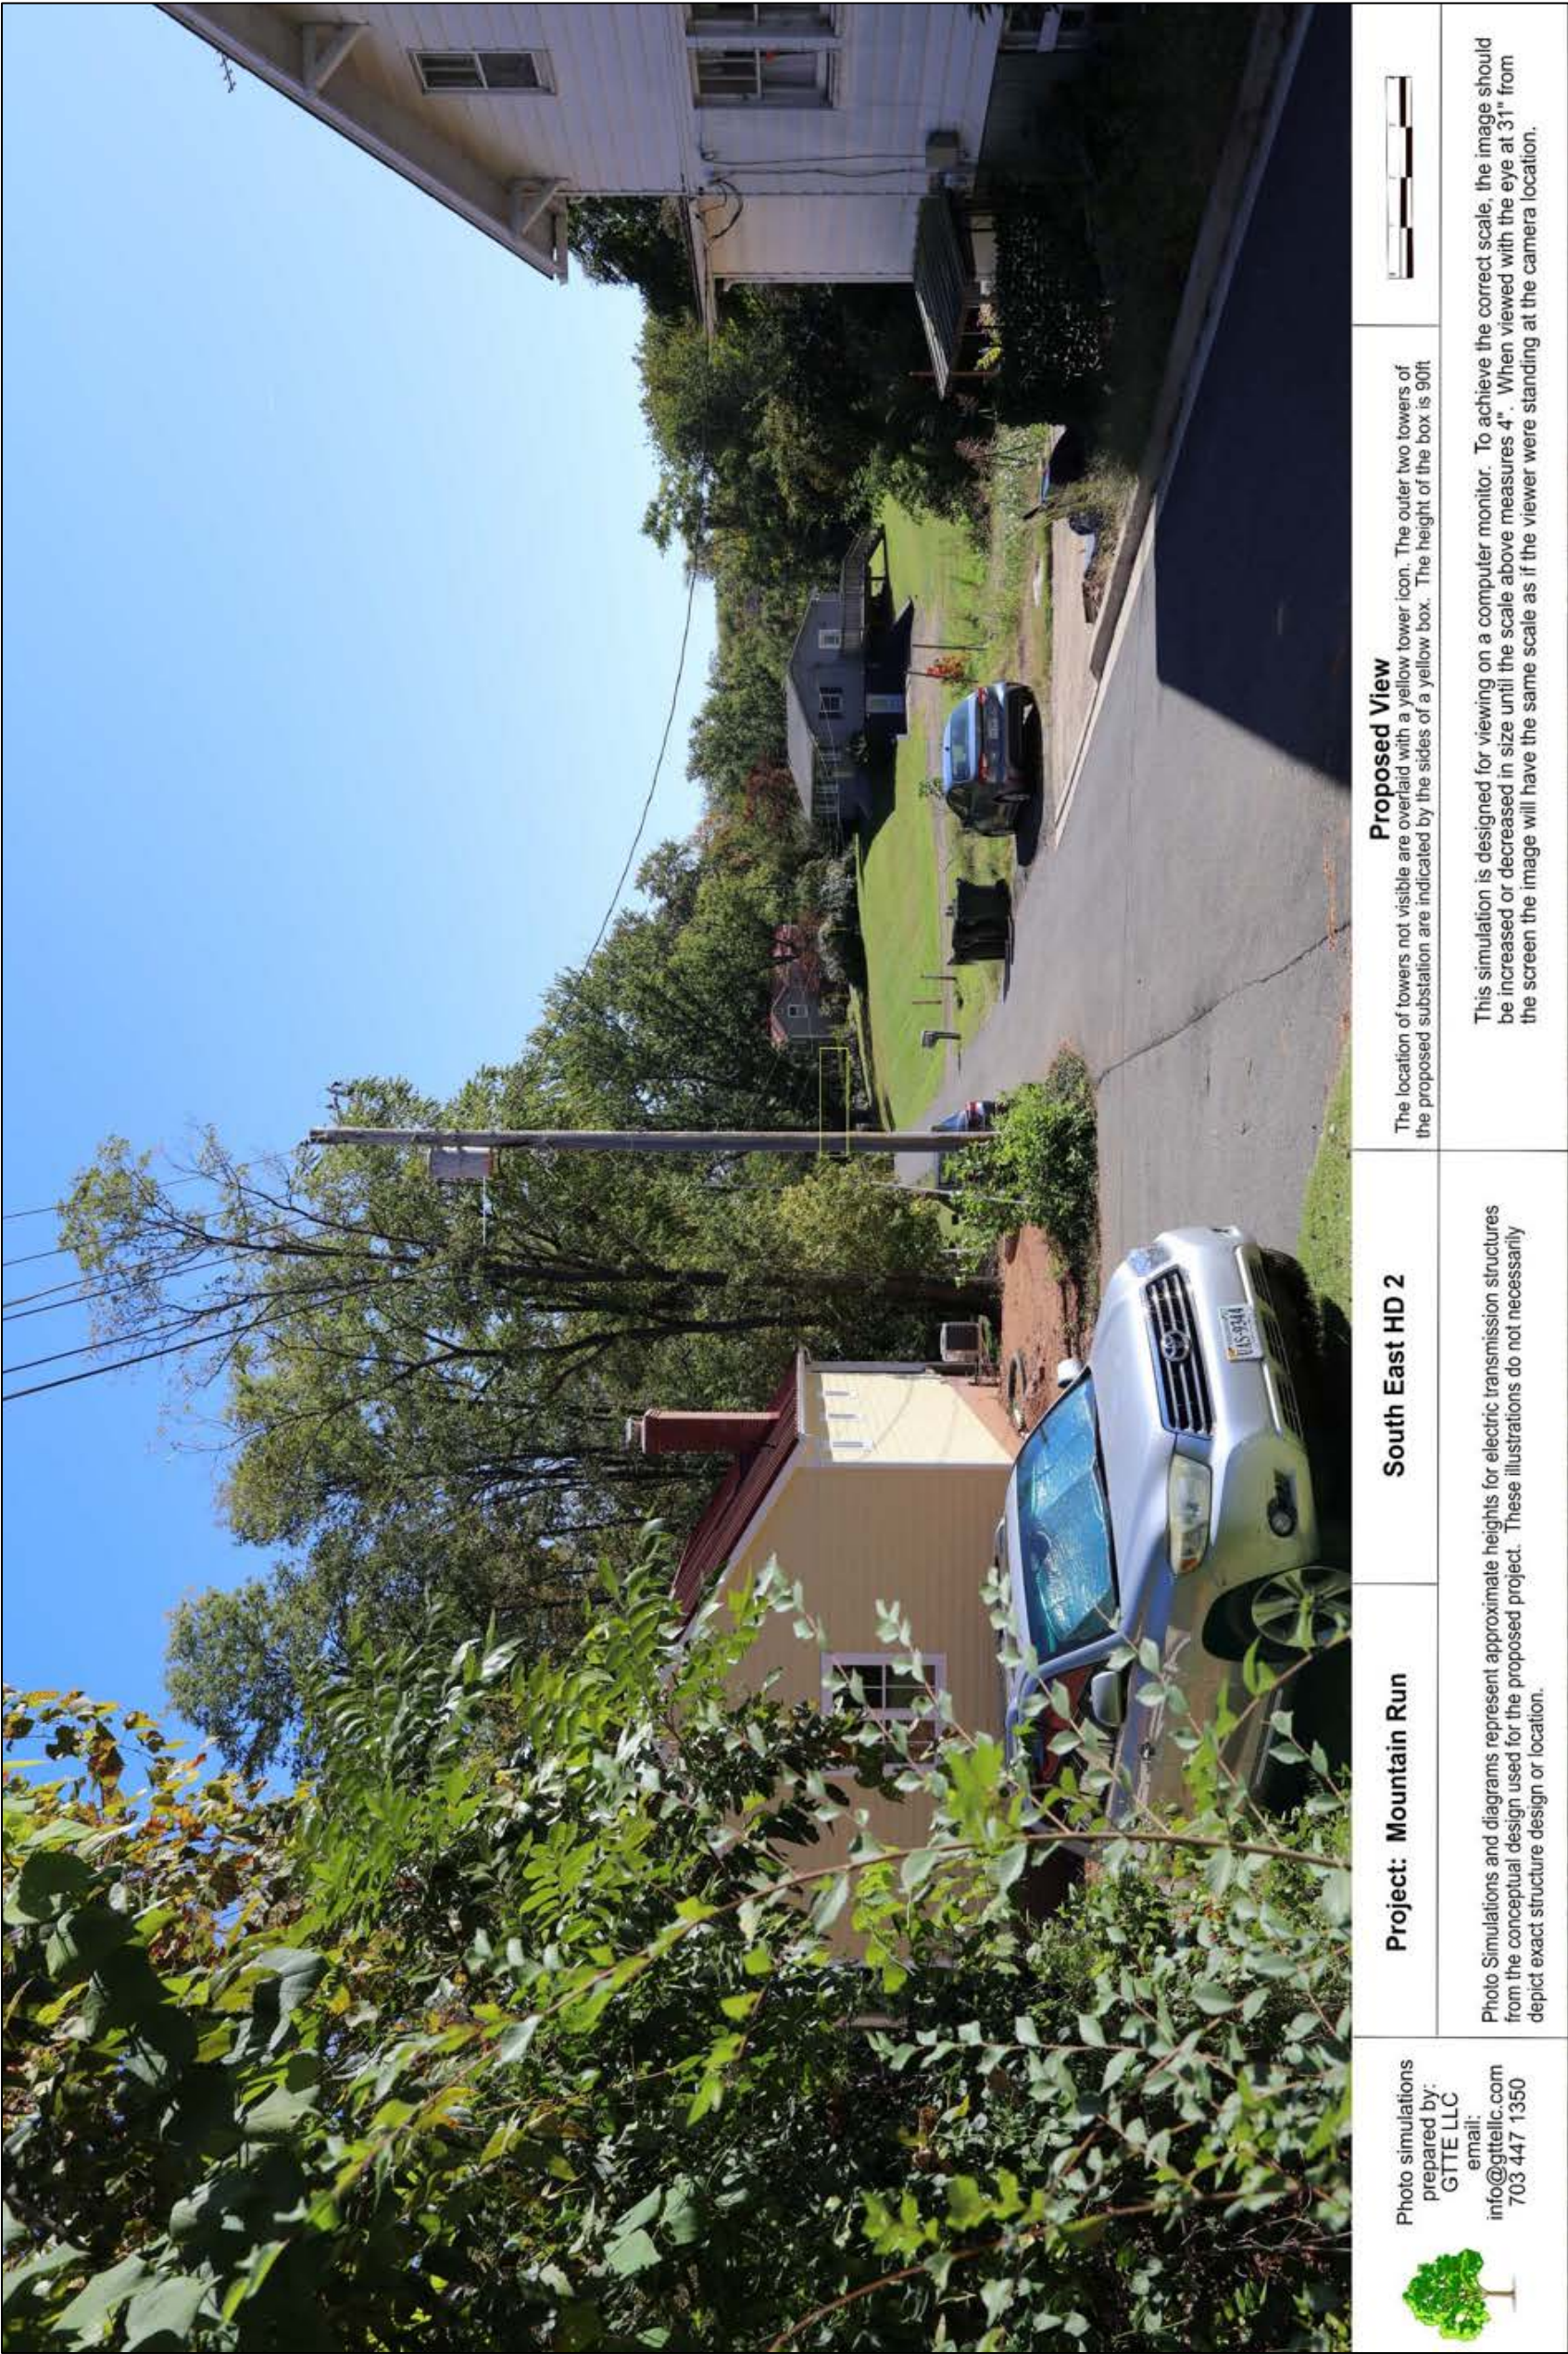
Figure 5-76: South East Street Historic District Simulation 2 – Proposed view from Rosson Lane – (Structures not visible shown in yellow). Source: GTTE, LLC

Inspection from publicly-accessible vantage points throughout the district found that none of the existing structures on the project alignment are visible. However, a number of structures and a substation on other transmission lines not included in the project, but in closer proximity to the district are visible from a number of locations. The existing structures to be replaced as part of this project are each 80-feet in height and the proposed replacement structures will generally average 100-feet in height. The tallest structures within the proposed substation in closer proximity to the district will be no more than 90 feet tall with an average structure height of 77 feet tall. As such, it is anticipated that the intervening topography, vegetation, and urban development patterns that currently screen views of the project alignment will continue to screen the replacement structures and substation from publicly-accessible locations throughout the district. This was confirmed by photo simulation from representative vantage points that depict all structures remaining screened beneath the intervening terrain and vegetation. Therefore, the project will not introduce any noticeable change in setting or viewshed of or from the district which does not include any of the existing project structures, nor will it include views of any replacement structures, and it is therefore D+A's opinion that the Cirrus – Keyser 230 kV Loop and Related Projects will pose ***no impact*** on the South East Street Historic District.

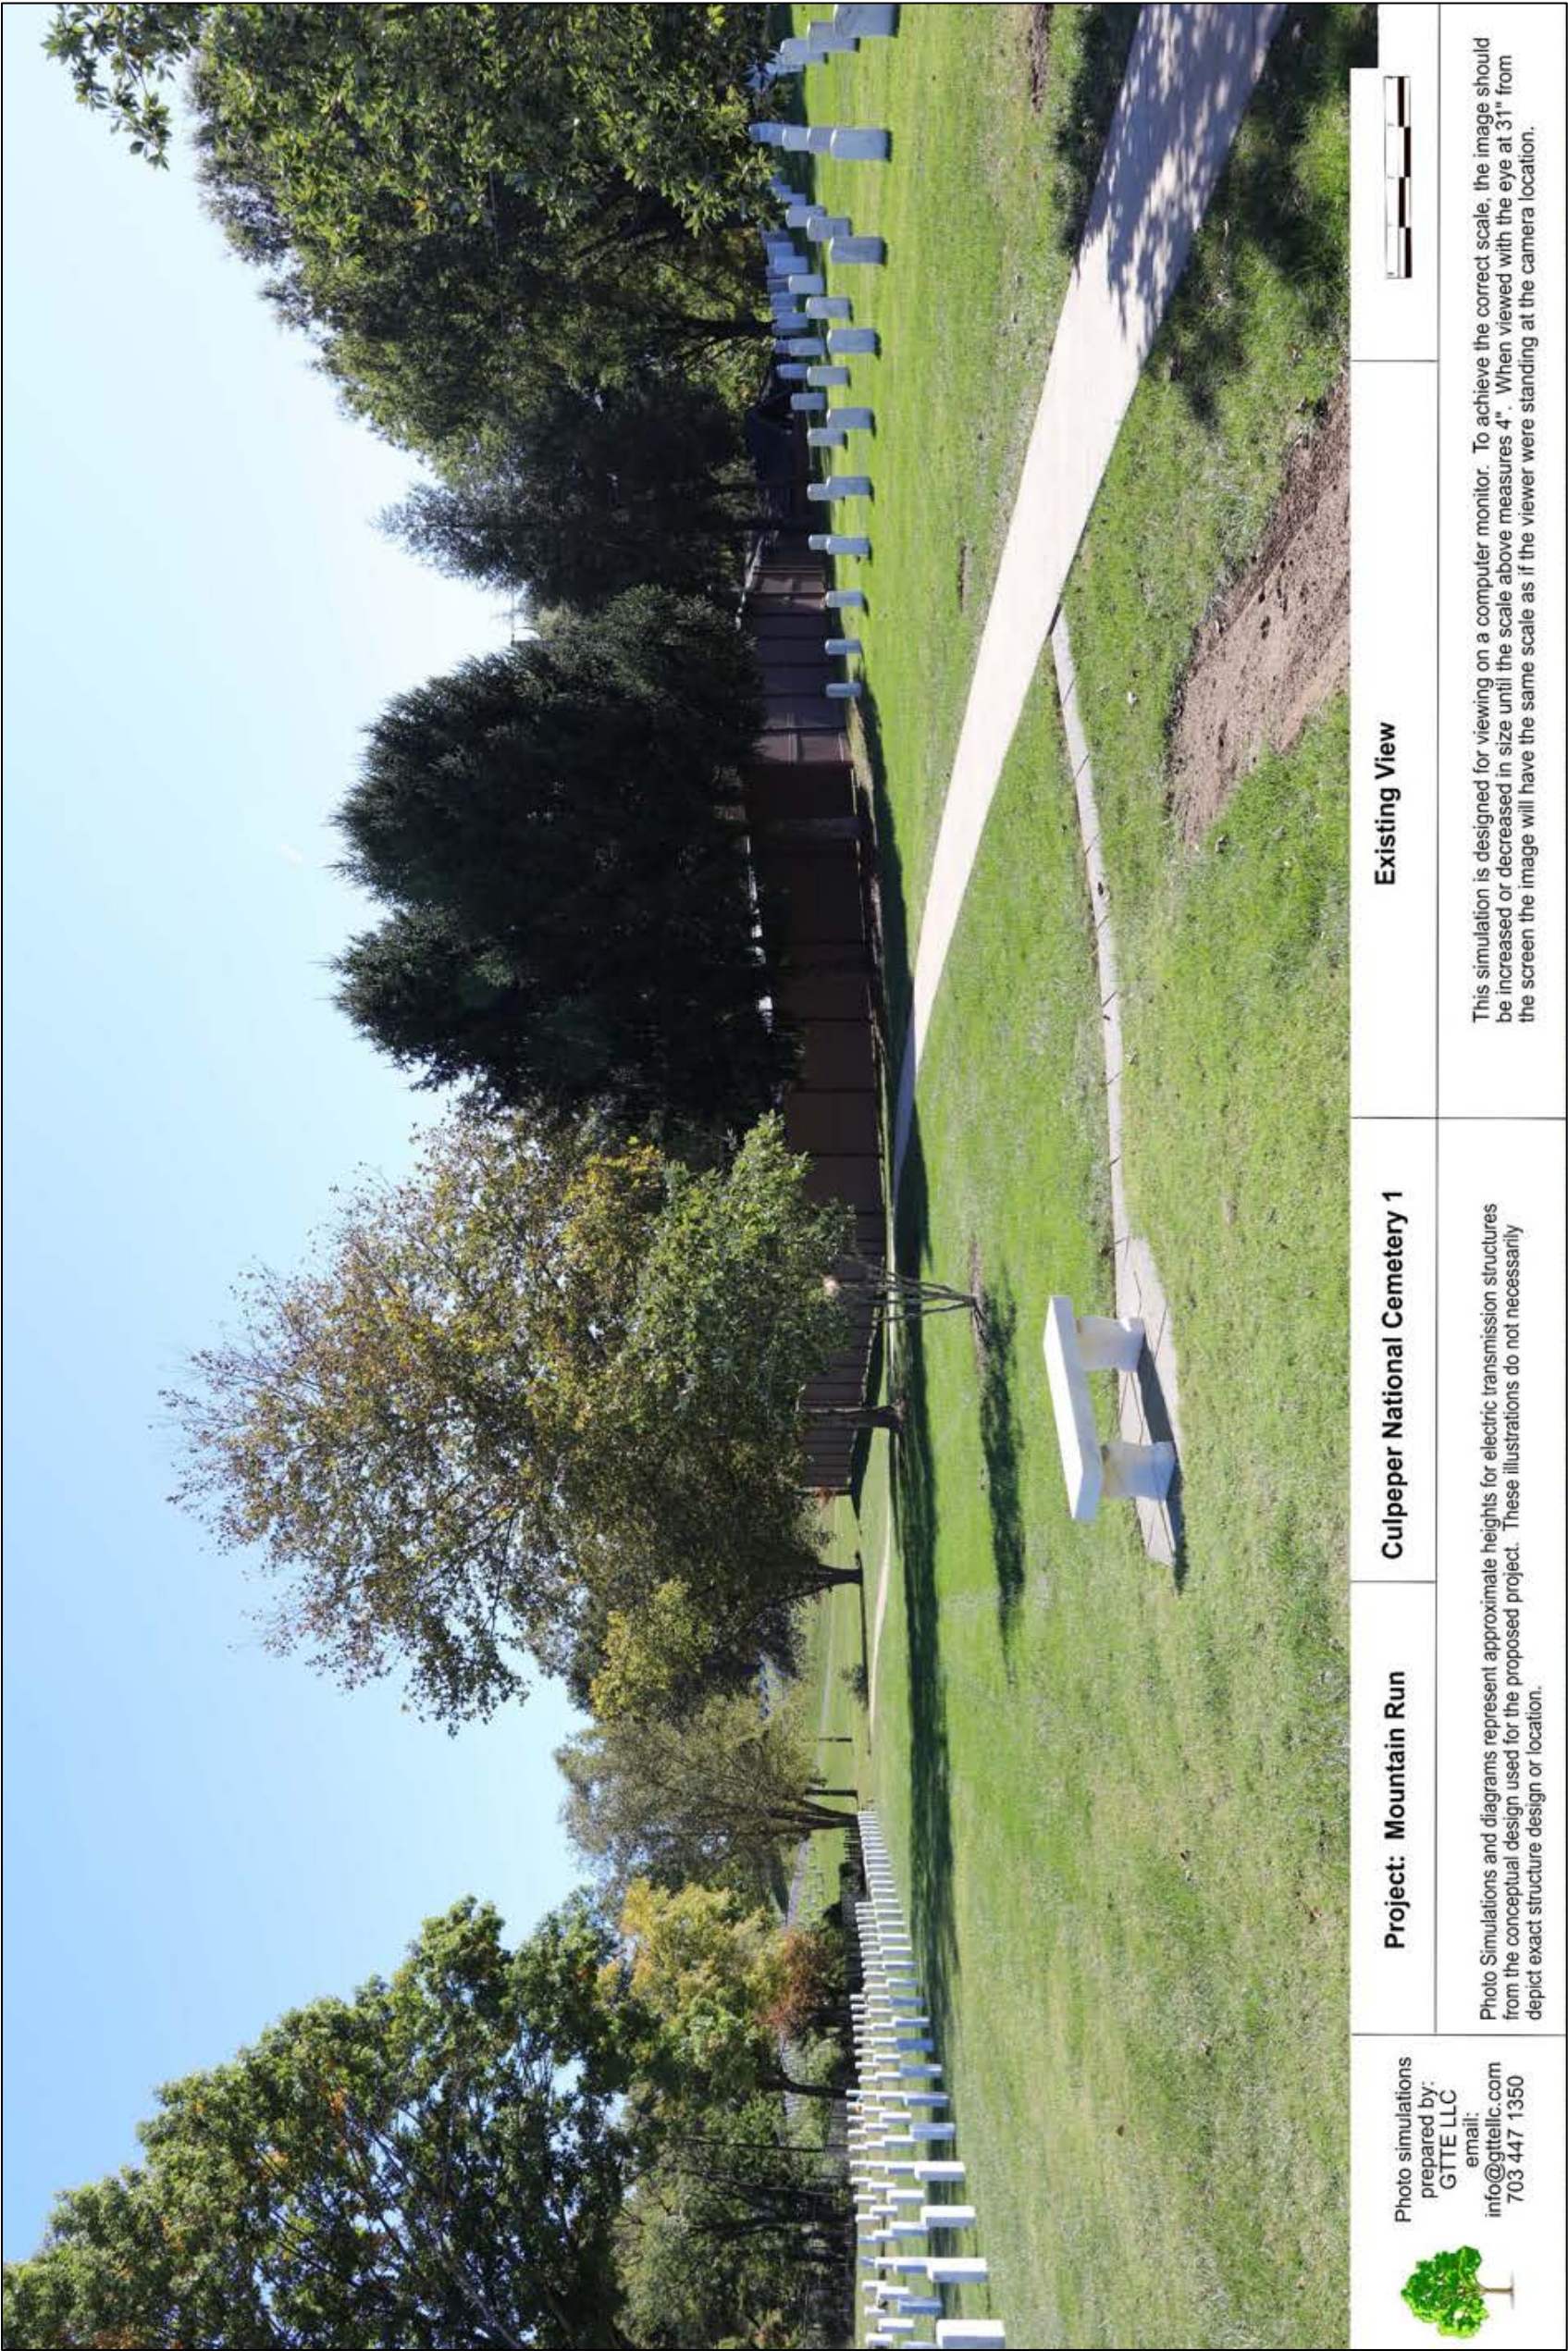
Figure 5-87: Culpeper National Cemetery Simulation 1 – Existing view from west annex. Source: GTTE, LLC

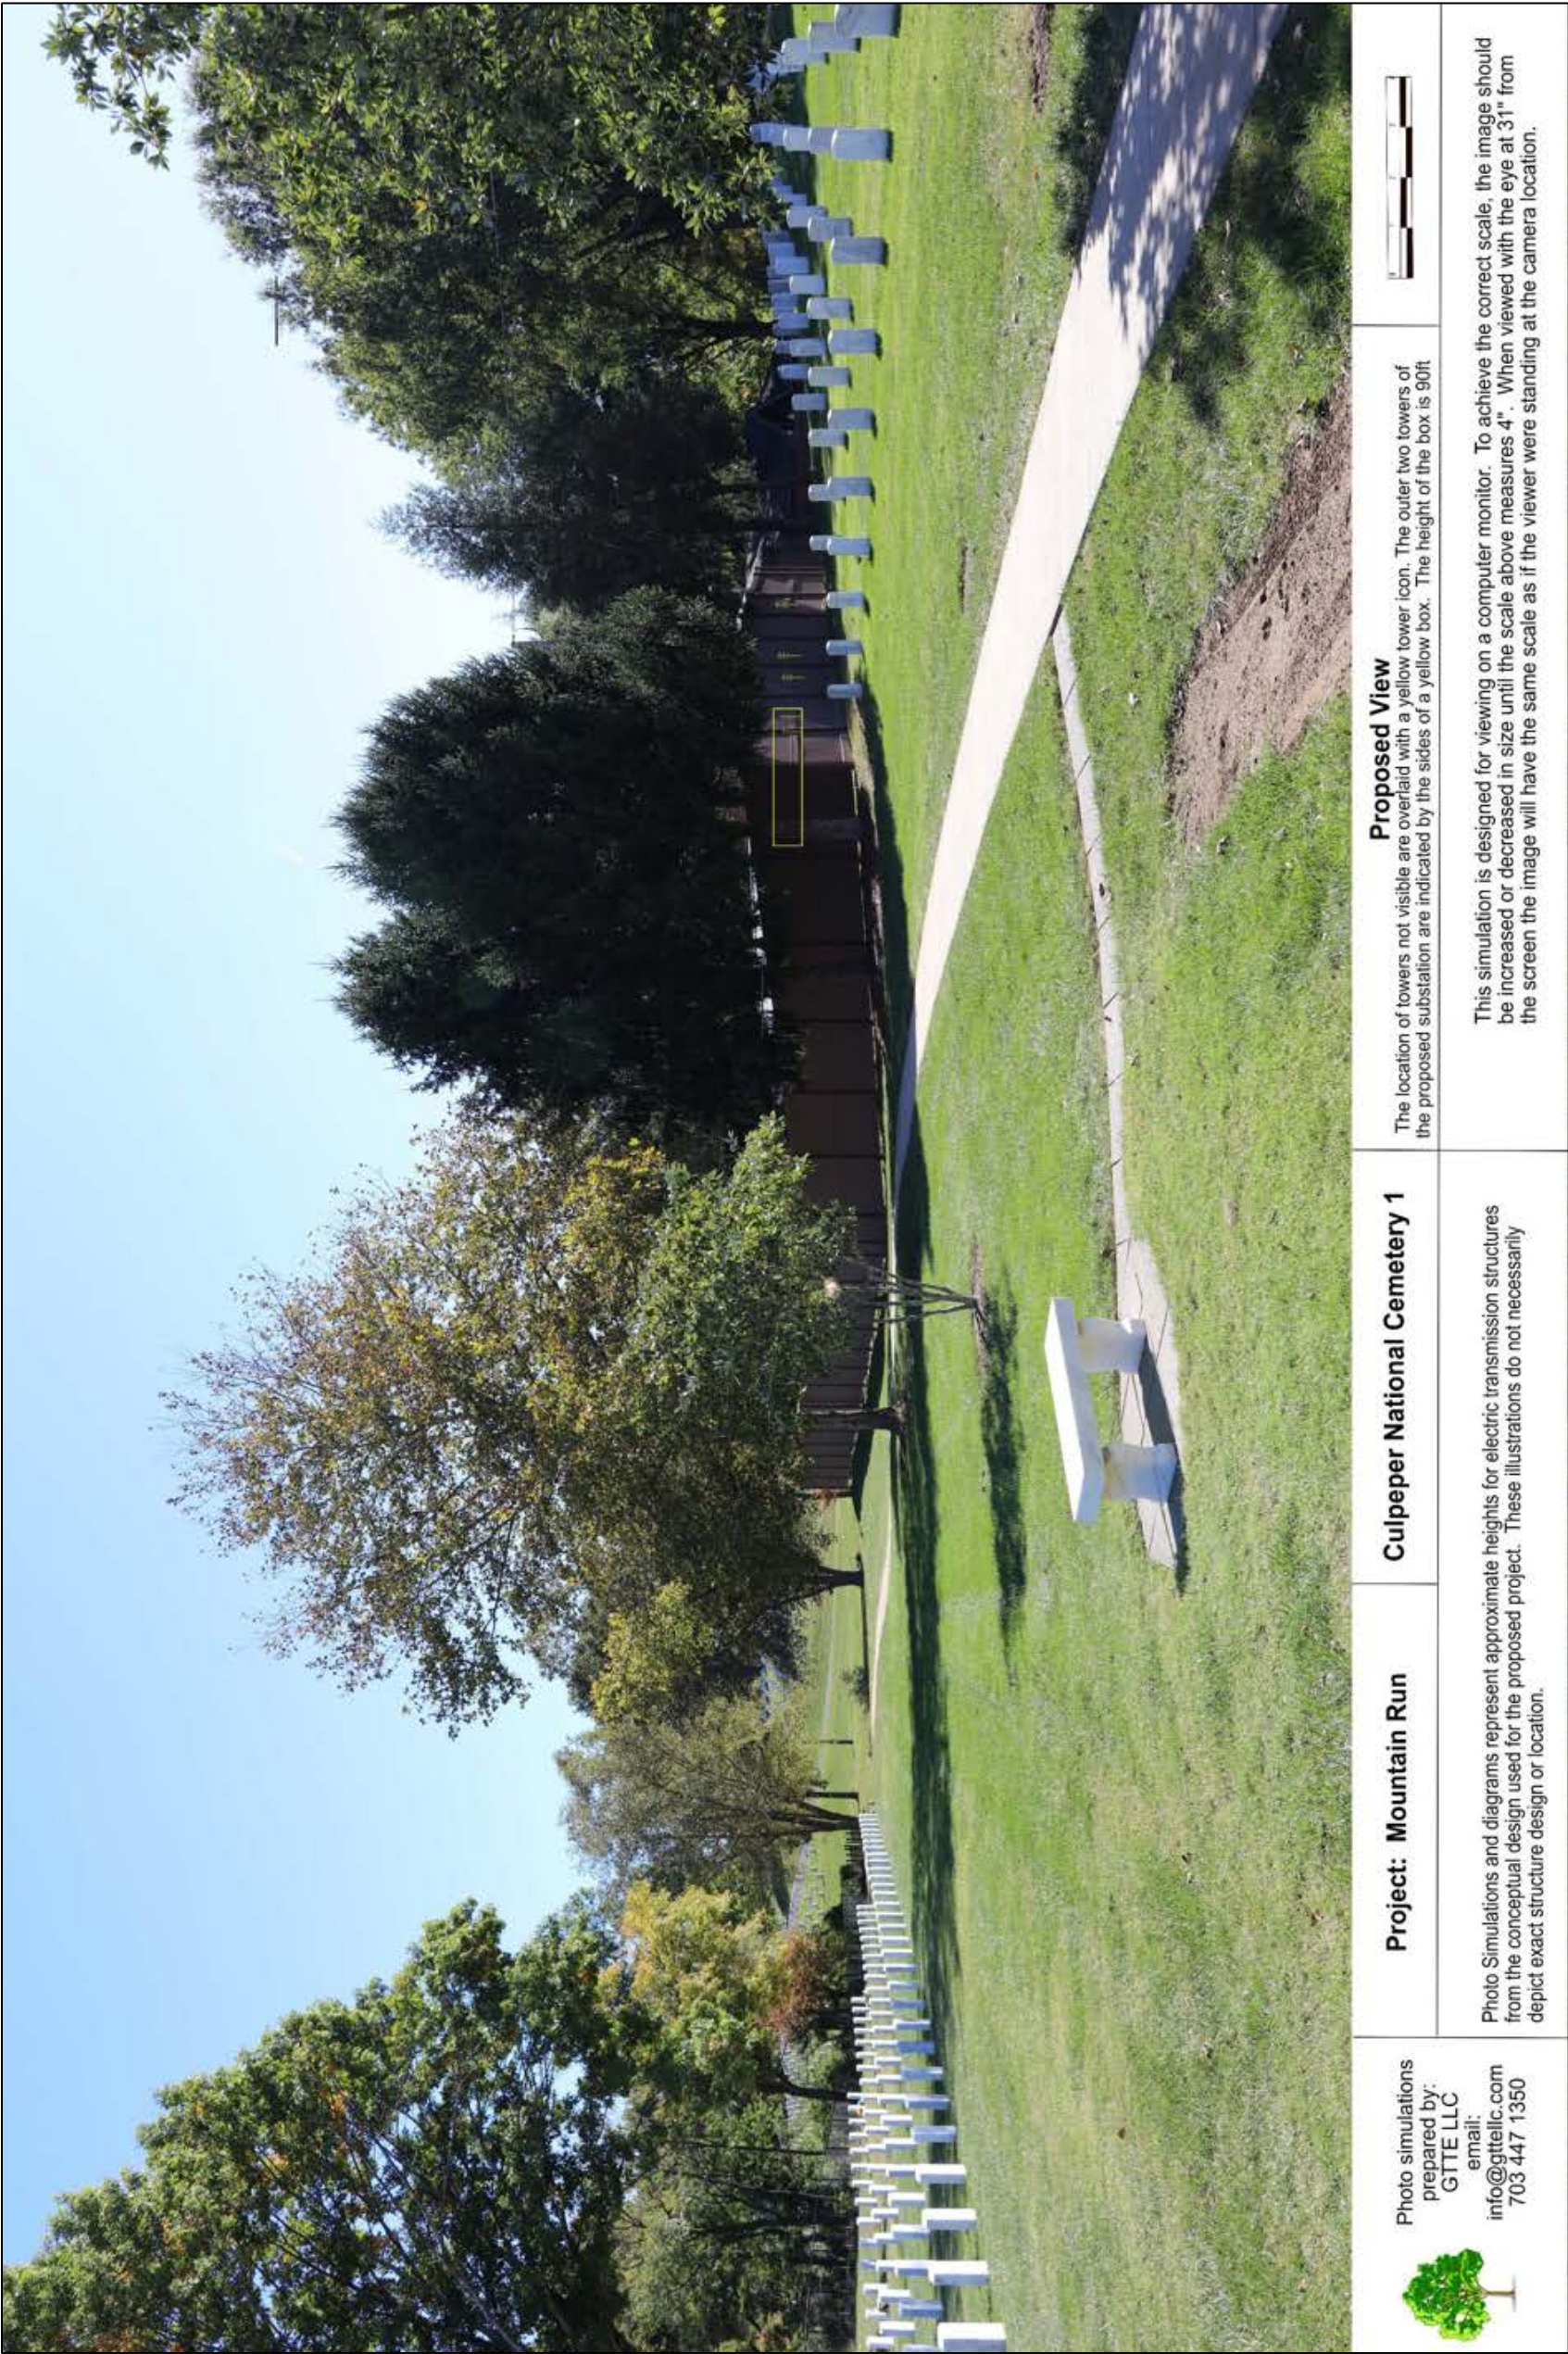
Figure 5-88: Culpeper National Cemetery Simulation 1 – Proposed view from west annex – (Structures not visible shown in yellow). Source: GTTE, LLC

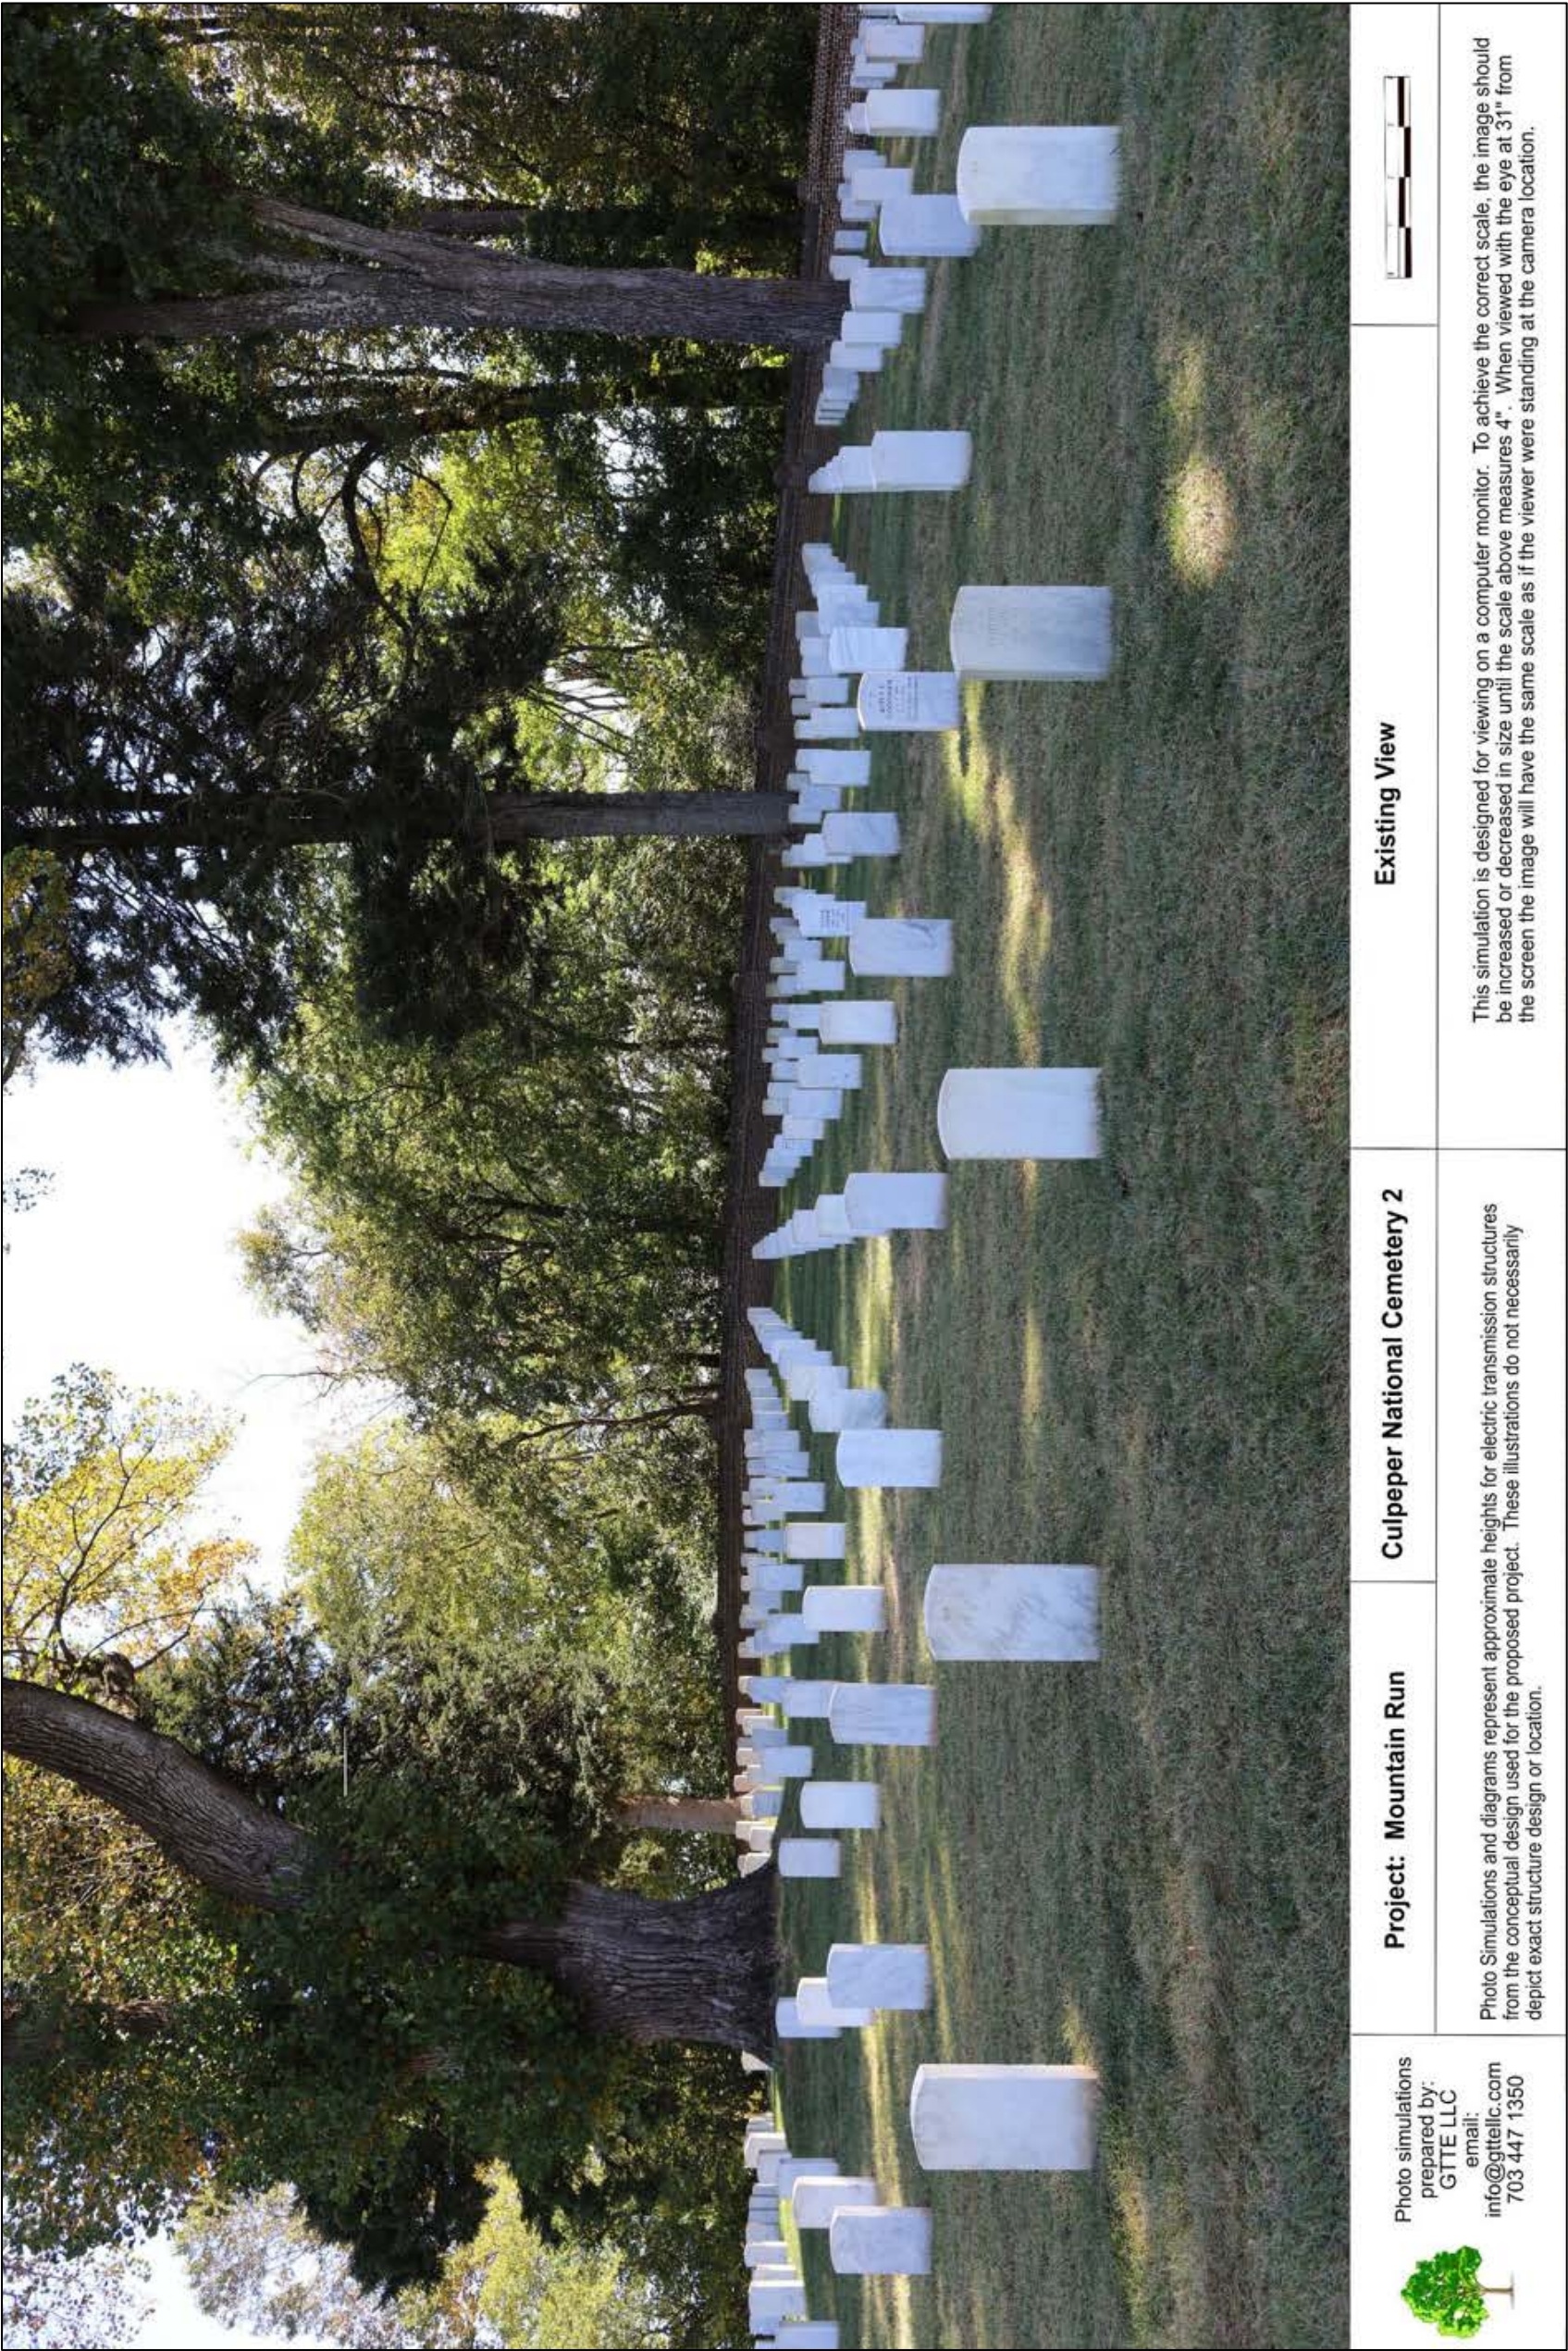
Figure 5-90: Culpeper National Cemetery Simulation 2 – Existing view from Officers’ circle. Source: GTTE, LLC

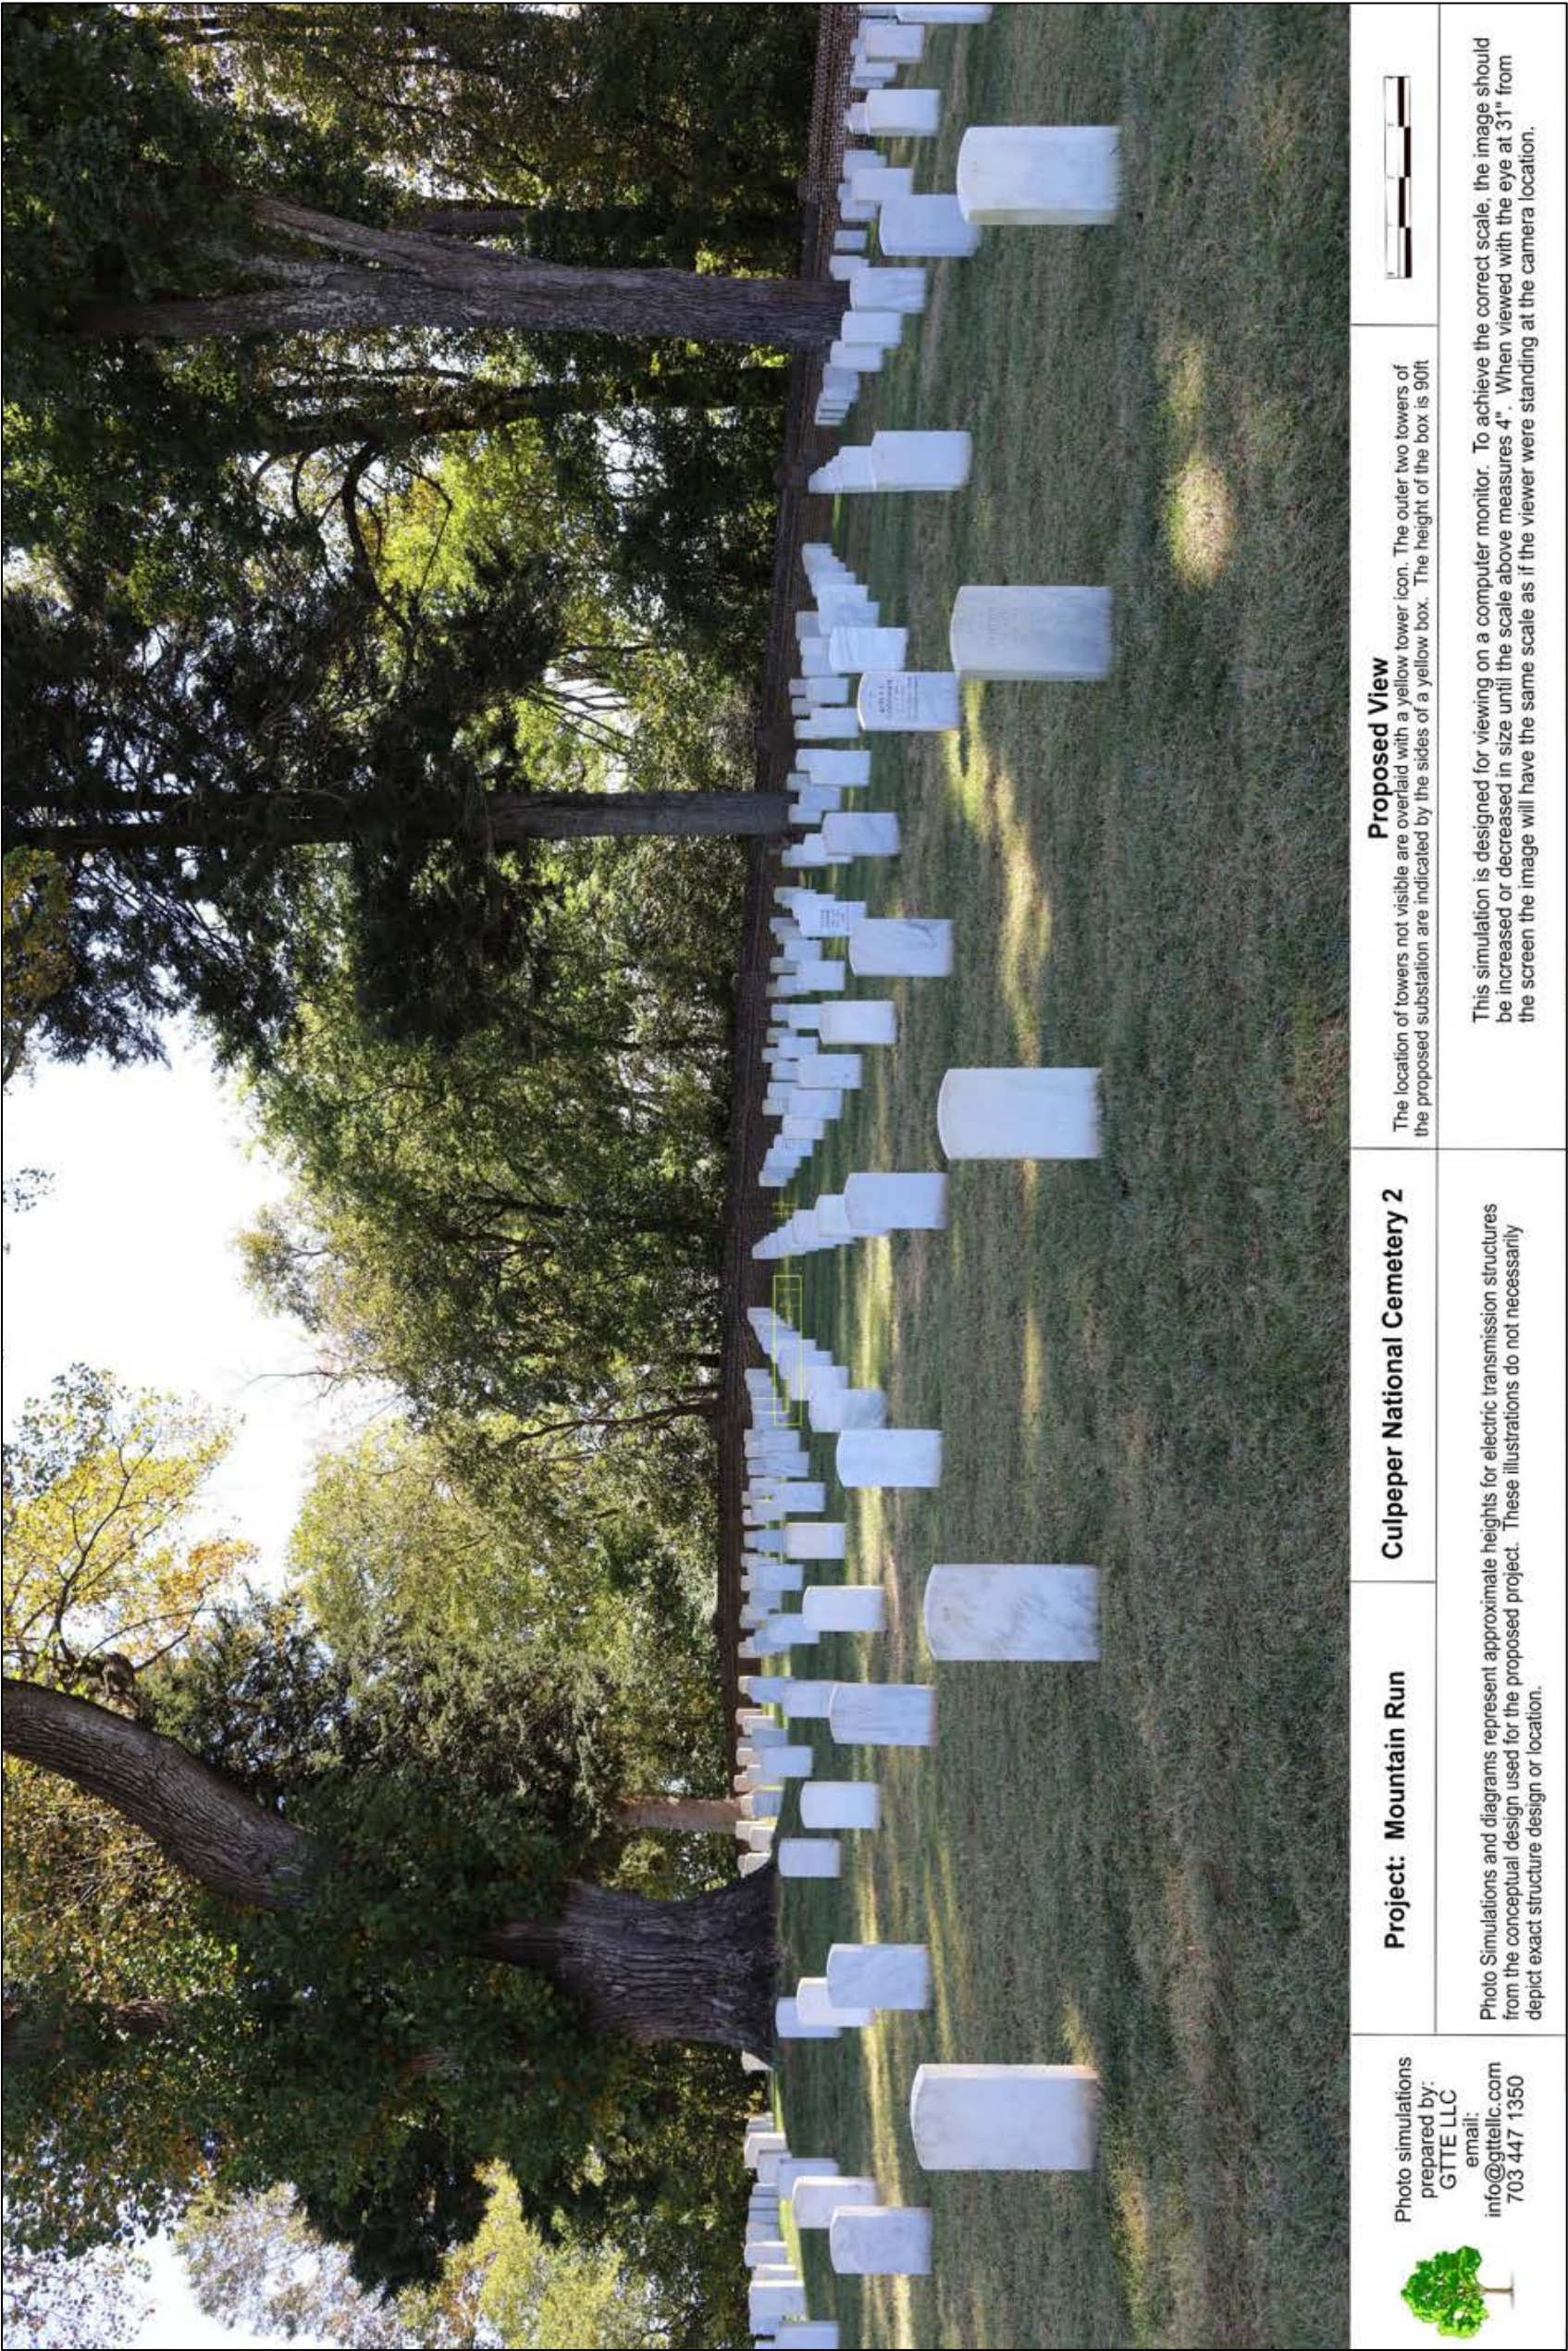
Figure 5-91: Culpeper National Cemetery Simulation 2 – Proposed view from Officers’ circle – (Structures not visible shown in yellow). Source: GTTE, LLC

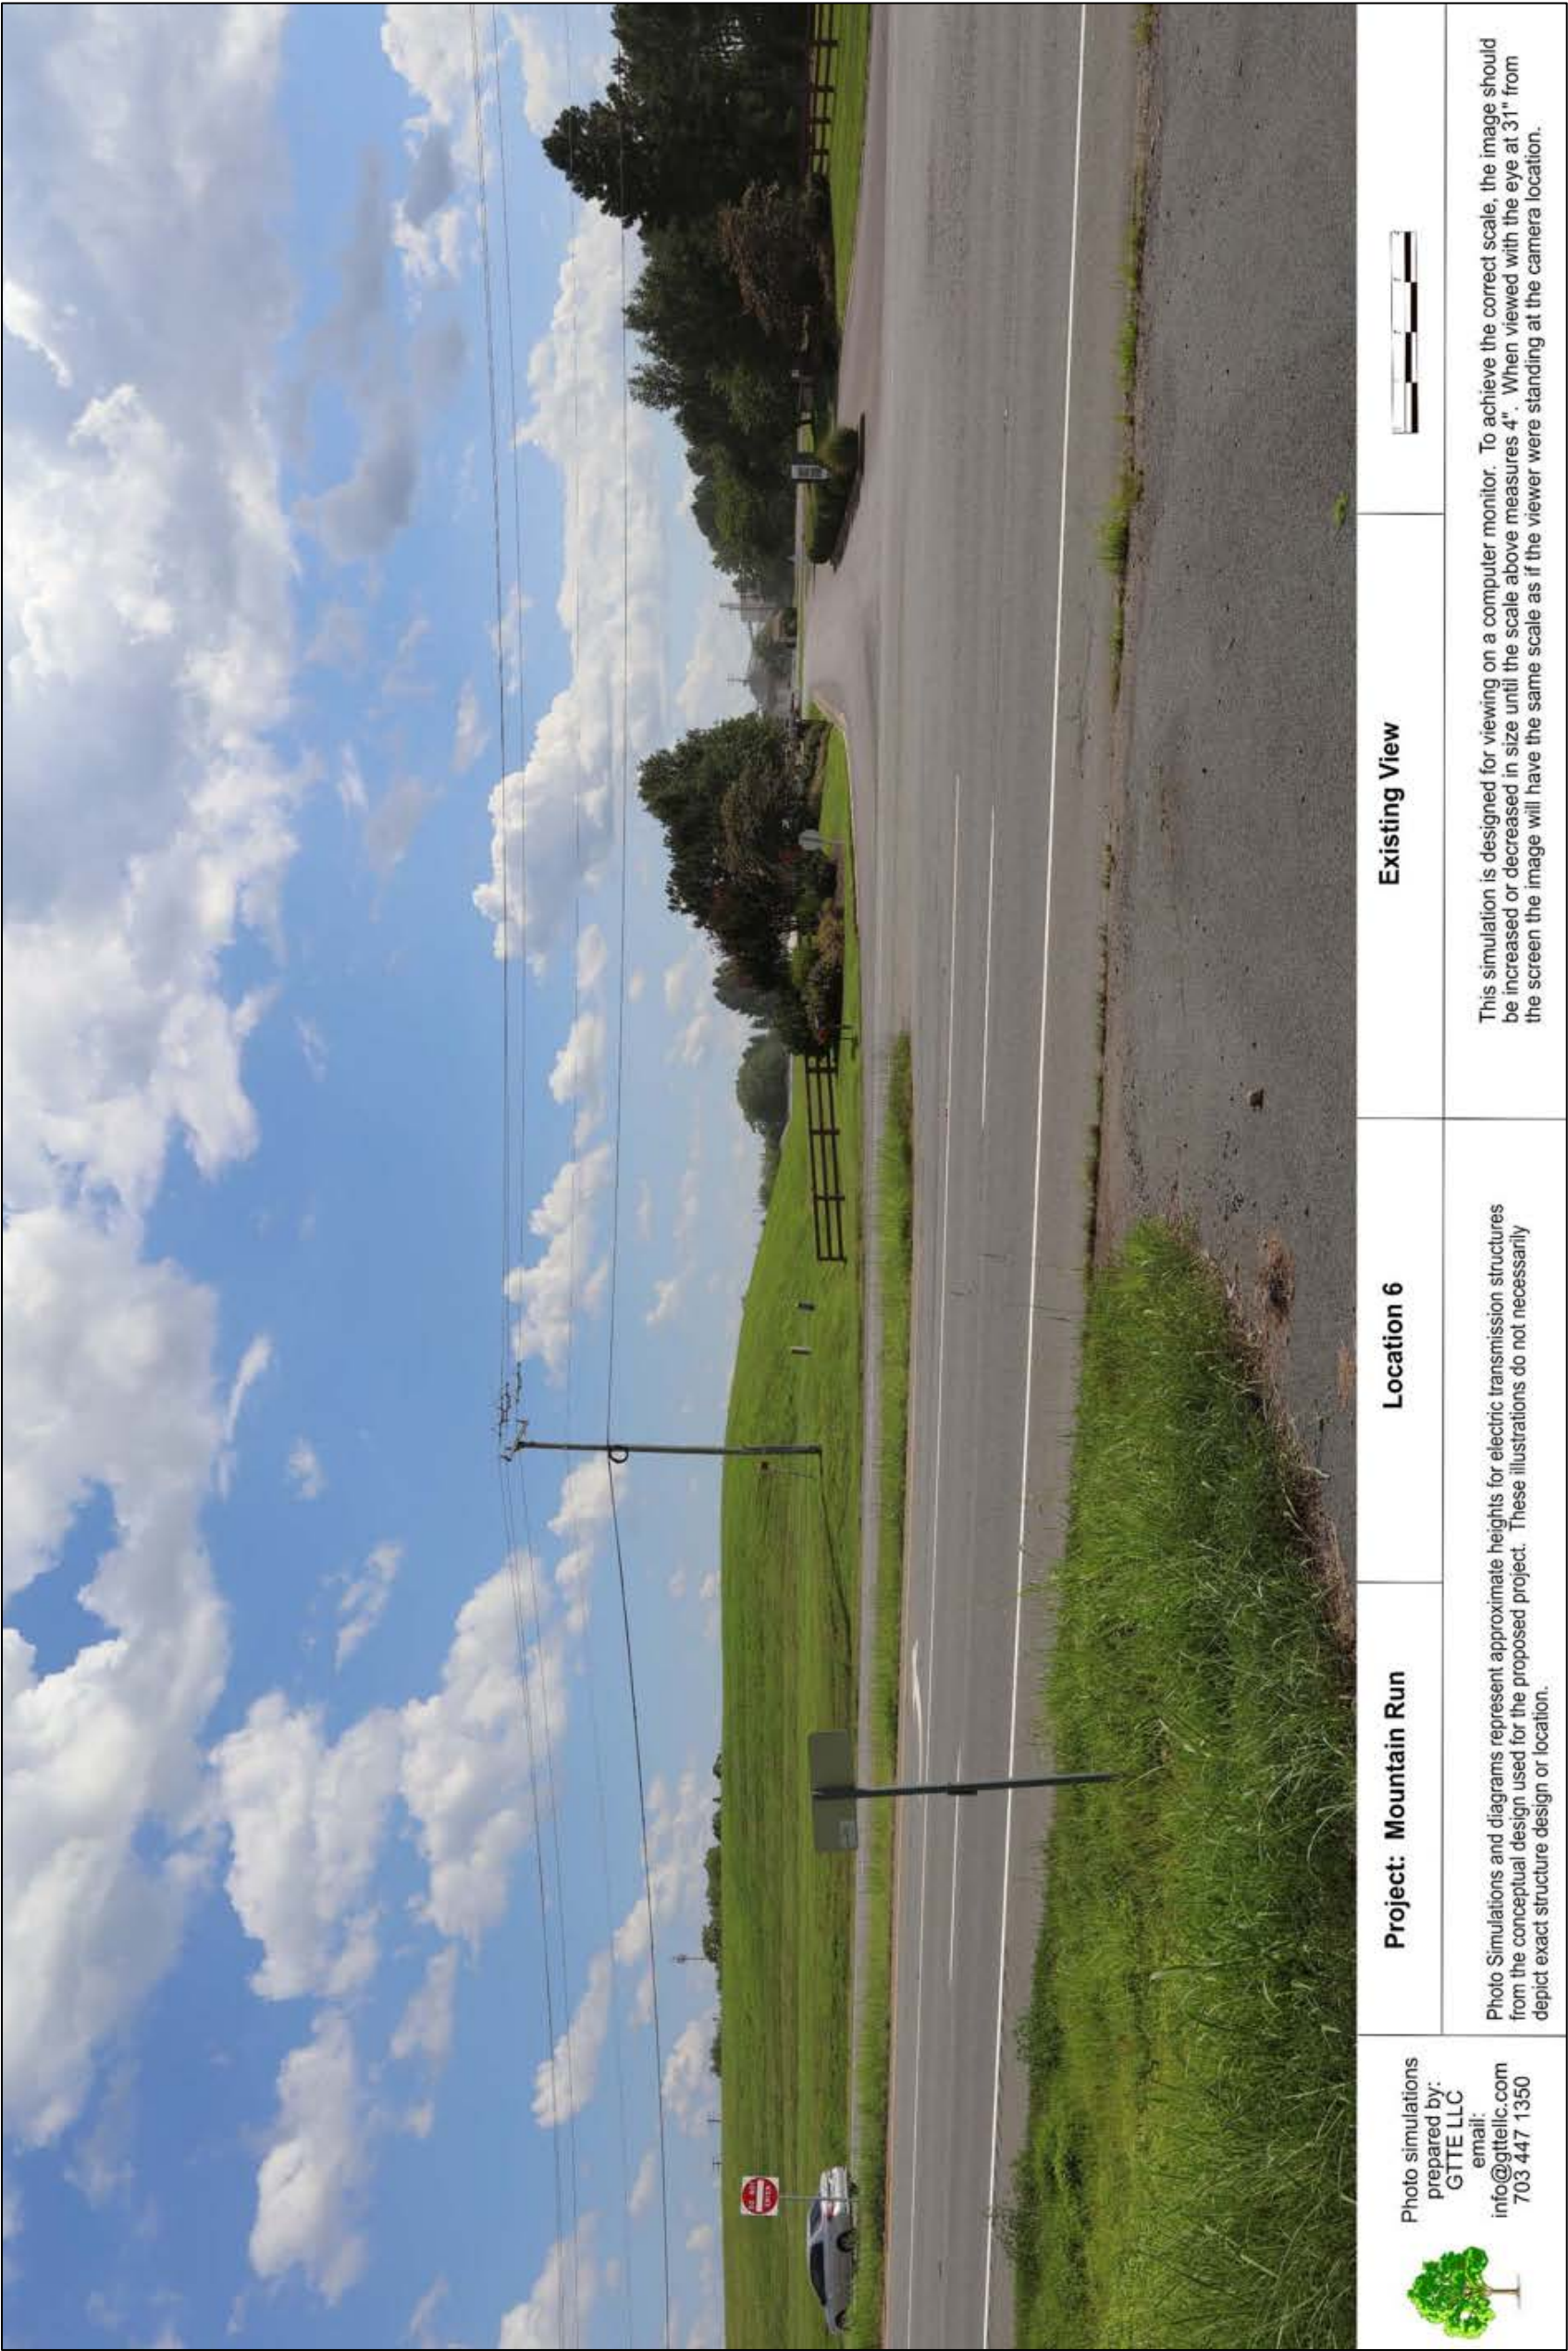
Figure 5-111: Brandy Station Battlefield Simulation 1 – Existing view from Route 3 at Clover Hill Road. Source: GTTE, LLC
