**Application, Appendix,
DEQ Supplement, Direct
Testimony and Exhibits of
Virginia Electric and Power
Company**

**Cirrus-Keyser 230 kV Loop and
Related Projects**

Case No. PUR-2022-00198

DEQ Supplement

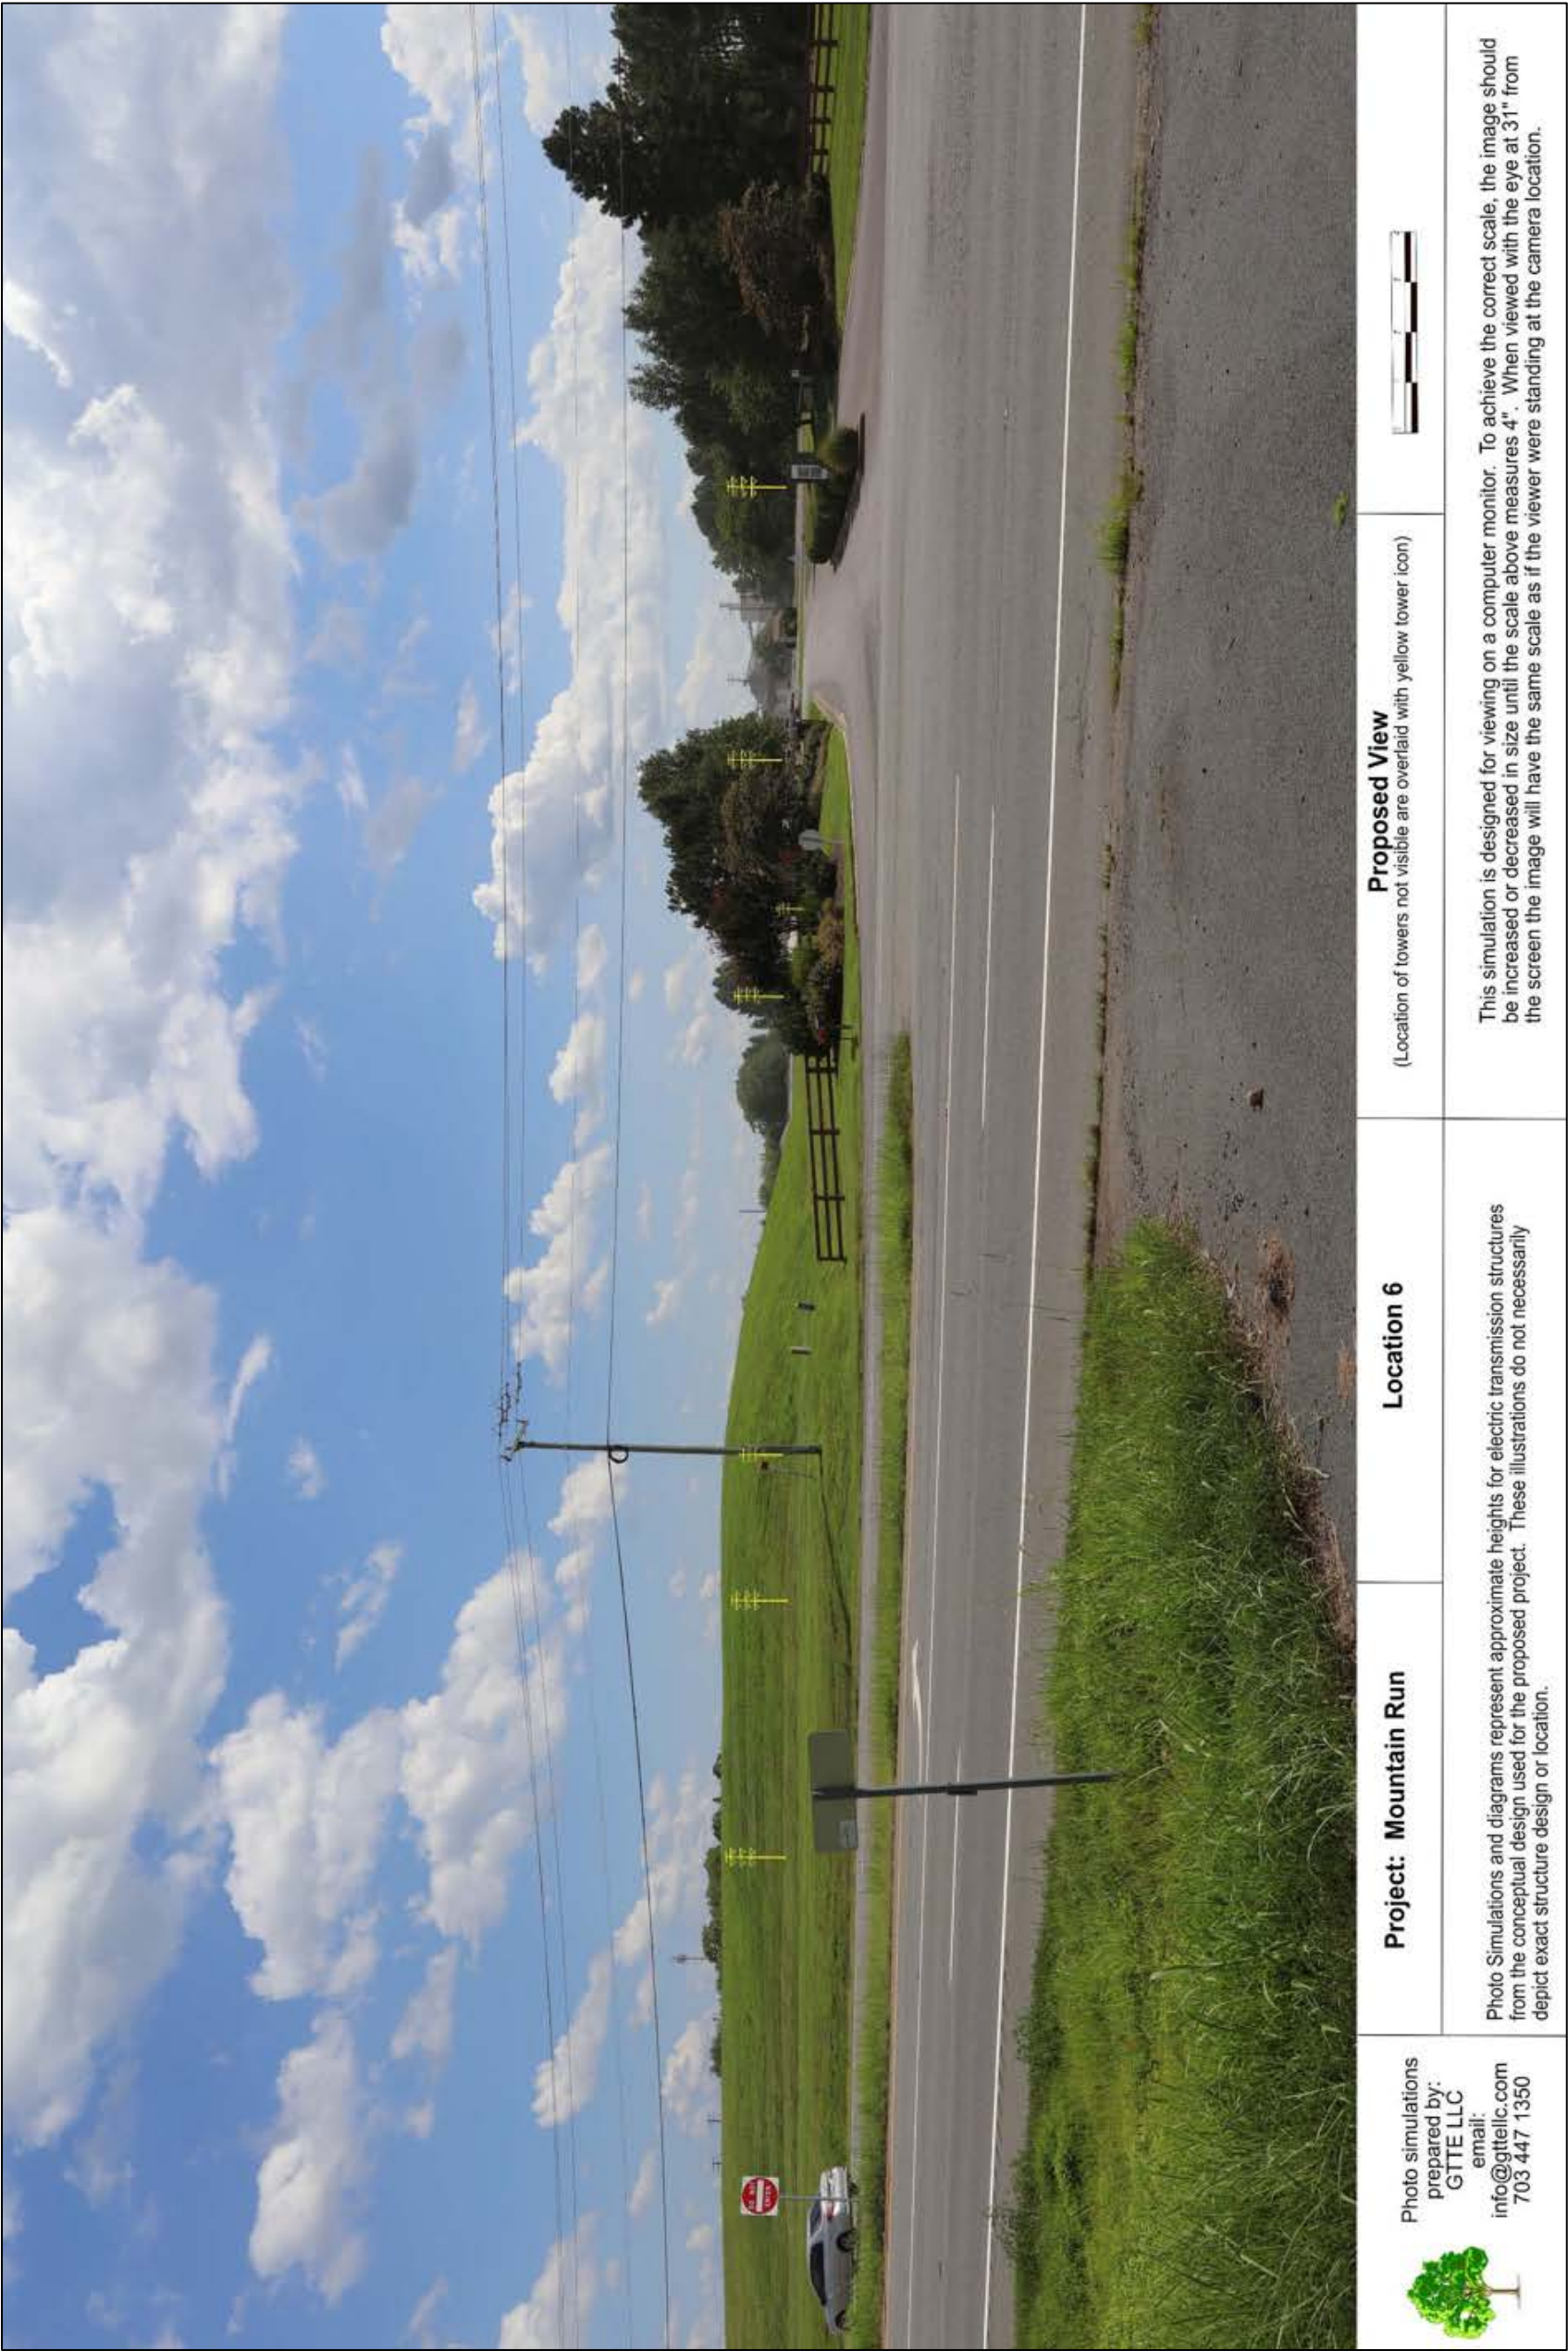
Figure 5-112: Brandy Station Battlefield Simulation 1 – Proposed view from Route 3 at Clover Hill Road – (Visible structure shown as it would appear. Structures not visible shown in yellow). Source: GTTE, LLC

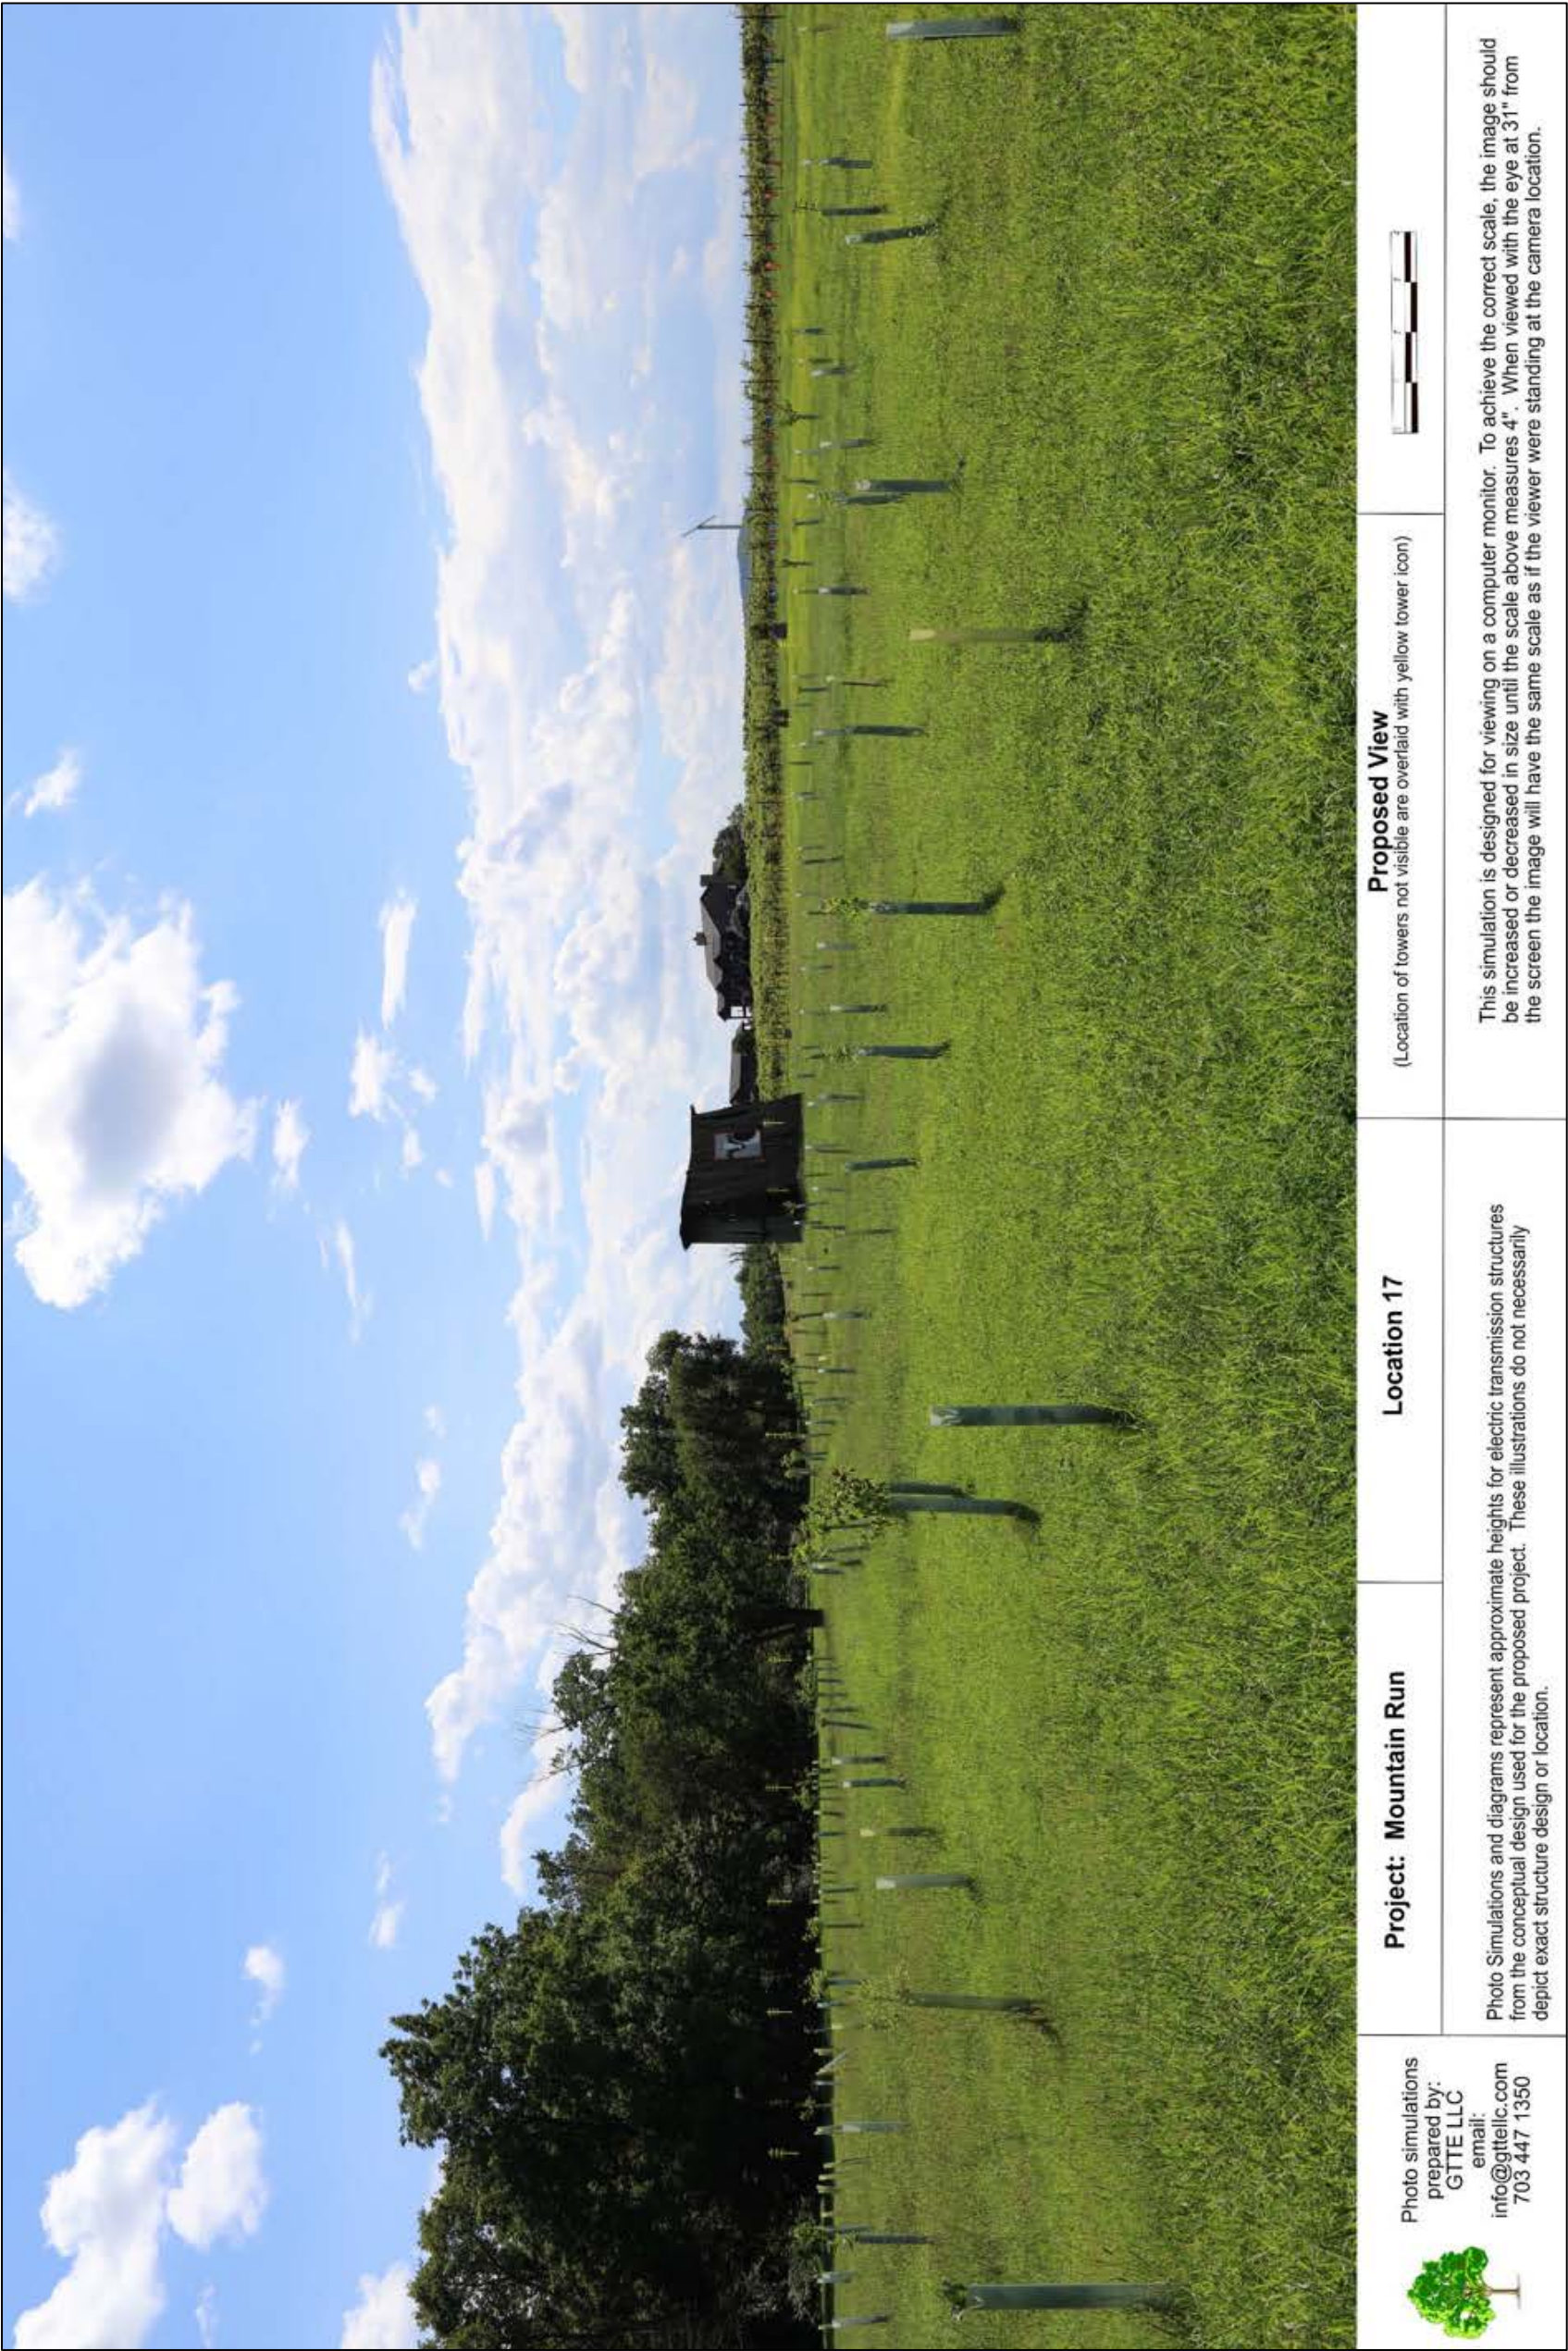
Figure 5-115: Brandy Station Battlefield Simulation 2 – Proposed view from Mountain Run Winery – (Structures not visible shown in yellow). Source: GTTE, LLC

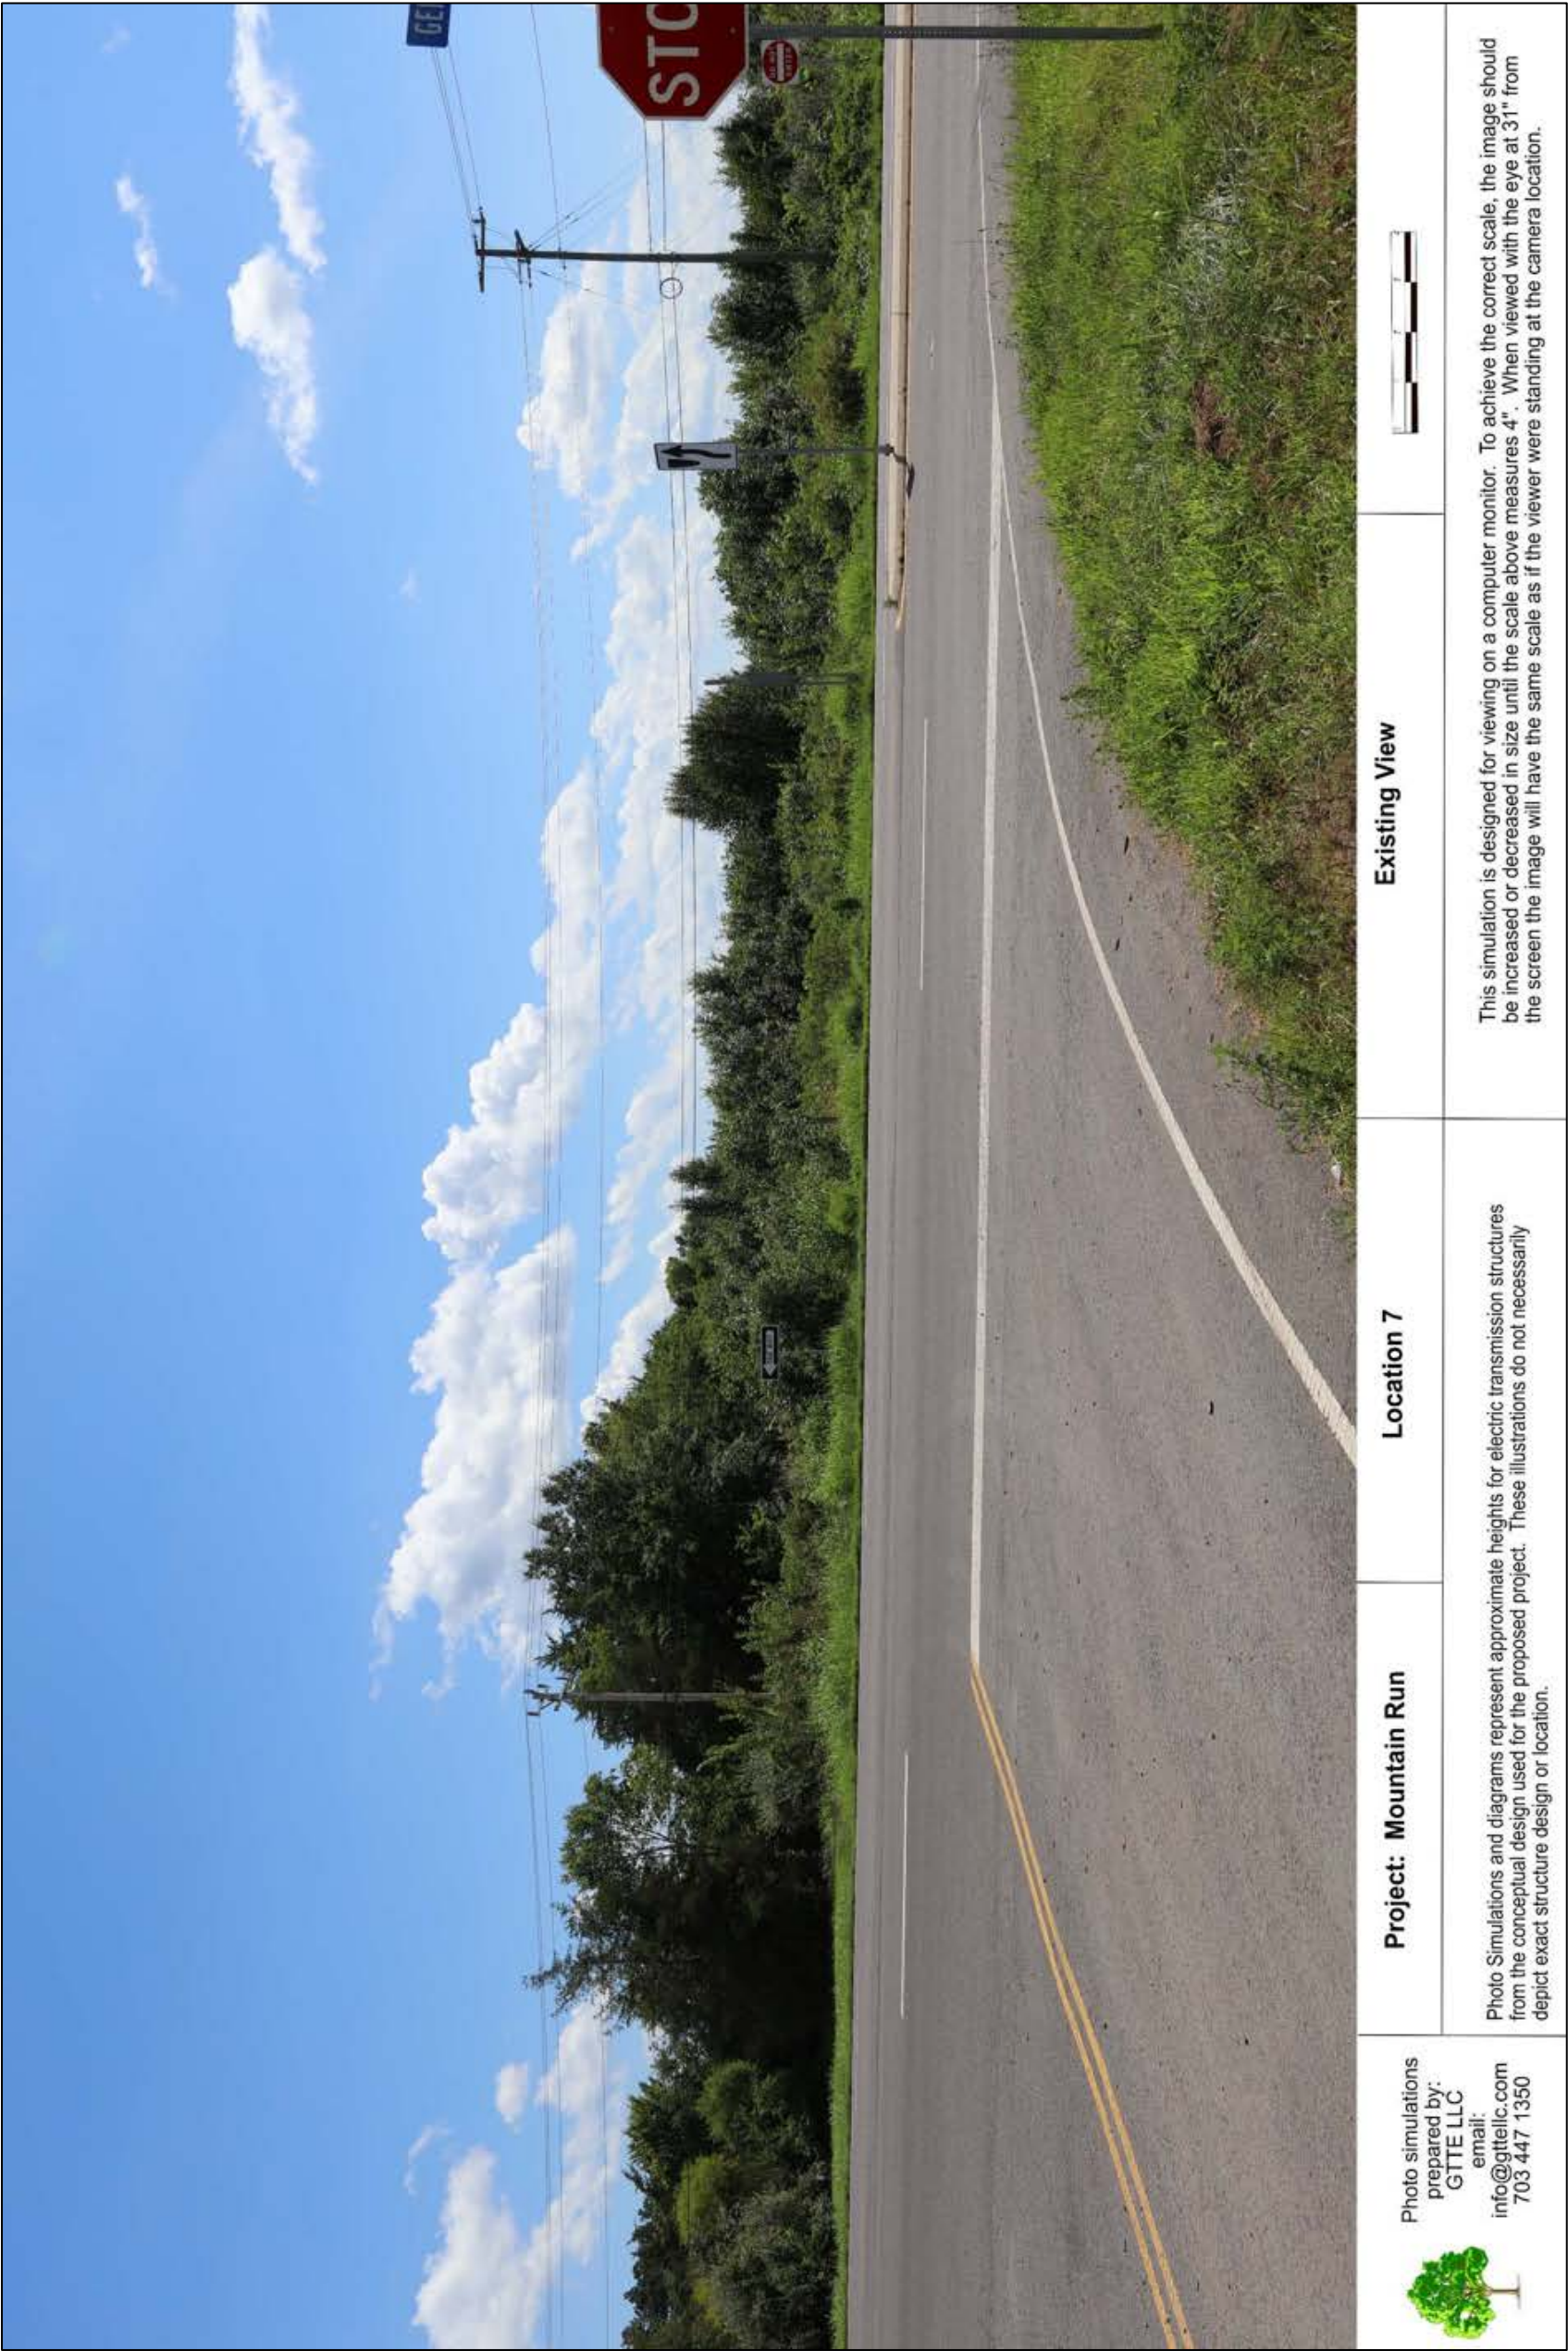
Figure 5-117: Brandy Station Battlefield Simulation 3 – Existing view from Route 3 at York Road. Source: GTTE, LLC

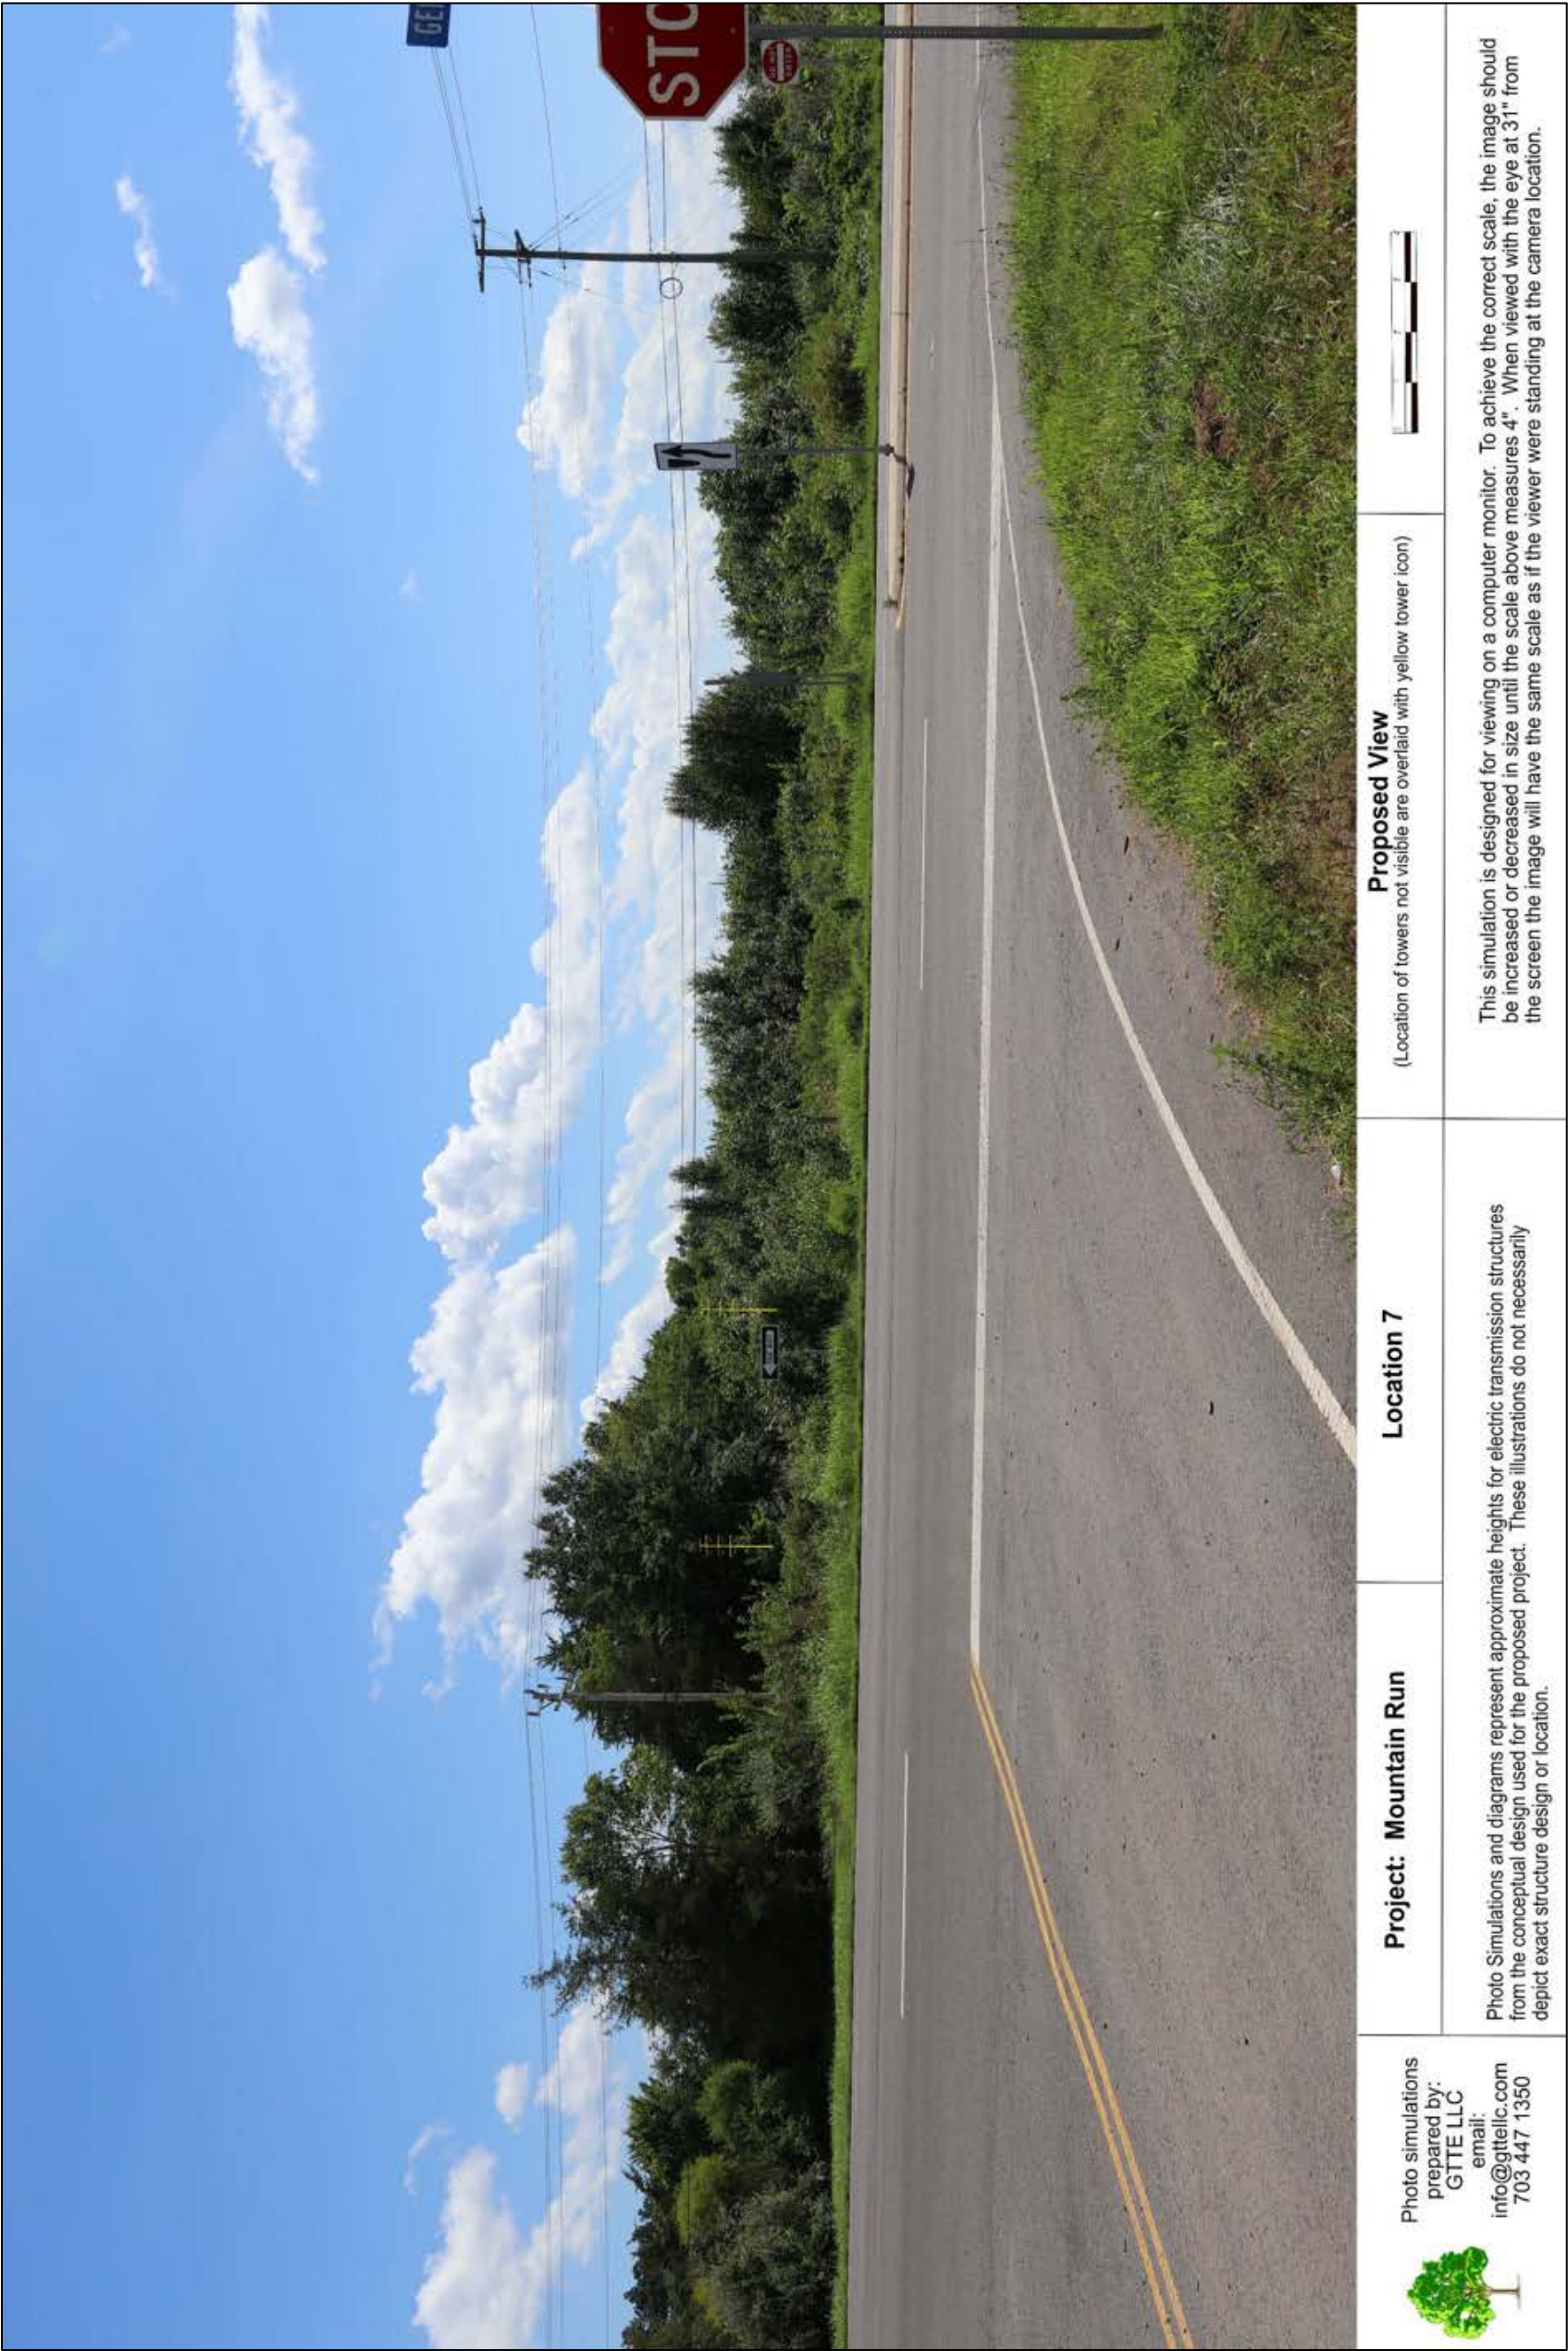
Figure 5-118: Brandy Station Battlefield Simulation 3 – Proposed view from Route 3 at York Road – (Visible structure shown as it would appear). Source: GTTE, LLC

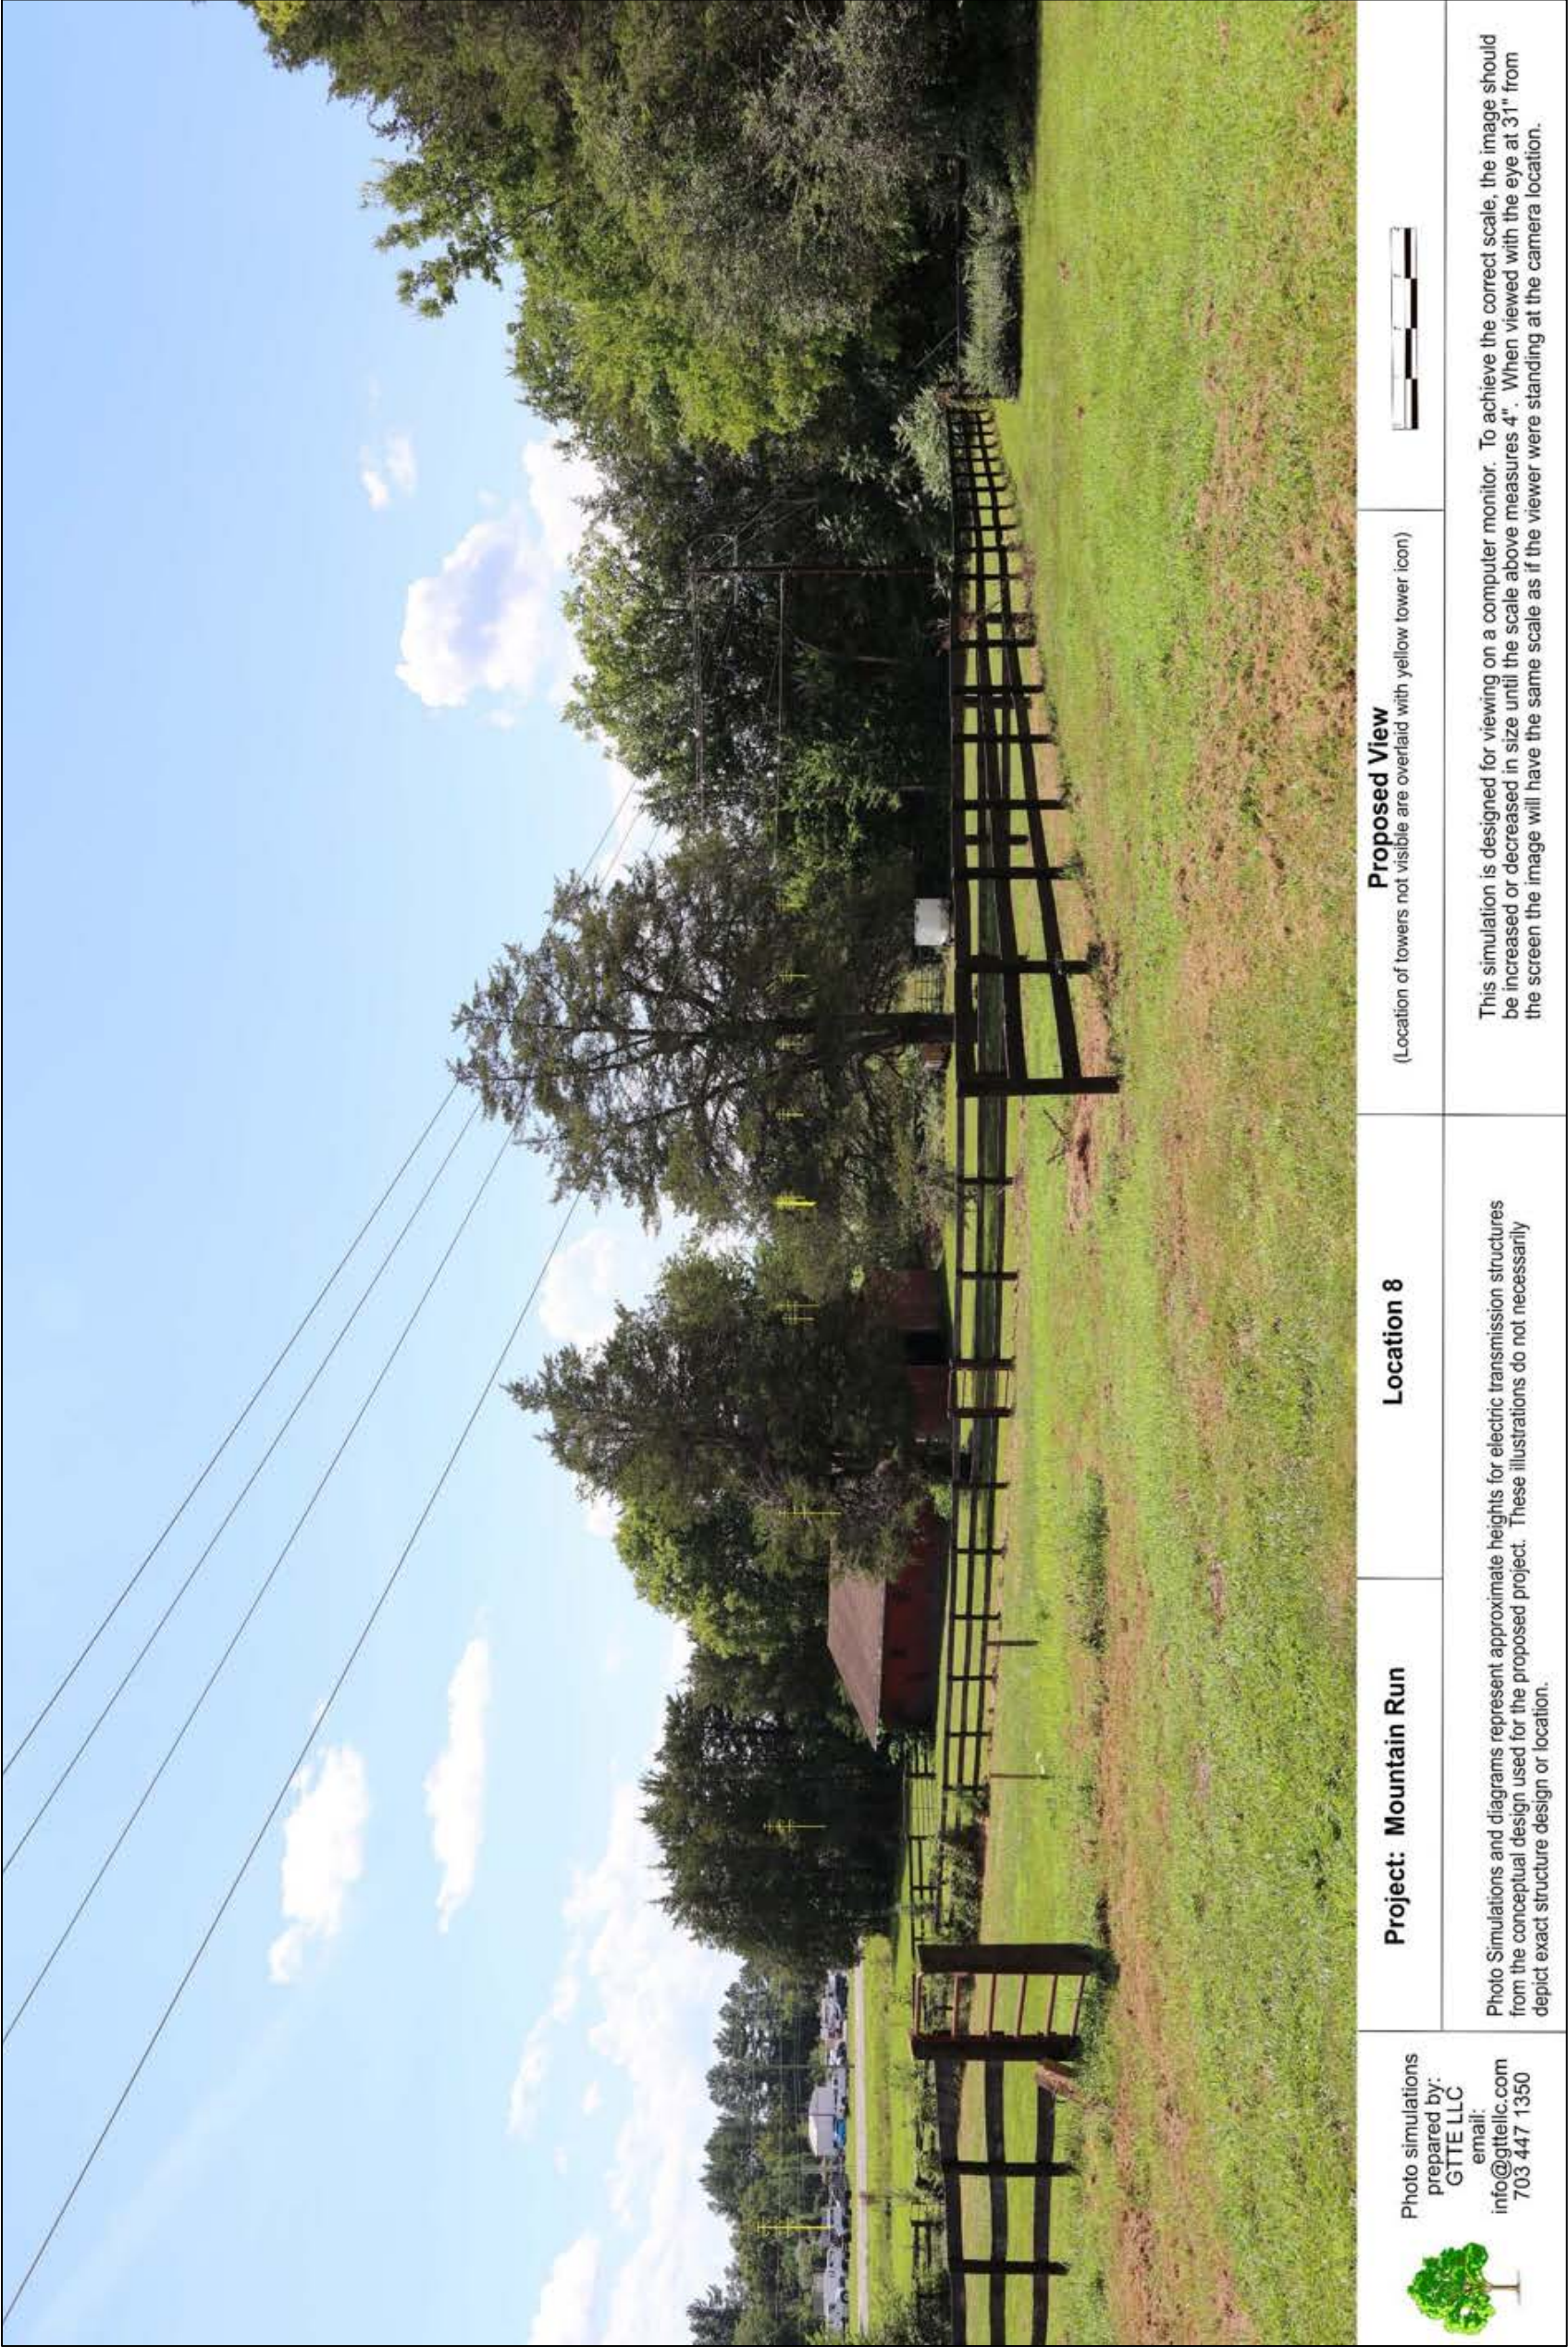
Figure 5-121: Brandy Station Battlefield Simulation 4 – Proposed view from Zimmermann’s Tavern – (Structures not visible shown in yellow). Source: GTTE, LLC

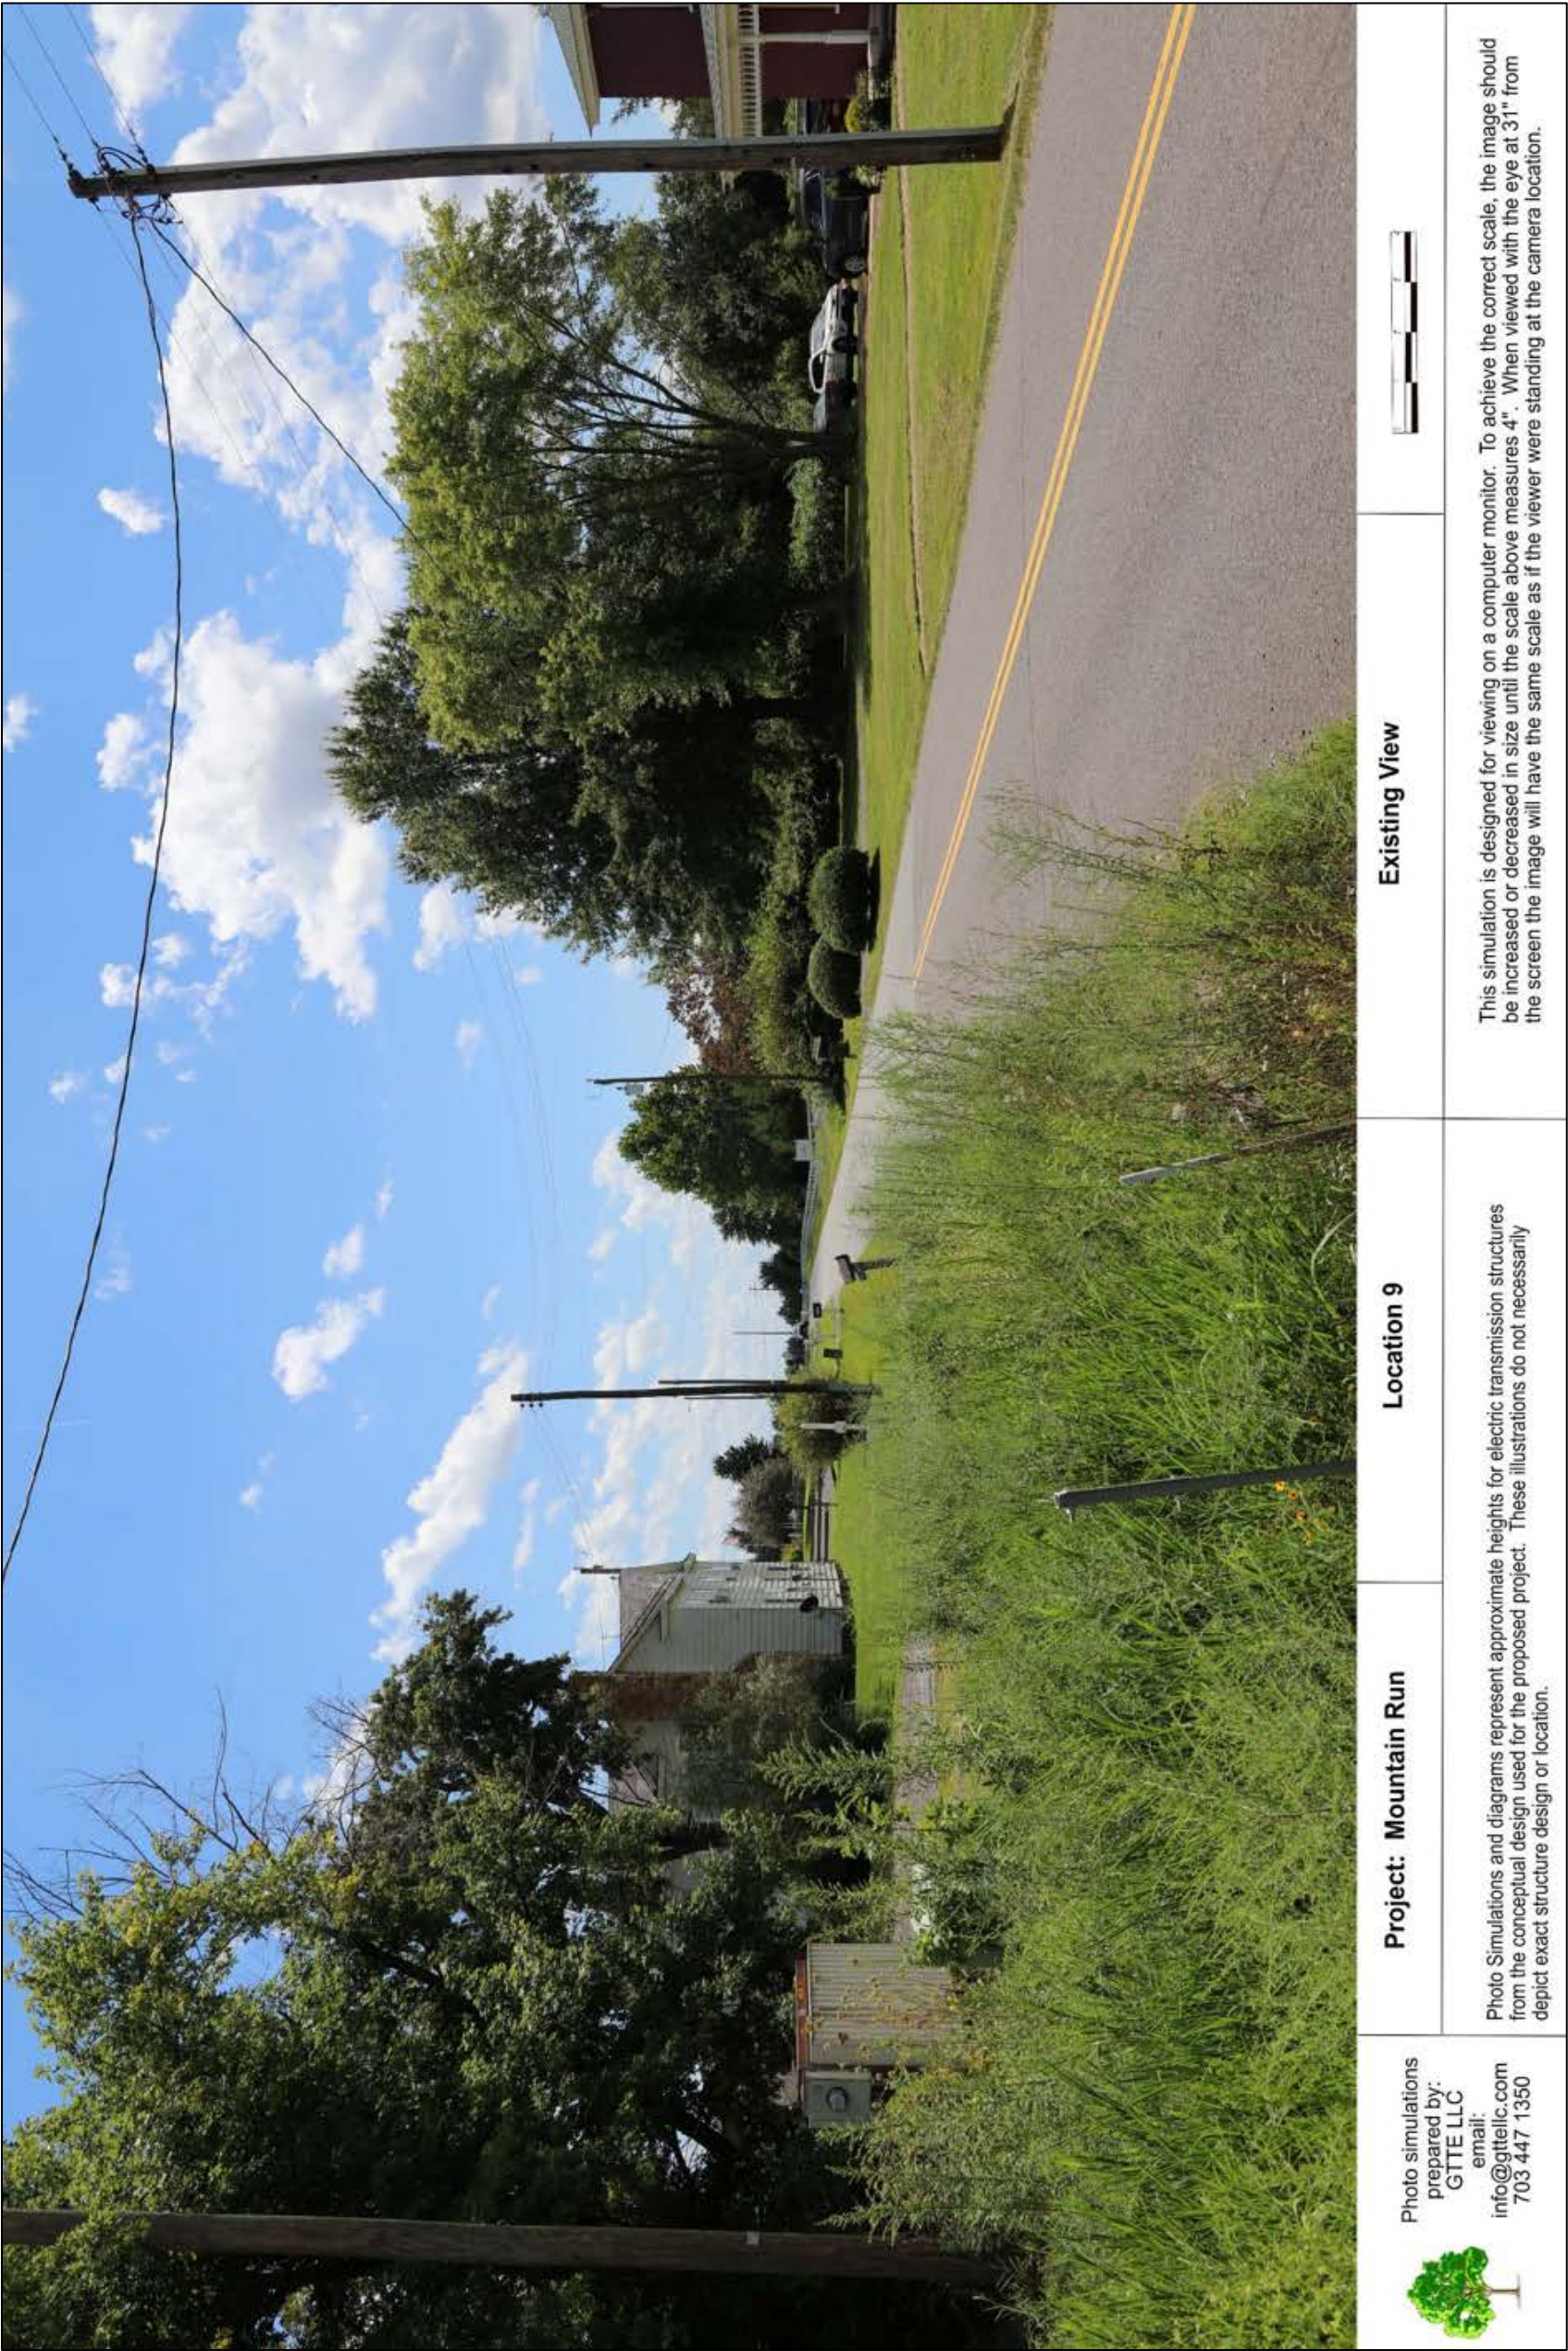
Figure 5-123: Brandy Station Battlefield Simulation 5 – Existing view from Route 3 at Batna Road. Source: GTTE, LLC
