**Application, Appendix,
DEQ Supplement, Direct
Testimony and Exhibits of
Virginia Electric and Power
Company**

**Cirrus-Keyser 230 kV Loop and
Related Projects**

Case No. PUR-2022-00198

DEQ Supplement

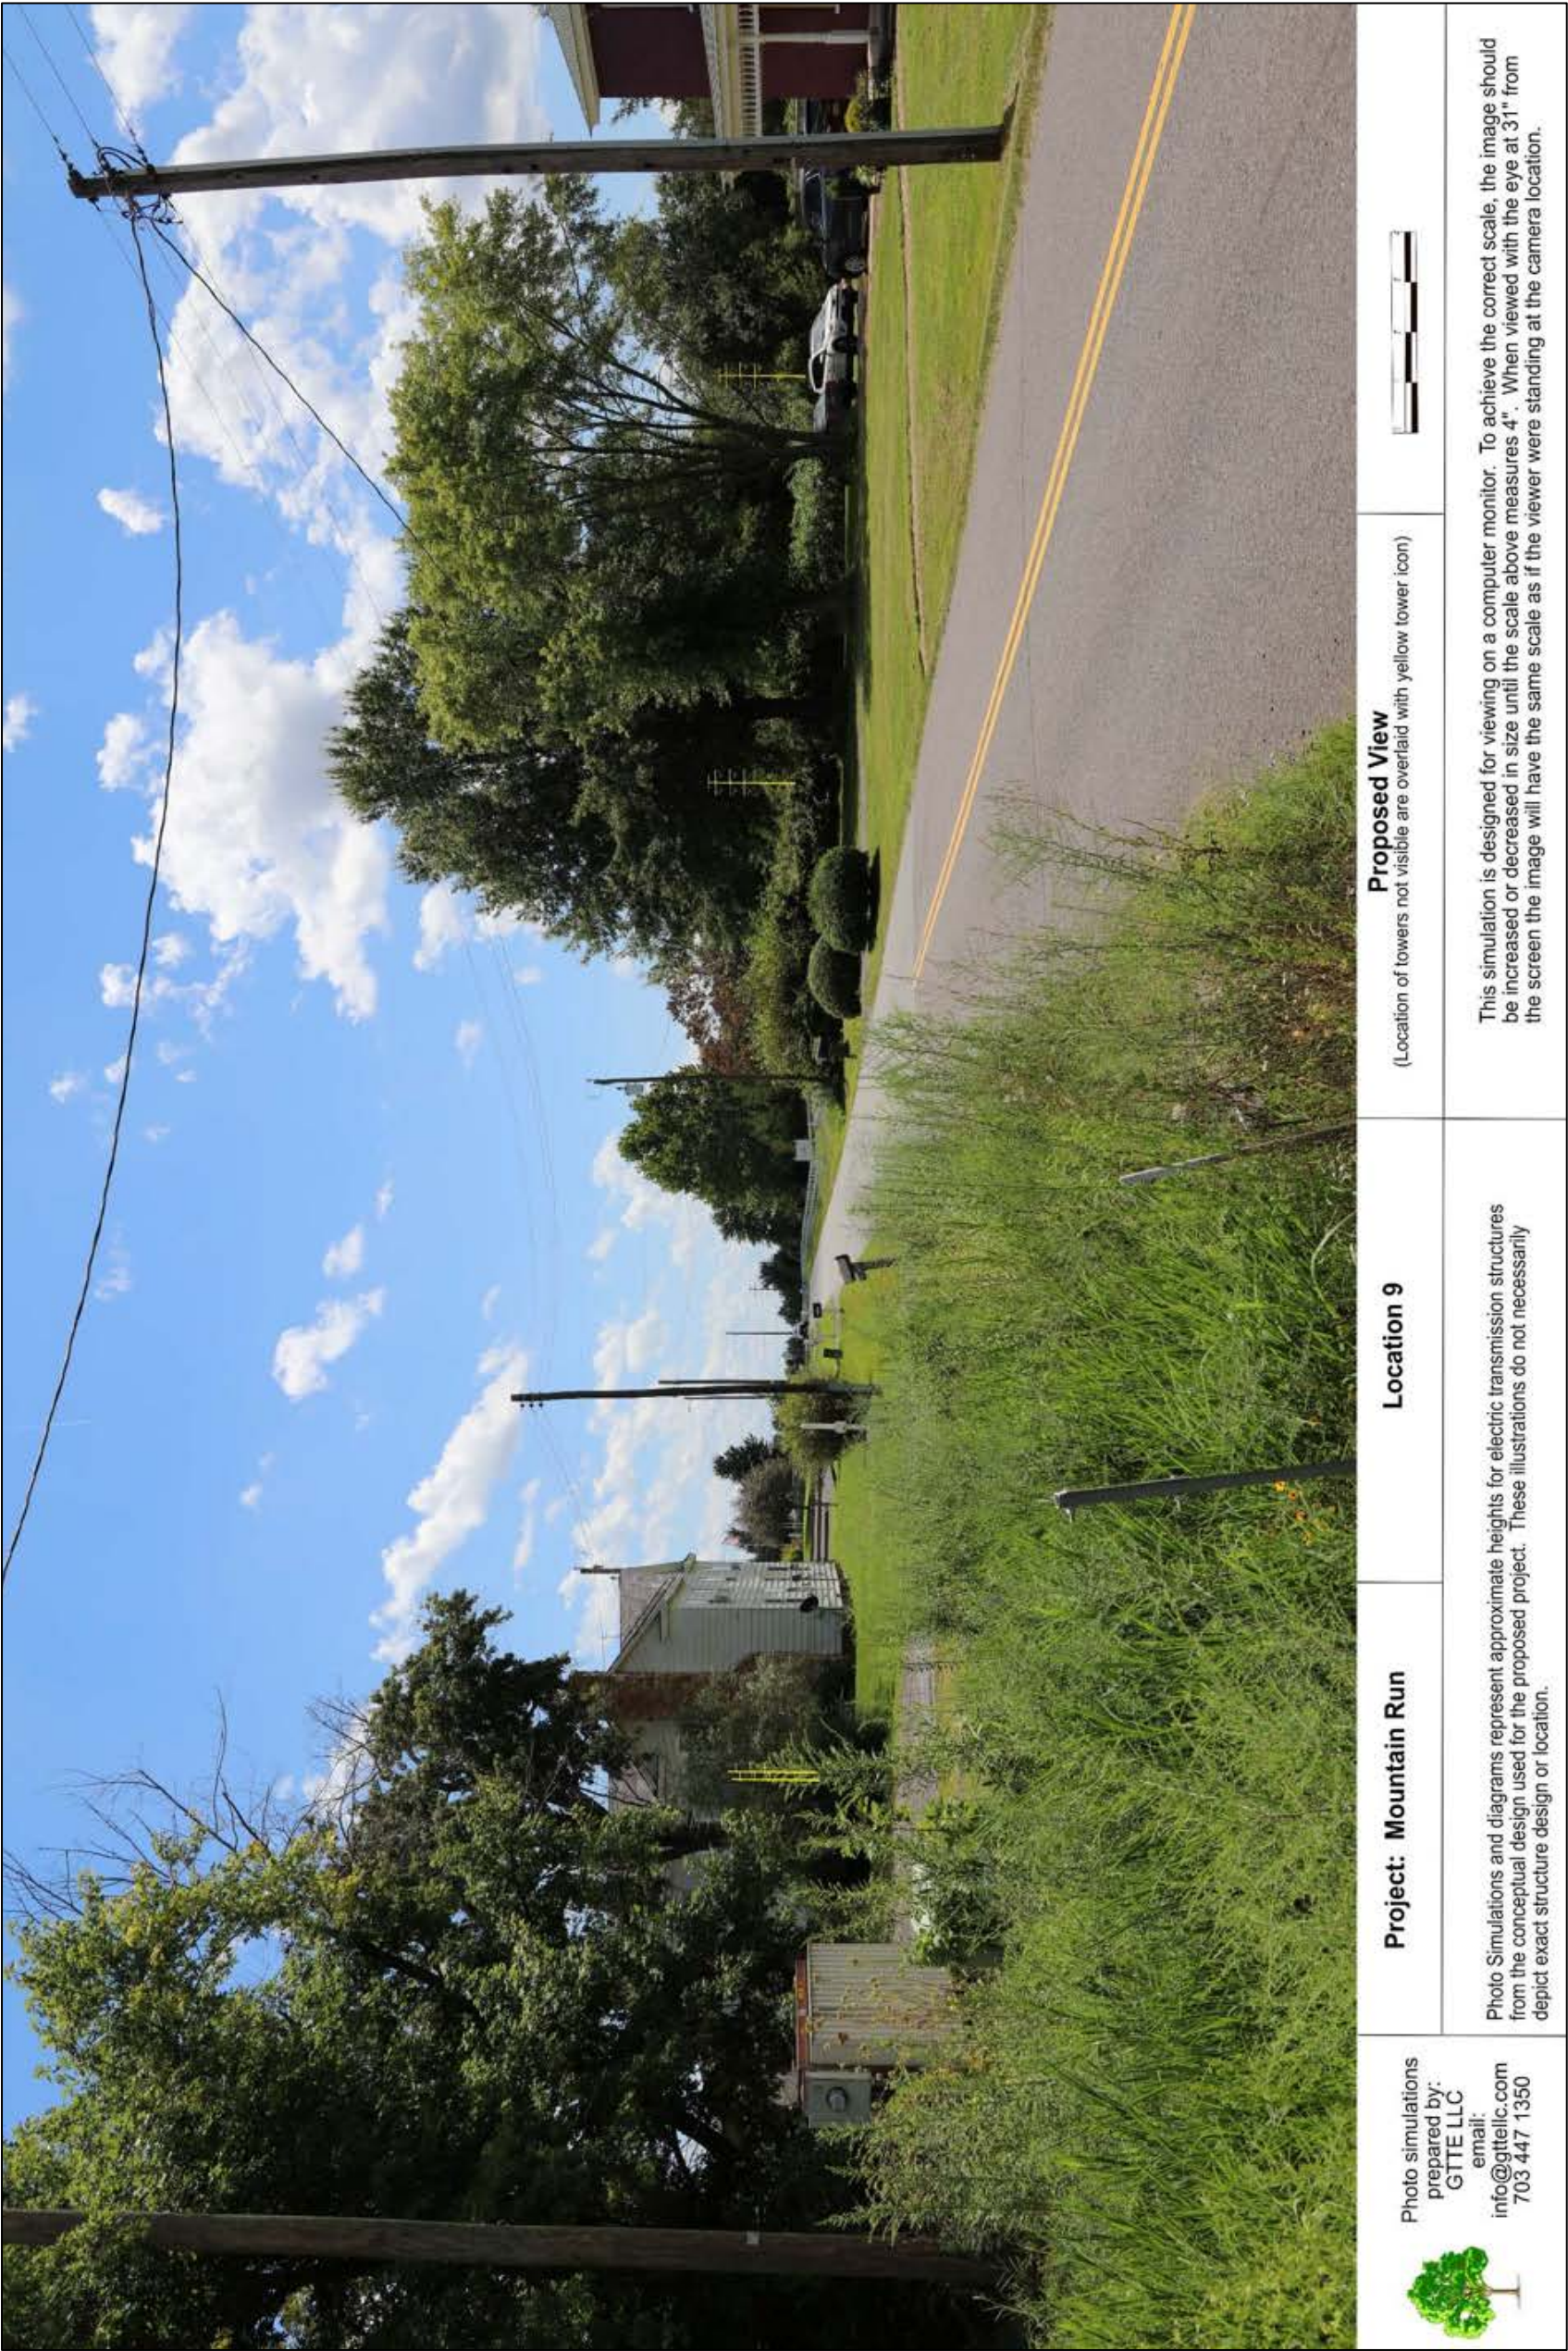
Figure 5-124: Brandy Station Battlefield Simulation 5 – Proposed view from Route 3 at Batna Road – (Visible structure shown as it would appear. Structures not visible shown in yellow). Source: GTTE, LLC

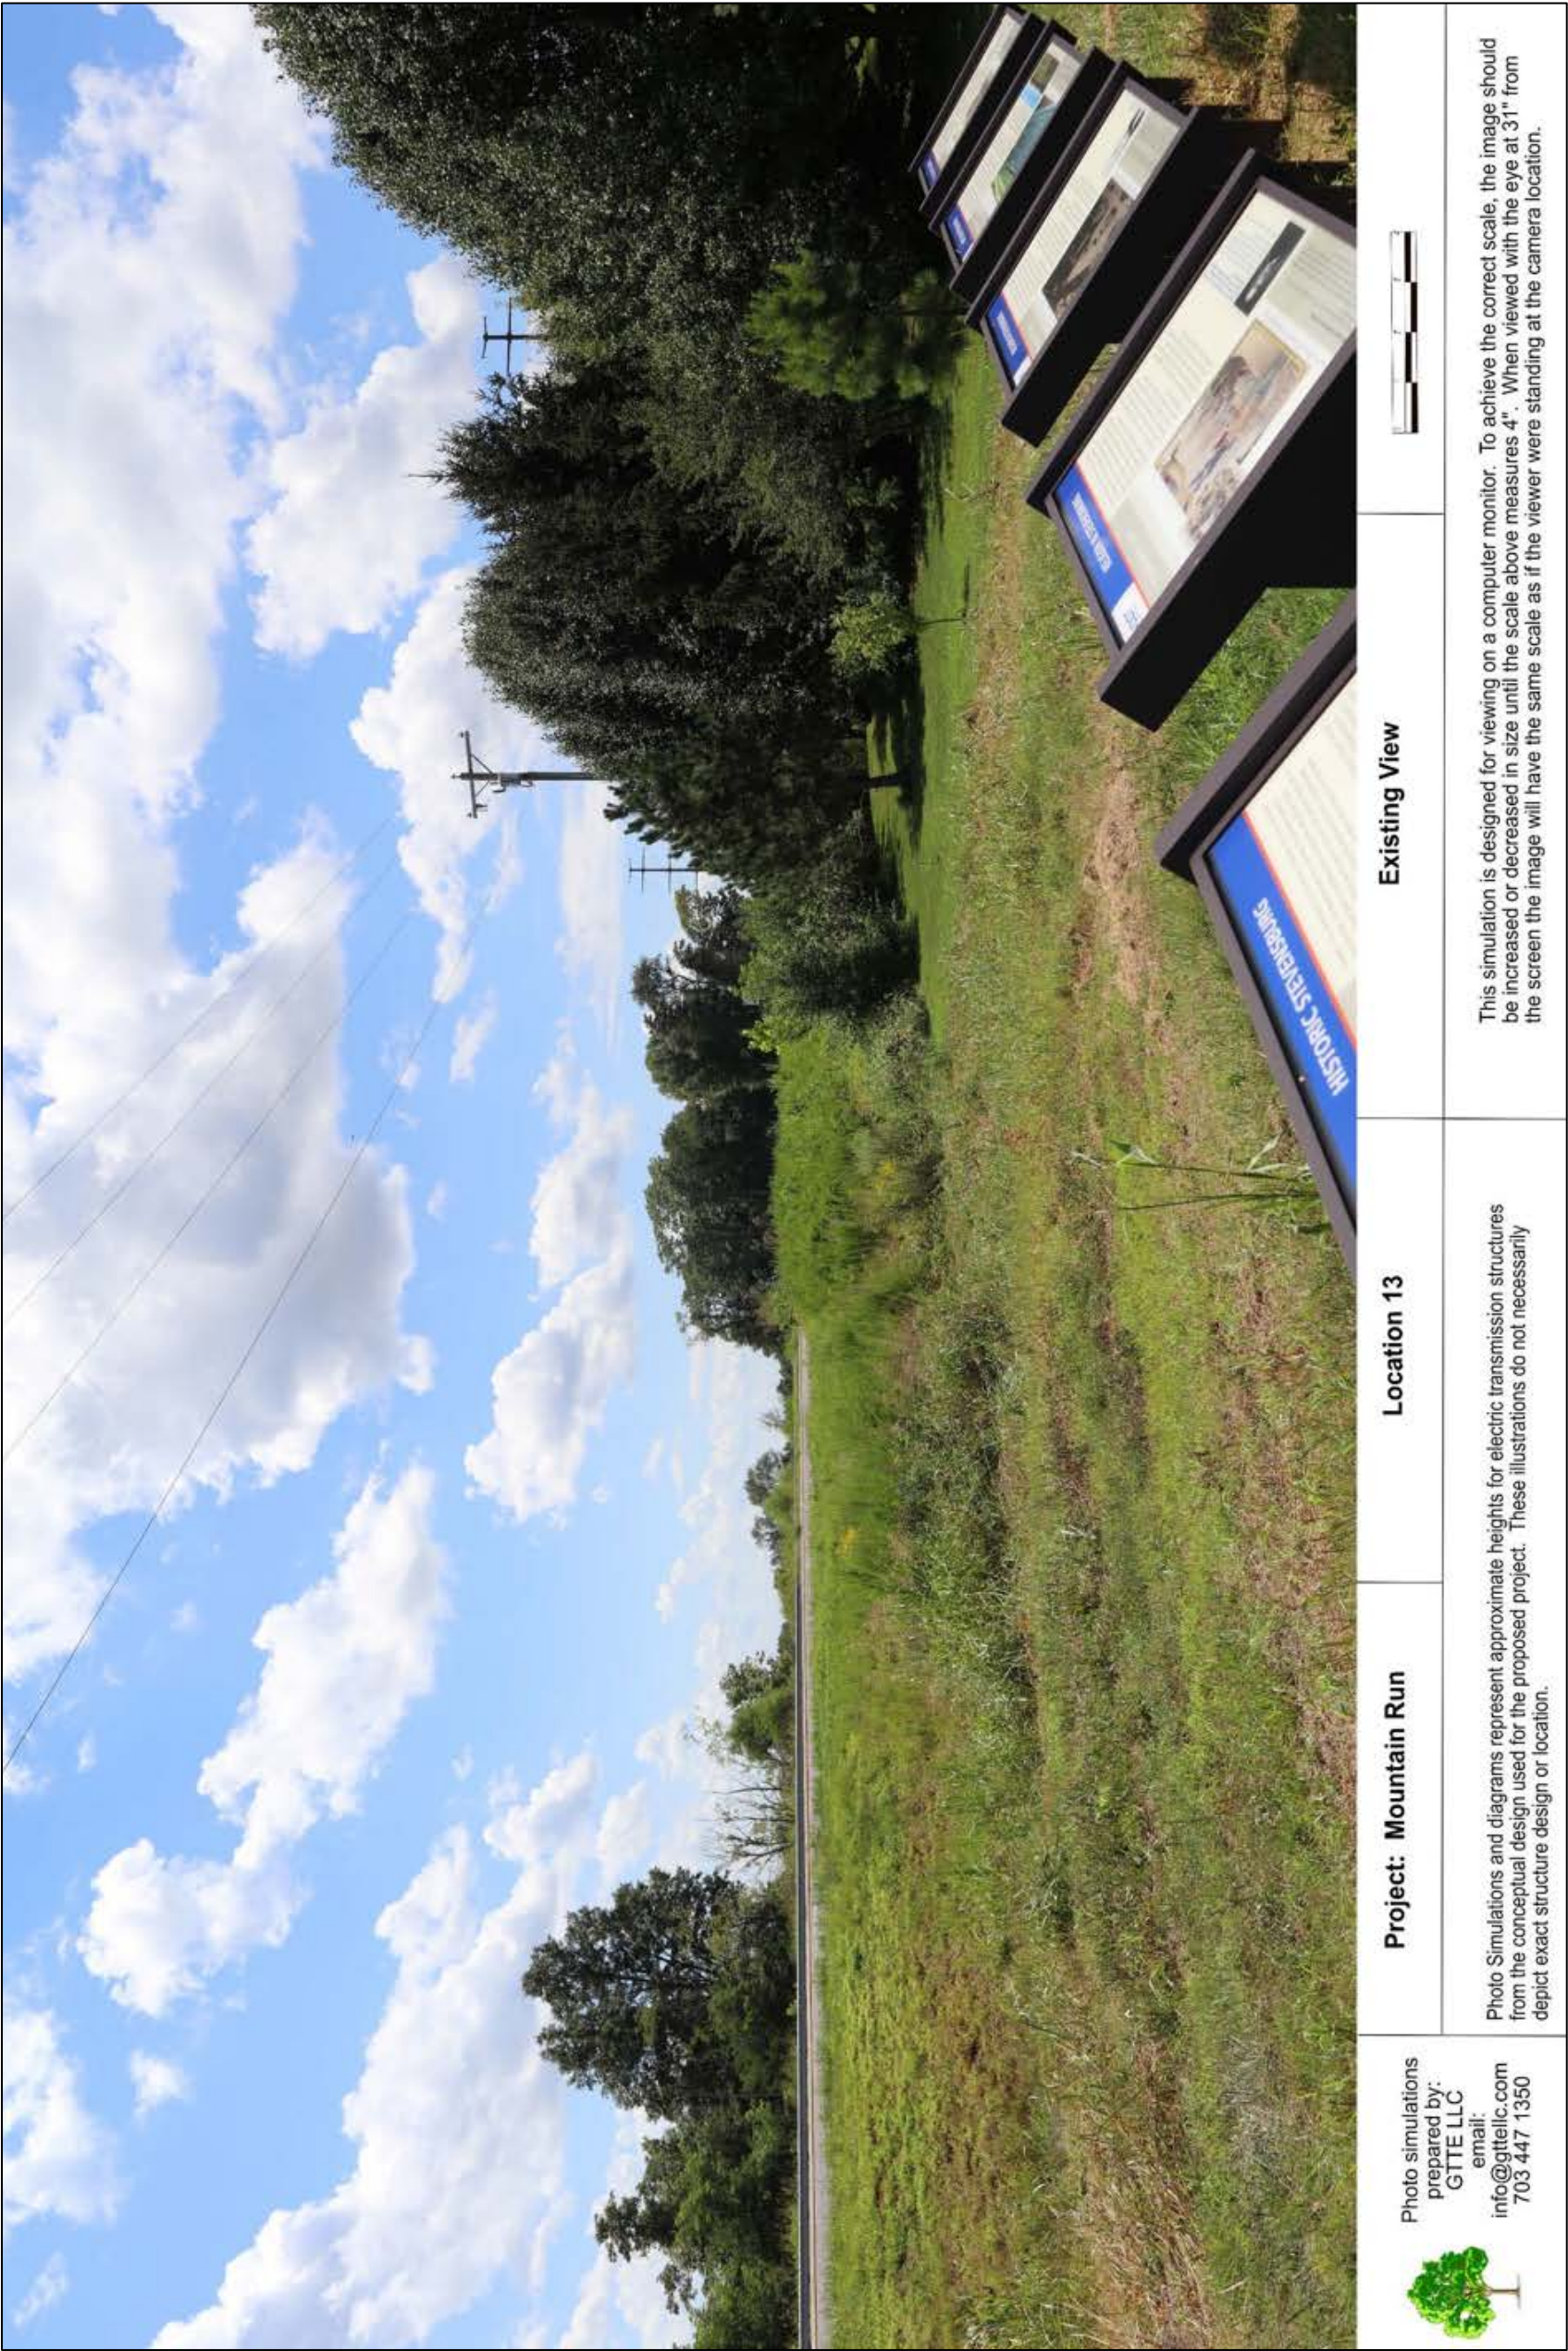
Figure 5-129: Brandy Station Battlefield Simulation 7 – Existing view from Wayside at York Road. Source: GTTE, LLC

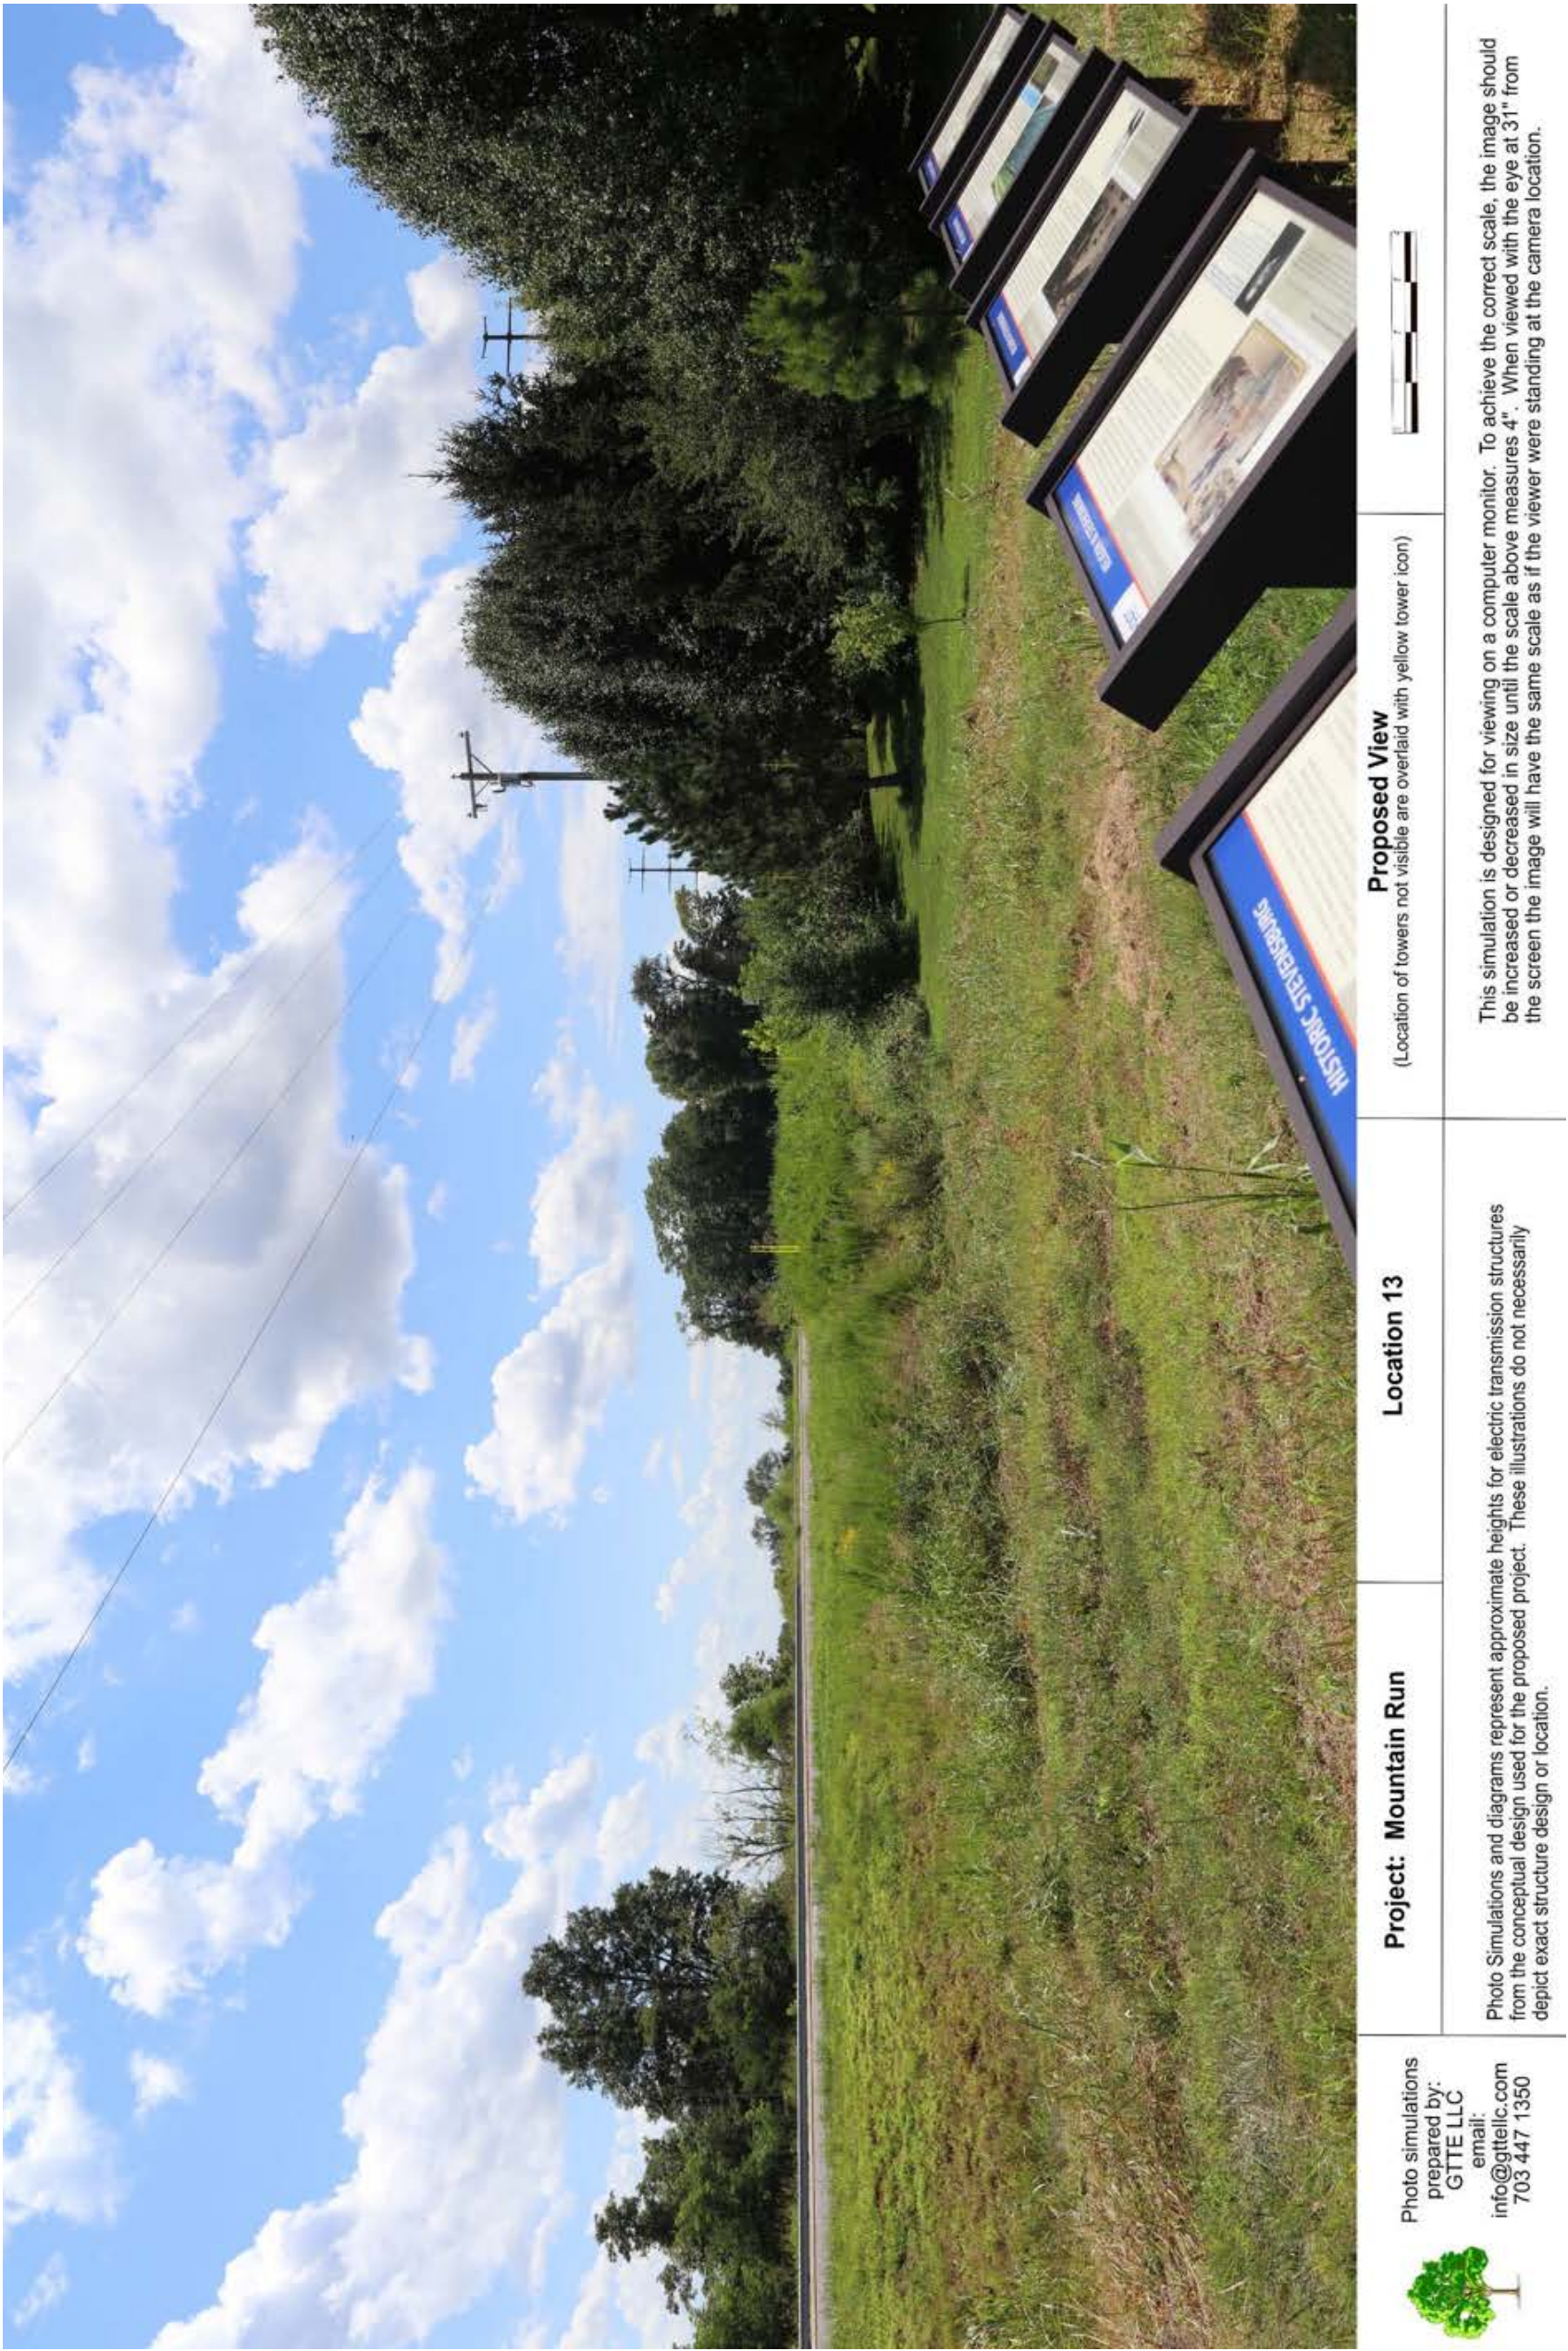
Figure 5-130: Brandy Station Battlefield Simulation 7 – Proposed view from Wayside at York Road – (Structures not visible shown in yellow). Source: GTTE, LLC

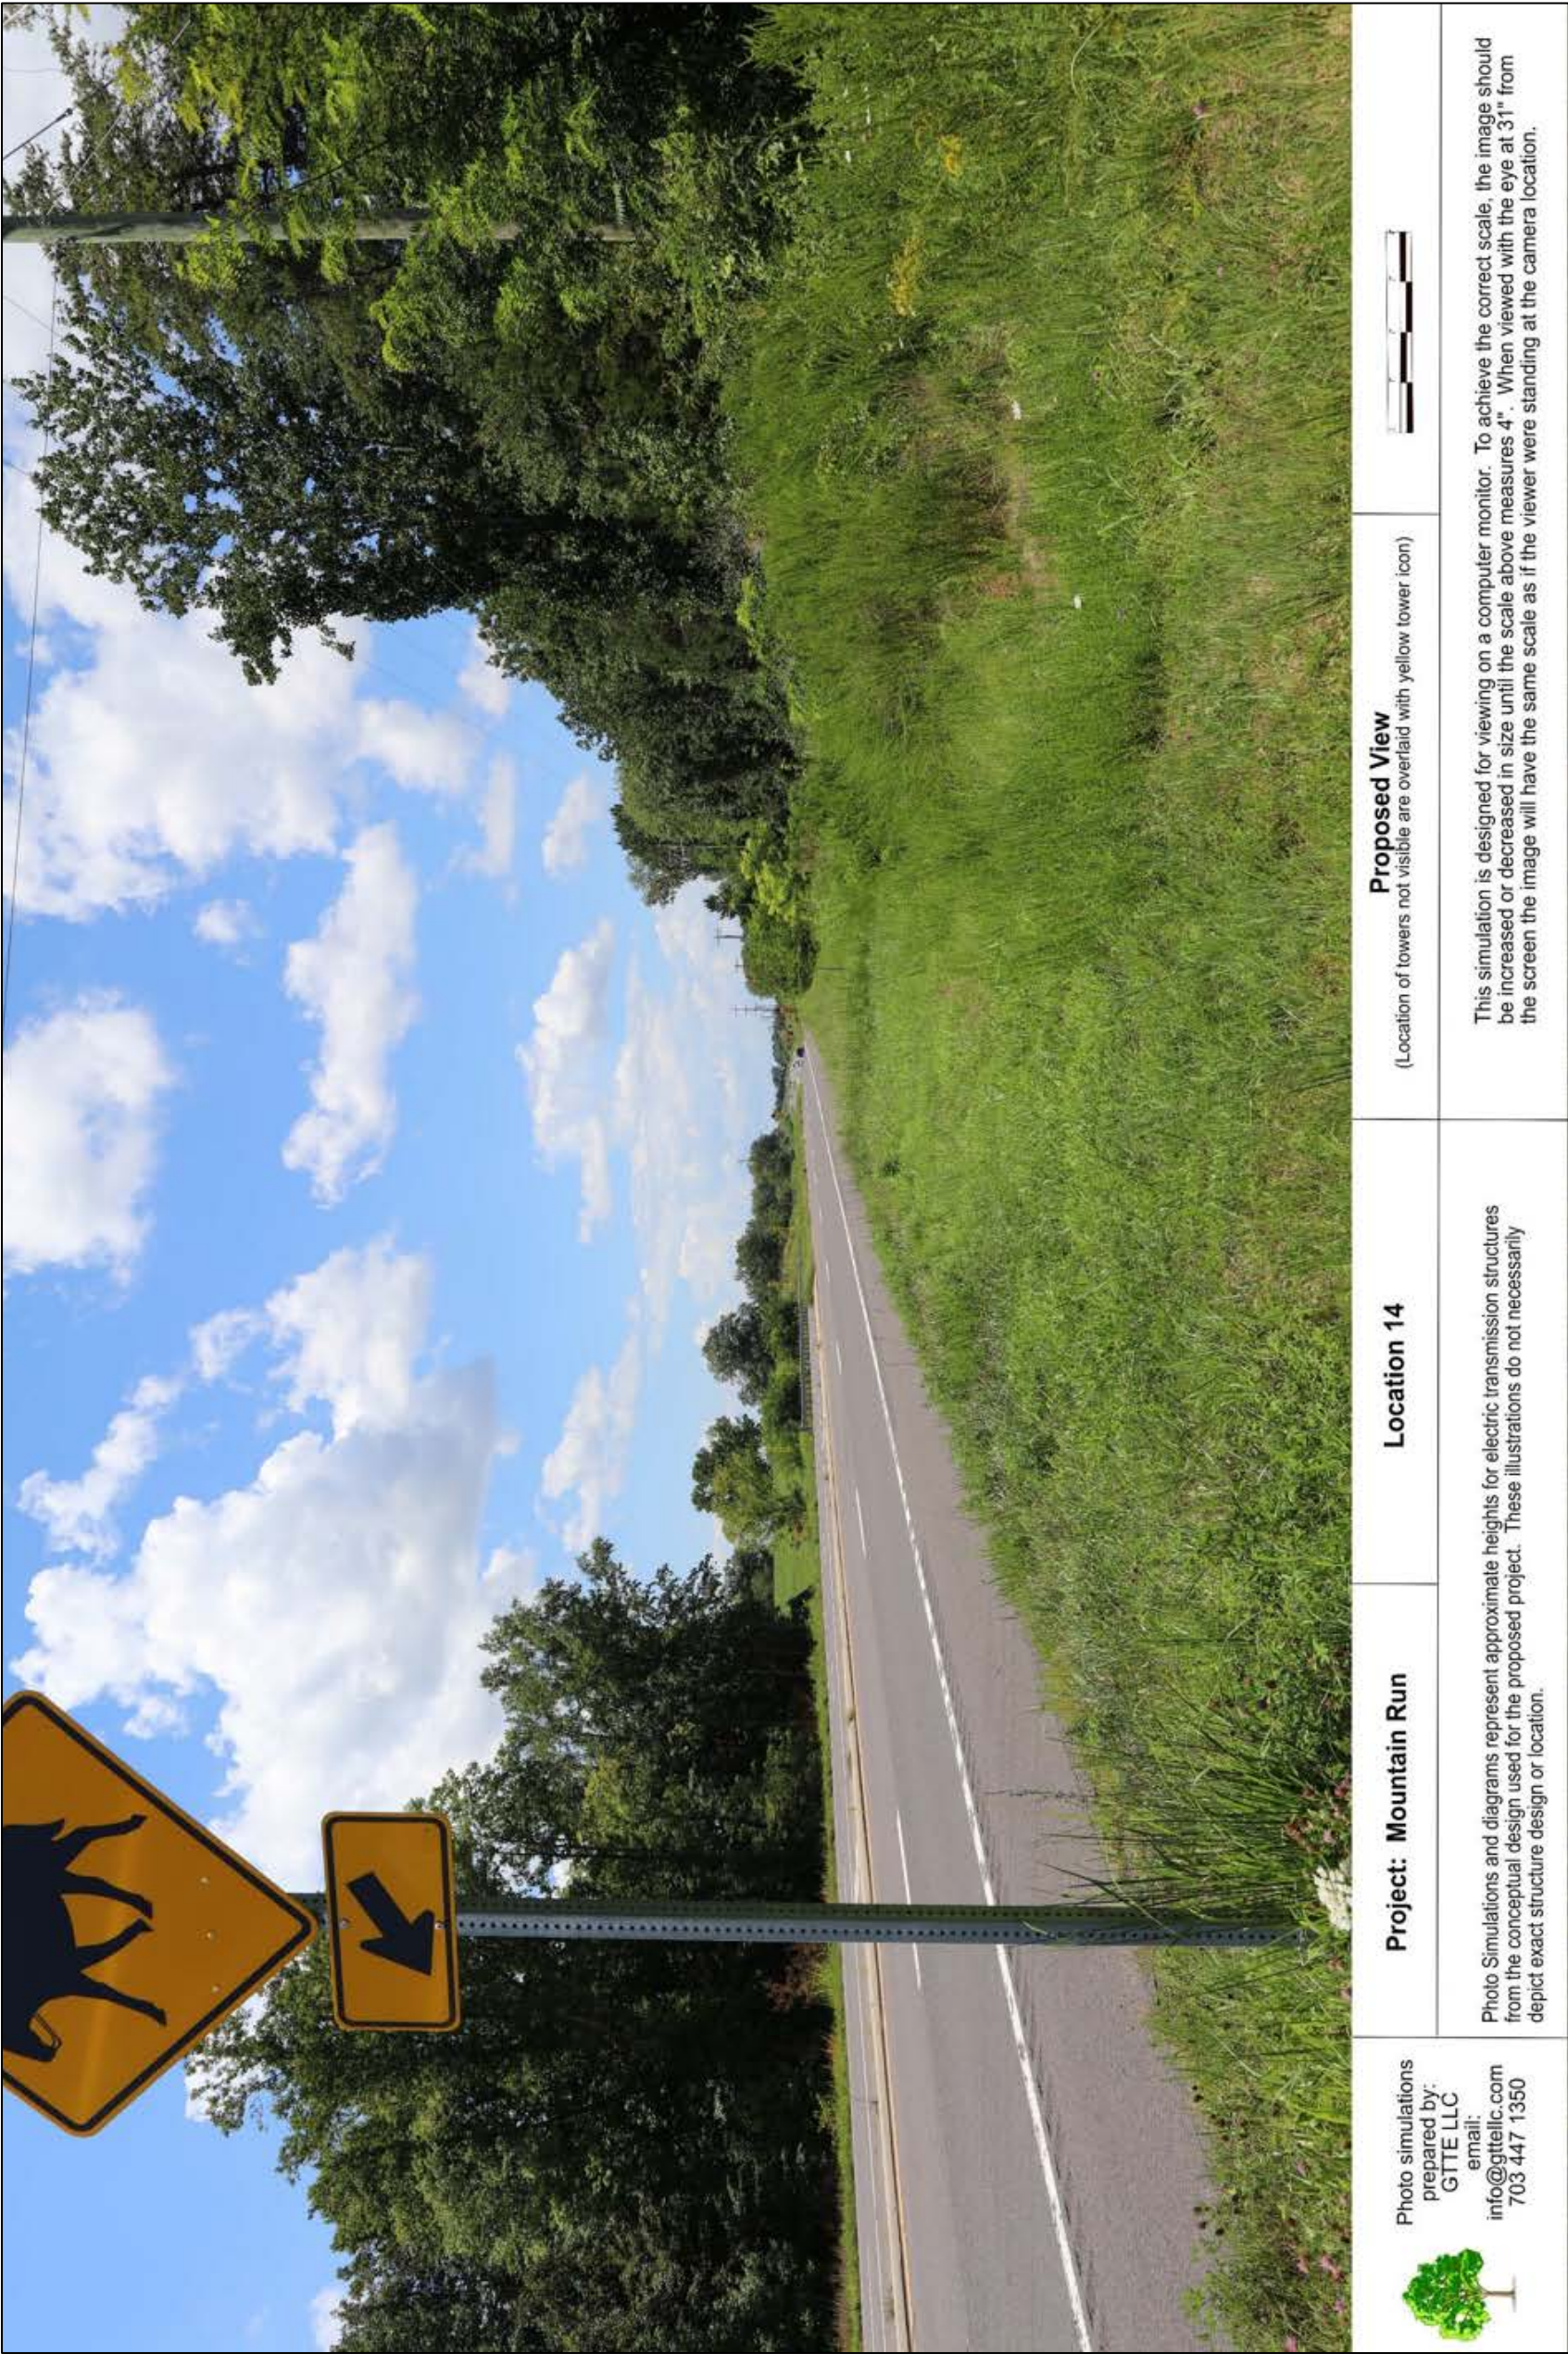
Figure 5-136: Brandy Station Battlefield Simulation 9 – Proposed view from Route 3 at Hansbrough Ridge – (Structures not visible shown in yellow). Source: GTTE, LLC

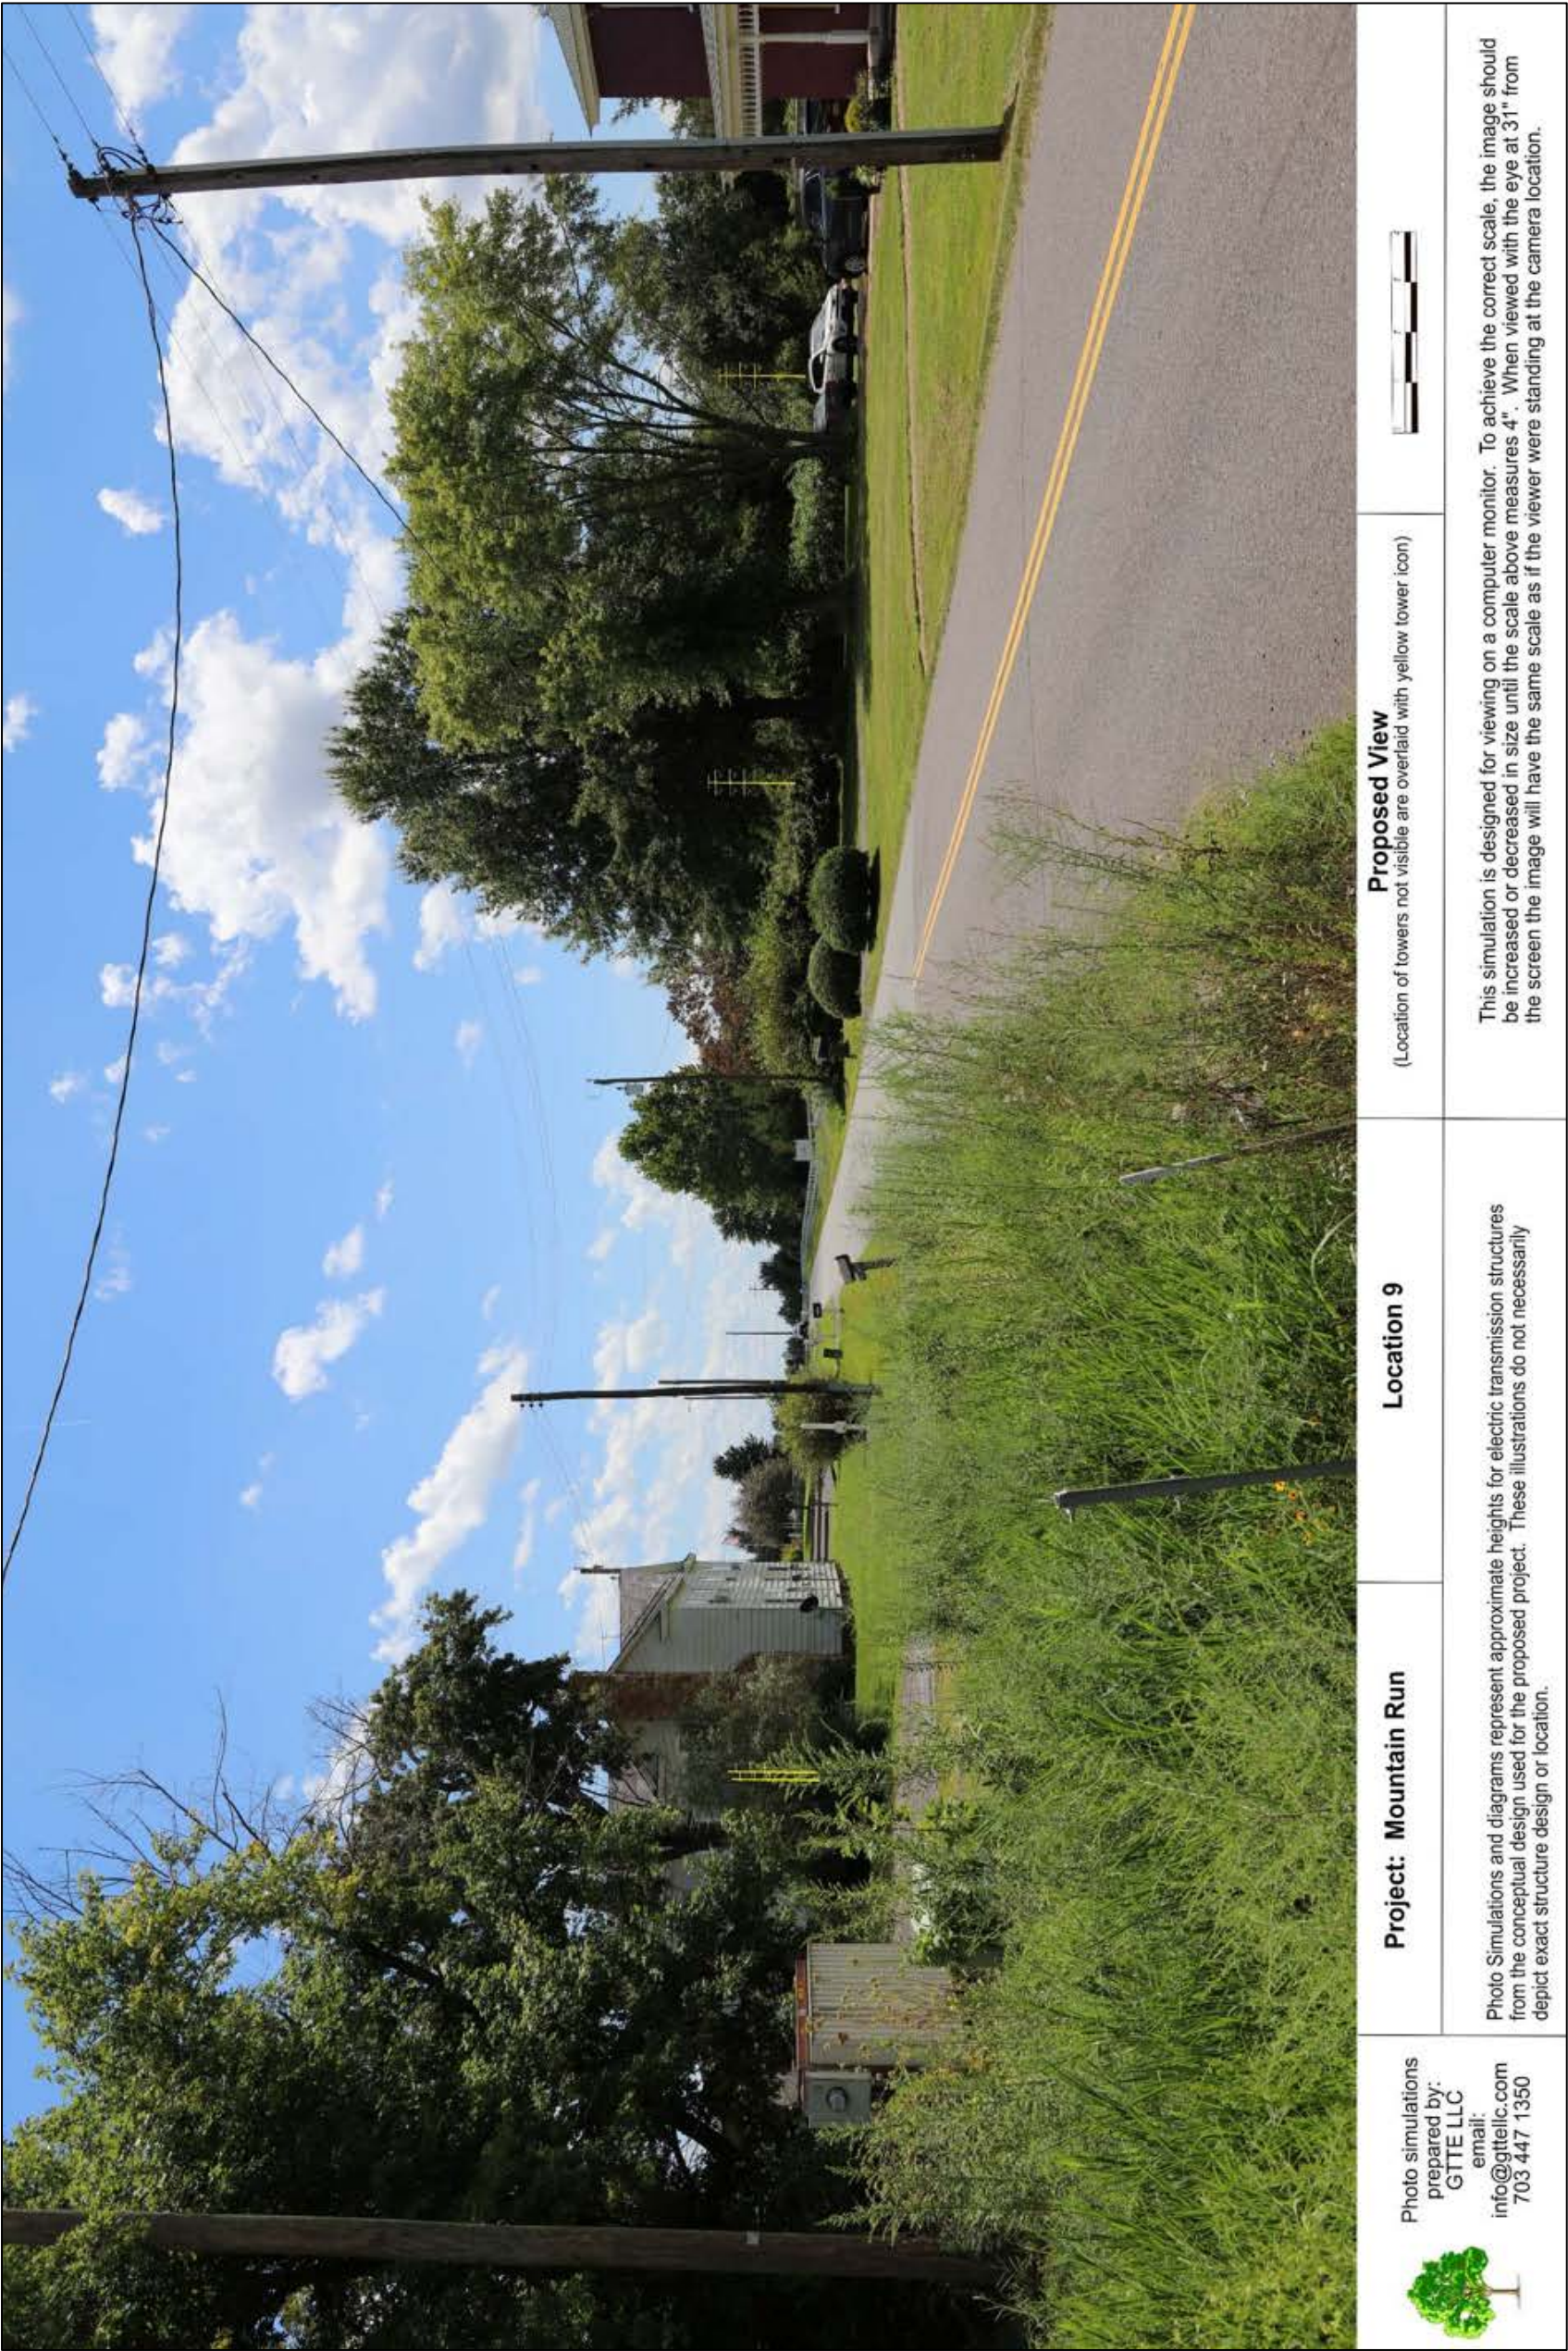
Figure 5-150: Mortons Ford Battlefield Simulation 1 – Proposed view from Batna Road at Route 3 – (Visible structure shown as it would appear. Structures not visible shown in yellow). Source: GTTE, LLC

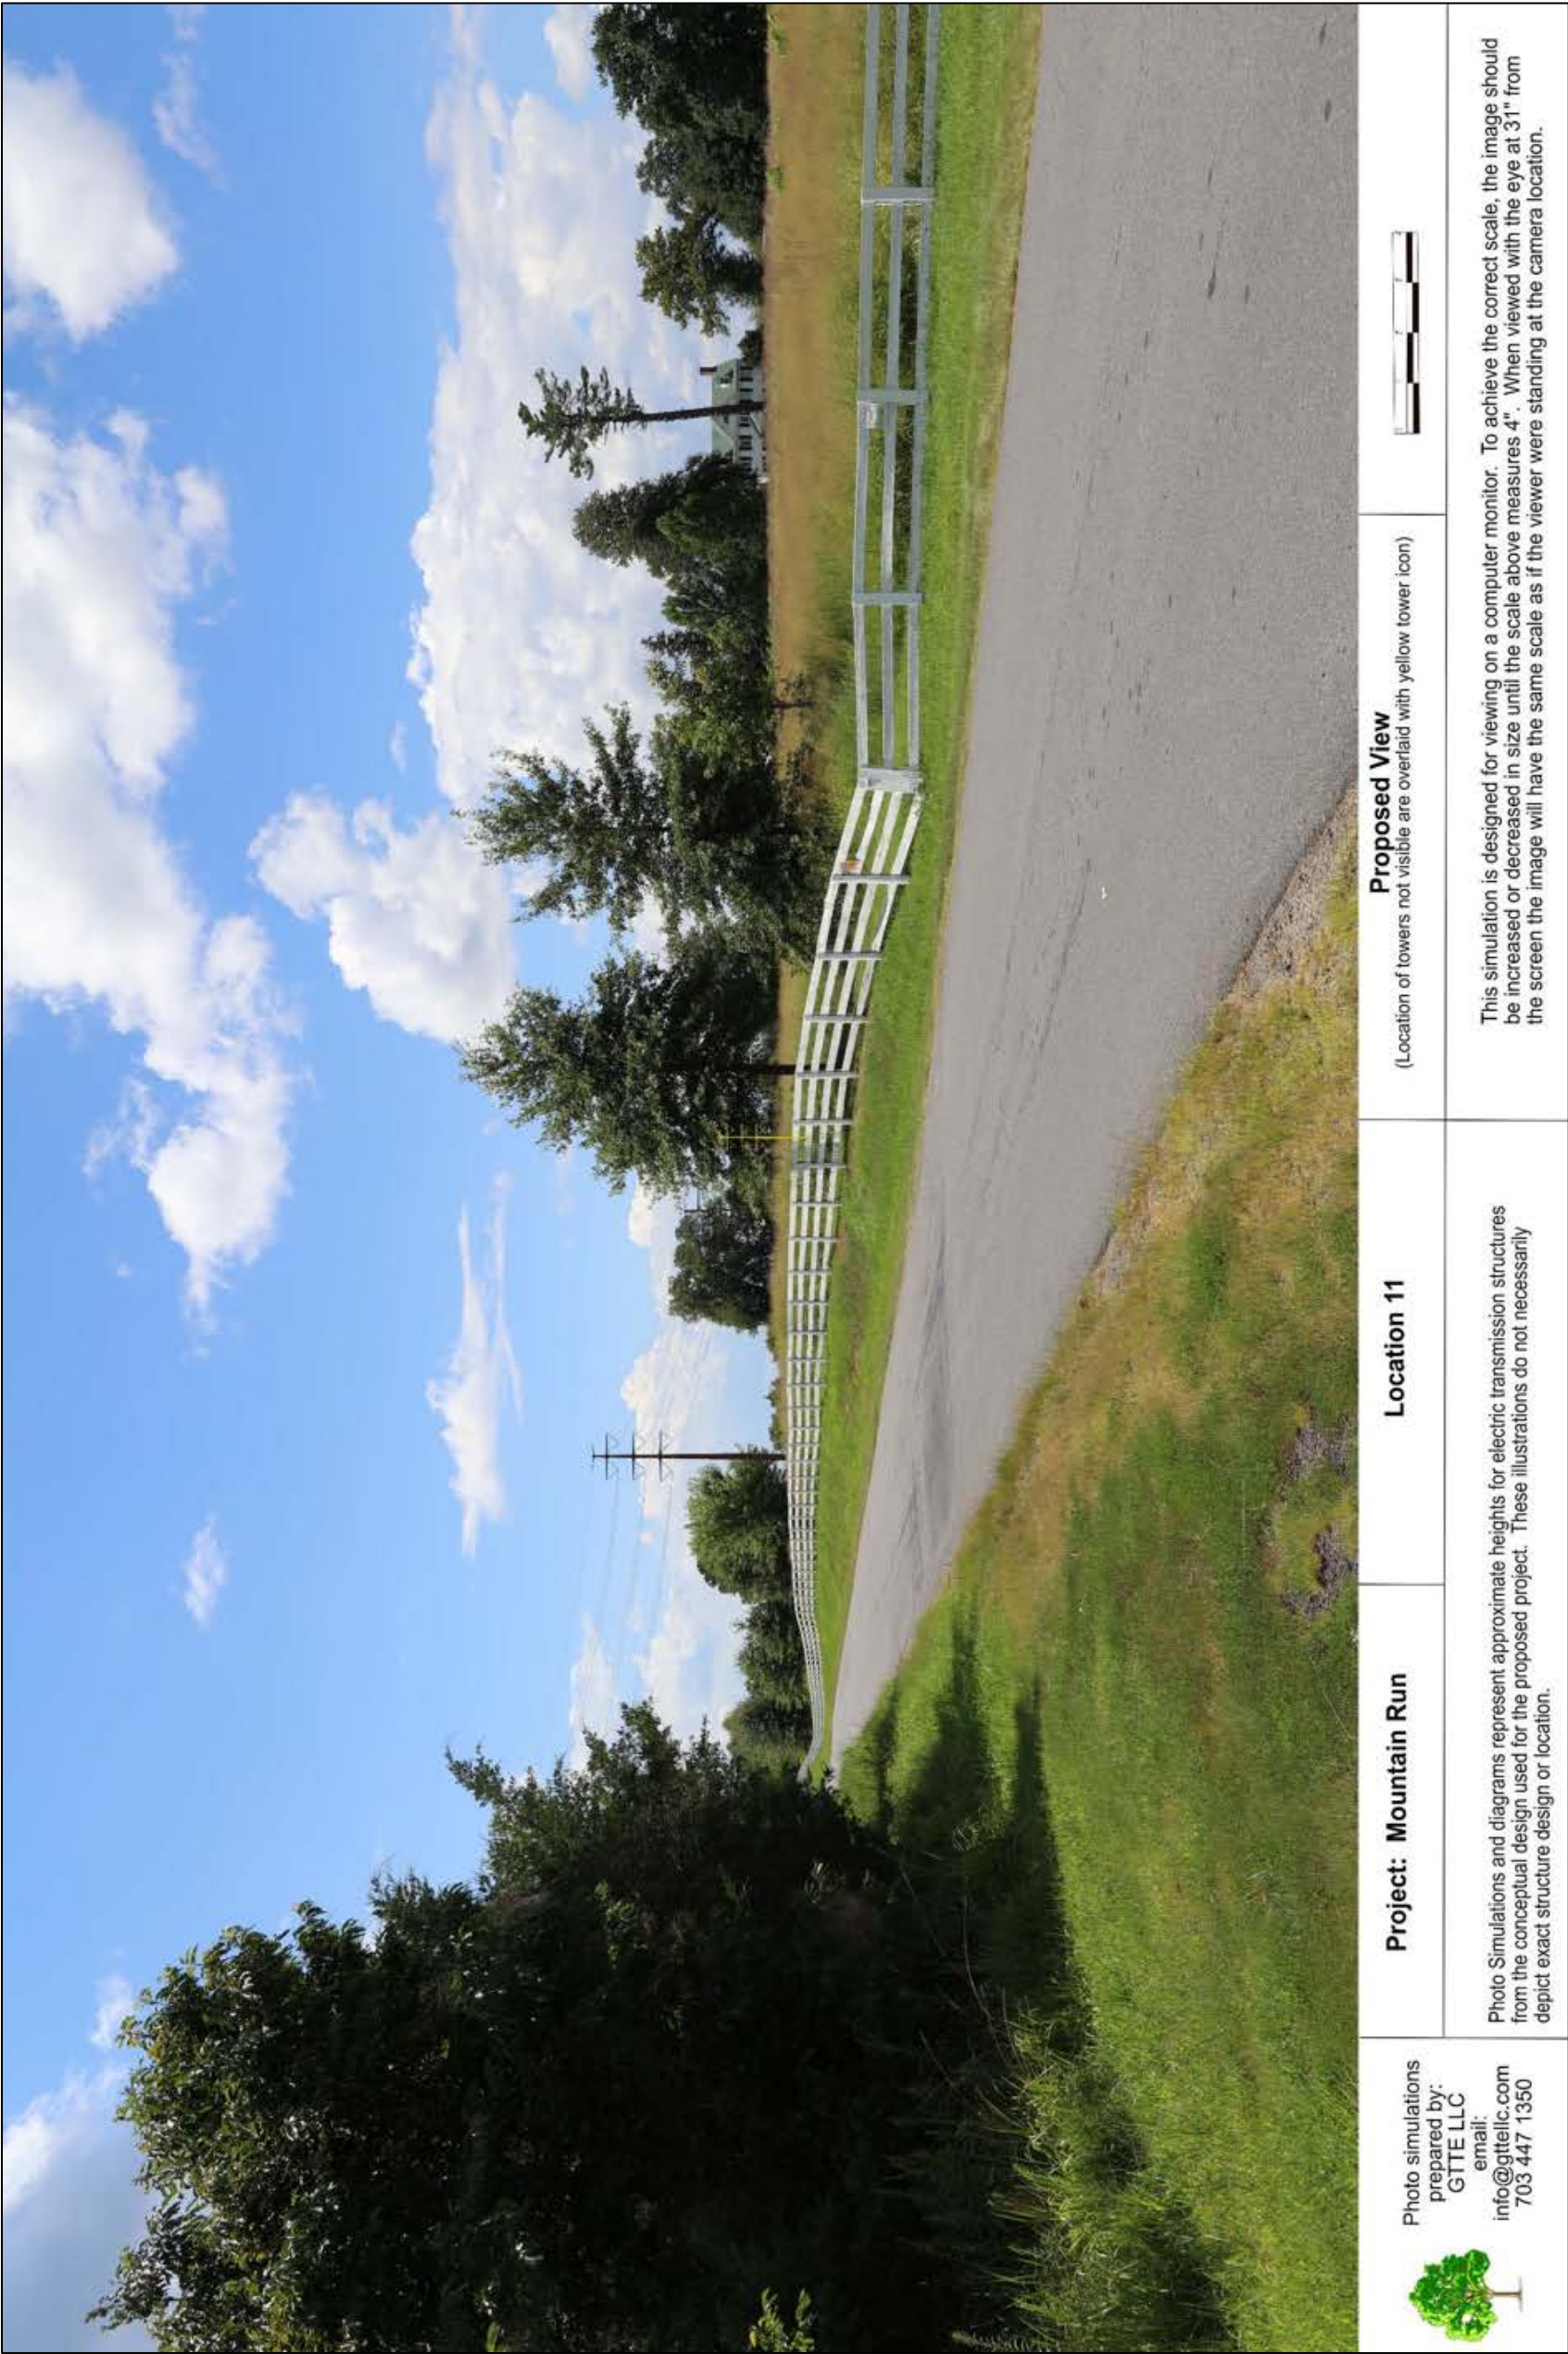
Figure 5-153: Mortons Ford Battlefield Simulation 2 – Proposed view from Batna Road at Blackjack Road – (Visible structures shown as they would appear. Structures not visible shown in yellow). Source: GTTE, LLC
