**Application, Appendix,
DEQ Supplement, Direct
Testimony and Exhibits of
Virginia Electric and Power
Company**

**Cirrus-Keyser 230 kV Loop and
Related Projects**

Case No. PUR-2022-00198

DEQ Supplement

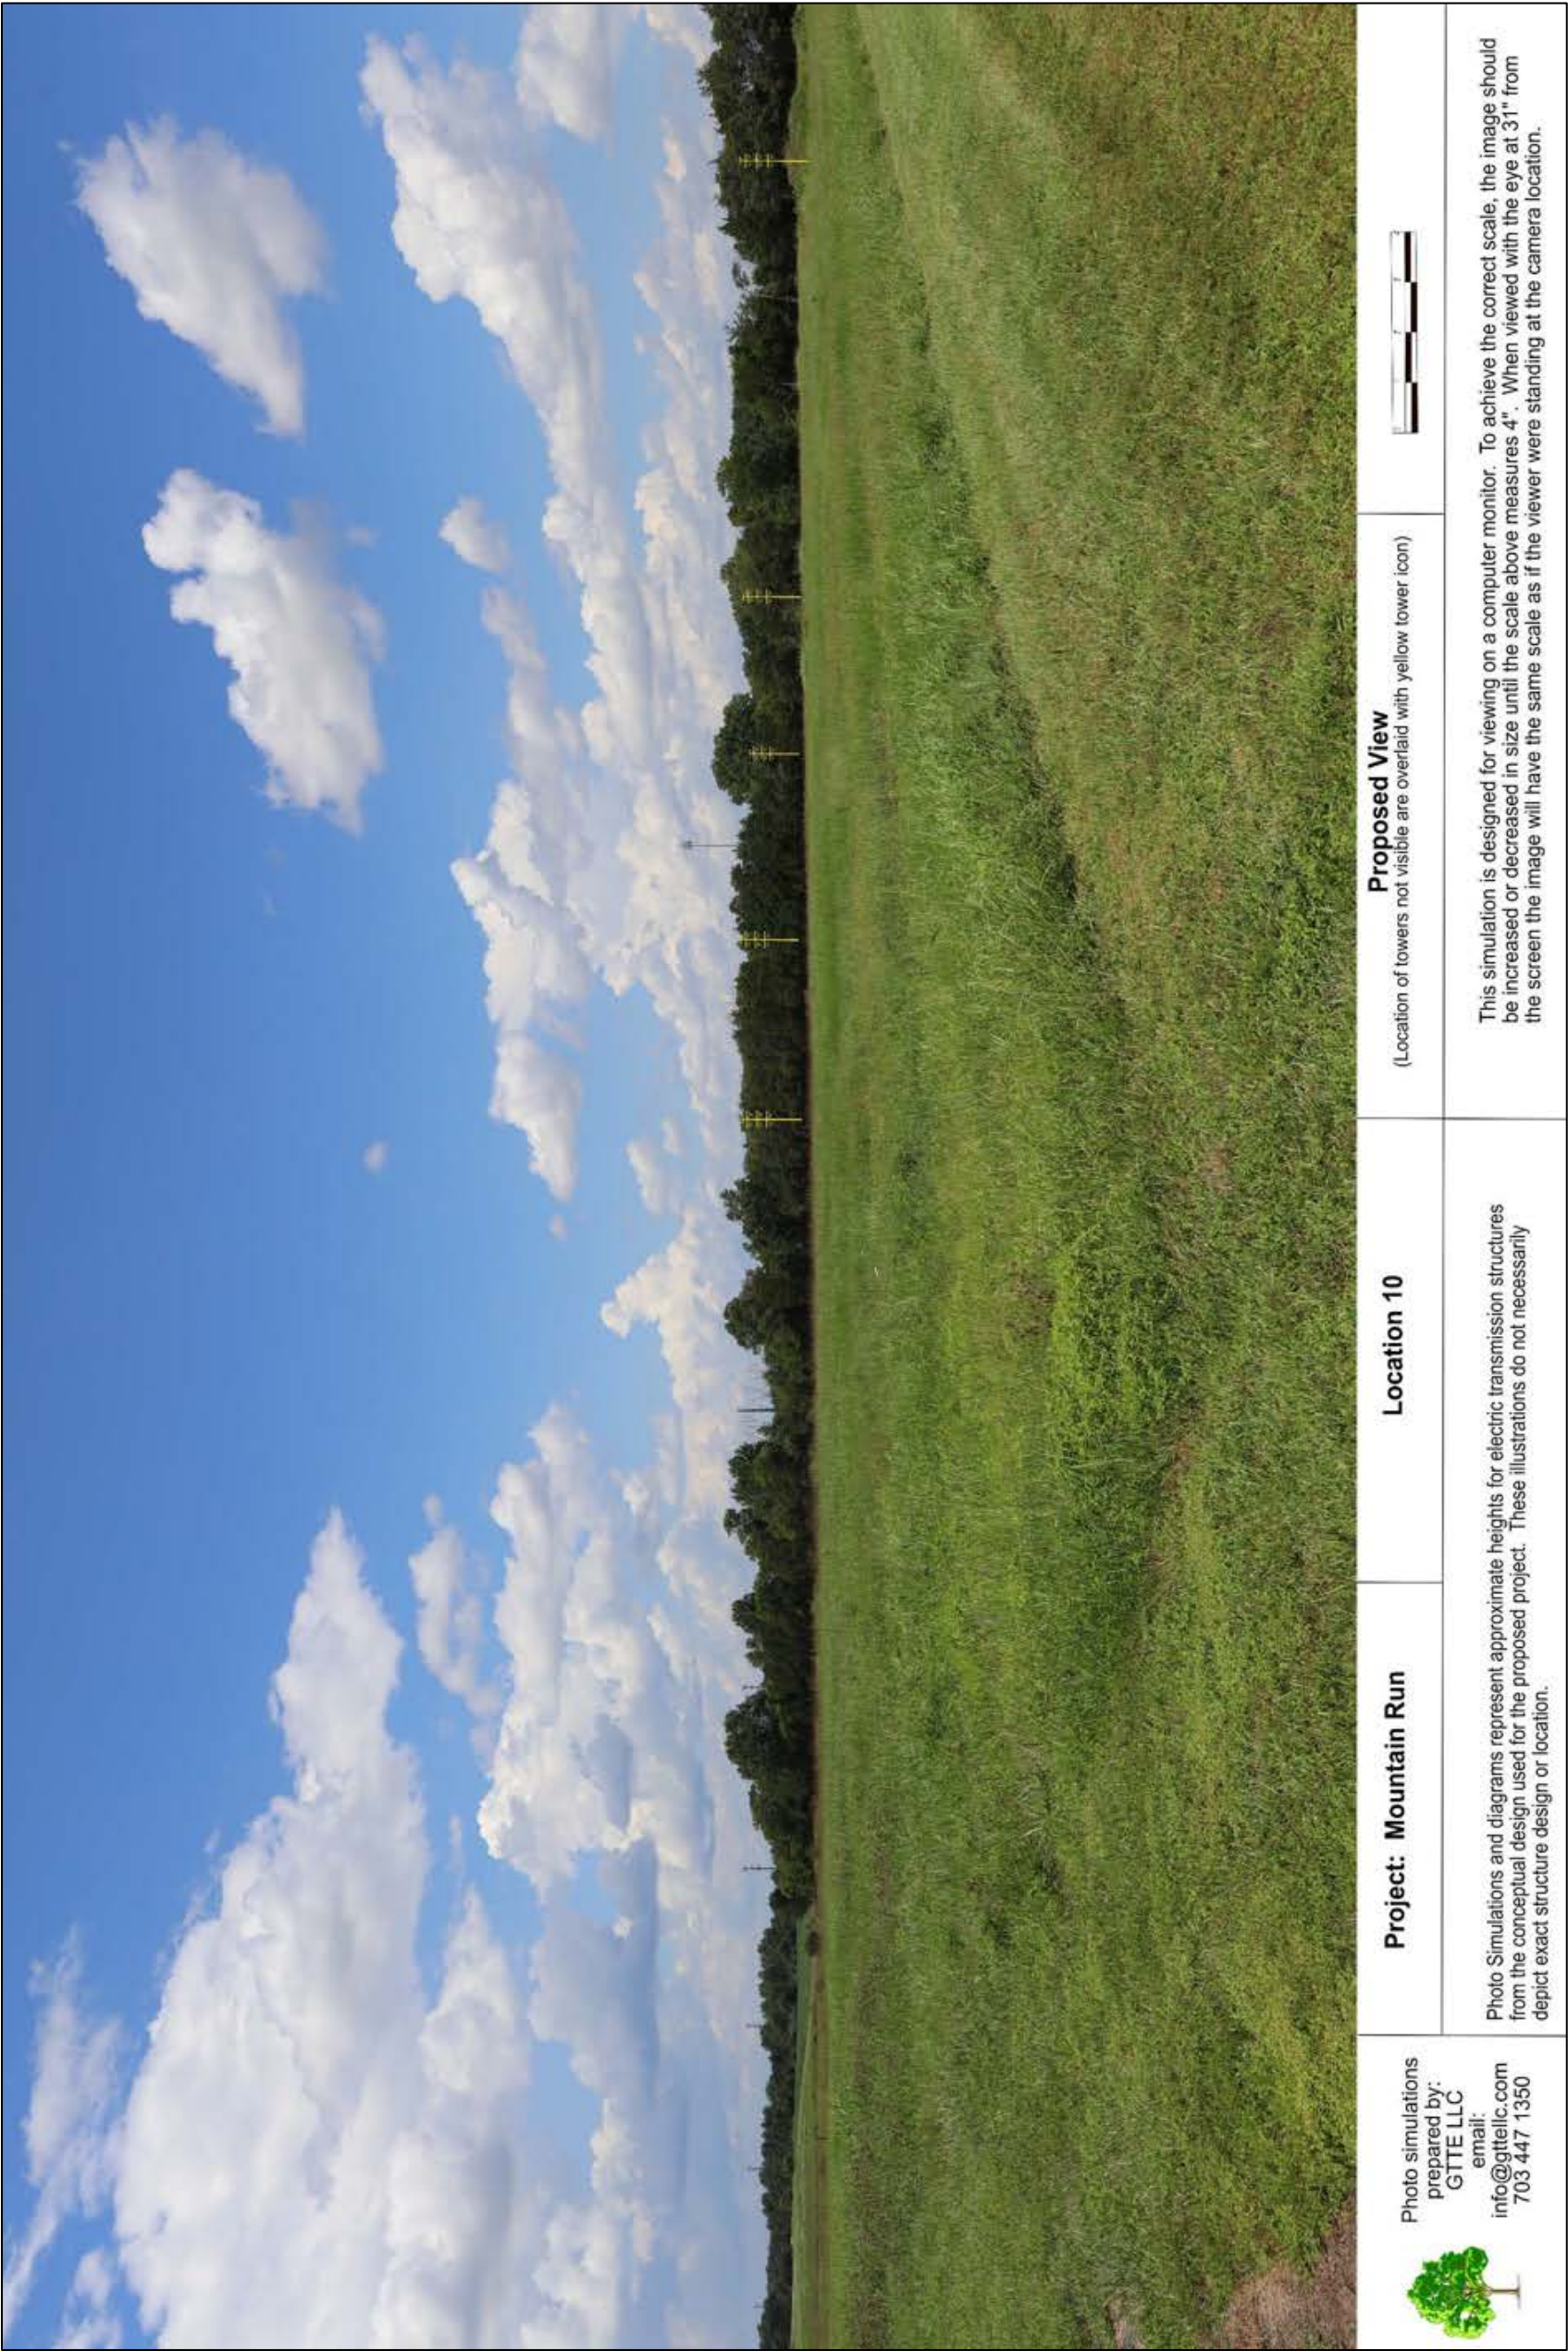
Figure 5-156: Mortons Ford Battlefield Simulation 3 – Proposed view from Blackjack Road – (Visible structure shown as it would appear. Structures not visible shown in yellow). Source: GTTE, LLC

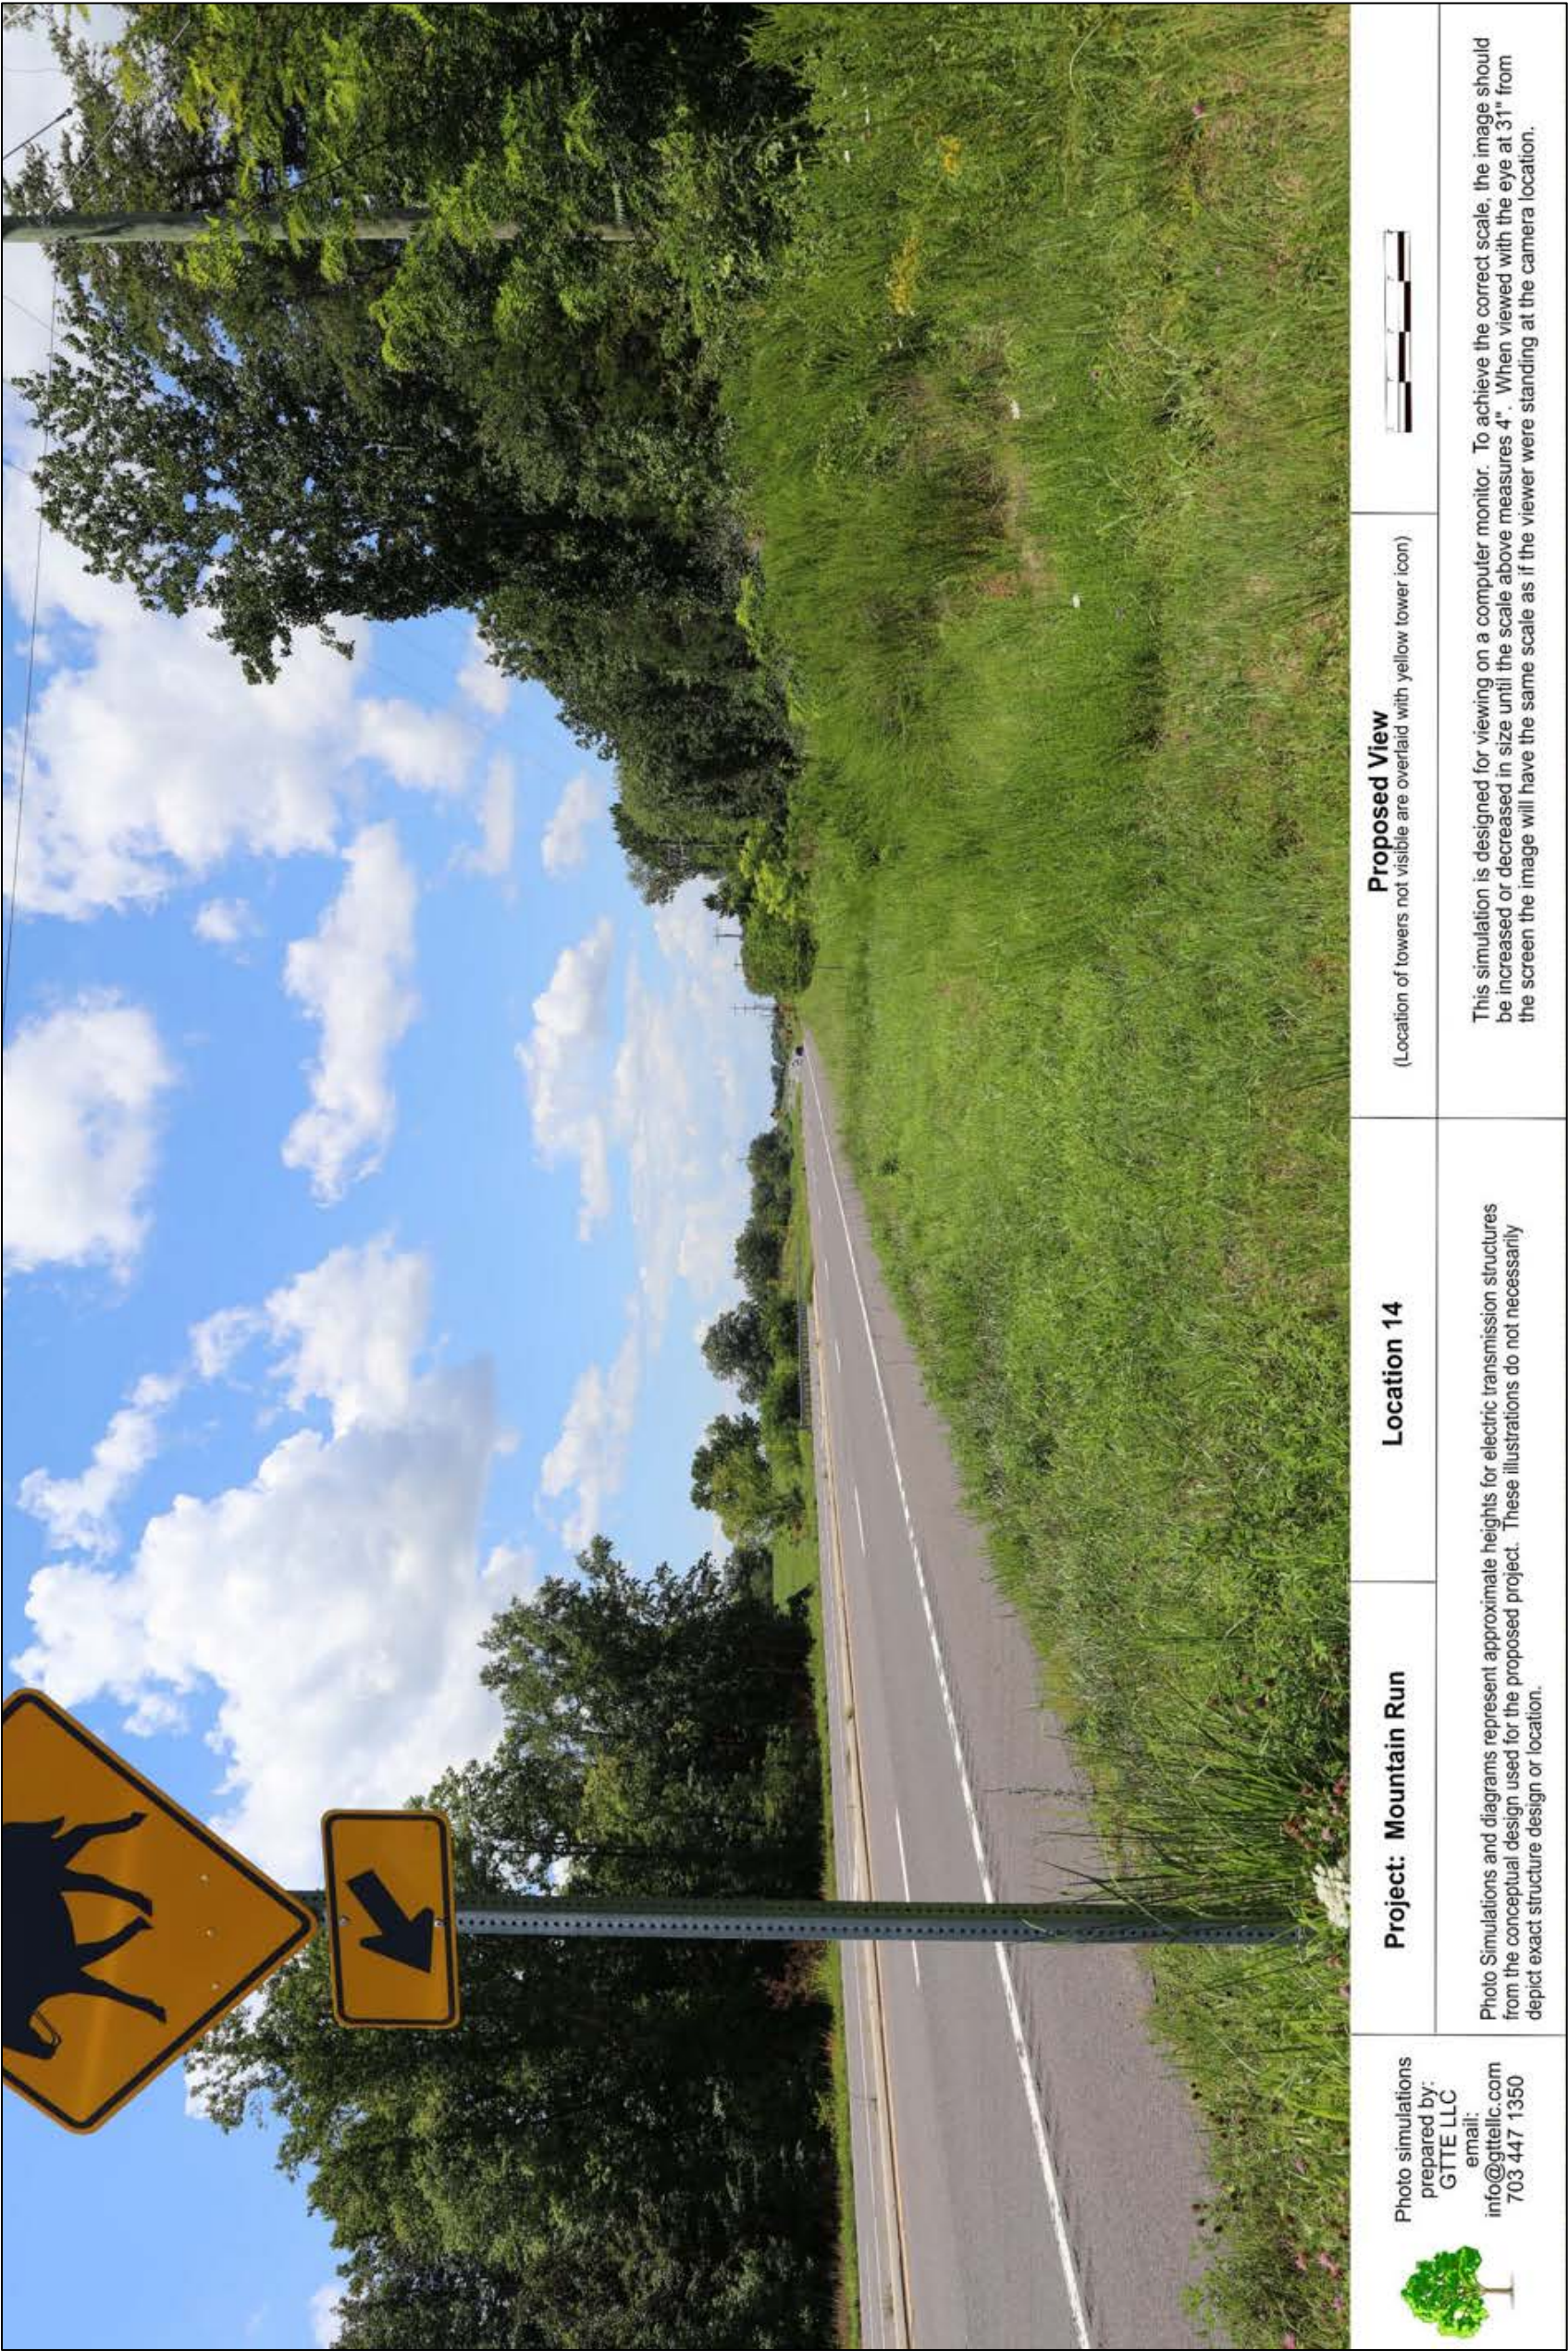
Figure 5-164: Hansbrough Ridge Simulation 1 – Proposed view from Route 3 at entry to site – (Structures not visible shown in yellow). Source: GTTE, LLC

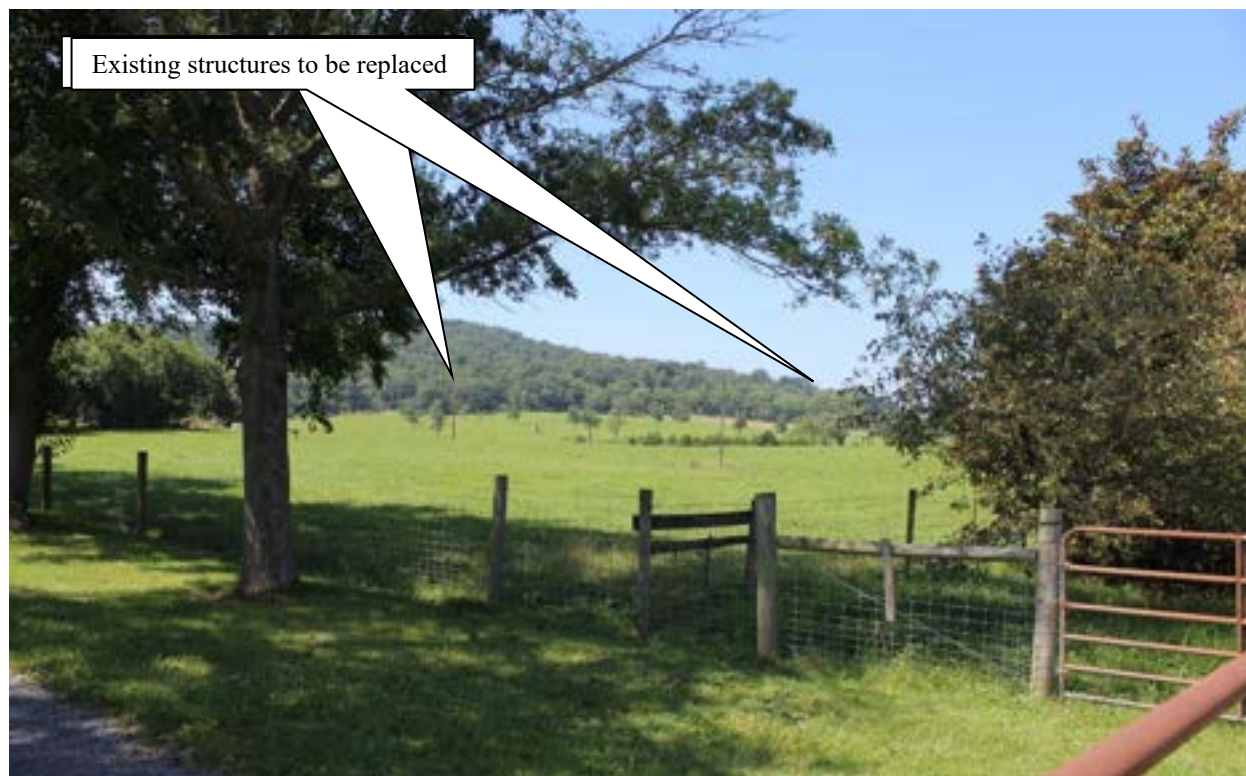
Figure 5-172: Photo location 7- View from Route 3 at Signal Hill Farm (Multiple existing project structures visible), facing southwest.

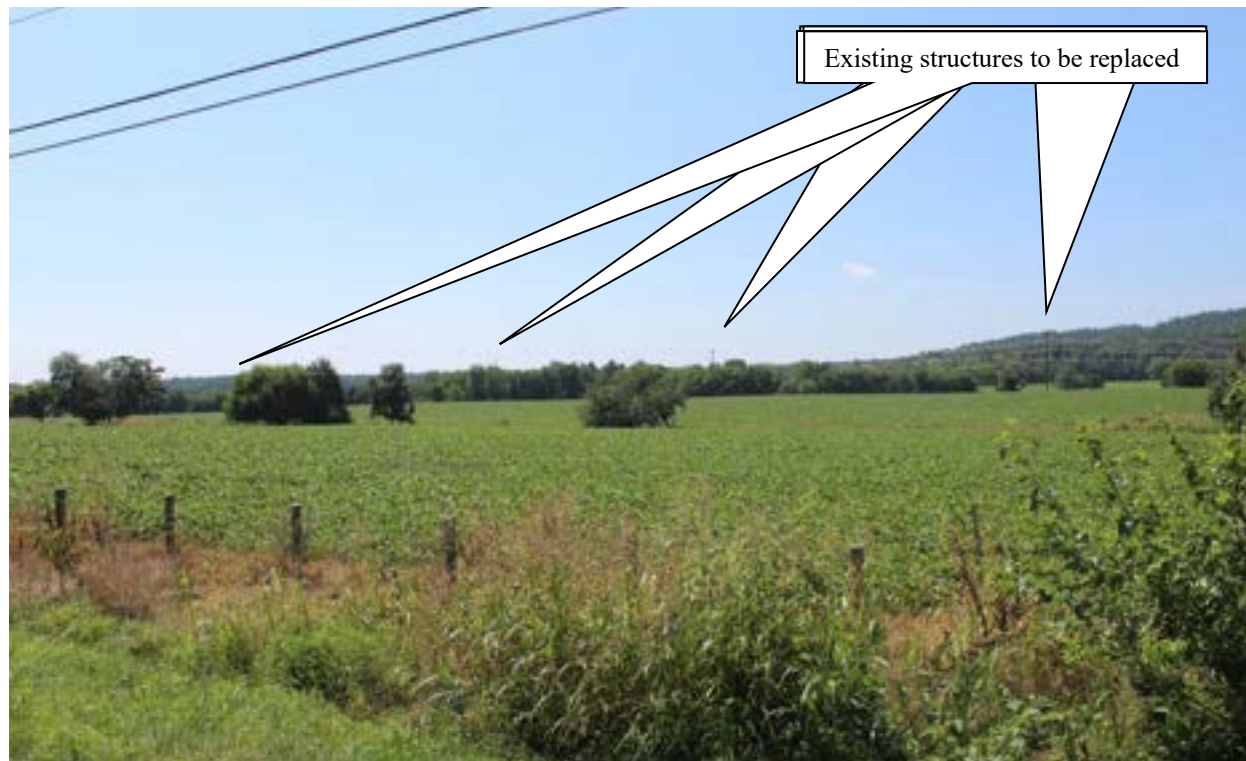
Figure 5-173: Photo location 8- View from Route 3 at Signal Hill Farm (Multiple existing project structures visible), facing southeast.

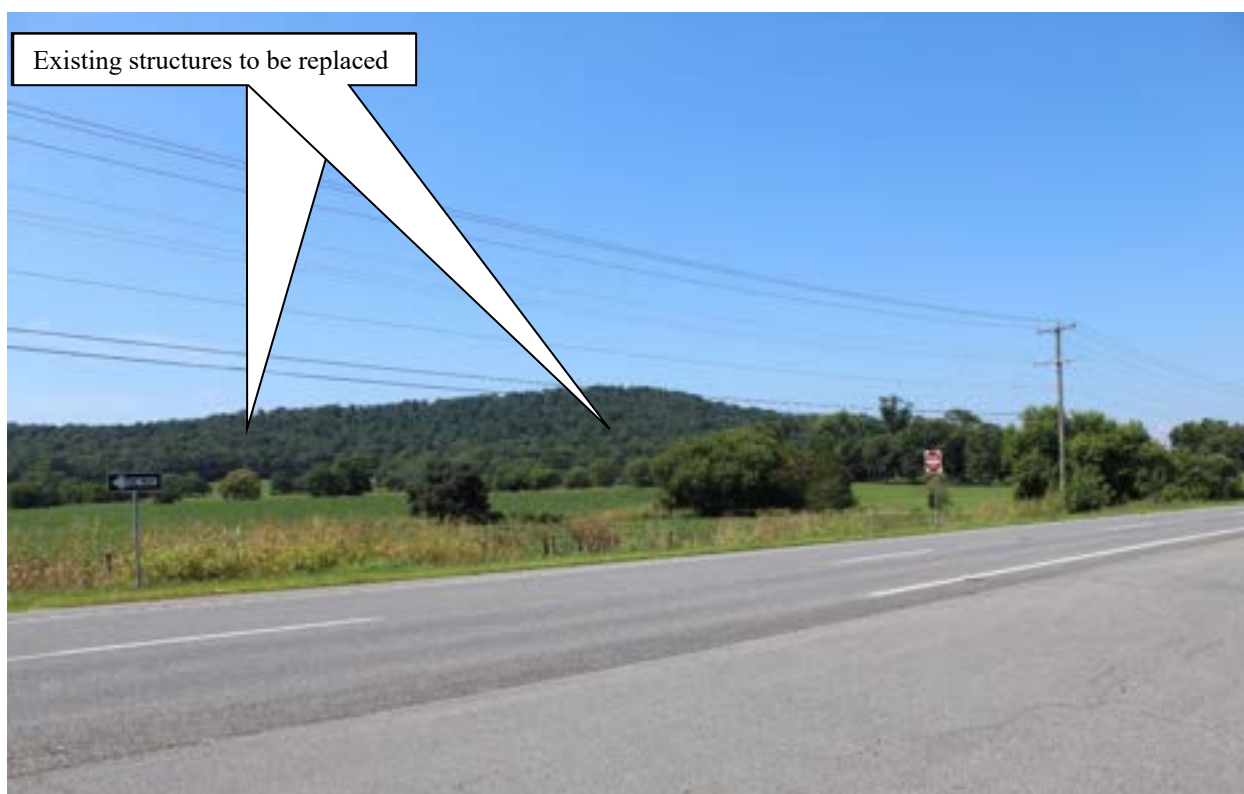
Figure 5-175: Photo location 10- View from Route 3 near Signal Hill Farm (Multiple existing project structures visible), facing southwest.

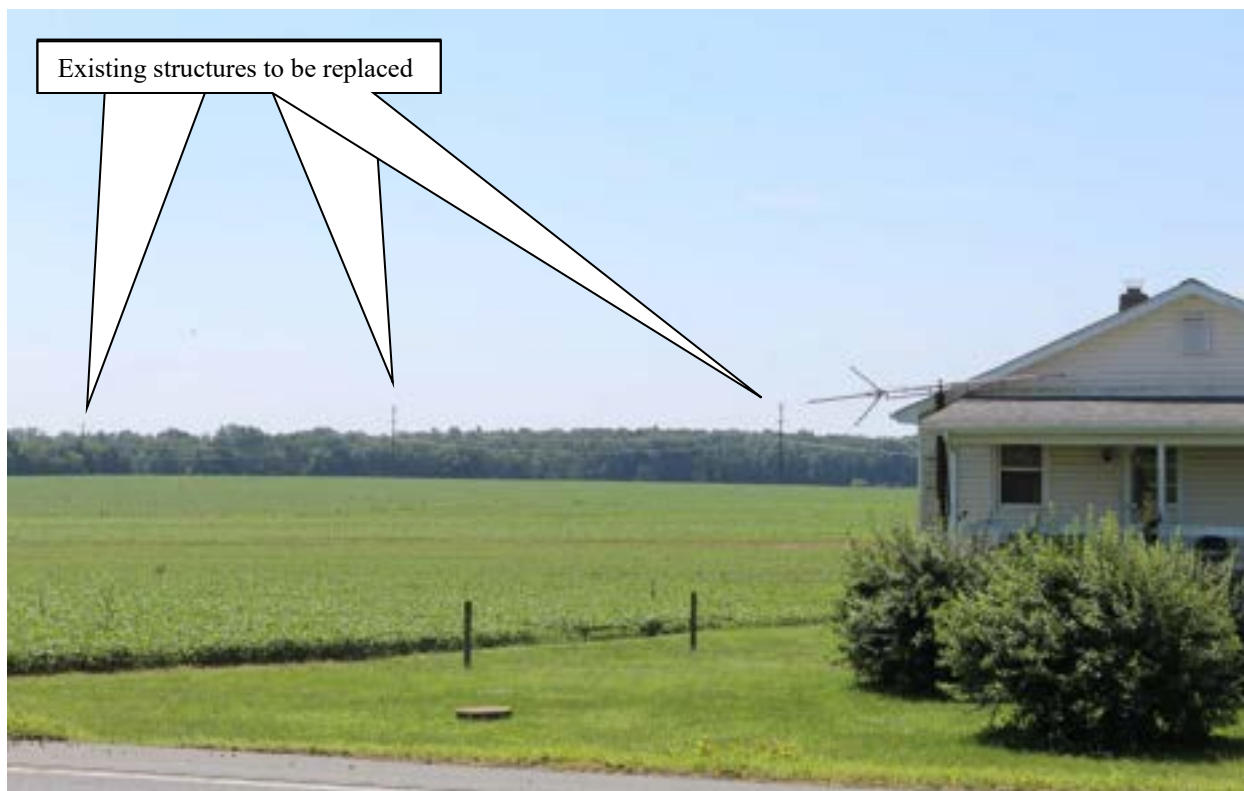
Figure 5-176: Photo location 11- View from Route 3 in central portion of district (Multiple existing project structures visible), facing southeast.

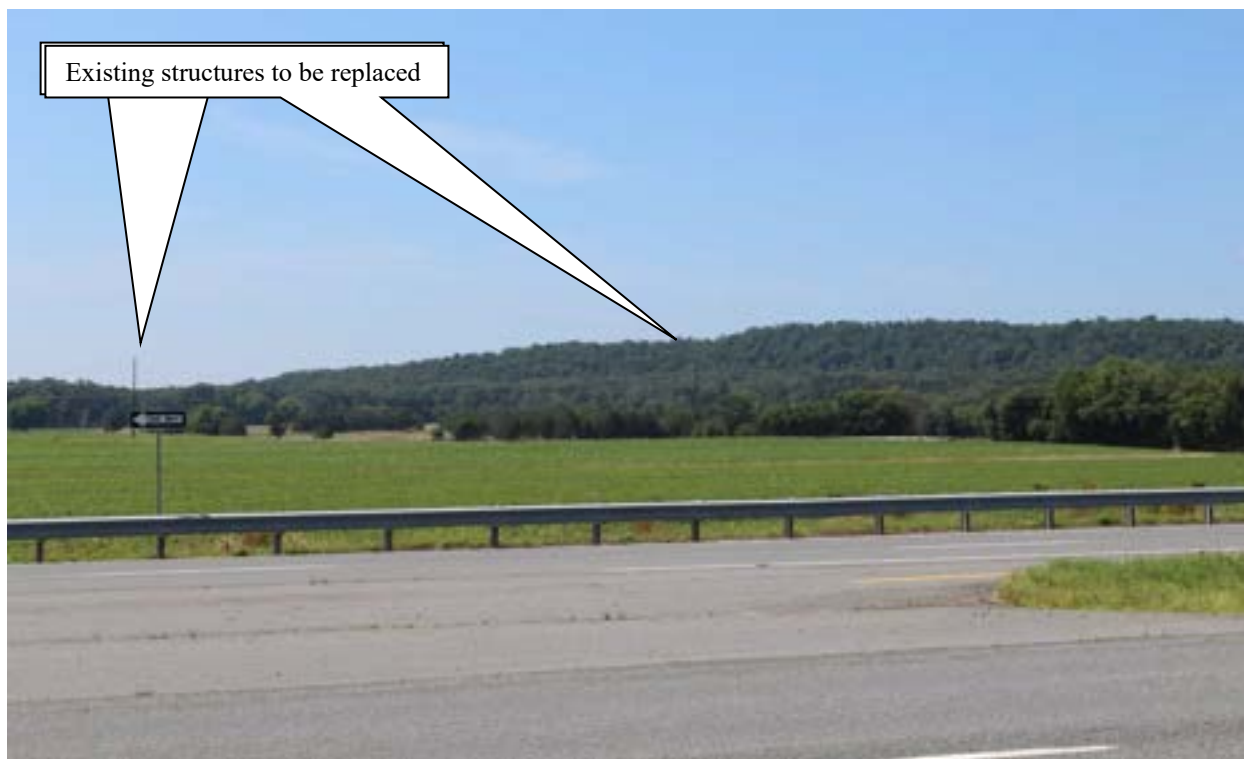
Figure 5-178: Photo location 13- View from Route 3 near eastern edge of district (Multiple existing project structures visible), facing south.

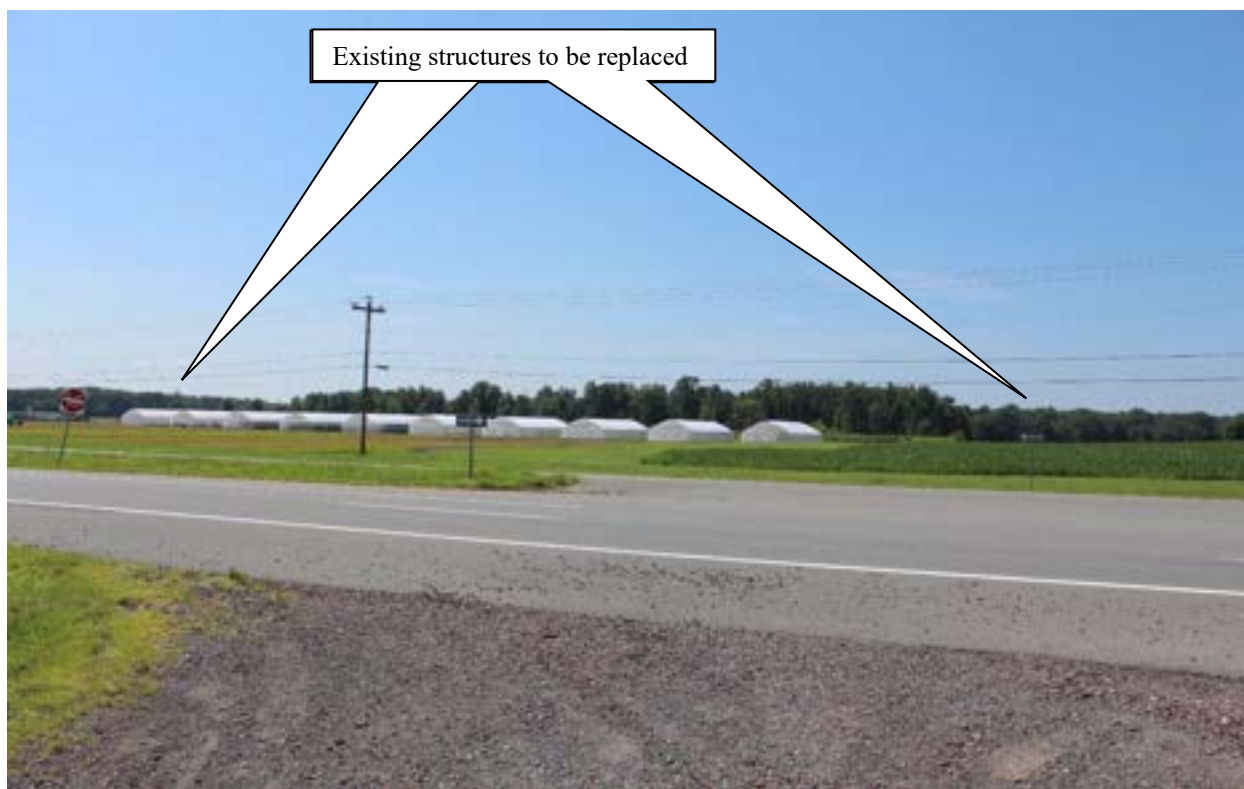
Figure 5-179: Photo location 14- View from Route 3 near eastern edge of district (Multiple existing project structures visible), facing southeast.

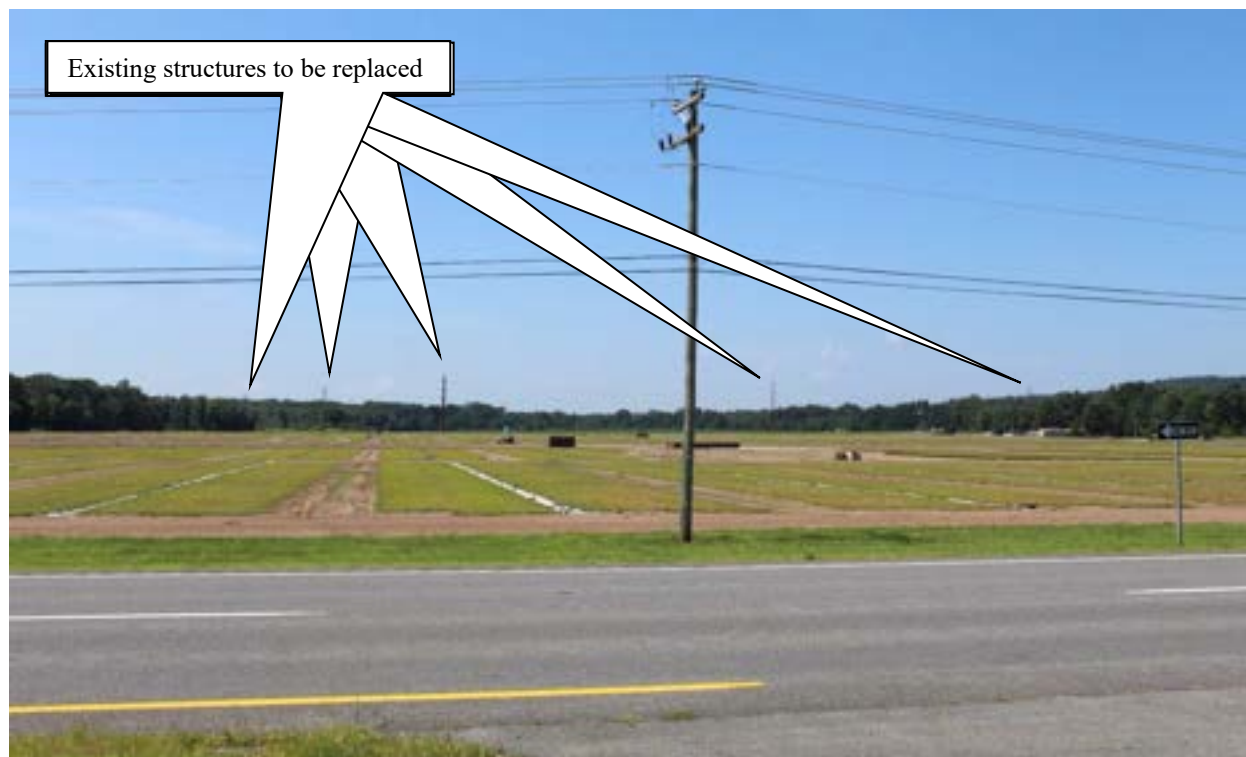
Figure 5-180: Photo location 15- View from Route 3 near eastern edge of district (Multiple existing project structures visible), facing south.

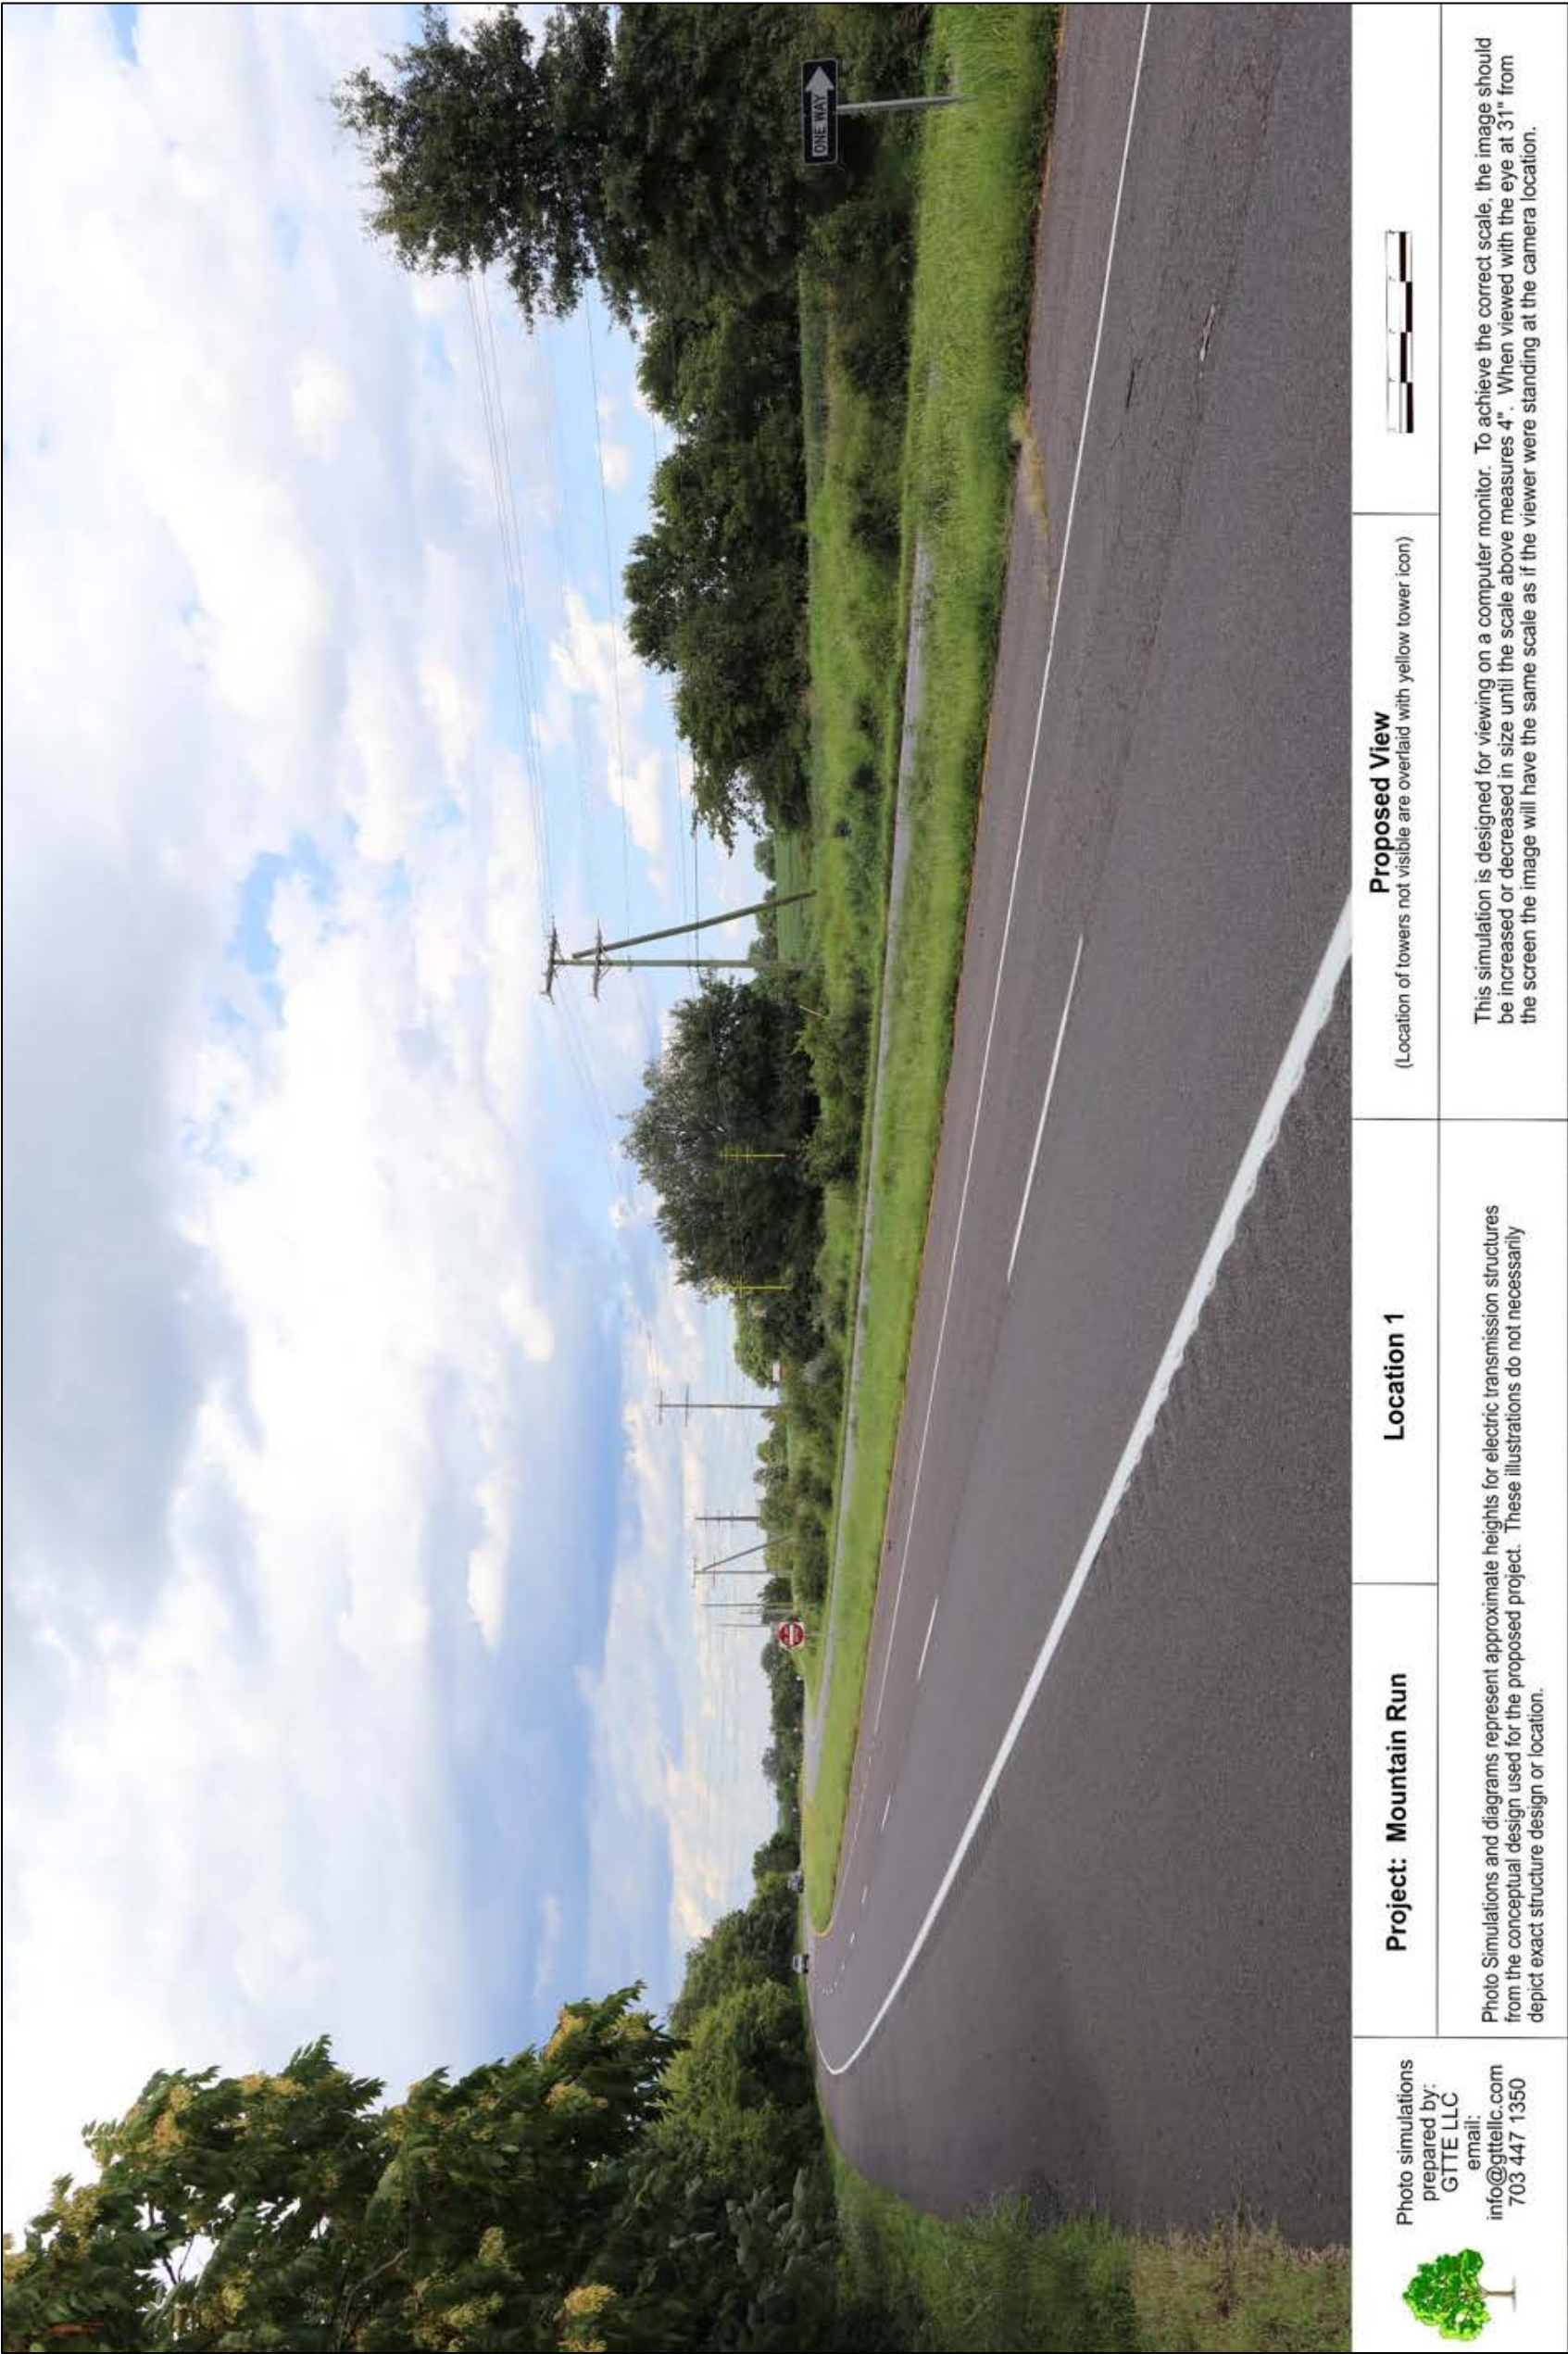
Figure 5-184: Mount Pony Rural Historic District Simulation 1 – Proposed view from driveway to Croftburn Farm – (Visible structure shown as it would appear. Structures not visible shown in yellow). Source: GTTE, LLC

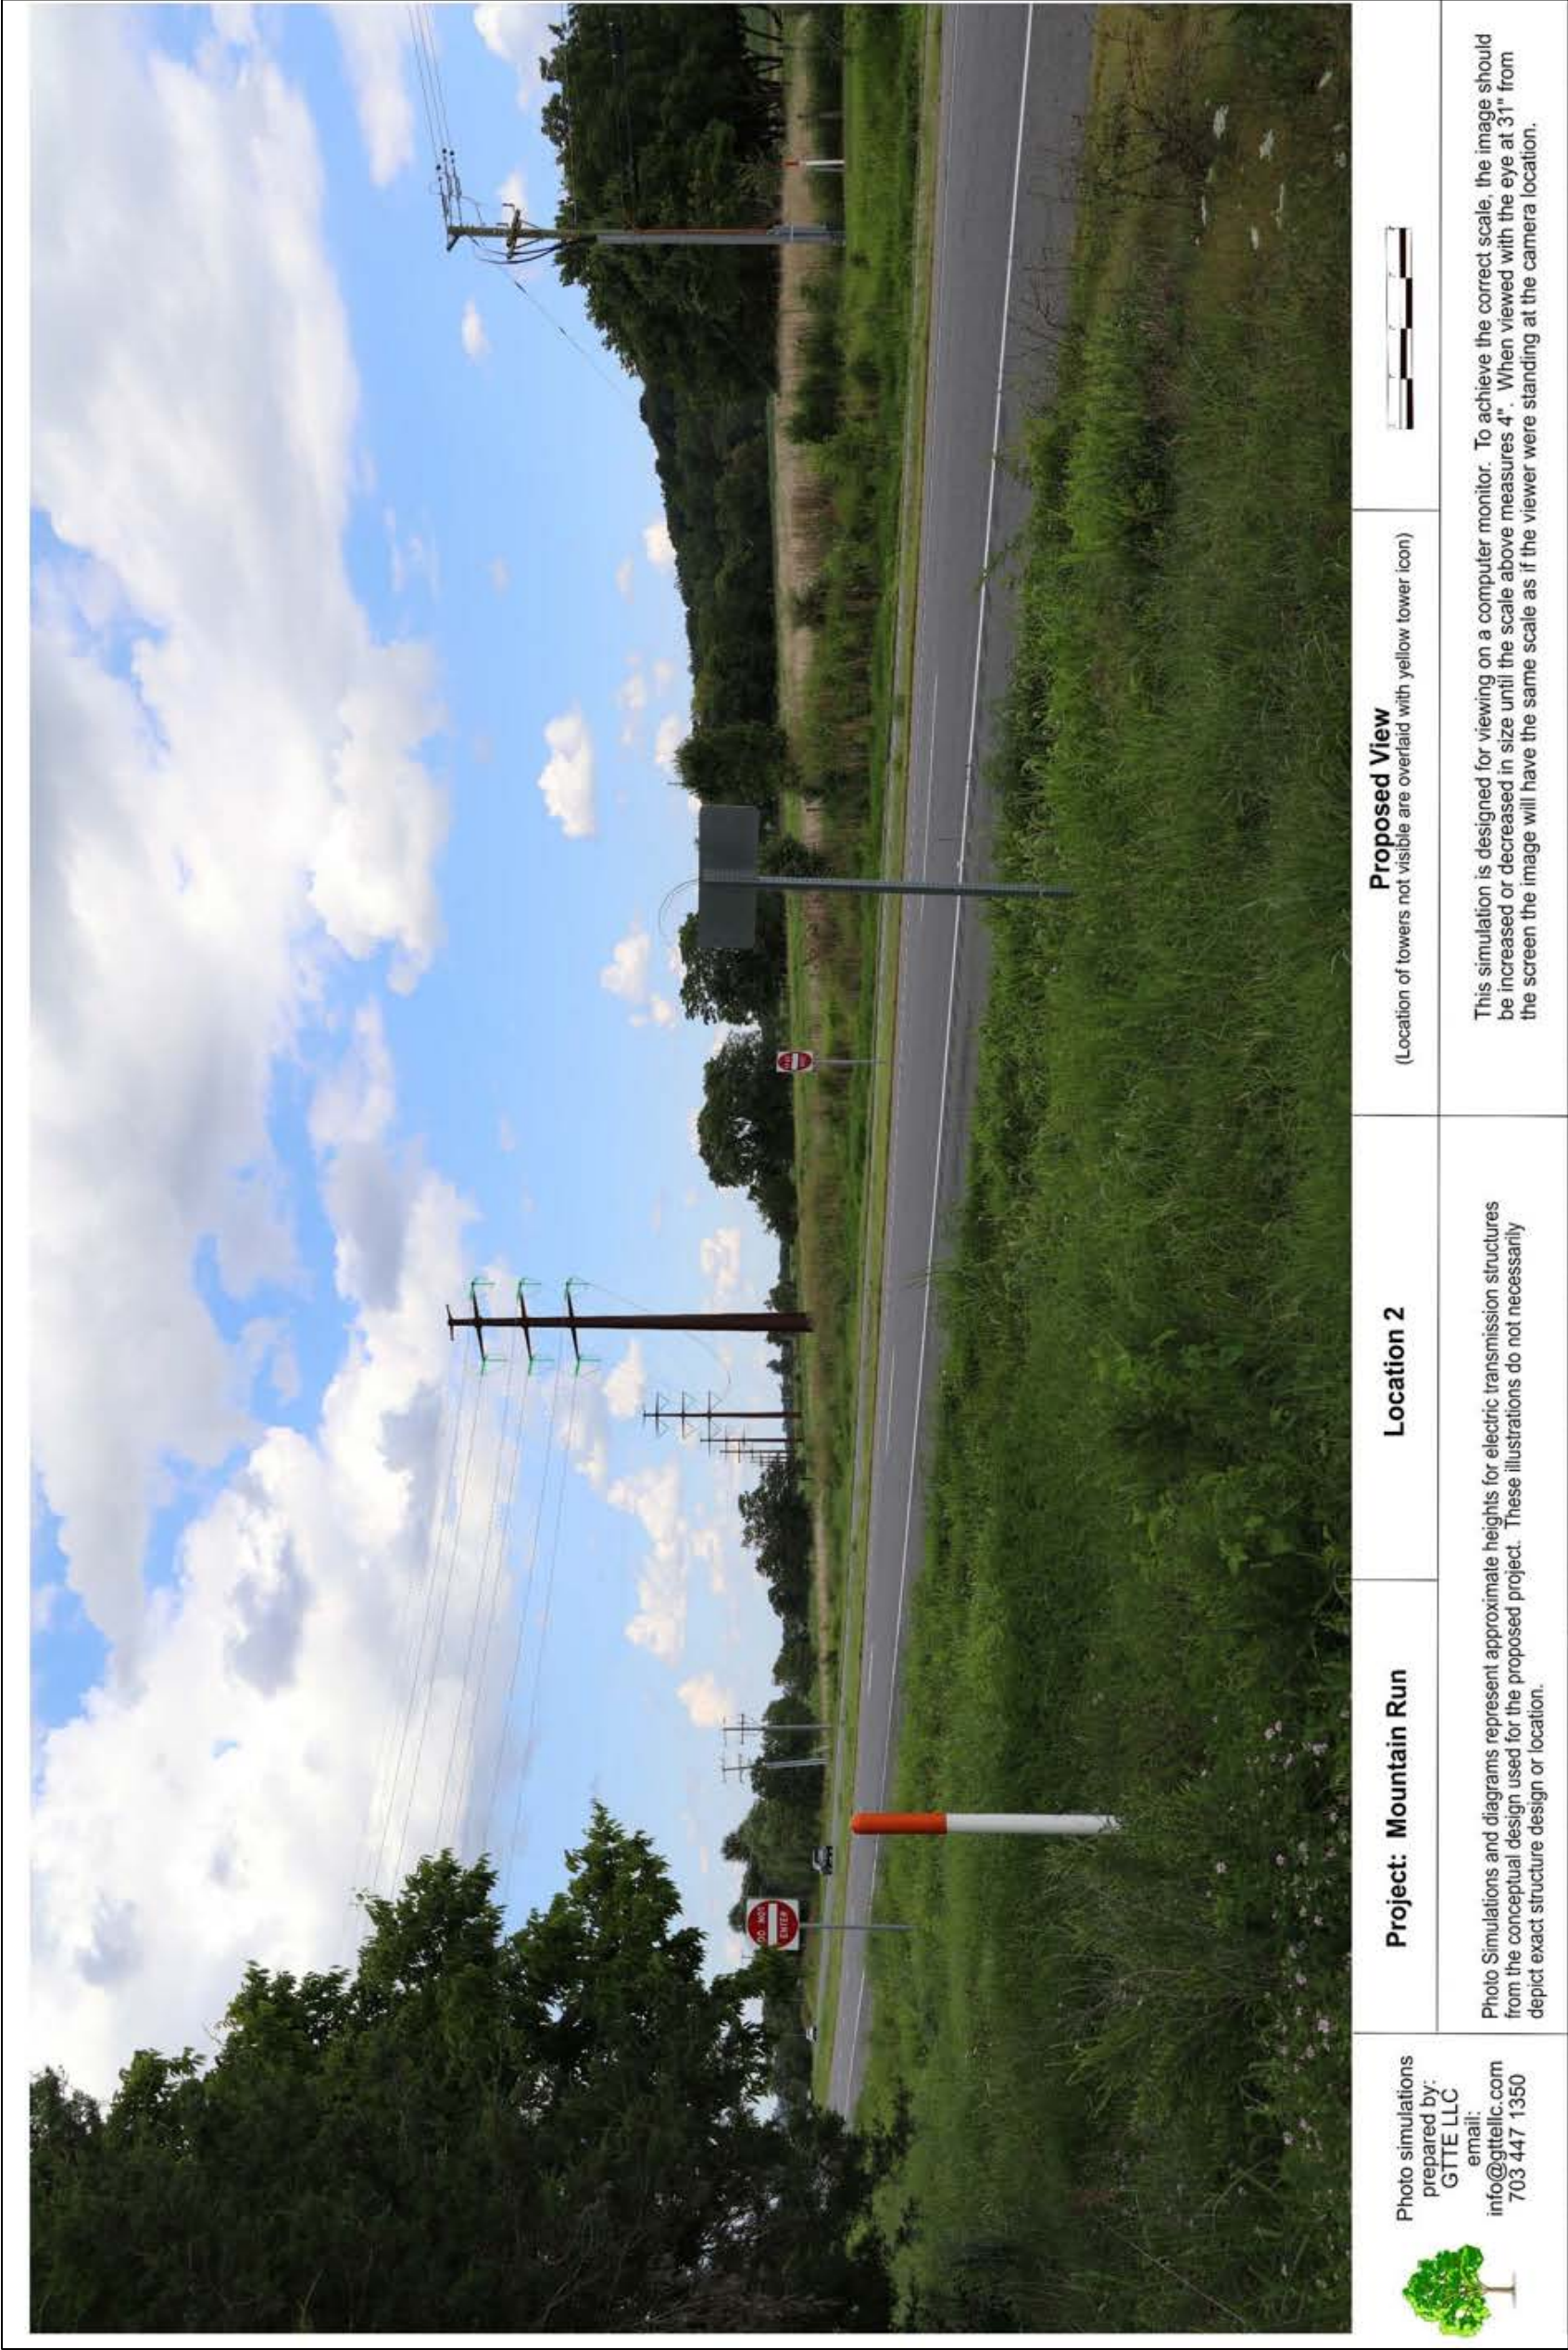
Figure 5-190: Mount Pony Rural Historic District Simulation 3 – Proposed view across road from Croftburn Farm – (Visible structures shown as they would appear). Source: GTTE, LLC
