**Application, Appendix,
DEQ Supplement, Direct
Testimony and Exhibits of
Virginia Electric and Power
Company**

**Cirrus-Keyser 230 kV Loop and
Related Projects**

Case No. PUR-2022-00198

DEQ Supplement

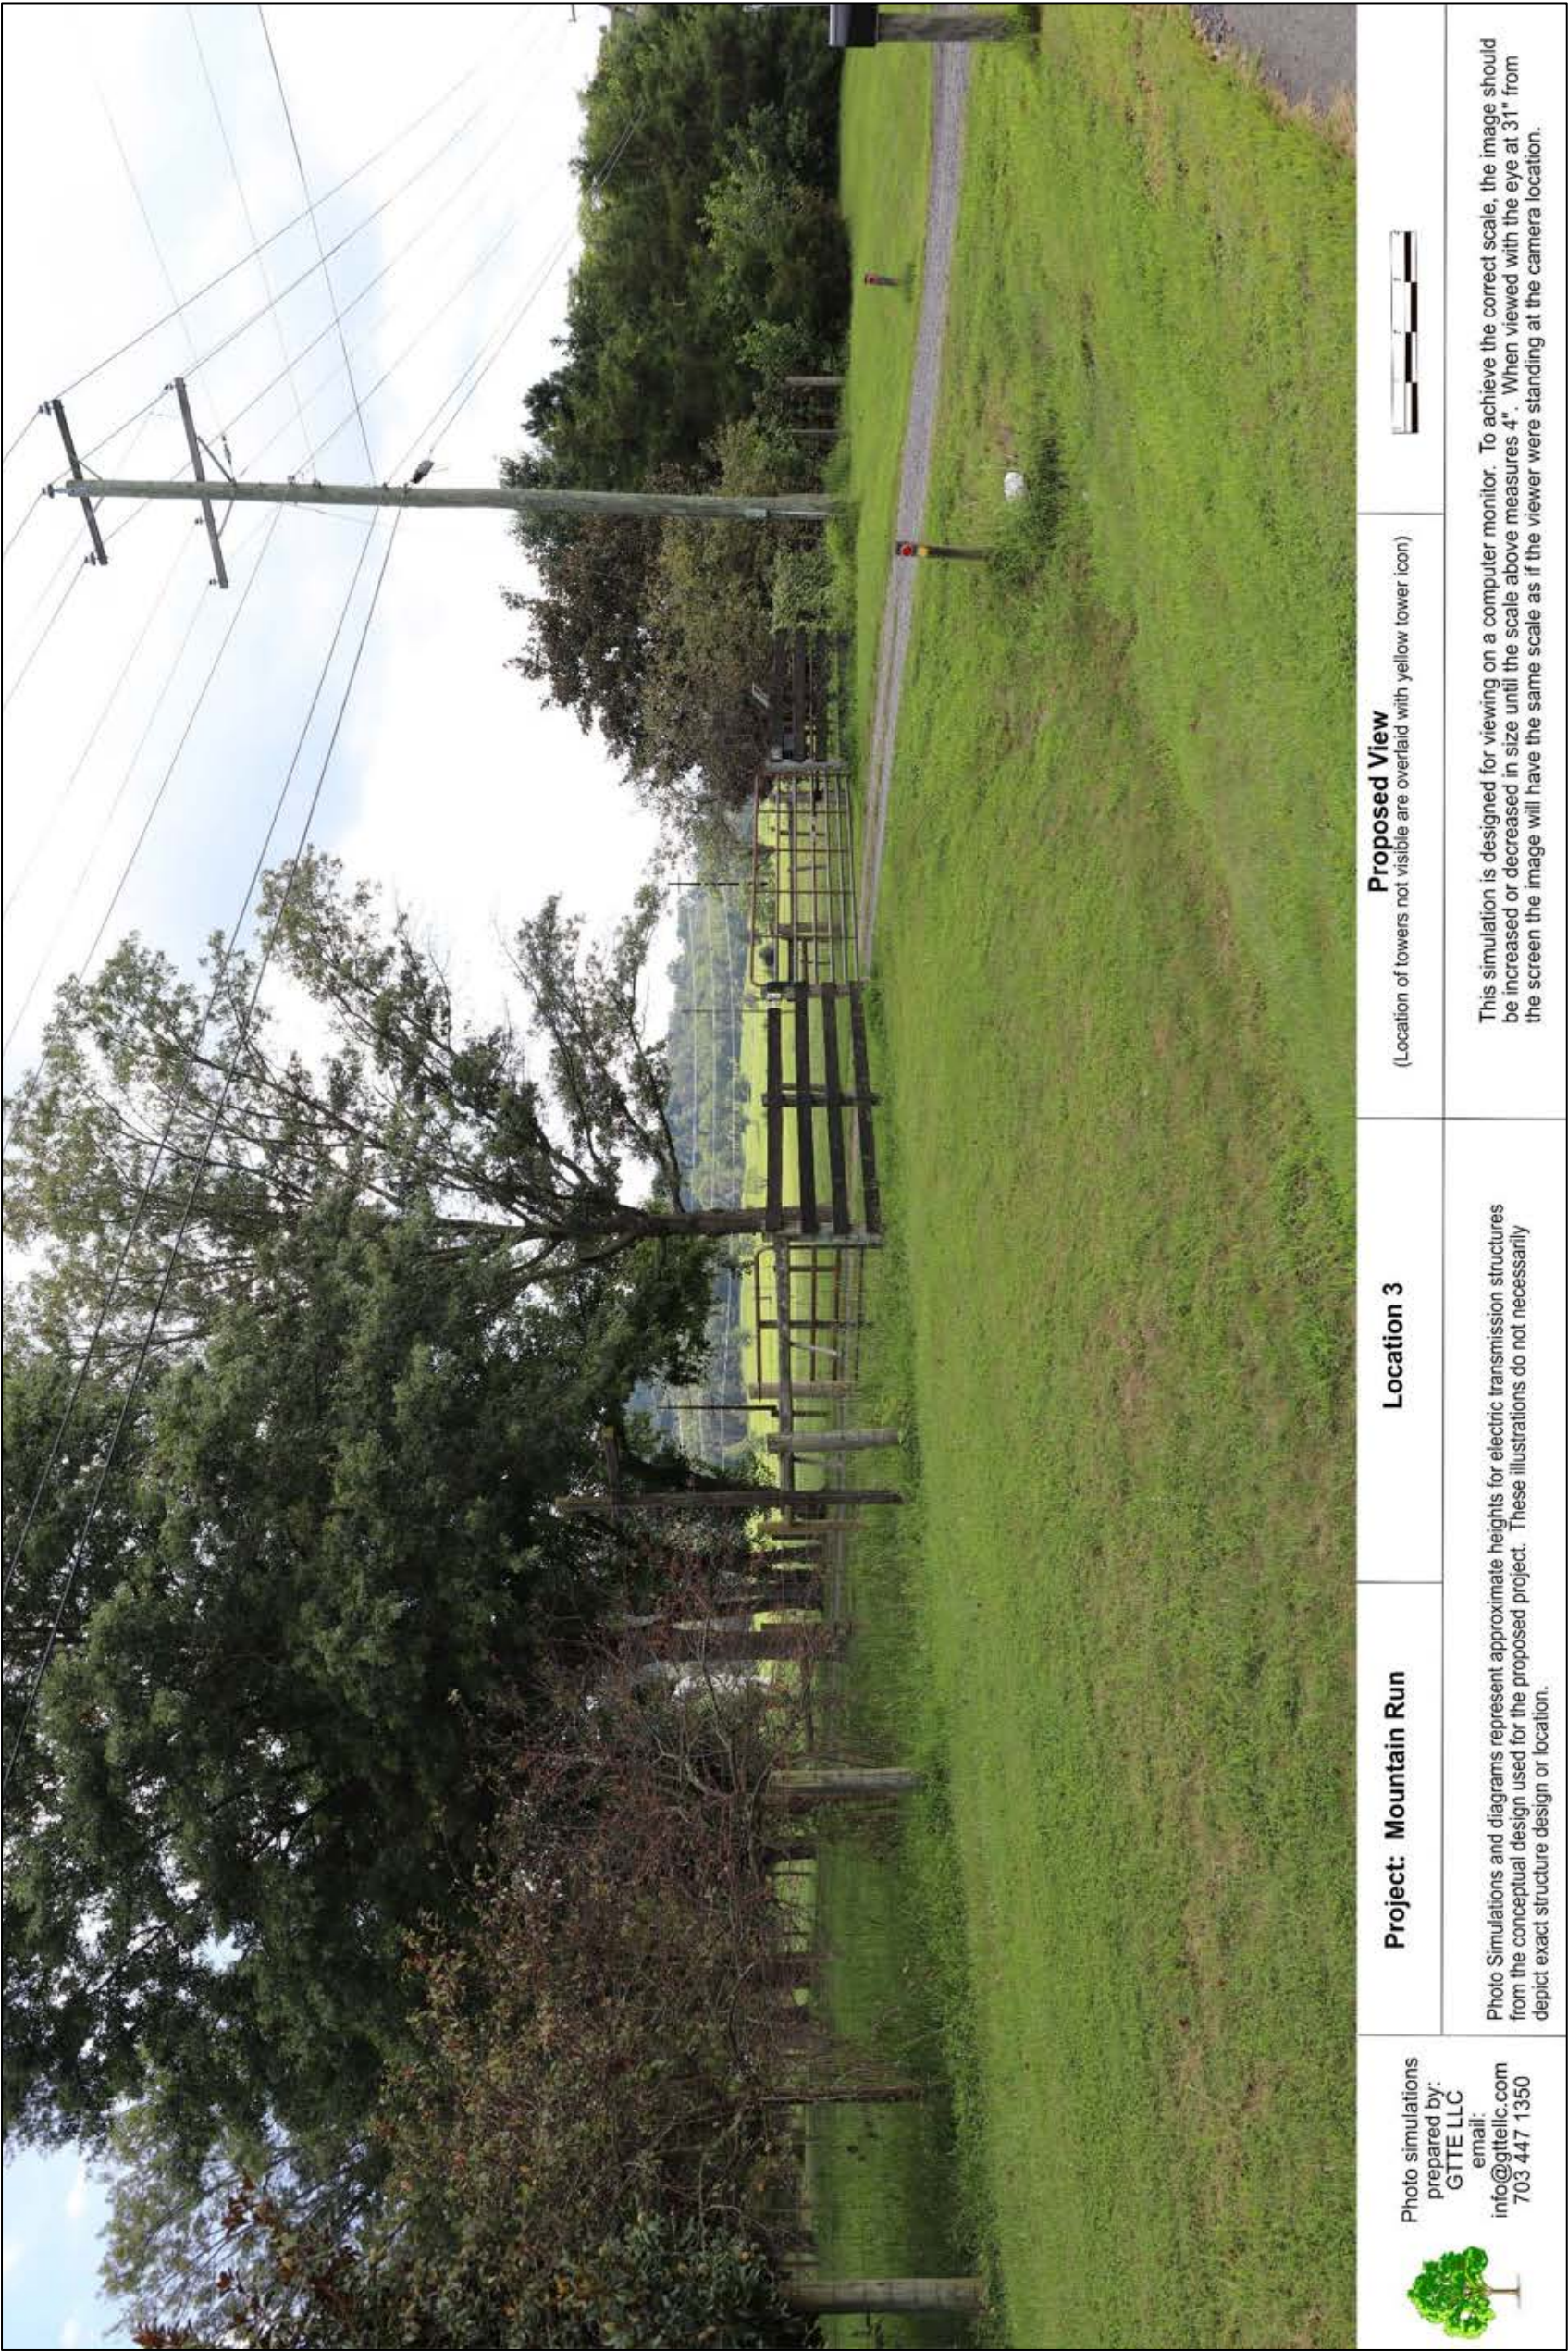
Figure 5-193: Mount Pony Rural Historic District Simulation 4 – Proposed view from driveway to Signal Hill Farm – (Visible structures shown as they would appear). Source: GTTE, LLC

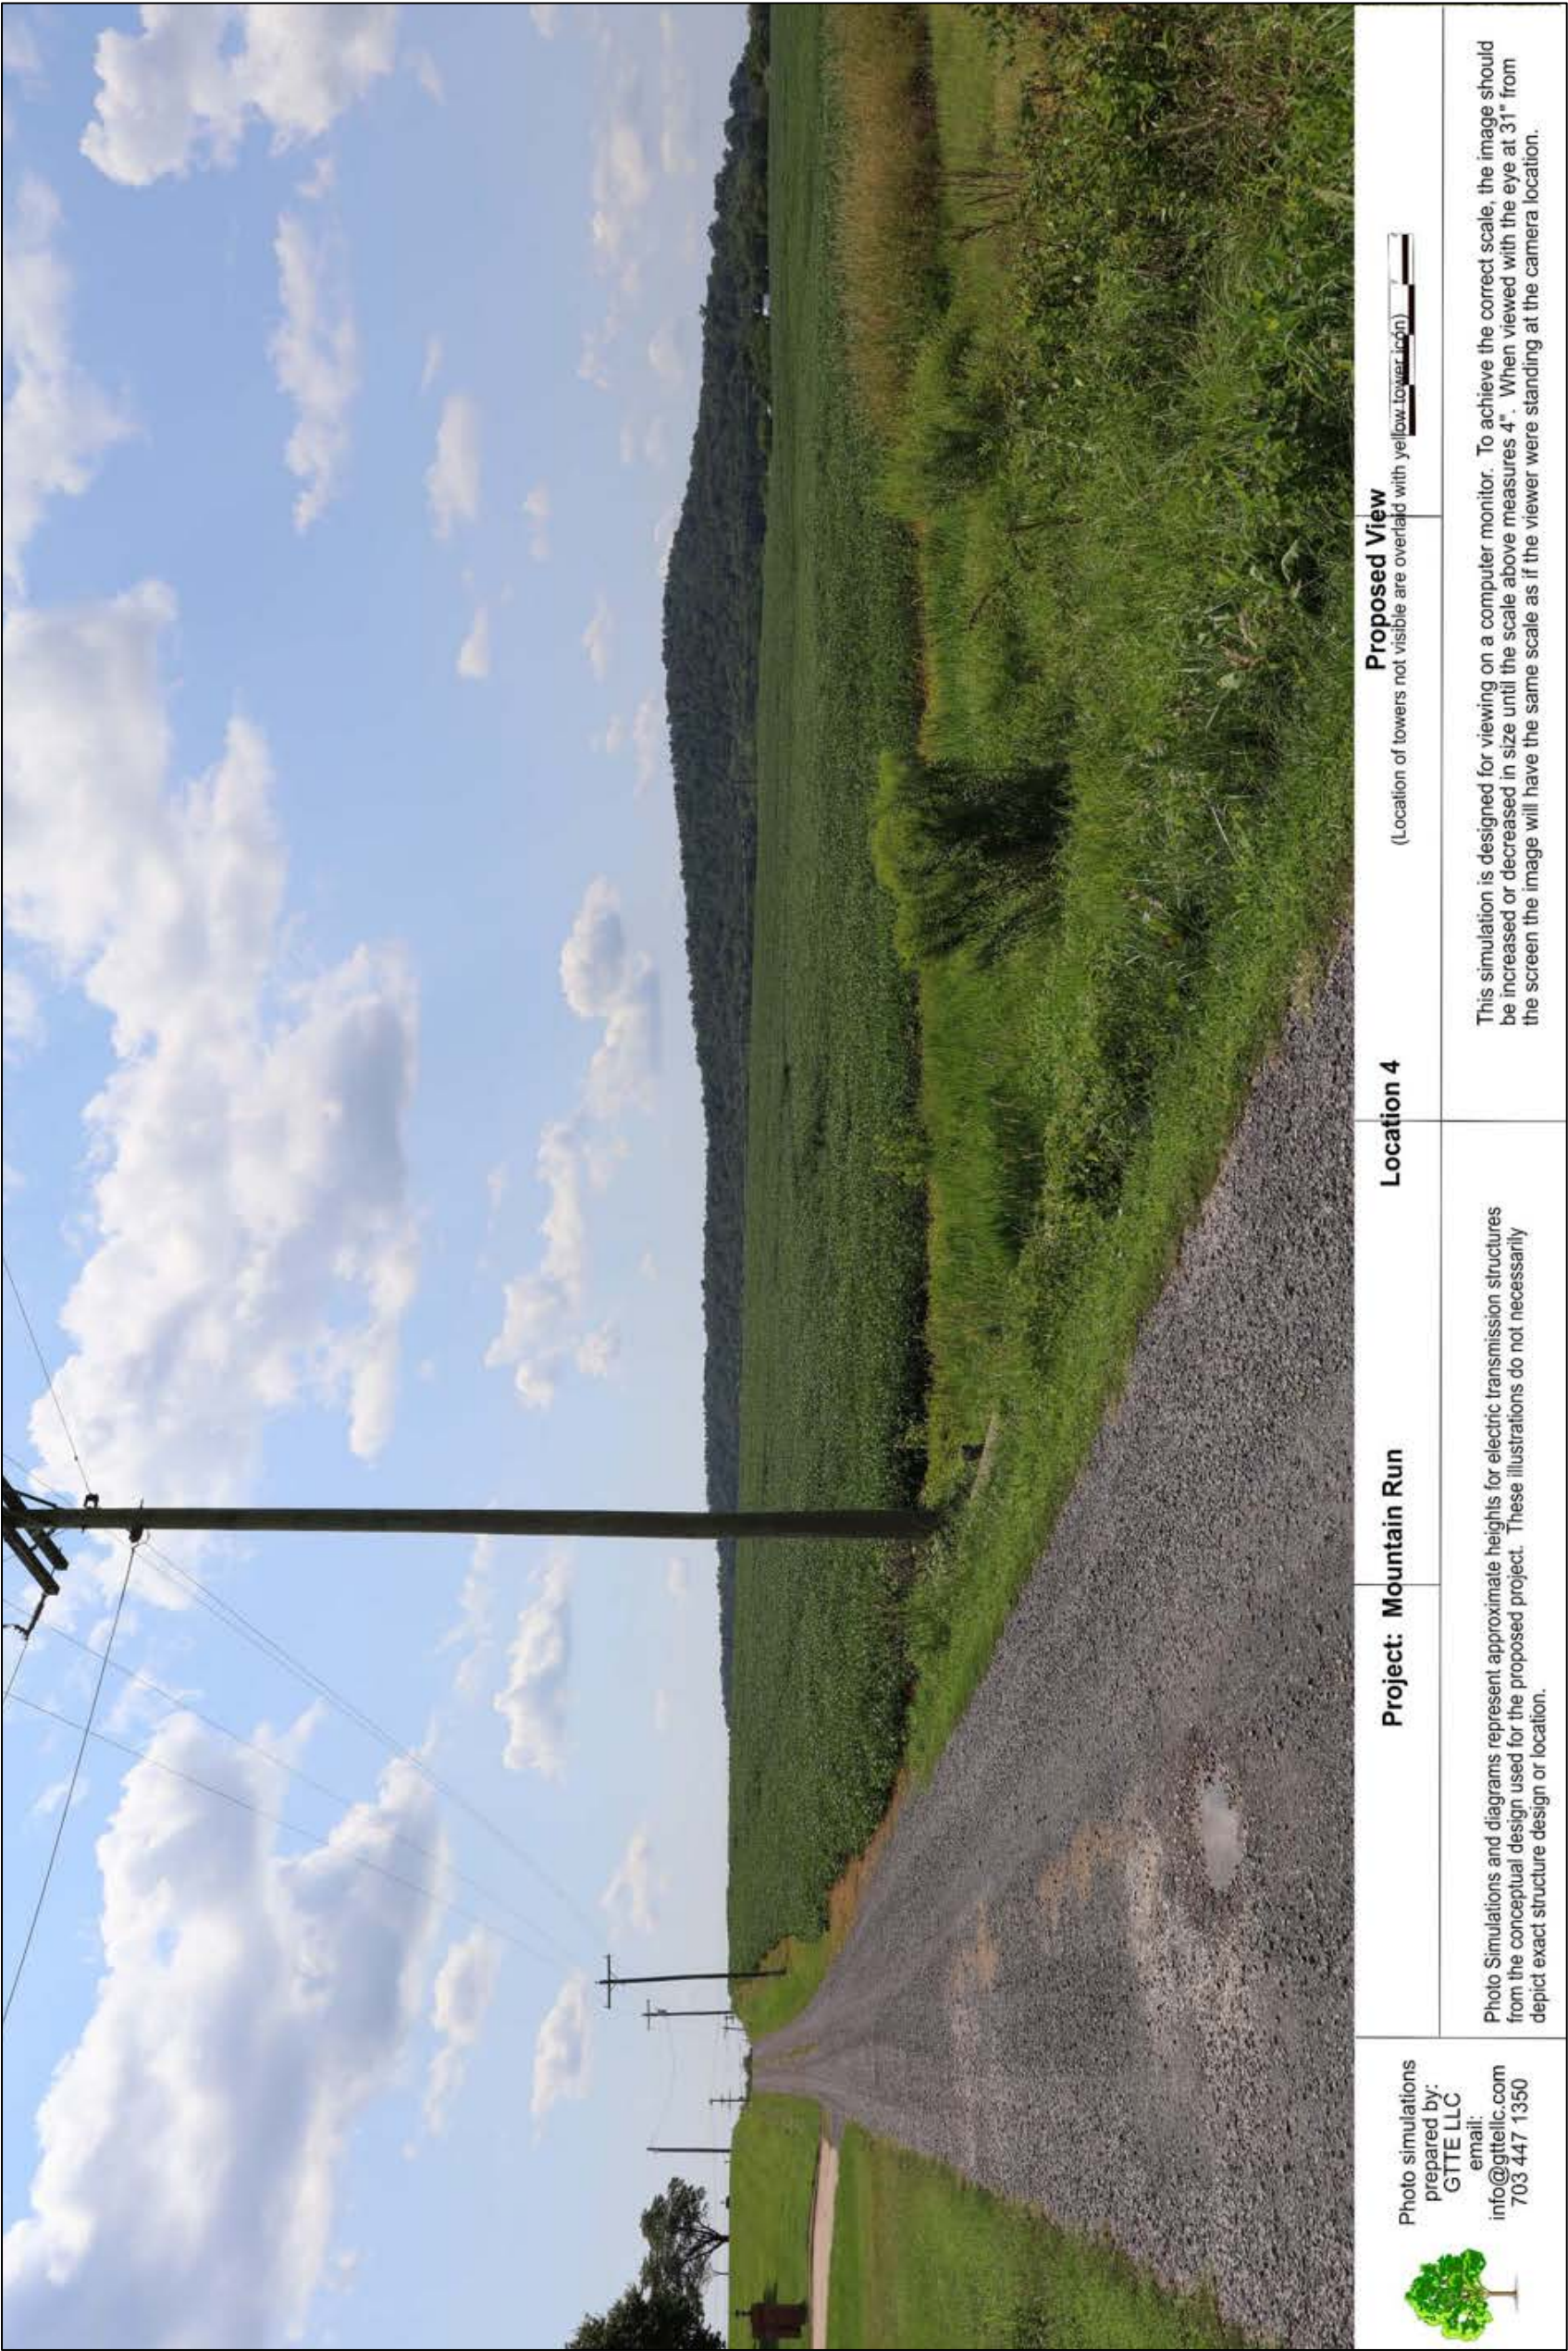
Figure 5-196: Mount Pony Rural Historic District Simulation 5 – Proposed view from Ashland Farm Road – (Visible structures shown as they would appear). Source: GTTE, LLC

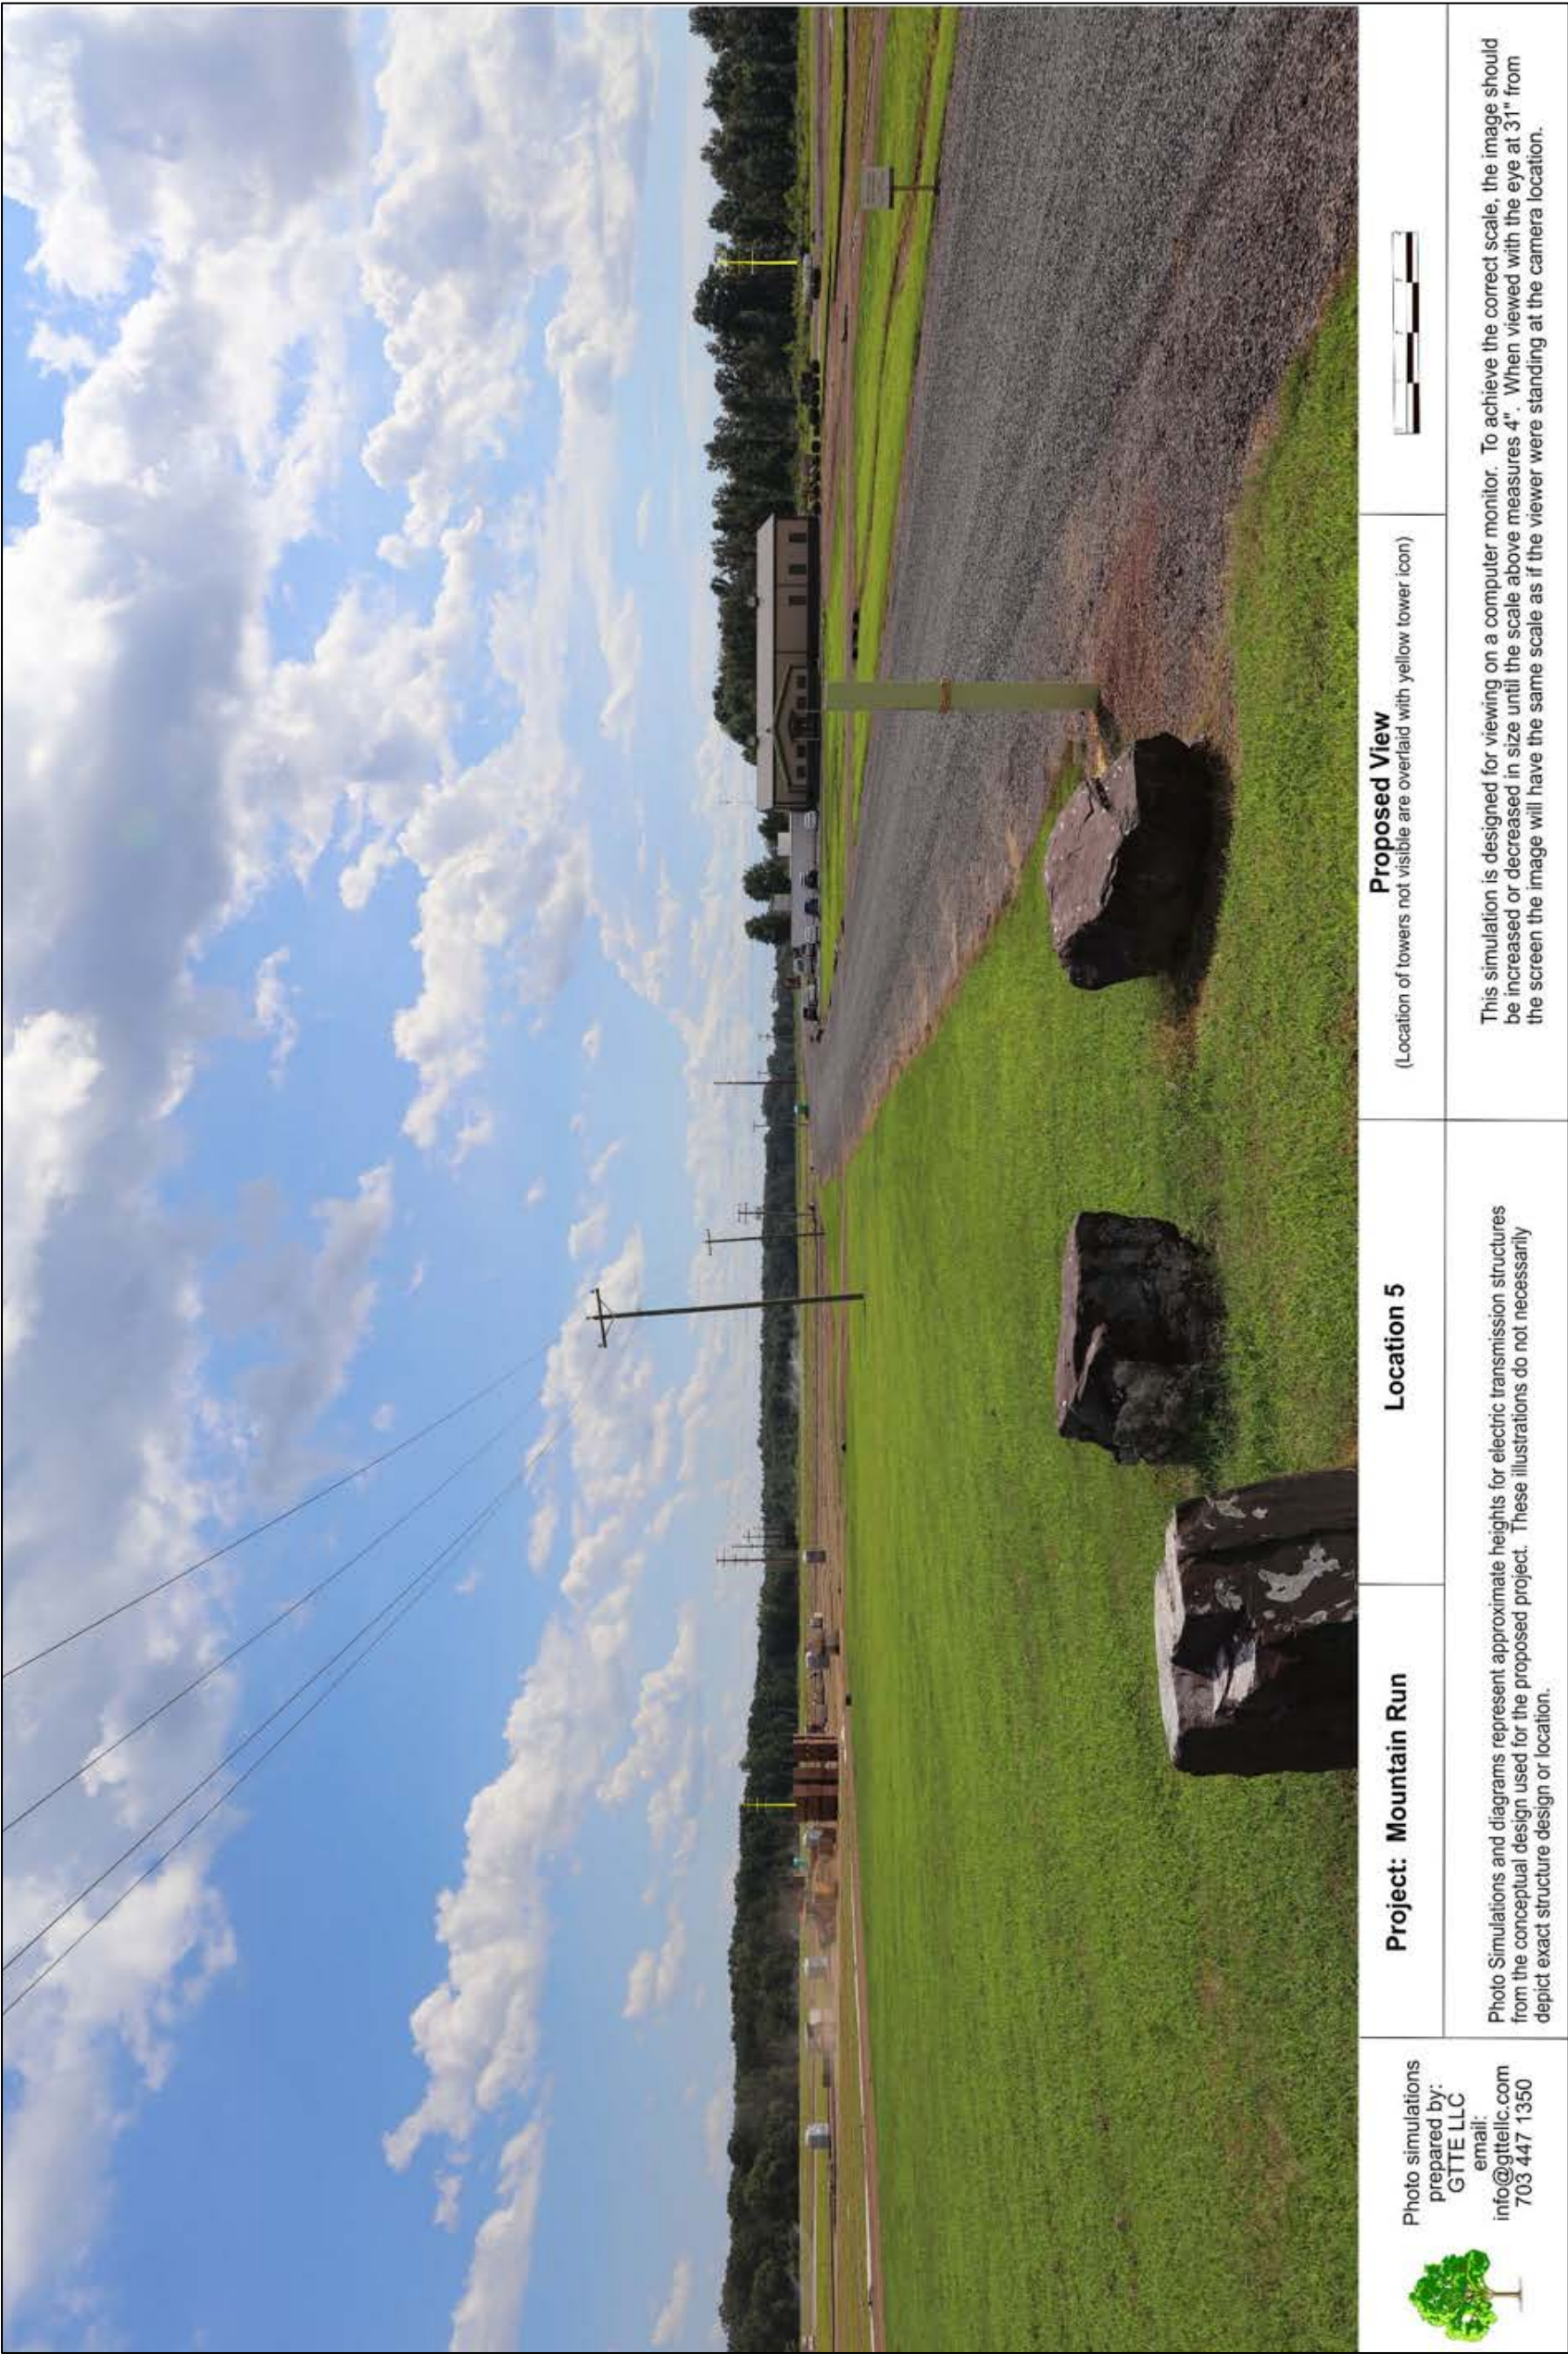
Figure 5-199: Mount Pony Rural Historic District Simulation 6 – Proposed view from Route 3 at Moerings Nursery – (Visible structures shown as they would appear. Structures not visible shown in yellow). Source: GTTE, LLC

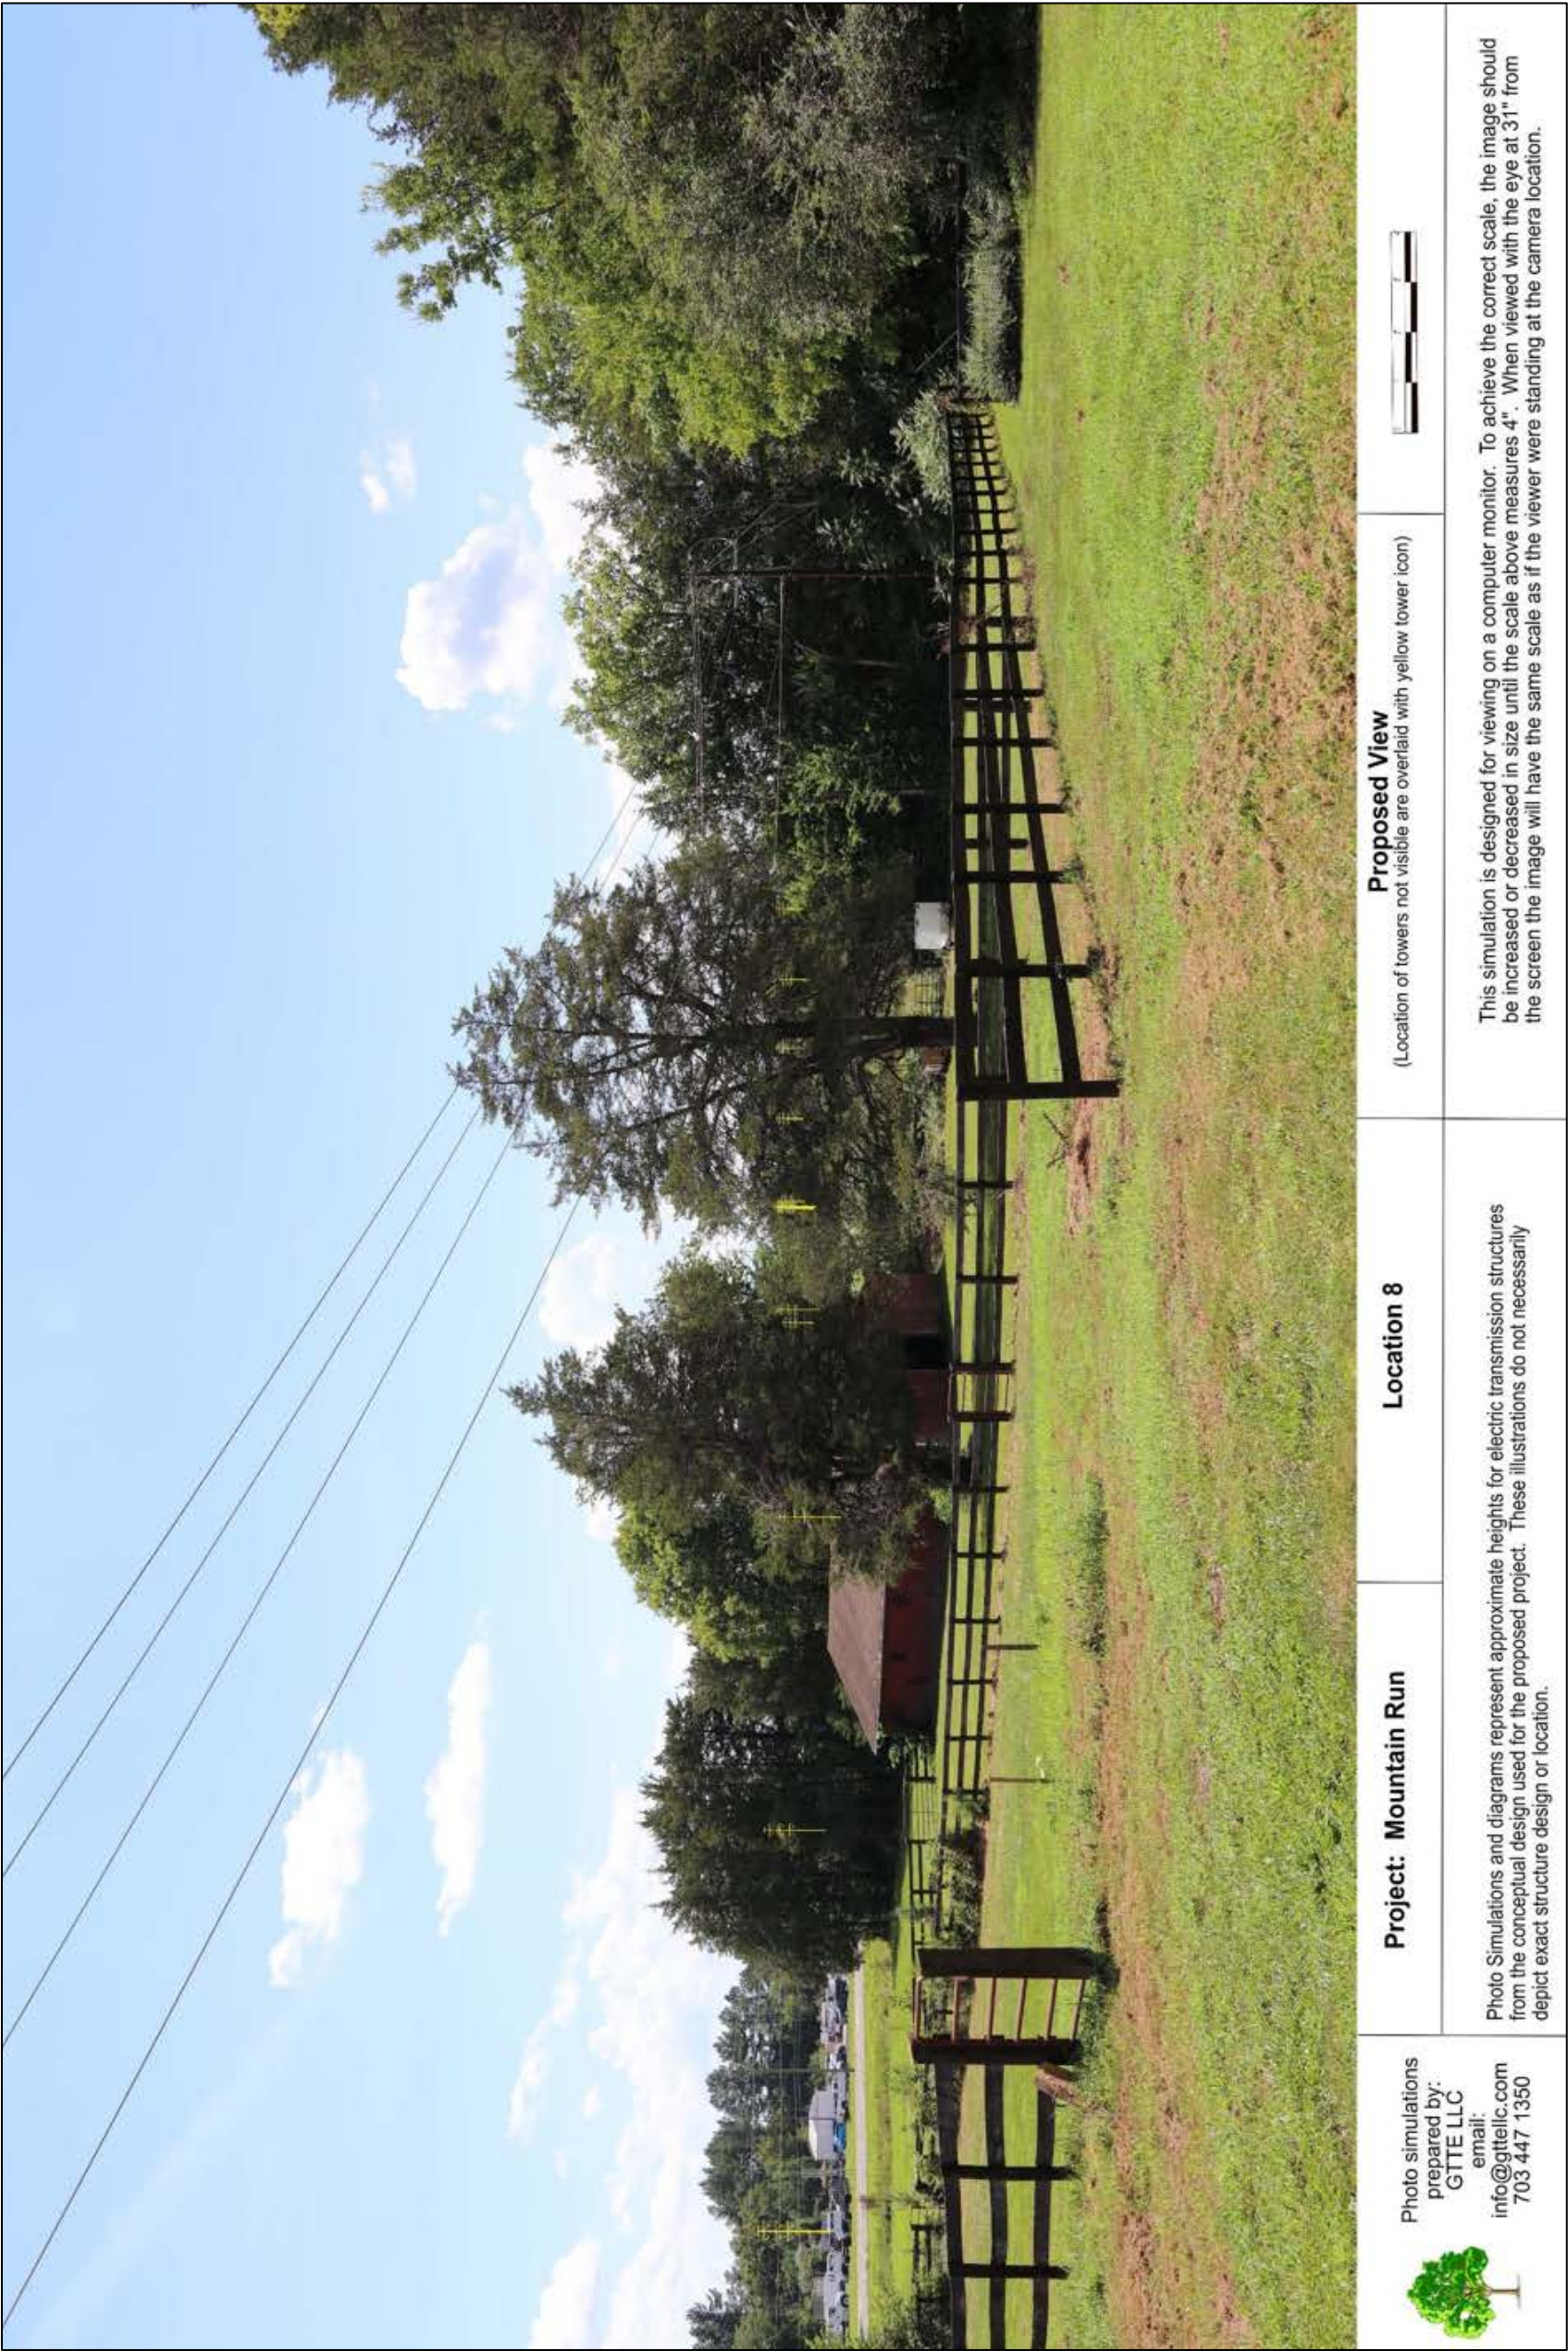
Figure 5-221: Zimmerman’s Tavern Simulation 1 – Proposed view from front of the building – (Structures not visible shown in yellow). Source: GTTE, LLC

The existing structures to be replaced as part of this project are each 80-feet in height and the proposed replacement structures will generally average 100-feet in height. As such, it is anticipated that the intervening topography, vegetation, and development will continue to screen the replacement structures from view from the front of the property. Views from the far western edge of the property may include additional portions of structures currently visible above development and vegetation, however, the viewshed and setting in this portion of the property includes extensive other nonhistoric development and intrusion. This was confirmed by photo simulation that reveals all proposed structures will remain screened by intervening vegetation from the front of the house, and portions of structures may rise above the treeline from the western edge of the property, most of the structures would be screened and seen behind modern infrastructure in the foreground. Therefore, while the increase in height may be visible from discrete vantage points, it will not be visible from the primary resource or public ROW nearby, and therefore the project will not introduce any substantial or cumulative change in setting or viewshed of or from the property. It is therefore D+A's opinion that the Cirrus – Keyser 230 kV Loop and Related Projects will pose no more than a *minimal impact* on Zimmerman's Tavern.

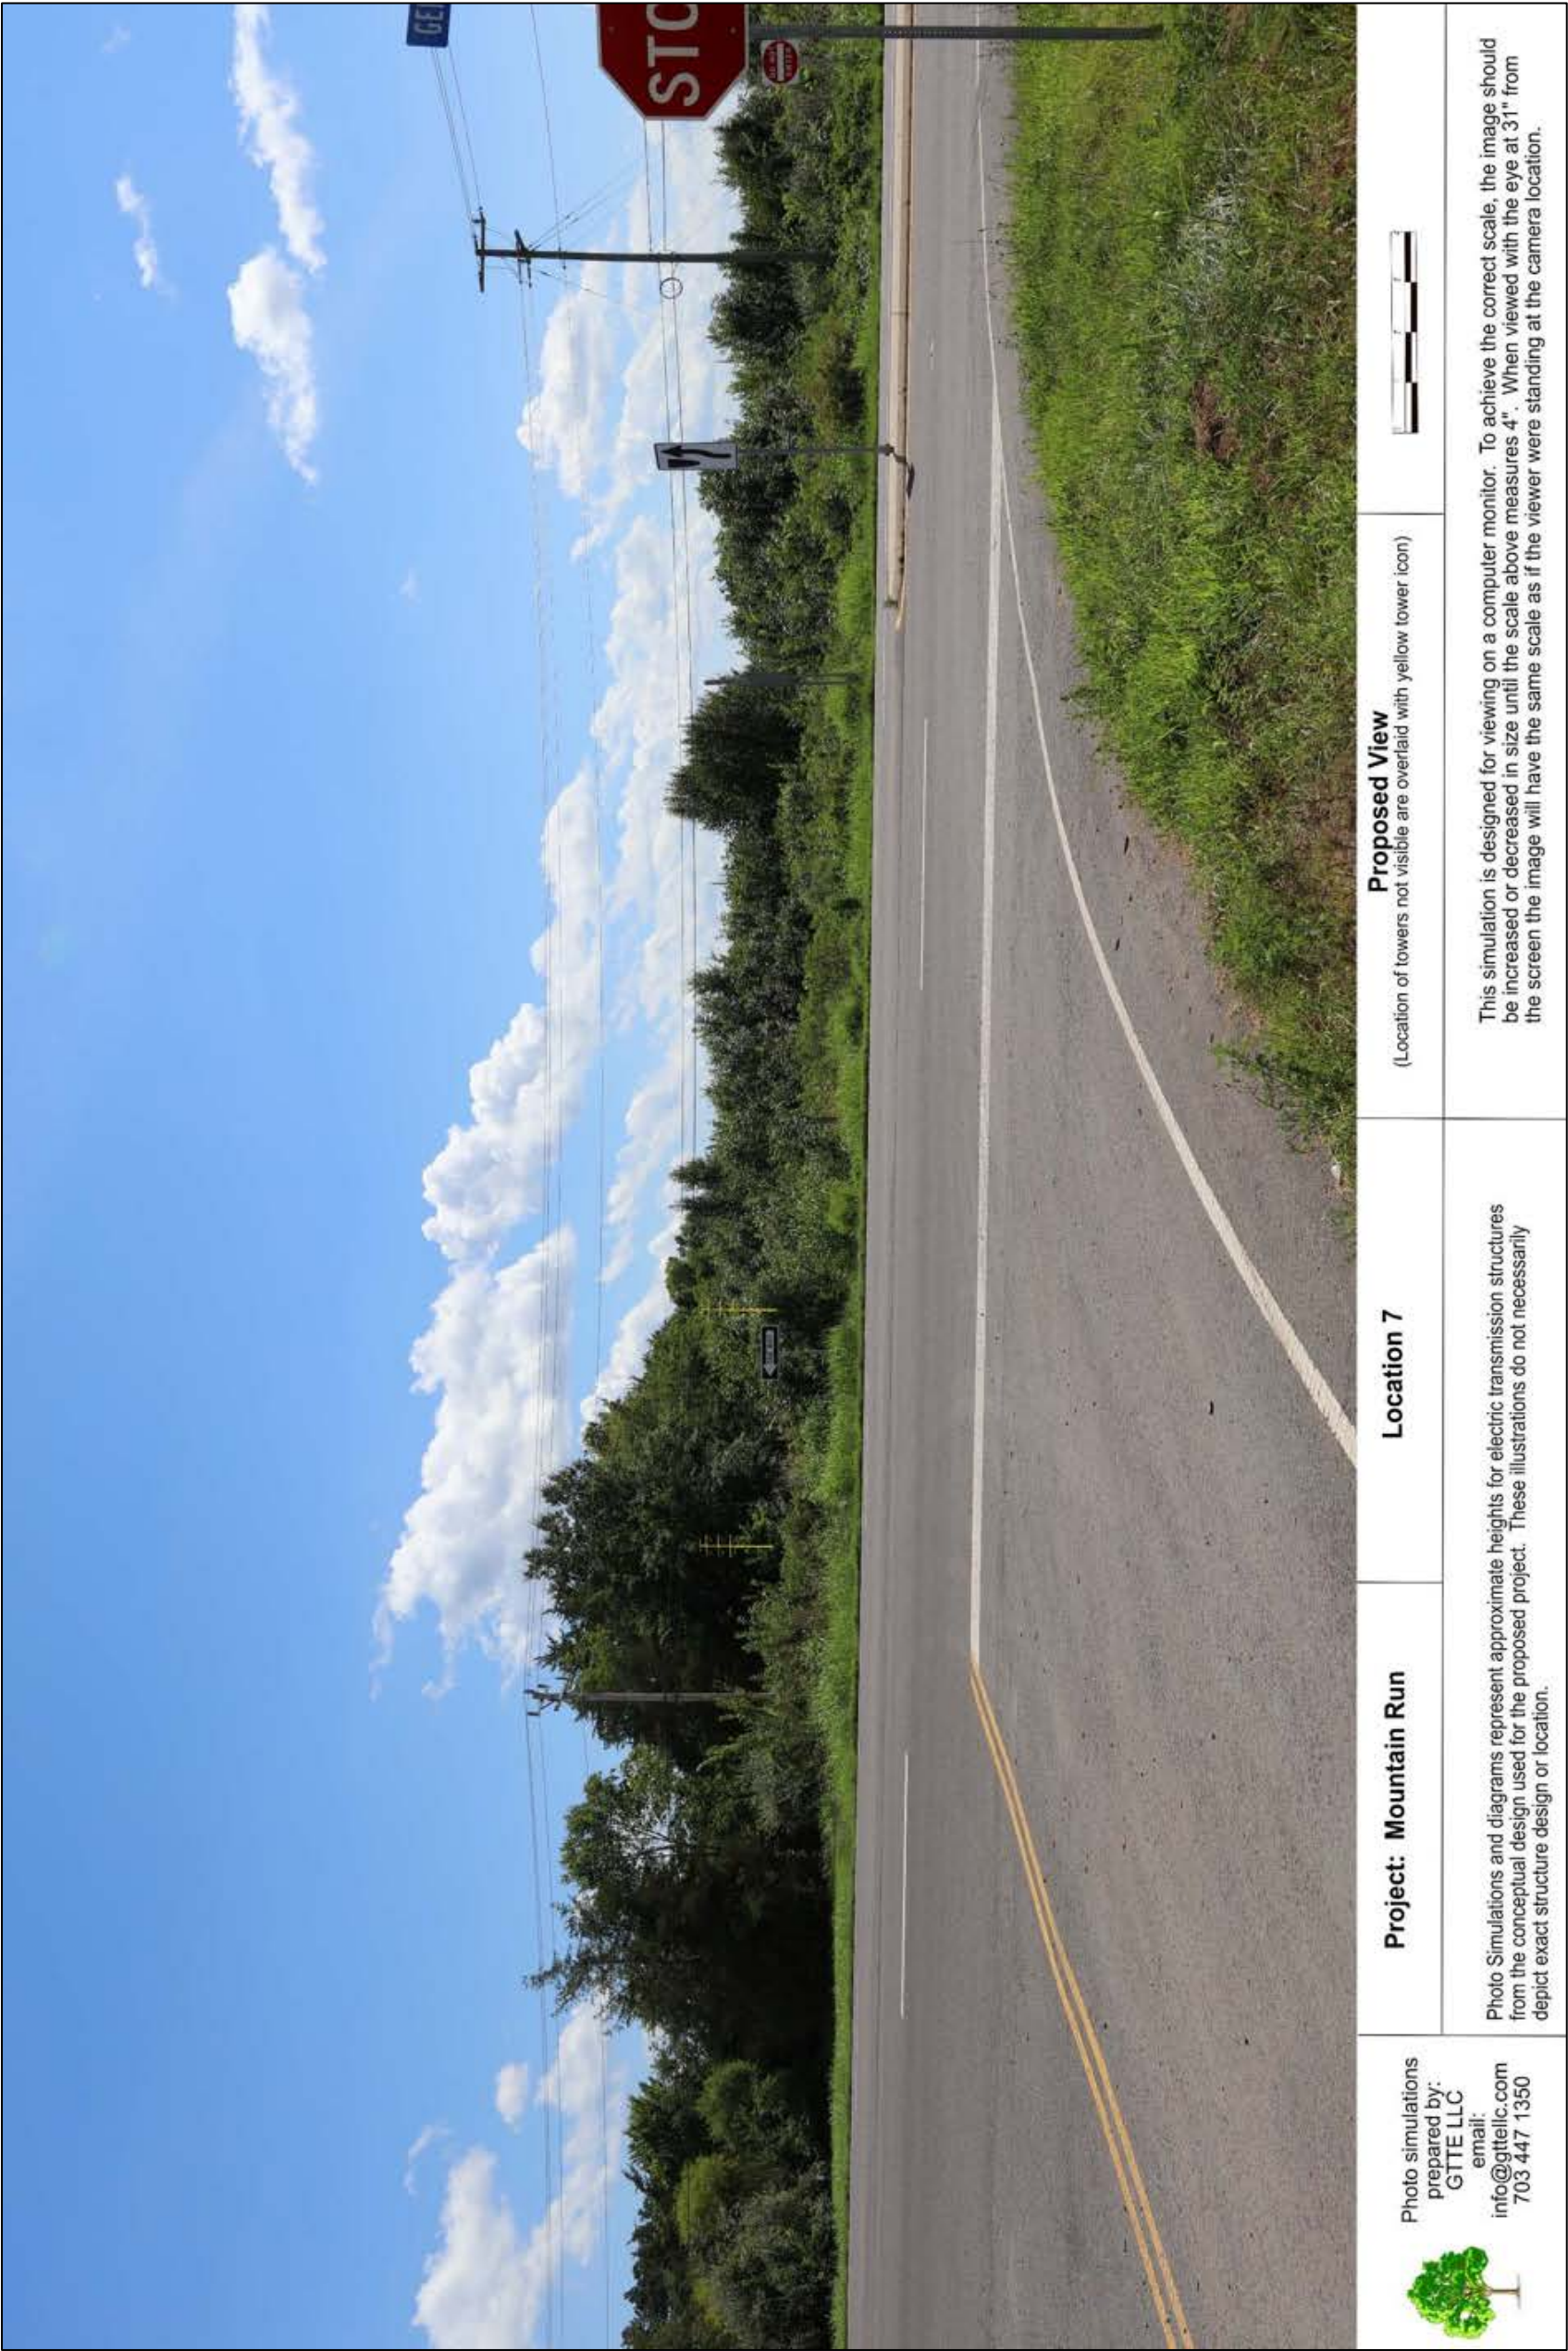
Figure 5-224: Zimmermann’s Tavern Simulation 2 – Proposed view from west edge of property along Route 3 – (Visible structures shown as they would appear. Structures not visible shown in yellow). Source: GTTE, LLC

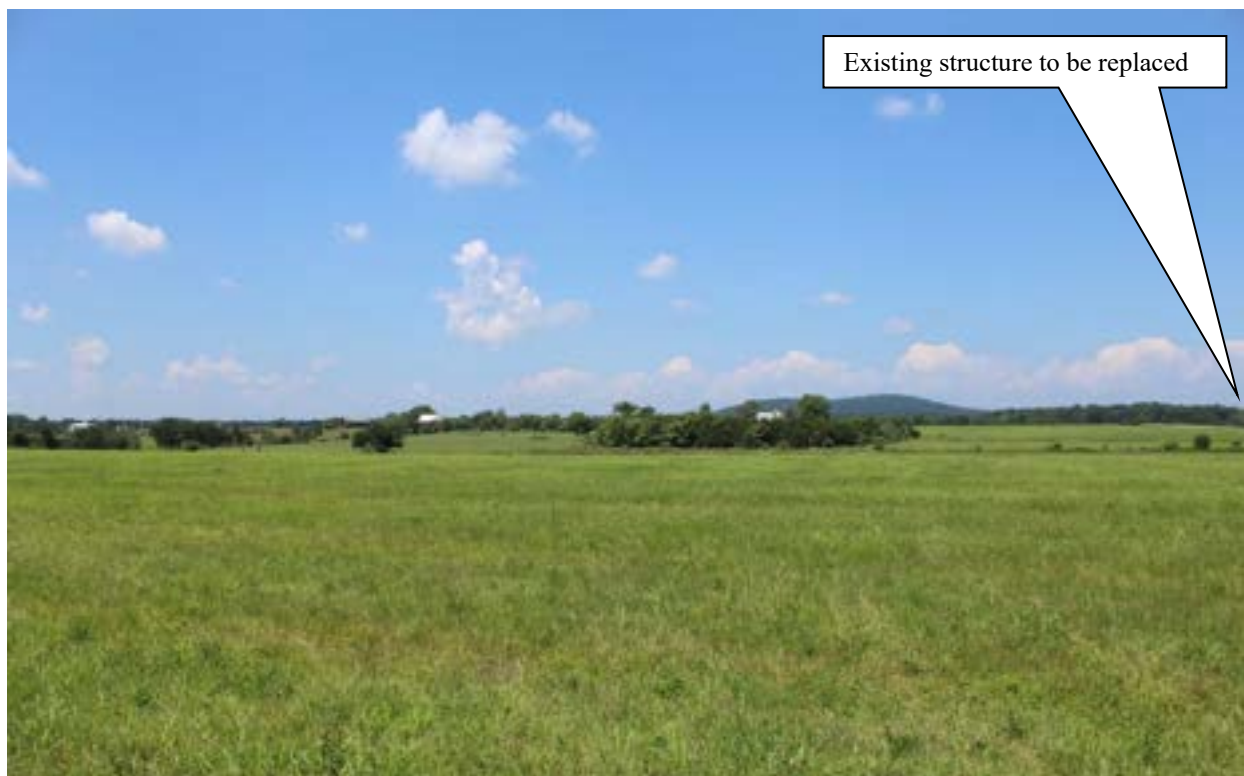
Figure 5-226: Photo location 1- View of property from Blackjack Road (existing project structure visible), facing south.

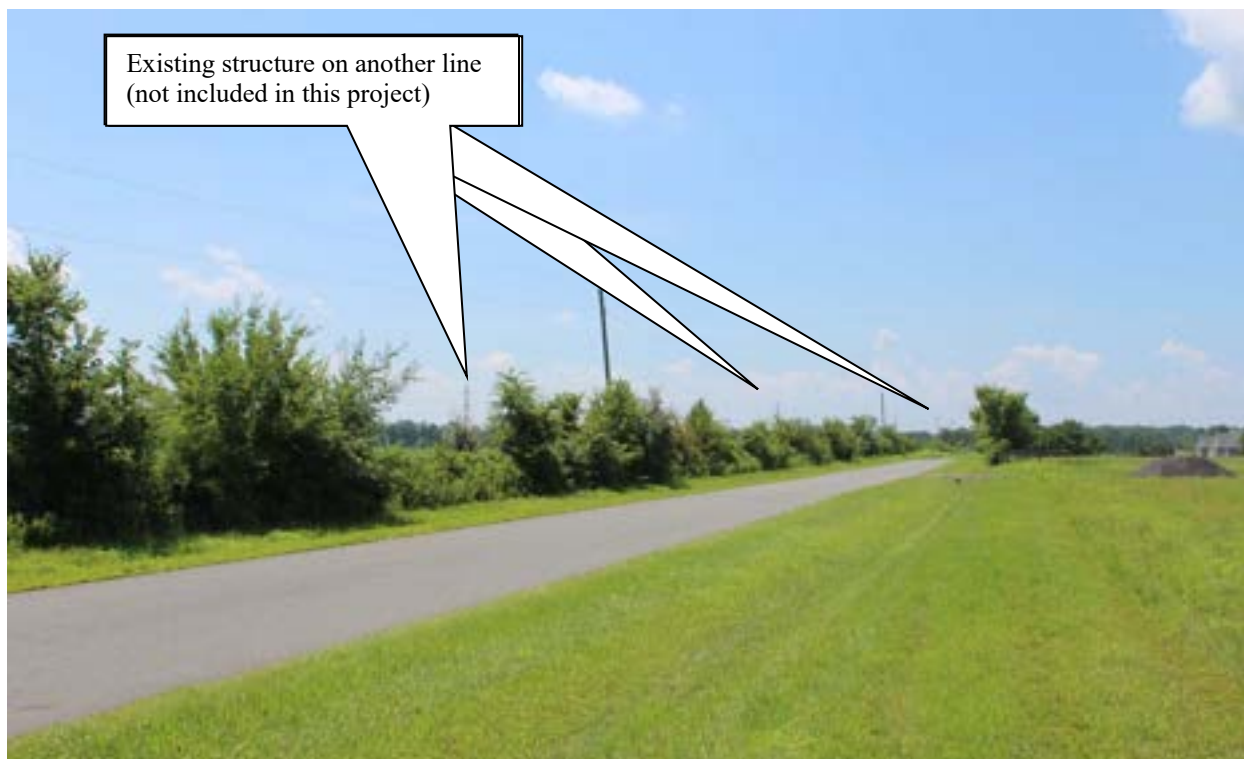
Figure 5-228: Photo location 3- View from edge of property along Blackjack Road (multiple project structures visible), facing northwest.

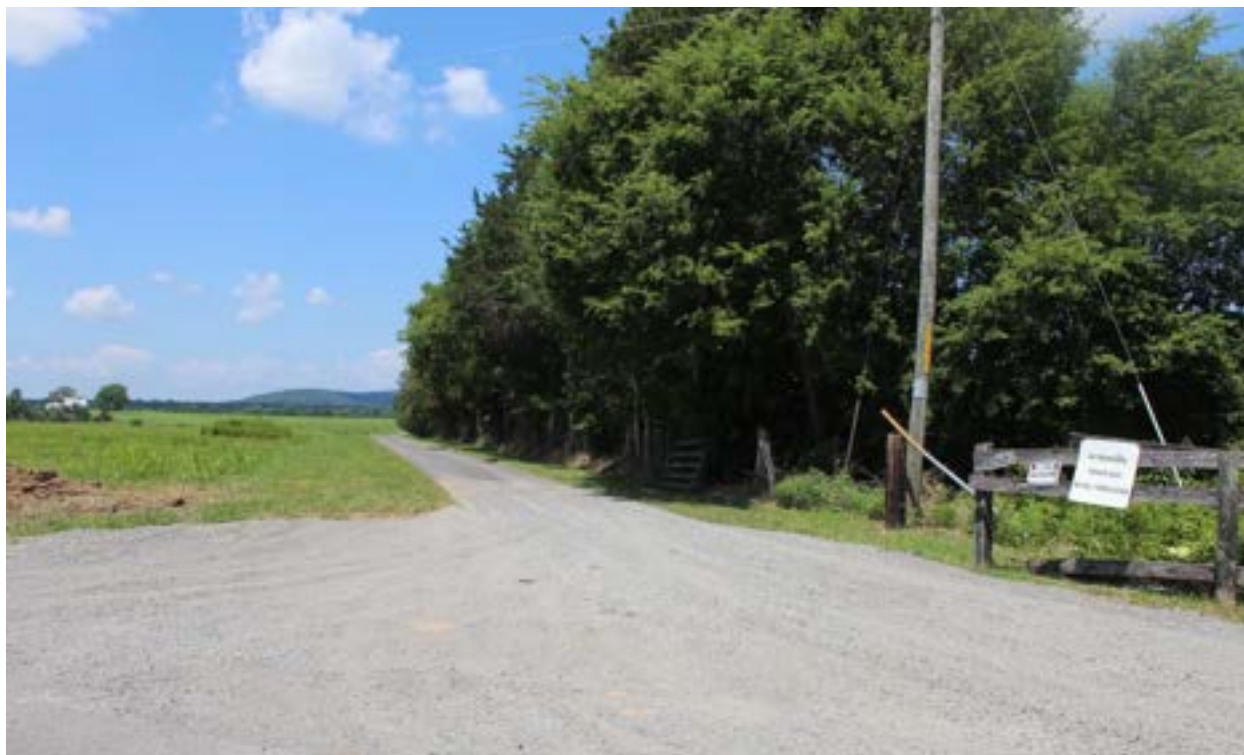
Figure 5-230: Photo location 5- View from intersection of Blackjack Road and Alvere Road (No structures visible), facing northwest.
