**Application, Appendix,
DEQ Supplement, Direct
Testimony and Exhibits of
Virginia Electric and Power
Company**

**Cirrus-Keyser 230 kV Loop and
Related Projects**

Case No. PUR-2022-00198

DEQ Supplement

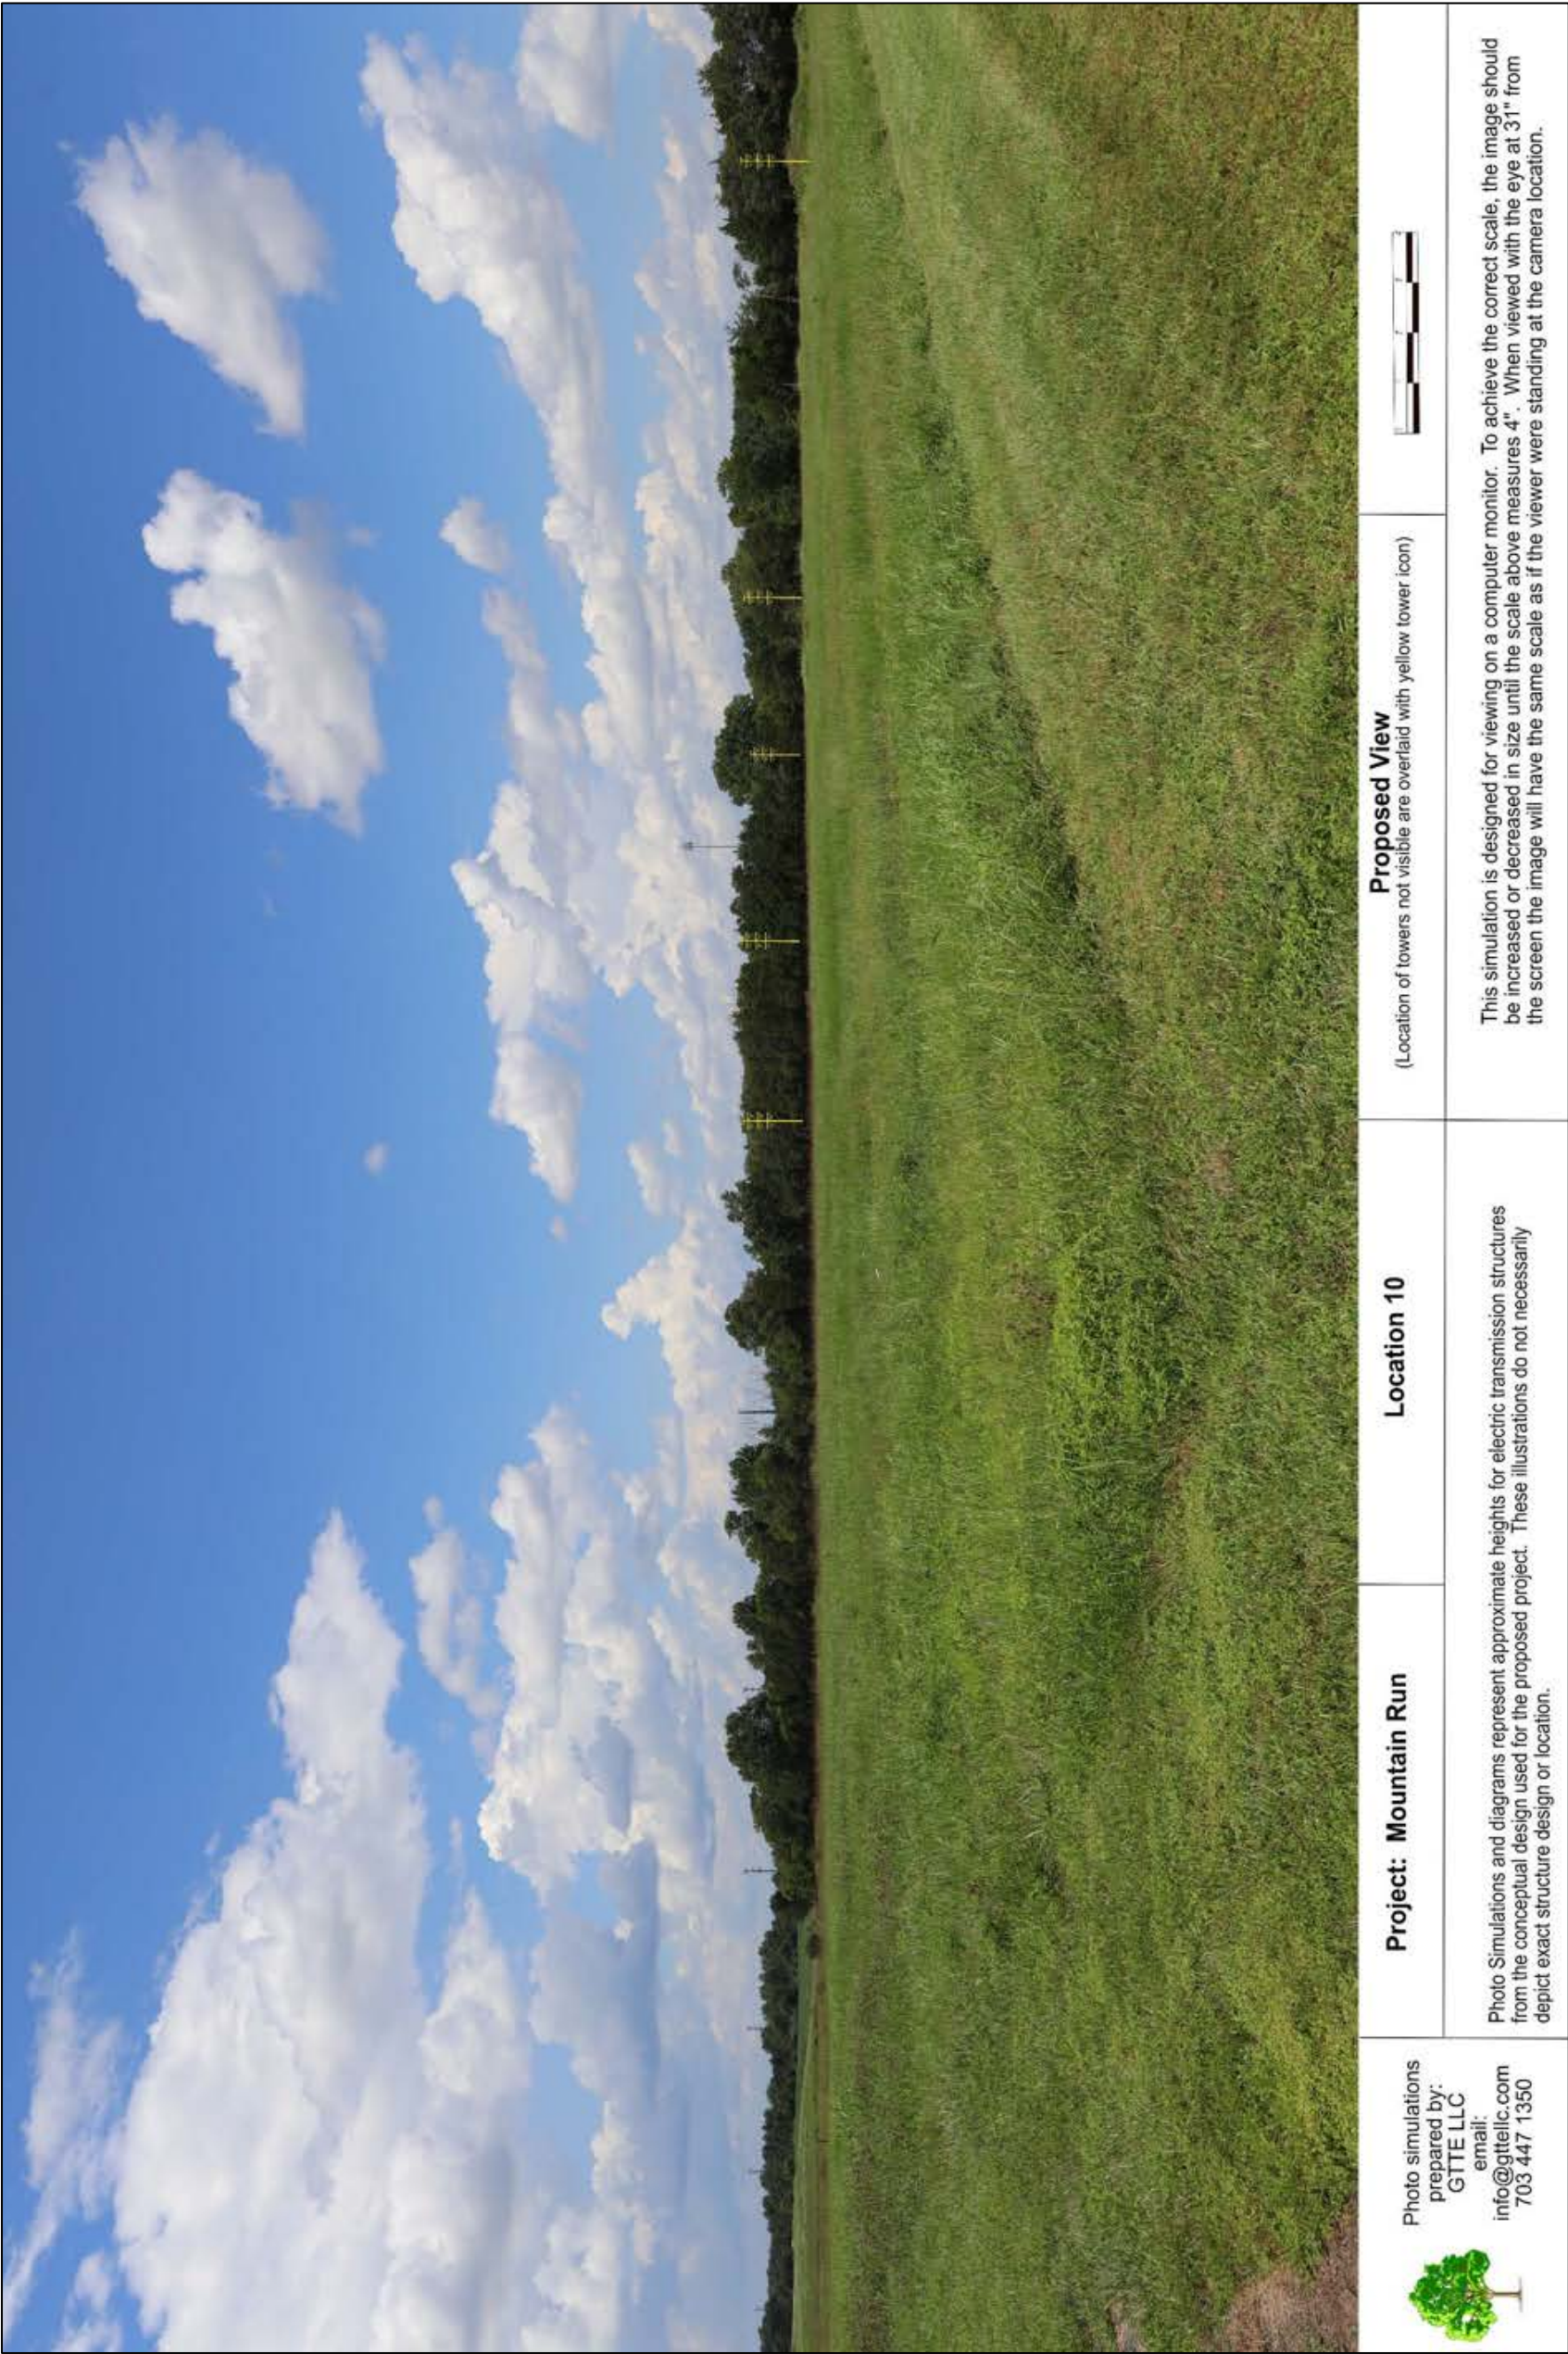
Figure 5-234: 19564 Alvere Road Simulation 1 – Proposed view from Blackjack Road – (Visible structures shown as they would appear. Structures not visible shown in yellow). Source: GTTE, LLC

The existing structures to be replaced as part of this project are each 80-feet in height and the proposed replacement structures will generally average 100-feet in height. As such, it is anticipated that the increase in structure height may be noticeable from both public ROW as well as the property, however, the views already include large portions of multiple existing structures, as well as a variety of other nonhistoric features and intrusions. While the visible project structures will rise higher above the intervening treeline, it is not anticipated that any new or additional structures not currently visible will become such. This was confirmed by photo simulation from public ROW bordering the property that shows currently visible structures will increase in height above the treeline while structures that are currently screened behind vegetation will remain as such, although all proposed structures will remain lower than an existing cellular communications tower visible in the same direction. Therefore, while the increase in height may be noticeable, however, it will be seen in conjunction with and amongst a wide variety of nonhistoric features. Further, the eligibility of this property has not been confirmed, and at this time is only being treated as potentially eligible due to insufficient data as a part of previous study. It is therefore D+A's opinion that the Cirrus – Keyser 230 kV Loop and Related Projects will pose no more than a *minimal impact* on the house at 19564 Alvere Road.
