HISTORY OF CONSTRUCTION

Bremo Power Station CCR Surface Impoundment: East Ash Pond

Submitted By: Golder Associates Inc.

April 2018

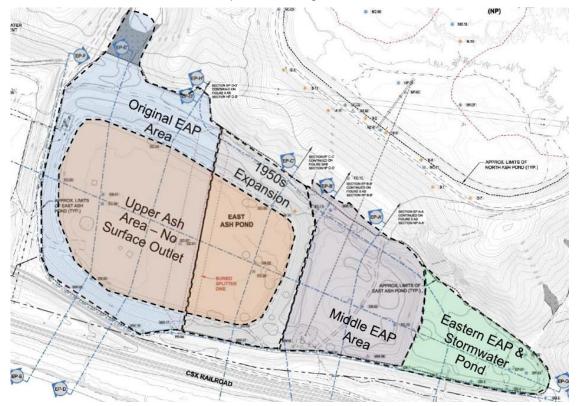
Figure 1: General Layout of the Historical East Ash Pond Construction

By about 1982, the EAP was largely filled to the dike crest elevation, with standing water in the eastern portion and ash mounded several feet above the dike elevation and covered by a thin soil cap in the western portion. Using ash to create an inner, upper level perimeter dike stepped in from the west and south dike, a 10-acre vertical expansion was constructed, raising the dike crest elevation to approximately 252 feet. The eastern portion of the EAP was dredged to elevation approximately 229 feet and a second splitter dike was constructed over the ash about 600 feet from the east end, dividing the area east of the vertical expansion into ash storage on the west and stormwater management on the east. A general layout of the historical EAP construction is provided in Figure 1 below.

In the late 1970's to early 1980's, ash was deposited up to the EAP dike crest elevation along the natural rising ground on the north side of the EAP, filling various drainage features, such as the future "Stump Pond" area and North Ash Pond dike area, with ash.

Within a few years of the EAP's vertical expansion, in the mid-1980s, the EAP was removed from service. The ash was covered with soil for closure. The eastern portion of the pond remained wet, allowing pass-through of drainage from the adjacent area to the north.

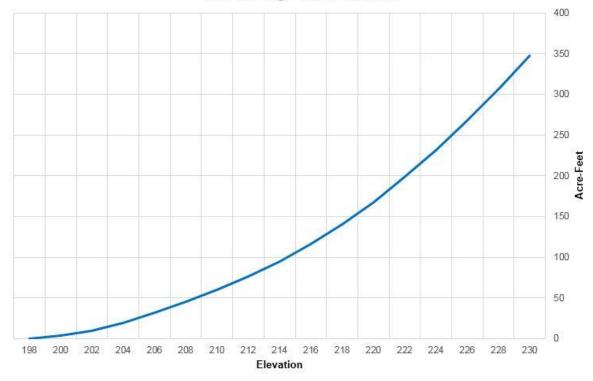
Figure 2: Stage-Storage Capacity Curve

Using the December 2017 aerial topographic survey, the available stage-storage capacity was computed from the top of the in-progress CCR excavation to the top of the embankment (elevation 230). The EAP stage-storage capacity data are provided in Table 3 and Figure 2, below.

Elevation	Area, square feet (sf)	Incremental Volume, cubic feet (ft³)	Incremental Volume, acre-feet (ac-ft)	Cumulative Volume, Ac-Ft
230	907,784	1,779,883	40.86	347.49
228	872,219	1,687,417	38.74	306.63
226	815,517	1,577,252	36.21	267.89
224	762,039	1,469,359	33.73	231.68
222	707,657	1,321,116	30.33	197.95
220	614,554	1,181,588	27.13	167.62
218	567,350	1,073,317	24.64	140.50
216	506,542	915,127	21.01	115.86
214	410,275	790,359	18.14	94.85
212	380,275	725,524	16.66	76.71
210	345,527	656,218	15.06	60.05
208	310,995	587,465	13.49	44.99
206	276,802	518,959	11.91	31.50
204	242,535	437,644	10.05	19.59
202	195,937	272,918	6.27	9.54
200	84,652	142,587	3.27	3.27
198	58,723	0	0	0

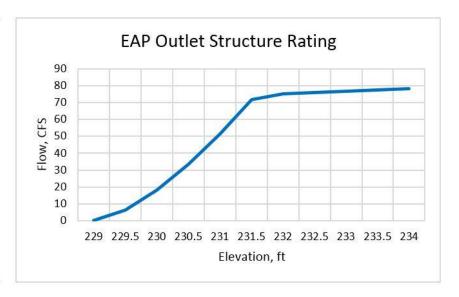
Figure 3: Riser Structure Rating

Elevation, ft	Structure Rating, CFS
229	0.00
229.5	6.42
230	18.15
230.5	33.34
231	51.34
231.5	71.74
232	75.10
232.5	75.90
233	76.70
233.5	77.40
234	78.20

Prior to closure activities, the primary spillway, an intake tower and 24-inch diameter reinforced concrete pipe, regulated the pool elevation in the eastern portion of the EAP. The intake tower, in the eastern end of the impoundment area, is constructed of concrete and regulated by concrete stop logs. The current lowest stoplog elevation is approximately 229.0. A 24-inch diameter pipe extends from the structure under the EAP dike to a drainage channel and ultimately through a permitted outfall. As of mid-2017, the EAP has been dewatered for closure activities and the 24-inch diameter pipe has been temporarily plugged to satisfy discharge permit requirements. Surface water and pore water within the EAP are pumped to the on-site CSWTS for treatment and discharge. There is no auxiliary spillway. The primary spillway capacity table and curve are shown in Figure 3 below. The analysis of the spillway capacity is included in Appendix B of the Inflow Design Flood Control System Plan.

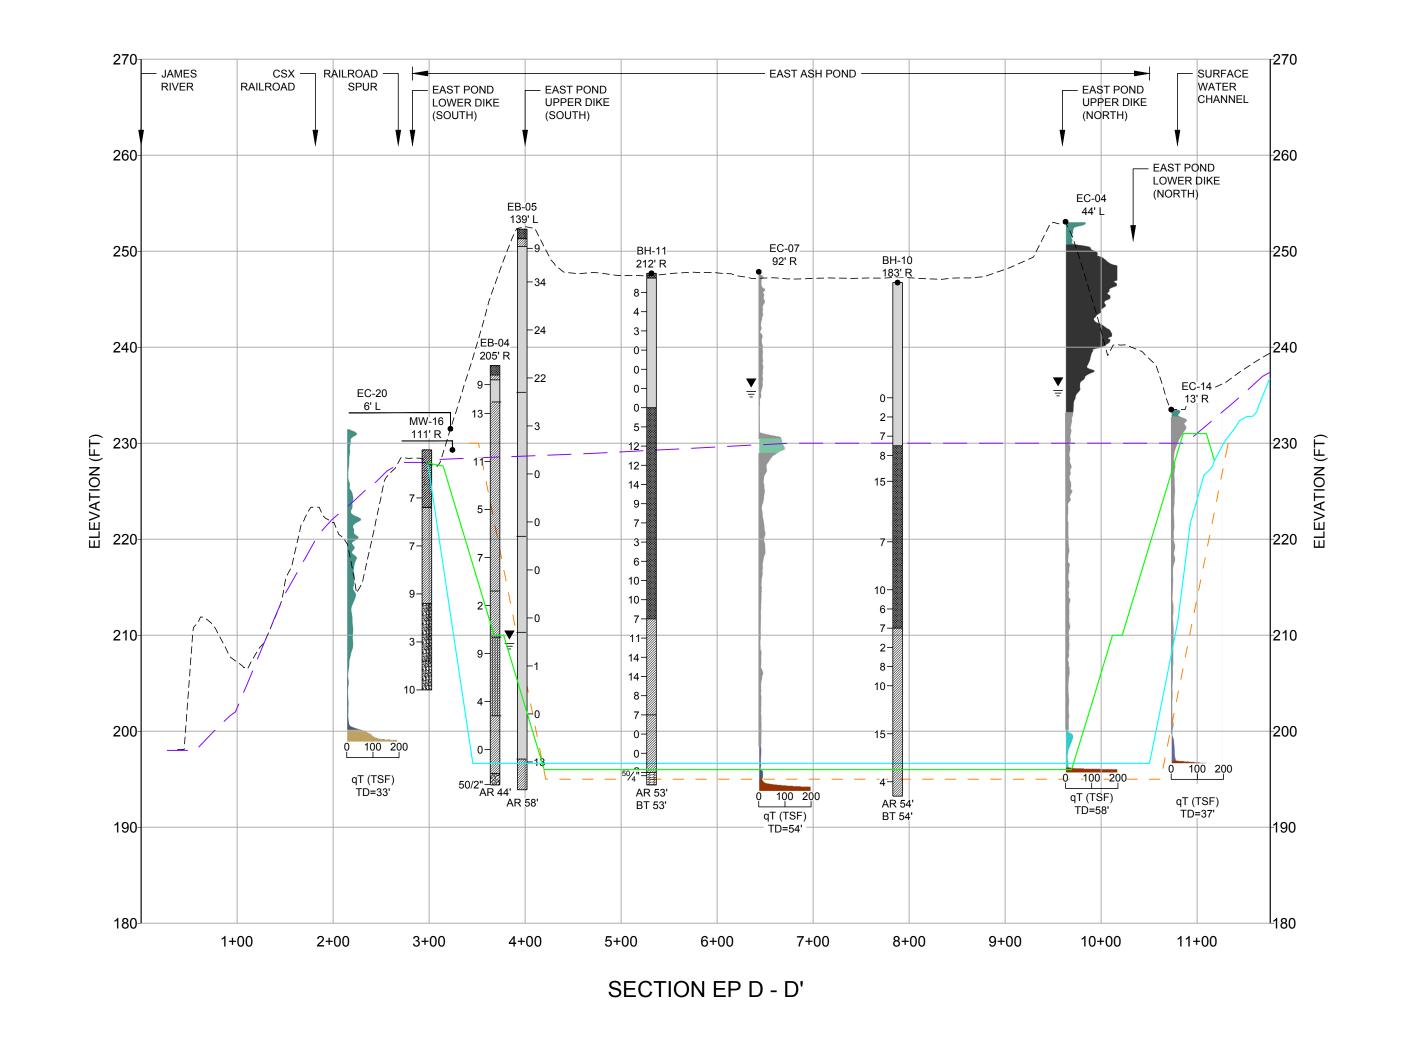
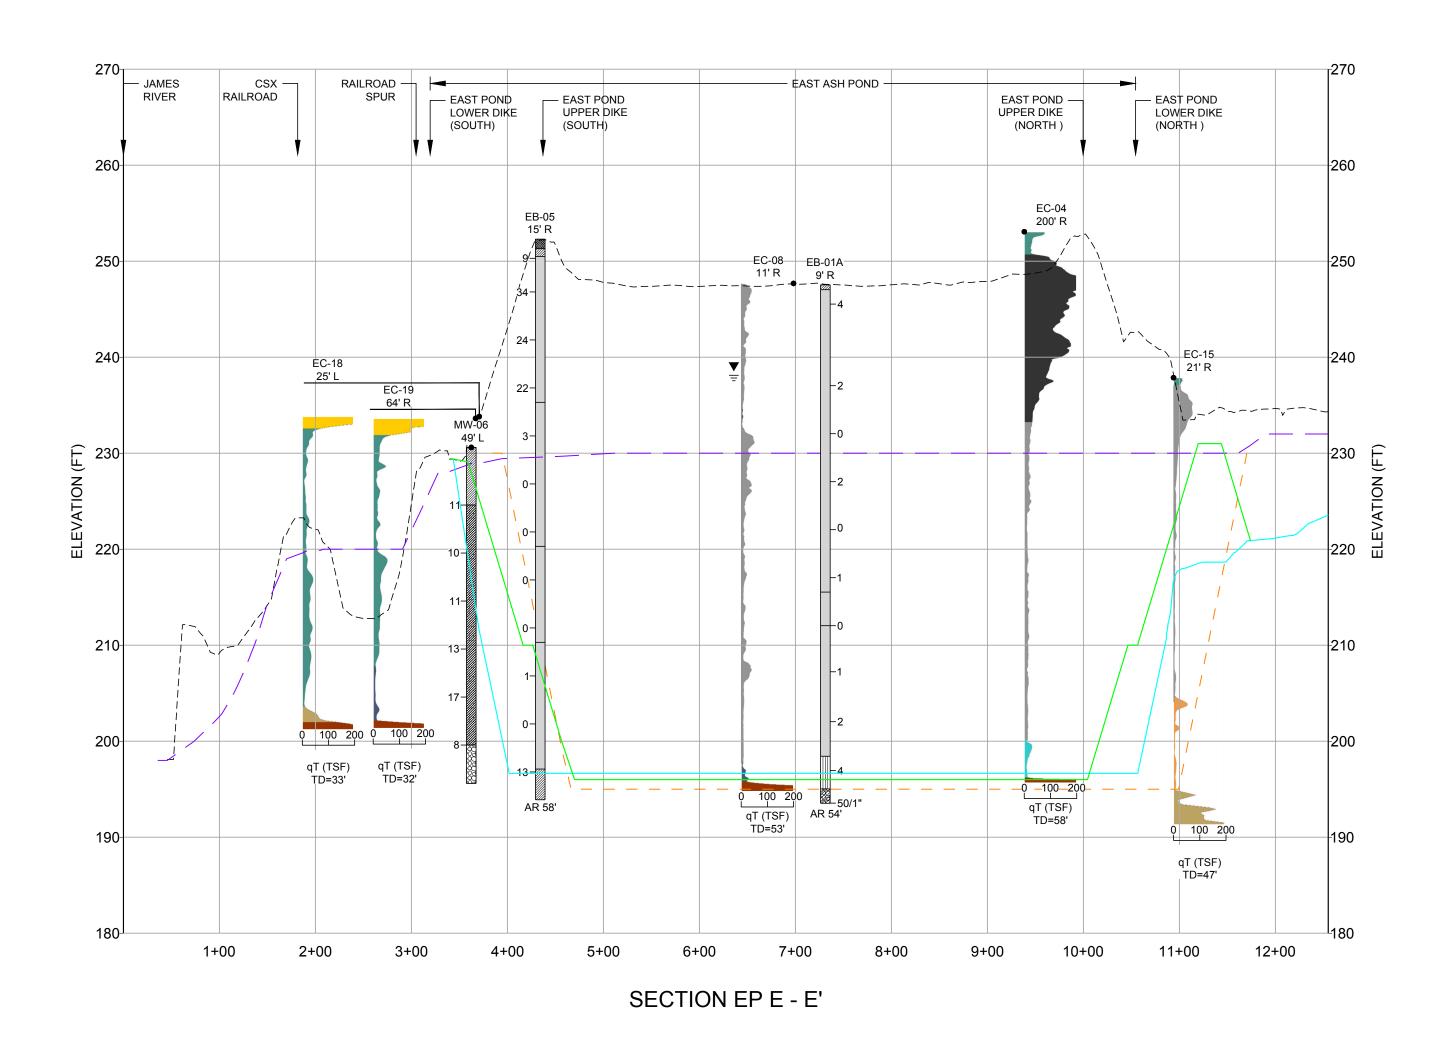
GEOTECHNICAL EXPLORATION SECTIONS (EAST POND 2 OF 4)

10X VERTICALLY EXAGGERATED
