Application, Appendix, DEQ Supplement, Direct Testimony and Exhibits of Virginia Electric and Power Company

Line #2011 230 kV Partial Rebuild Project

Application No. 323

DEQ Supplement

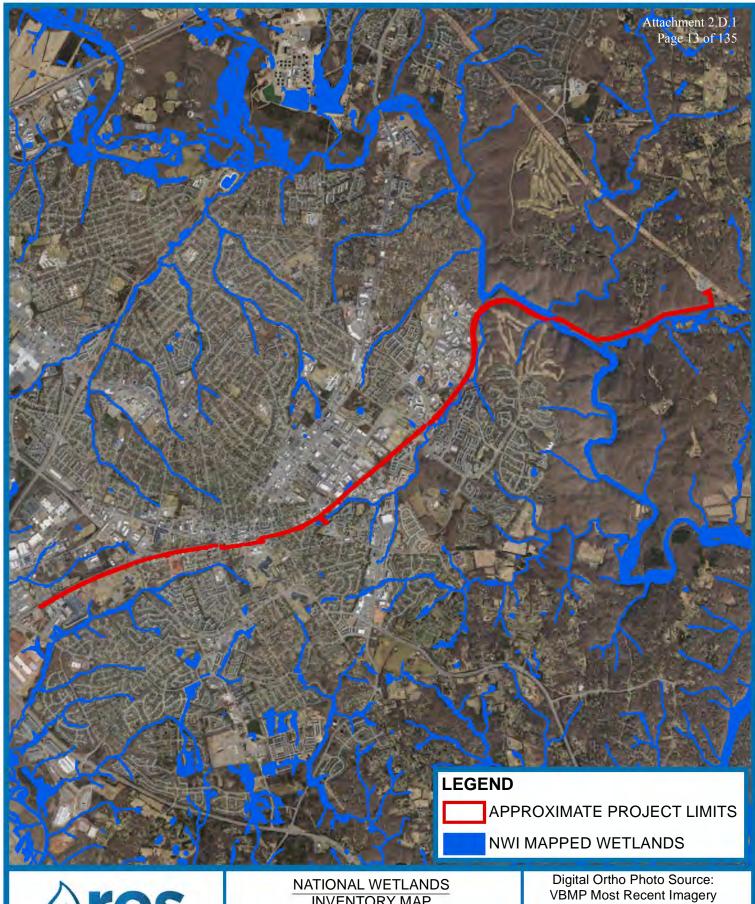
INVENTORY MAP

Virginia Lambert (VGIN) National Wetlands Inventory (NWI) Source http://www.fws.gov/

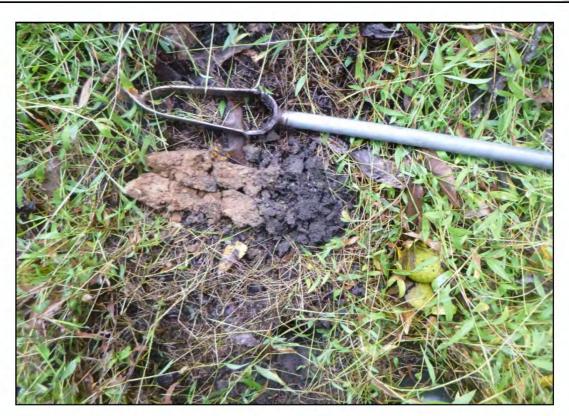
Photograph 1. Data Point 1 Soil

Profile De	-		=			or or confi	irm the absence of i	ndicators.)	
Depth	<u>Matri</u>		F	Redox Feat	ures				
(ln.)	Color (moist)		Color (moist)	<u>%</u>	Type ¹	Loc ²	Texture	Remarks	
0-3	10YR 2/1	100%					Gravelly Clay Loa	gravel/small co	bble
3-20	10YR 4/4	83%	10YR 6/6	10%	C	M	Gravelly Clay Loa		
			10YR 7/1	5%	D	M	Gravelly Clay Loa

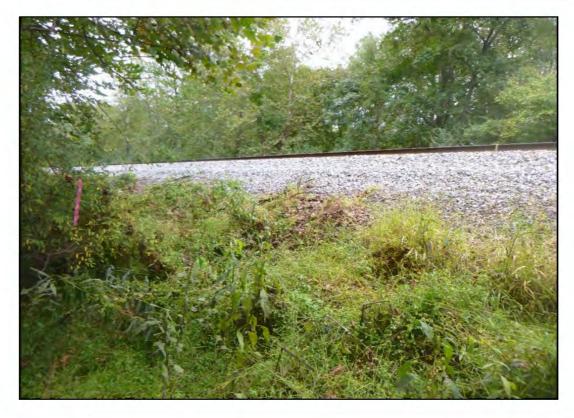
Photograph 2. Data Point 1 Vicinity

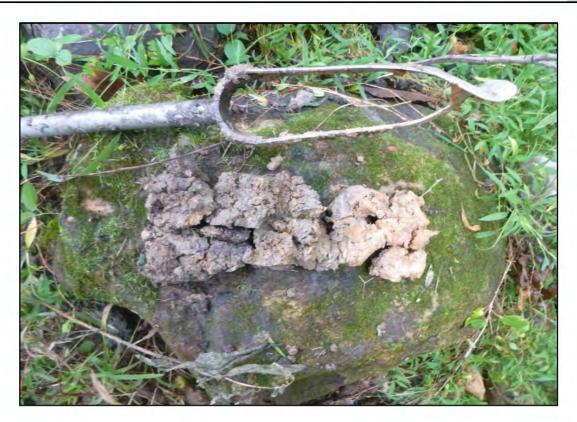
Photograph 1. Data Point 2 Soil

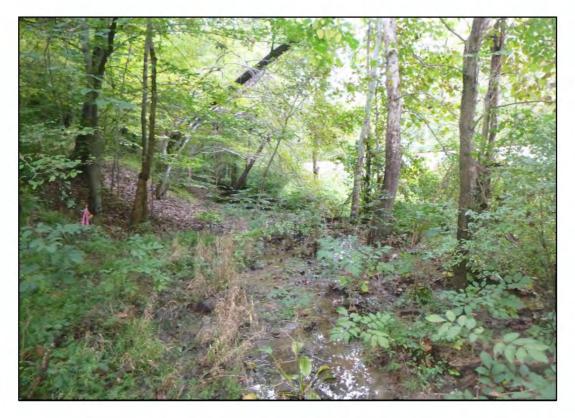
Photograph 2. Data Point 2 Vicinity

City/County: Clifton Sampling Date: 4-Oct-2022
Applicant/Owner: Dominion Energy	State: Virginia Sampling Point: DP-2
	Section, Township, Range: N/A
	cal relief (concave, convex, none) Concave Slope (%): 0
,	897362 Long: 38.778292 Datum: NAD 1983
Soil Map Unit Name: Cordus Silt Loam	NWI Classification: N/A
Are climatic/hydrologic conditions of the site typical for this time of the	
Are vegetation , soil , or hydrology	significantly disturbed? Are "normal circumstances" present? Yes
Are vegetation, soil, or hydrology	naturally problematic? (If needed, explain any answers in remarks)
SUMMARY OF FINDINGS – Attach site map showing s	ampling point locations, transects, important features, etc.
Hydrophytic vegetation present? Y	
Hydric soil present?	Is the sampled area within a wetland?
Indicators of wetland hydrology present?	
Remarks: (Explain alternative procedures here or in a separate repo	prt)
Data Point 2 is within a managed utility easement

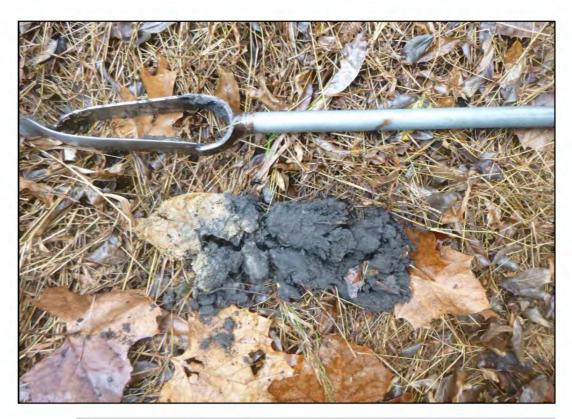
Photograph 1. Data Point 3 Soil

•			-		13)		er (explain in rema	iks)
	Sandy Mucky Mir			-	Masses (F	12)			
	(LRR N, MLR	-			LRA 136)			s of hydrophytic veg	
	Sandy Gleyed Ma				(F13) (MLR		ام ما ماس به مالم	ydrology must be pr or problematic.	esent, unless
	Sandy Redox (S5		Piedmo	nt Floodp	olain Soils (F	19) (MLR	A 148) disturbed	or problematic.	
	Stripped Matrix (S	S6)							
	e Layer (if observ	-							
Type:	Compacted grave	el					Hydric	Soil Present?	N
Depth (inc	:hes): 10"								
Remarks:

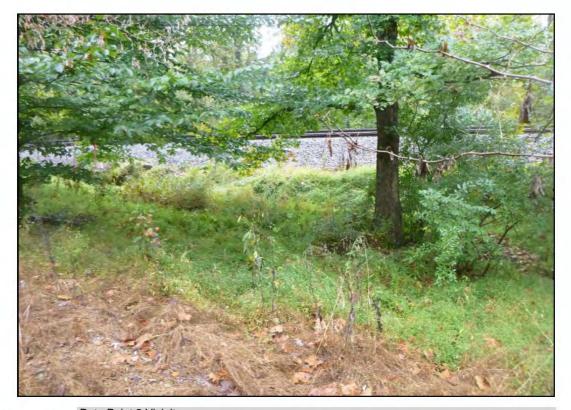
Photograph 2. Data Point 3 Vicinity

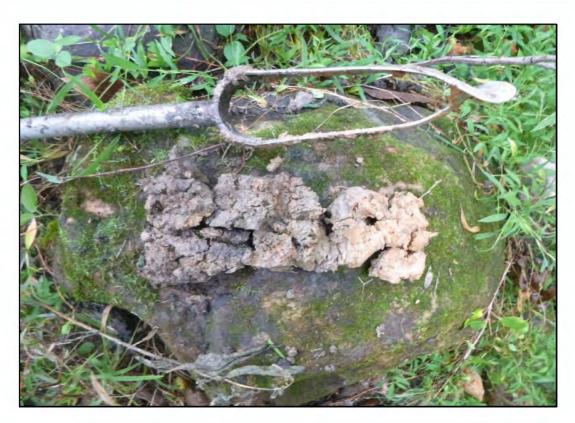
Photograph 1. Data Point 4 Soil

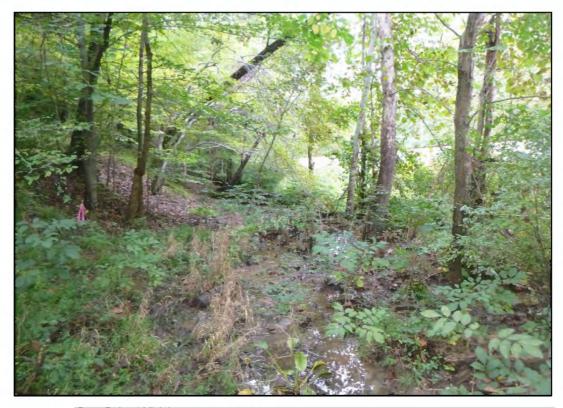
Photograph 2. Data Point 4 Vicinity

Project/Site: Line #2011 Cannon Branch to C		County: Clifton		Sampling Date: 5-Oct-2022
	City/	· <u> </u>		Sampling Date: 5-Oct-2022
Applicant/Owner: Dominion Energy	-	State: Virginia		Bampling Point. DP-4
Investigator(s): Graham Shell and Katie Ratcliffe		Section, Township,		Slope (%): 3-5%
Landform (hillslope, terrace, etc.): Hillside		relief (concave, convex	· · · · · ·	
Subregion (LRR or MLRA): MLRA 136	Lat:77.4023			Datum: NAD 1983
Soil Map Unit Name: Wheaton-Codorus complex			ication: None	
Are climatic/hydrologic conditions of the site typica			(If no, explain i	·
		gnificantly disturbed?		cumstances" present? Yes
Are vegetation, soil, c	r hydrology na	turally problematic?	(If needed, exp	lain any answers in remarks)
SUMMARY OF FINDINGS – Attach site n	nap showing sam	pling point location	ons, transect	s, important features, etc.
Hydrophytic vegetation present?	Y			
Hydric soil present?	Y	Is the sampled	area within a w	etland? Y

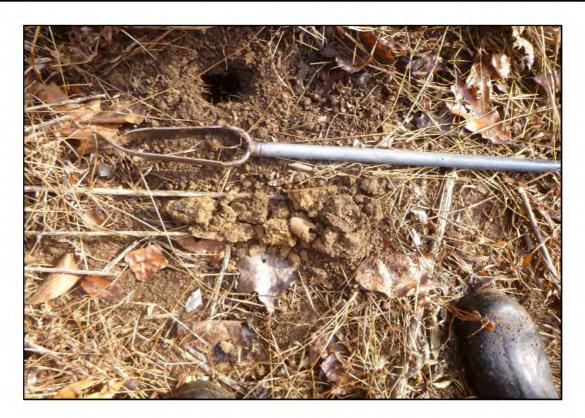
Photograph 1. DP-5 Soil

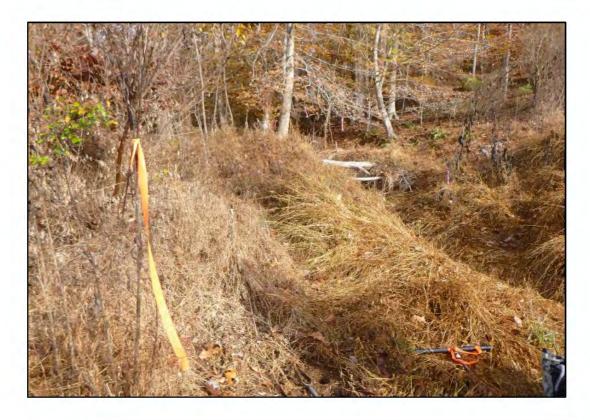
Photograph 2. DP-5 Vicinity

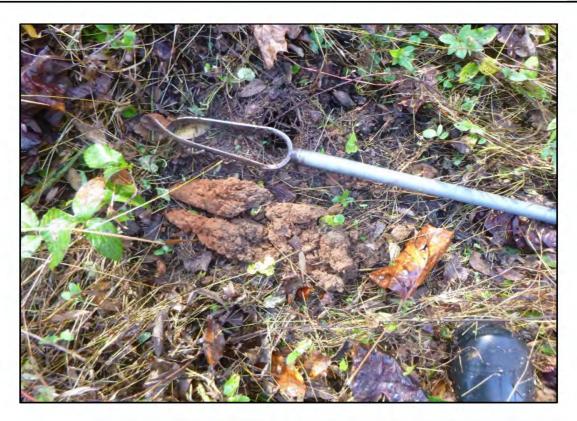
Photograph 1. Data Point 6 Soil

Profile De Depth	escription: (Describe to th Matrix		ocument tedox Feat		or or confi	rm the absence o	f indicators.)	
(In.)	Color (moist) %	Color (moist)	%	Type ¹	Loc ²	Texture	Remarks	
0-4	10YR 5/3 90%	10YR 5/6	2%	С	M	Clay Loam	Gravel inclusion	ne
4-9	7.5YR 6/8 100%	10110 3/0				Clay Loam	Gravel inclusion	
9	7.511(0/0 100/0					Clay Loan	Restrictive layer	
							- Restrictive layer	71

(LRR N, MLRA 147, 14		RR N, MI	-			rs of hydrophytic veg	
	Sandy Gleyed Matrix (S4)			F13) (MLR		۔ حاسب باعدالہ	nydrology must be pr	esent, unless
	Sandy Redox (S5)	Piedmo	ont Floodp	lain Soils (F	19) (MLR	A 148) disturbed	d or problematic.	
	Stripped Matrix (S6)							
Restrictiv	e Layer (if observed):							
Type:	Compacted gravel from adj	acent railraod				Hydric	Soil Present?	N
Depth (inc	ches): 9"

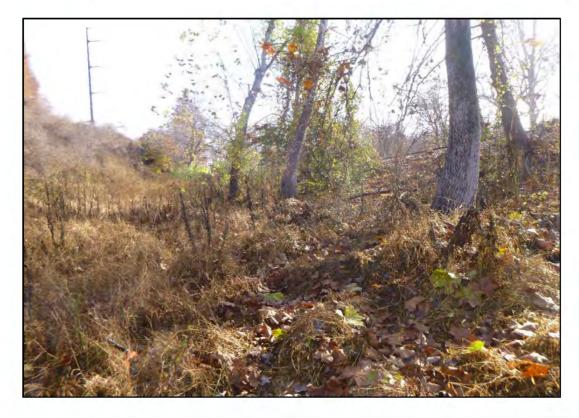
Photograph 2. Data Point 6 Vicinity

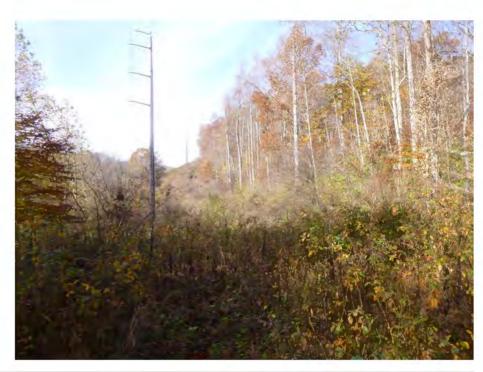
Photograph 1. Data Point 7 Vicinity

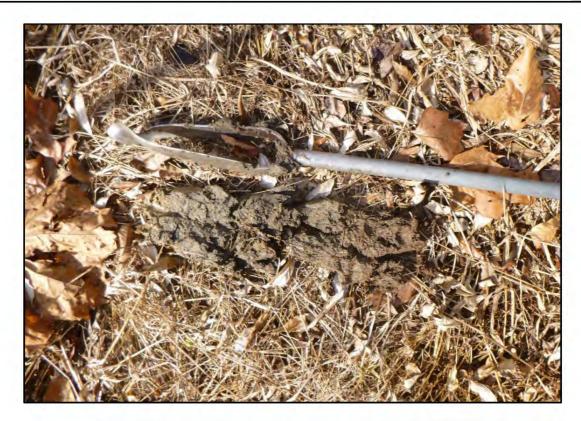
Photograph 1. Data Point 8 Soil

(ln.)	Matrix	<		Redox Feat	ures				
	Color (moist)	%	Color (mois	it) %	Type ¹	Loc ²	Texture	Remarks	
·2	10YR 4/2	95%	10YR 4/4	5%	C	M	Gravel Clay Loan		
·16	10YR 4/1	97%	2.5Y 4/3	3%	C	M	Silty Clay Loam	Soil had a mud	cky texture.
6-20	10YR 4/1	88%	2.5Y 5/4	10%	C	M	Loamy Clay

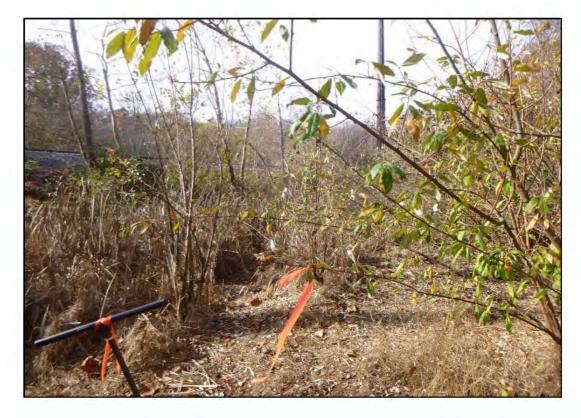
Photograph 2. Data Point 8 Vicinity

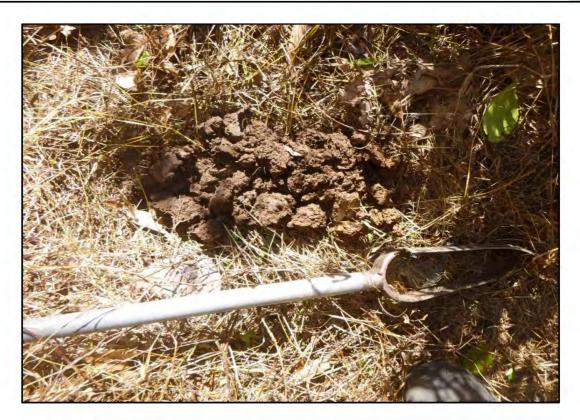
Photograph 1. Data Point 9 Soil

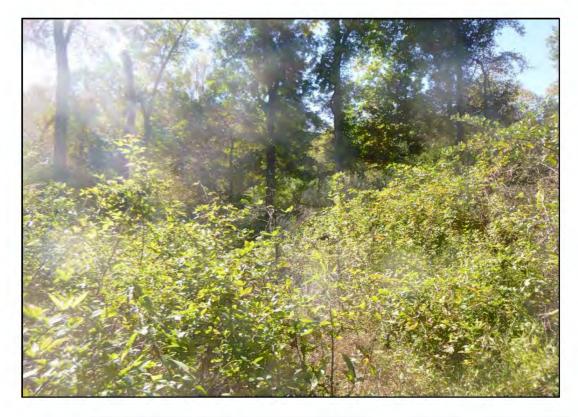
Photograph 2. Data Point 9 Vicinity

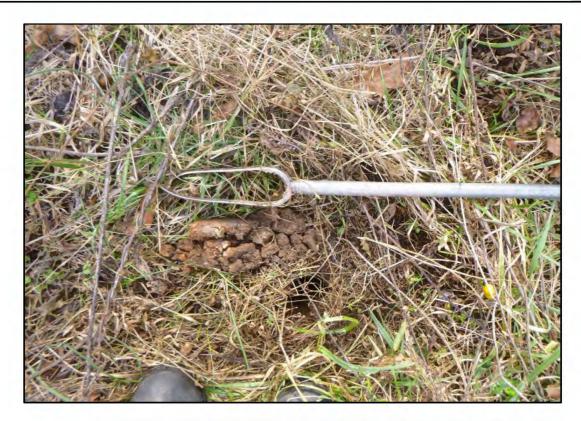
Photograph 1. Data Point 10 Soil

Profile De	escription: (Describe to the de	=			or or confi	rm the absence of	indicators.)	
Depth	Matrix	Red	dox Fea	tures				
(ln.)	Color (moist) %	Color (moist)	%	Type ¹	Loc ²	Texture	Remarks	
0-4	10YR 5/3 98%	10YR 5/6	2%	С	М	Gravel Clay Loan		
4-8	7.5YR 4/6 100%						*restrictive laye	er at 8"

-	Redox D	-		2)	Ouie	er (explain in rema	iiks)
	Sandy Mucky Mineral (S1)		_	Masses (F1	2)			
	(LRR N, MLRA 147, 148)	=		LRA 136)			of hydrophytic veg	
	Sandy Gleyed Matrix (S4)			(F13) (MLR		بالمصاسينة مثلم	drology must be pror problematic.	resent, unless
	Sandy Redox (S5)	Piedmon	t Floodp	olain Soils (F	19) (MLRA	A 148)	or problematio.	
	Stripped Matrix (S6)							
	ve Layer (if observed):							
Type:	Compacted gravel from adjace	nt railroad				Hydric	Soil Present?	N
Depth (inc	ches): 8"							
Remarks:

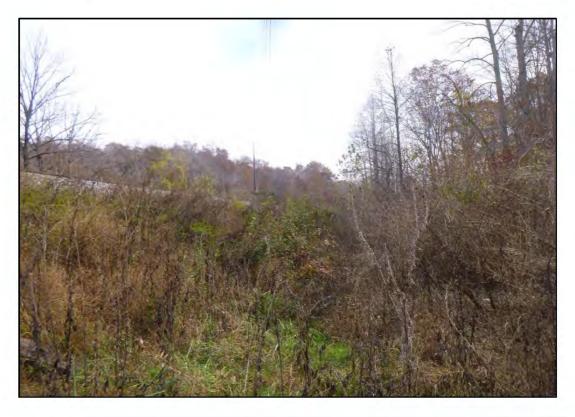
Photograph 2. Data Point 10 Vicinity

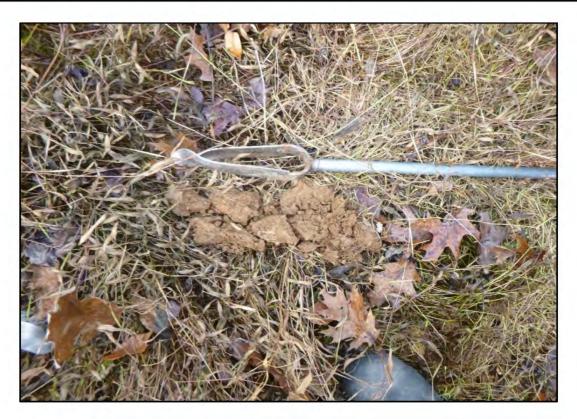
Photograph 1. Data Point 11 Soil

Depth (In.)	Matrix		edox Feat		0. 00111	irm the absence		
(111.)	Color (moist) %	Color (moist)	%	Type ¹	Loc ²	Texture	Remarks	
)-18	10YR 4/4 87%	7.5YR 4/6	10%	<u> </u>		Clay Loam	gravel inclusions	 S

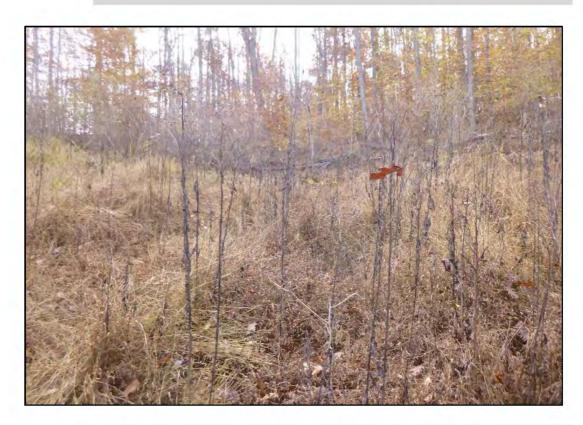
Photograph 2. Data Point 11 Vicinity

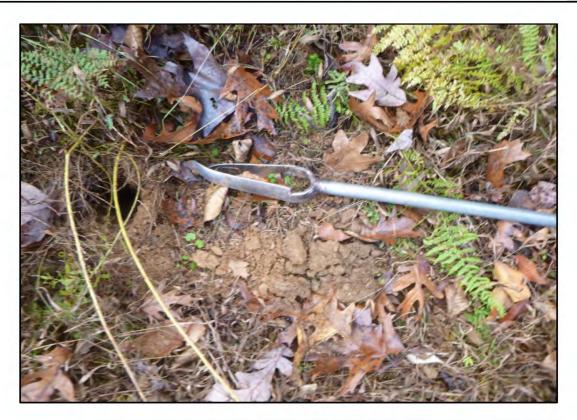
Photograph 1. Data Point 12 Soil

I Jenin	Matrix		edox Feat			irm the absence of	a.catoro.,	
Depth (In.)	Color (moist) %	Color (moist)	%	Type ¹	Loc ²	Texture	Remarks	
0-6	10YR 4/4 100%			1,700		Clay Loam	Gravel inclusion	ns
6-20	10YR 5/6 100%					Clay Loam	Gravel inclusion

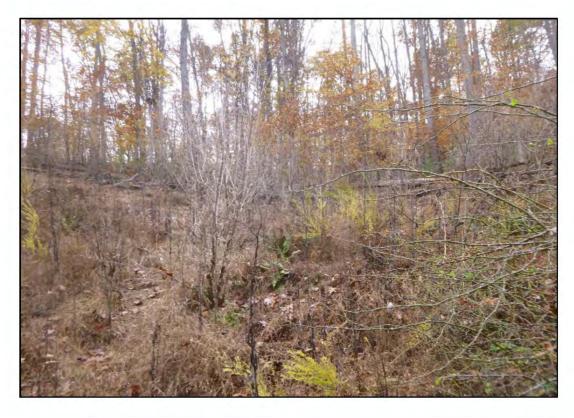
Photograph 2. Data Point1 2 Vicinity

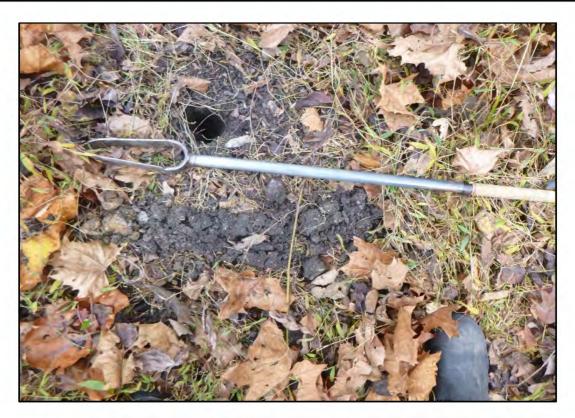
The soil	had mica and g	ravel inclus	ions throughout.

Photograph 1. Data Point 13 Soil

Profile De	escription: (Desc	ribe to the d	epth needed to do	cument	the indicato	r or confi	irm the a	bsence of i	indicators.)	
Depth	Matrix	X	Re	edox Feat	tures					
(ln.)	Color (moist)	%	Color (moist)	%	Type ¹	Loc ²	Texture		Remarks	
0-18	10YR 2/1	100%					Loam			
18-20	10YR 4/1	95%	10YR 5/8	5%	С	M	Gravely	Loam

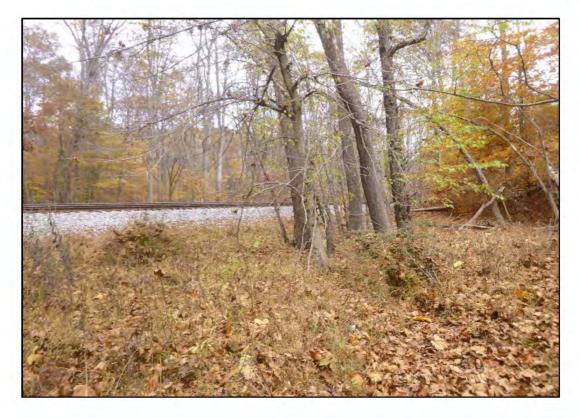
Photograph 2. Data Point 13 Vicinity

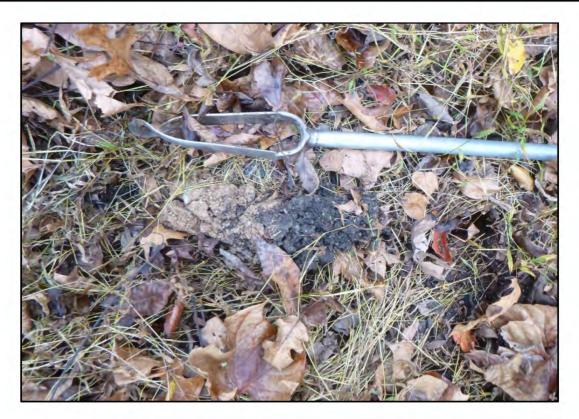
Photograph 1. Data Point 14 Soil

-		depth needed to do			or or confi	irm the absen	ce of indicators.)	
Depth	Matri			edox Feat					
(ln.)	Color (moist)	<u>%</u>	Color (moist)	%	Type ¹	Loc ²	Texture	Remarks	
0-9	10YR 2/1	100%					Gravely Loar		
9-20	10YR 5/4	97%	7.5YR 4/6	3%	C	M	Gravely Loar	<u> </u>	
¹ Type: C :	= Concentration, D	= Depletion	, RM = Reduced Ma	trix, MS =	= Masked Sa	and Grains	s. ² Location	n: PL = Pore Lining, I	M = Matrix
	oil Indicators:							s for Problematic H	
	Histisol (A1)		Dark Su	urface (S7	7)			2cm Muck (A10) (N	=
	– Histic Epipedon (A2)			Surface (S8	3) (MLRA '	147. 148)	Coast Prairie Redo	
	Black Histic (A3)	,			ce (S9) (MLF	, ,	· · · · · · · · · · · · · · · · · · ·	(MLRA 147, 14	
	Hydrogen Sulfide	e (A4)			latrix (F2)	, 17	,	Piedmont Floodplai	
	Stratified Layers			ed Matrix ((MLRA 136, 14	
	2 cm Muck (A10)			Dark Surf	` ,			Red Parent Materia	-
	Depleted Below I	-			urface (F7)		-	Very Shallow Dark	` '

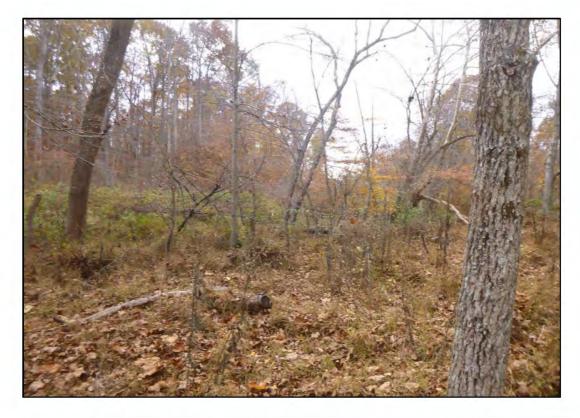
Photograph 2. Data Point 14 Vicinity

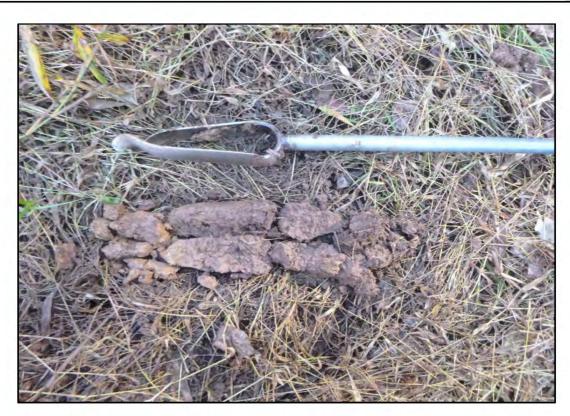
Photograph 1. Data Point 15 Soil

Depth	Matri	х	Re	dox Feat	tures				
(ln.)	Color (moist)	%	Color (moist)	%	Type ¹	Loc ²	Texture	Remarks	
)-8	5YR 4/3	100%					Silty Clay Loam		
-20	5YR 4/3	85%	7.5YR 5/6	15%	С	M	Silty Clay Loam		
Гуре: С =	Concentration, D	Depletion, I	RM = Reduced Mat	rix, MS =	= Masked S	and Grains	² Location: PL	= Pore Lining, M	= Matrix
ydric So	il Indicators:						Indicators for	Problematic Hye	dric Soils³:
	Histisol (A1)		Dark Su	rface (S7	7)		2cm	Muck (A10) (ML	RA 147)
	Histic Epipedon ((A2)	Polyvalu	ie Below	Surface (St	B) (MLRA 1	147, 148) Coa	st Prairie Redox	(A16)
	Black Histic (A3)		Thin Da	rk Surfac	e (S9) (ML I	RA 147, 14	88)	(MLRA 147, 148)	
	Hydrogen Sulfide	e (A4)	Loamy (Gleyed M	latrix (F2)		Pied	dmont Floodplain	Soils (F19)
	Stratified Layers	(A5)	Depleted	d Matrix ((F3)			(MLRA 136, 147)	
	2 cm Muck (A10)	(LRR N)	Redox D	Oark Surfa	ace (F6)		X Red	Parent Material	(TF2)
	Depleted Below I	Dark Surface (A11) Depleted	d Dark Sı	urface (F7)		Very	y Shallow Dark S	urface (TF12)

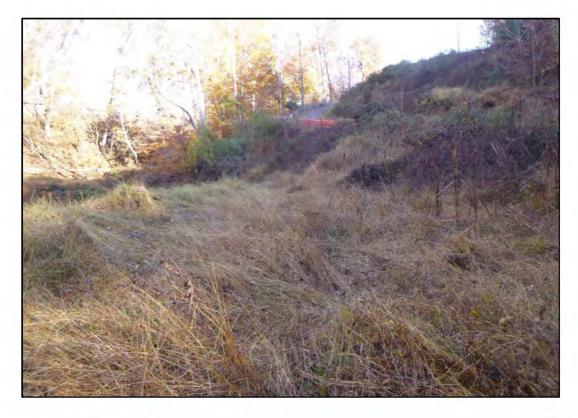
Photograph 2. Data Point 15 Vicinity

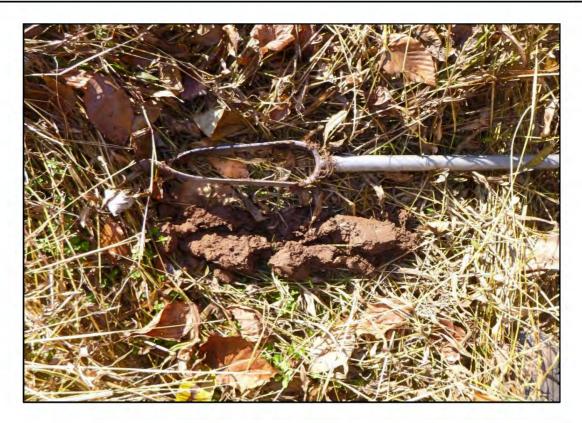
Photograph 1. Data Point 16 Soil

Pescription: (Describe to the dep Matrix		dox Fea		or or confi	irm the al	osence of i	ndicators.)	
Depth (In.)					1 2	Tarduma		Domorko	
	Color (moist) %	Color (moist)	<u>%</u>	Type ¹	Loc ²	Texture		Remarks	
0-18	5YR 3/3 100%					Silt Loai	<u>m</u>		
	<u> </u>								
						'

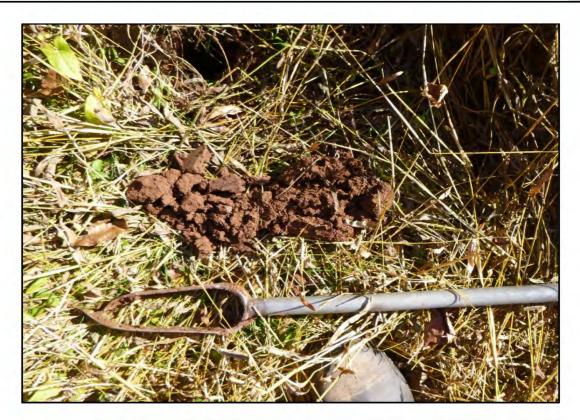
Photograph 1. Data Point 17 Soil

epth (In.)	Matrix	Red	dox Feat	ures		m the al			
	Color (moist) %	Color (moist)	%	Type ¹	Loc ²	Texture		Remarks	
	5YR 4/4 100%			.,,,,,		Sandy L			
	·							Refusal due to	compaction
	·								<u> </u>
	·

Sandy Redox (S5)			lain Soils (F					
	Stripped Matrix (S6)	—— Pleamon	ı Fiooup	iairi 30iis (F	19) (IVILKA	140)			
	e Layer (if observed):								
e: .							Hydric S	oil Present?	N
oth (inch	hes):								
		ctarting at Q" fro	m the	soil surfac	е.				
	as a compacted gravel layer	starting at 9 mc							
	as a compacted gravel layer	starting at 9 mc							
	as a compacted gravel layer	starting at 9 mc							
	as a compacted gravel layer	starting at 9 mc							
	as a compacted gravel layer	starting at 9 mc							
	as a compacted gravel layer	starting at 9 mc							
	as a compacted gravel layer	starting at 9 mc							
	as a compacted gravel layer	starting at 9 mc							
	as a compacted gravel layer	starting at 9 mc							
	as a compacted gravel layer	starting at 9 mc							
	as a compacted gravel layer	starting at 9 mc							
	as a compacted gravel layer	Starting at 9 inc							
	as a compacted gravel layer	Starting at 9 mc

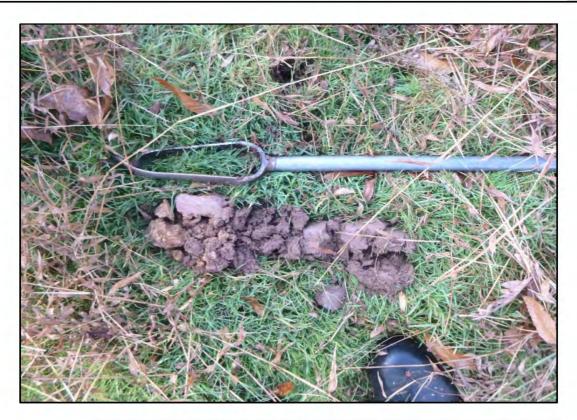
Photograph 1. Data Point 18 Soil

•		lepth needed to do			or or confi	irm the absence	e of indicators.)	
Depth	Matri			edox Feat					
(ln.)	Color (moist)	%	Color (moist)	<u></u> %	Type ¹	Loc ²	Texture	Remarks	
0-8	5YR 4/3	100%					Silty Clay Loar		
8-20	5YR 4/3	85%	7.5YR 5/6	15%	C	M	Silty Clay Loar	<u>n</u>	
							<u> </u>		
								_

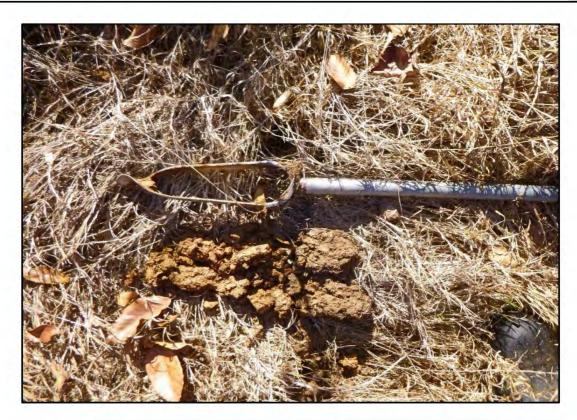
Photograph 1. Data Point 19 Soil

Depth	scription: (Desc Matri			edox Feat					•	
(In.)	Color (moist)	%	Color (moist)	%	Type ¹	Loc ²	Texture		Remarks	
2	10YR 4/4	100%			1,700		Clay Loa	<u>m</u>		
20	10YR 5/6		10YR 5/4	20%			Clay Loa		Gravel inclusio	ns

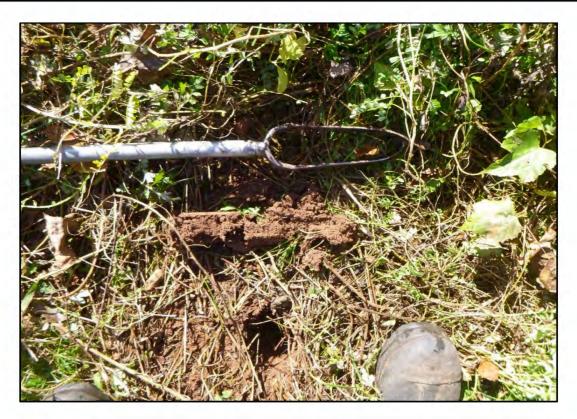
Photograph 1. Data Point 20 Soil

Depth	scription: (Describe to the de Matrix		dox Fea		or COIII	ini uie abselice of	mulcalUI 5.)	
(In.)	Color (moist) %	Color (moist)	%	Type ¹	Loc ²	Texture	Remarks	
9	5YR 4/4 100%			.,,,,,		Sandy Loam		
							Refusal due to	compaction
	Concentration, D = Depletion, F	RM = Reduced Mat	rix, MS =	= Masked S	and Grains		= Pore Lining, M =	
	I Indicators:						Problematic Hyd	
	Histisol (A1)	Dark Sur	face (S7	7)		2cm	Muck (A10) (MLR	RA 147)
	Histic Epipedon (A2)	Polyvalu	e Below	Surface (St	3) (MLRA 1	147, 148) Coa	st Prairie Redox (A	A16)
	Black Histic (A3)	Thin Dar	k Surfac	e (S9) (ML I	RA 147, 14	(8)	(MLRA 147, 148)	
	Hydrogen Sulfide (A4)	Loamy G	Sleyed M	latrix (F2)		Pied	lmont Floodplain S	Soils (F19)
	Stratified Layers (A5)	Depleted	Matrix	(F3)			(MLRA 136, 147)	
	2 cm Muck (A10) (LRR N)	Redox D	ark Surf	ace (F6)			Parent Material (1	ΓF2)
	Depleted Below Dark Surface (A			urface (F7)			/ Shallow Dark Sui

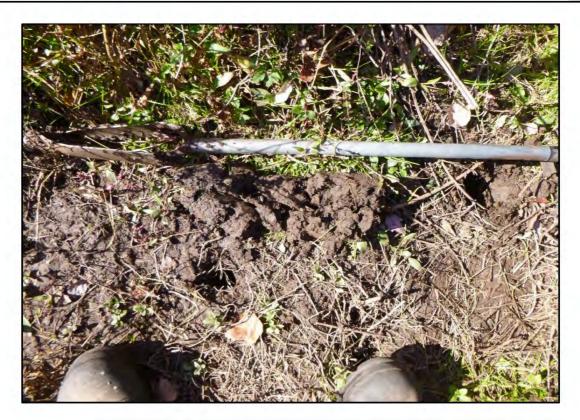
Photograph 1. Data Point 21 Soil

Bully Free co	itors.)
Depth Matrix Redox Features	
	marks
0-12 10YR 2/2 100% clay loam	
12-18 10YR 4/1 90% 7.5YR 4/3 10% C M Loamy sand

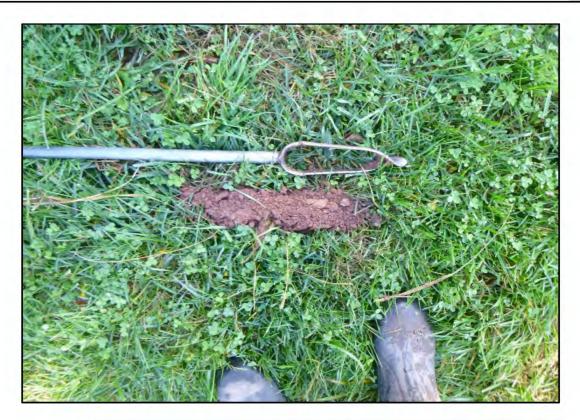
Photograph 1. Data Point 22 Soil

Profile De Depth	escription: (Describe to the de Matrix		cument dox Fea		or or confi	irm the absence	e of indicators.)	
(In.)	Color (moist) %	Color (moist)	%	Type ¹	Loc ²	Texture	Remarks	
)-18	5YR 3/4 100%	Color (molat)		Туре		gravely loam	- romano	
						gravery rearm		
						-		
						-		
							_	
							_

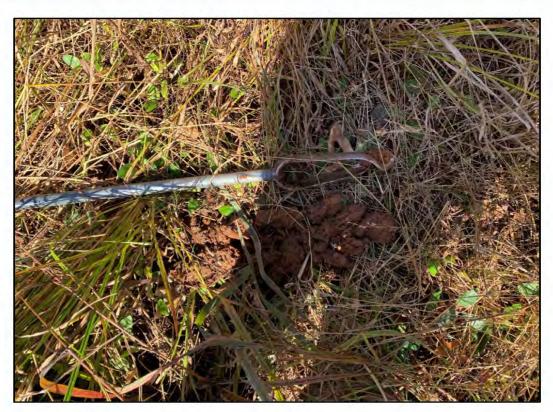
Photograph 1. Data Point 23 Soil

Profile De	•		depth needed to do			or or confi	irm the abse	ence of i	ndicators.)	
Depth	Matrix		R	edox Feat						
(ln.)	Color (moist)	%	Color (moist)	%	Type ¹	Loc ²	Texture		Remarks	
0-4	7.5YR 3/4	95%	7.5YR 5/8	10%	С	PL	Clay loam			
4-18	5YR 4/6	95%	2.5YR 4/8	5%	С	M	Clay

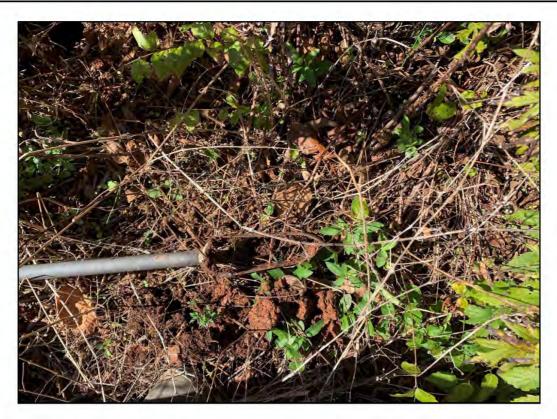
Photograph 1. Data Point 24 Soil

-		depth needed to do			or or conf	irm the ab	sence of	indicators.)	
Depth	Matrix		Redox Fe				- .			
(ln.)	Color (moist)	<u>%</u>	Color (moist)	<u>%</u>	Type ¹	Loc ²	Texture		Remarks	
0-4	7.5YR 3/3	100%					Clay loa			
4-18	5YR 4/6	75%	5YR 3/3	25%	C	M	Clay loam			
1	-		_ .				2.			
) = Depletion	, RM = Reduced Ma	trix, MS =	: Masked S	and Grains			= Pore Lining, M =	
Hydric So	oil Indicators:		5 6	, ,,			Indic		Problematic Hyd	
	Histisol (A1)			urface (S7					Muck (A10) (MLF	=
	Histic Epipedon (A2)			Surface (St		- 1		st Prairie Redox (A16)
	Black Histic (A3)	()			e (S9) (ML I	RA 147, 14	18)	-	MLRA 147, 148)	/=·
	Hydrogen Sulfide (A4)			Loamy Gleyed Matrix (F2)				Piedmont Floodplain Soils (F19)		
	Stratified Layers (A5)			Depleted Matrix (F3)				(MLRA 136, 147)		
	2 cm Muck (A10)		Redox Dark Surface (F6)				Red Parent Material (TF2)			
	Depleted Below Dark Surface (A11)			Depleted Dark Surface (F7) Redox Depressions (F8)				Very Shallow Dark Surface (TF12)

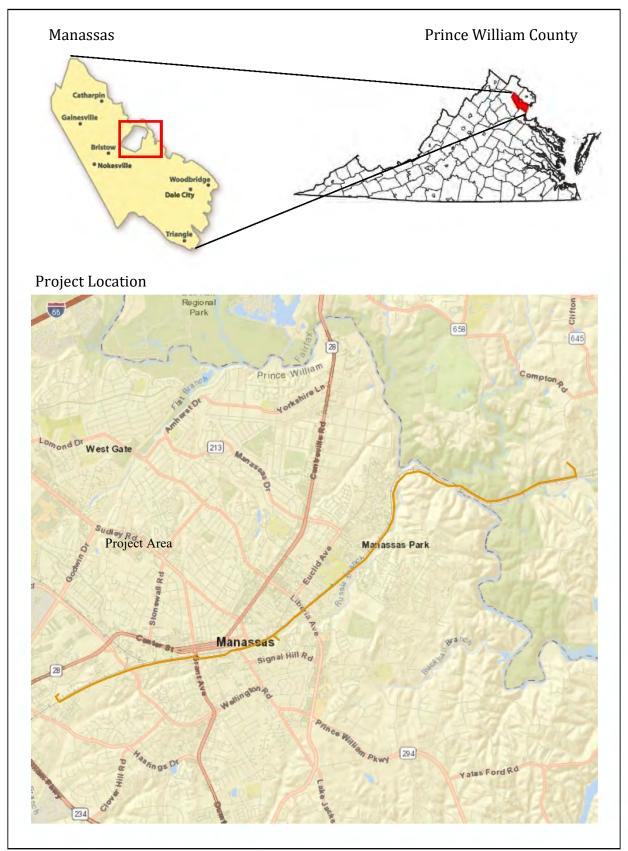
Figure 1-1: Project Area general location

In October 2022, Dutton + Associates, LLC (D+A) completed a Pre-Application Analysis (analysis) of cultural resources for the Line #2011 230 kV Partial Rebuild Project (Clifton to Winters Branch) in Prince William and Fairfax Counties, Virginia (Figure 1-1). The effort serves as a follow-up to the previously coordinated *Pre-Application Analysis (analysis) of cultural resources for the Line #2011 Extension from Cannon Branch to Winters Branch Project* (D+A 2021/ VDHR File No. 2021-4980), and therefore this effort includes the portion of the project extending from Cannon Branch to Clifton. The analysis was performed for Dominion Energy Virginia (Dominion) in support of a State Corporation Commission (SCC) application. The analysis was conducted in accordance with Virginia Department of Historic Resources' (VDHR) guidance titled *Guidelines for Assessing Impacts of Proposed Electric Transmission Lines and Associated Facilities on Historic Resources in the Commonwealth of Virginia* (January 2008) and Commonwealth of Virginia State Corporation Commission Division of Public Utility Regulation *Guidelines for Transmission Line Applications Filed Under Title 56 of the Code of Virginia* (August 2017).

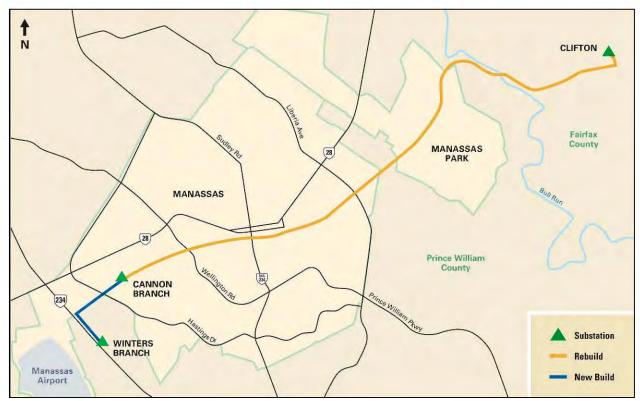
Figure 2-1: Project Alignment General Location. Source: Dominion Energy

The Line #2011 230kV Partial Rebuild Project (Clifton to Winters Branch) entails the rebuild of approximately 7.5 miles of existing 230kV transmission line and new build of approximately 1.5 mile of transmission line stretching through Prince William County, Fairfax County, and the City of Manassas, Virginia (Figure 2-1). The rebuild extends from the existing Cannon Branch Substation to the existing Clifton Substation and is being conducted in order to maintain reliable service for the overall growth in the area and to comply with mandatory North American Electric Reliability Corporation ("NERC") Reliability Standards. To strengthen system reliability and provide better service, the conductor, or wire, on this length of existing transmission line must be replaced with a new, stronger material capable of carrying a higher amount of electric current, or ampacity. Because this new wire is made of different, heavier material than the existing one, the structures that support the conductor must also be replaced. The new build extends roughly 1.5 miles from the Cannon Branch Substation to the Winters Branch Substation. The new build length of the project was previously coordinated with the VDHR (File No. 2021-4980) and is therefore not included in this study.

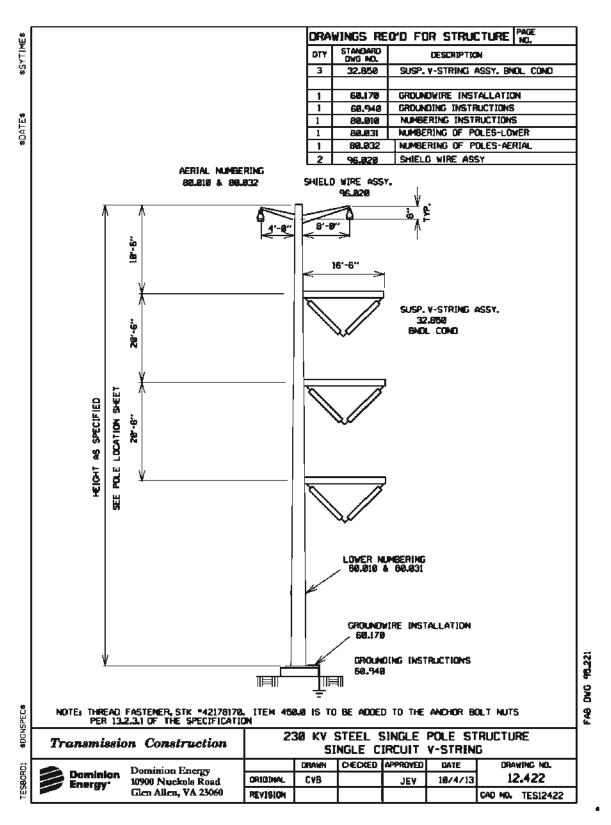
Figure 2-2: Detail of typical existing and proposed structures within ROW. Source: Dominion Energy Virginia

As part of the rebuild portion of the project, extending from Cannon Branch to Clifton, Dominion proposes to replace the existing structures and rebuild the lines to current 230kV standards. The existing structures are monopoles that average 110 feet in height and include both weathering steel and galvanized finished. They will be replaced with monopole structures of similar configuration that will average 115-feet in height and all have weathering streel finish (Table 2-1 and Figure 2-2). The structures will generally be replaced on a one-to-one basis near the same locations. All permanent improvements associated with the rebuild will take place within existing right-of-way (ROW) and will not require any additional vegetative clearing (Figures 2-3).

Structure Number	Existing Height (ft)	Proposed Height (ft)
Str 2011-18	95	105
Str 2011-19	120	125
Str 2011-20	120	120
Str 2011-21	90	90
Str 2011-22	95	95
Str 2011-23	120	120
Str 2011-24	125	125
Str 2011-25	120.333	130
Str 2011-26	120	140
Str 2011-27	130	130
Str 2011-28	130	140
Str 2011-29	135	140
Str 2011-30	110	110
Str 2011-31	115	115
Str 2011-32	130	130
Str 2011-33	130	130
Str 2011-34	110	125
Str 2011-35	115.167	115
Str 2011-36	115	115
Str 2011-37	120.667	120
Str 2011-38	107	120
Str 2011-39	116	115
Str 2011-40	132	125
Str 2011-41	111	115
Str 2011-42	114	115
Str 2011-43	95	105
Str 2011-44	99	125
Str 2011-45	95	105
Str 2011-46	97	105
Str 2011-46A (new)	N/A	100
Str 2011-47	80	115
Str 2011-48	100	115
Str 2011-49	95	95
Str 2011-50	65	80
Str 2011-51	60	80
Str 2011-53	105	105
Str 2011-54	120	120
Str 2011-55	120	125
Str 2011-56	129	120
Str 2011-57	115	125
Str 2011-58	115	120

Structure Number	Evisting Hoight (ft)	Droposed Height (ft)
	Existing Height (ft)	Proposed Height (ft)
Str 2011-59	115	120
Str 2011-60	115	120
Str 2011-61	115	115
Str 2011-62	115	120
Str 2011-63	110	130
Str 2011-64	110	115
Str 2011-65	115	120
Str 2011-66	115	115
Str 2011-67	120	115
Min	60	80
Max	132	140
Average	110	115

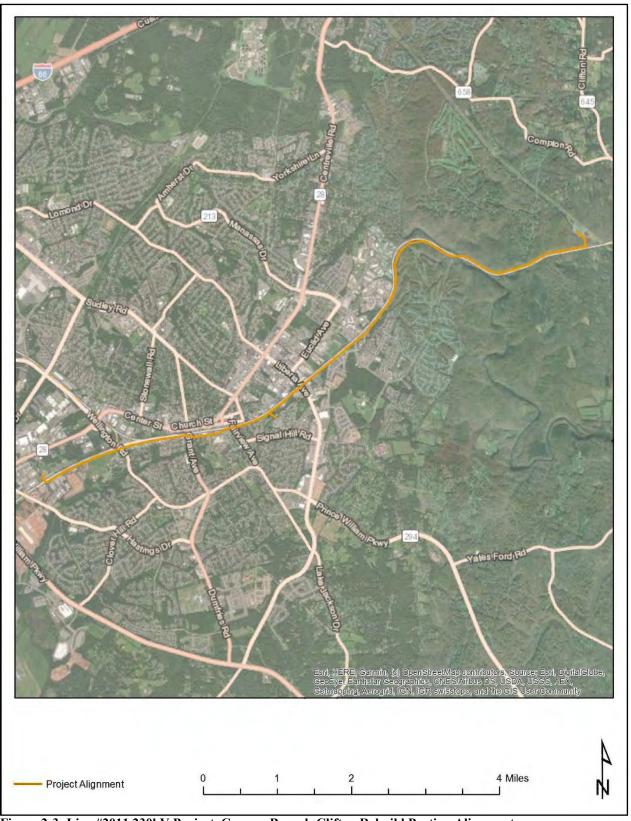
Figure 2-3: Line #2011 230kV Project, Cannon Branch-Clifton Rebuild Portion Alignment.

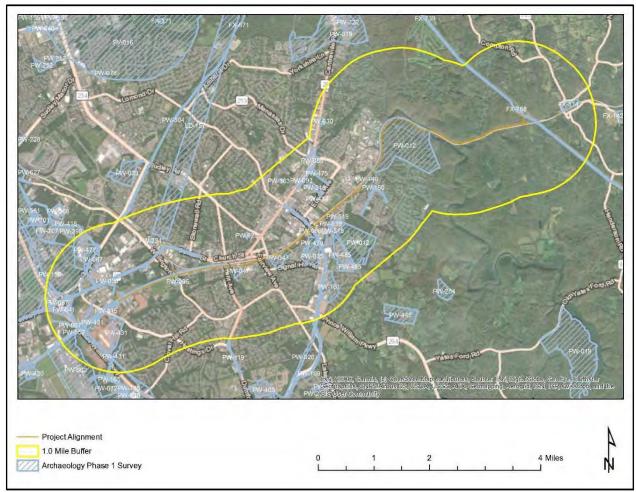
Figure 4-1: Previously conducted surveys within 1-mile of the project area. Source: VCRIS

VDHR and VCRIS records indicate that there have been thirty-eight (38) prior Phase I cultural resource surveys within 1-mile of the project area, including six (6) of which that overlap with or include portions of the project alignment. These surveys are at a minimum archaeological in nature, although some include architectural resources as well. The six surveys that include portions of the project area were conducted as part of a linear transportation projects, utility projects, development projects, and a targeted site study. As a result of these surveys, several discrete portions of the project ROW have been subject to Phase I archaeological identification, however, other portions remain unsurveyed. The six previously conducted cultural resource surveys that includes portions of the project alignment are listed in Table 4-1 and are illustrated in Figure 4-1.

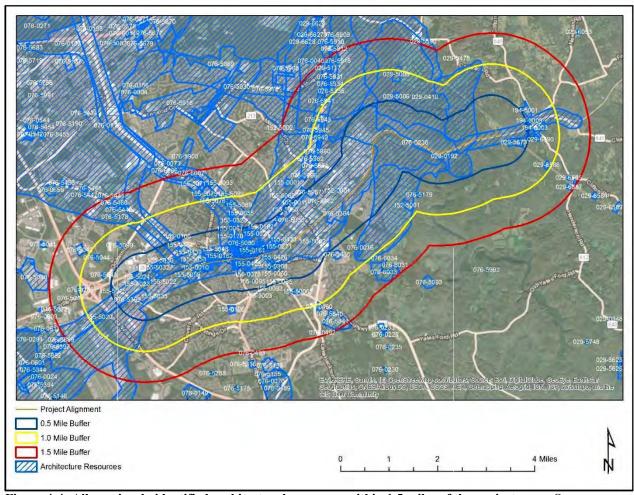
Figure 4-4: All previously identified architectural resources within 1.5 miles of the project area. Source: VCRIS

Table 4-3 lists all NHLs, NRHP-listed, and NRHP-eligible resources within their respective buffered tiers. A map of all previously recorded architectural resources within 1.5 mile of the project area is depicted in Figure 4-4 and a map of considered resources within their respective study tiers is included in Figure 4-5.

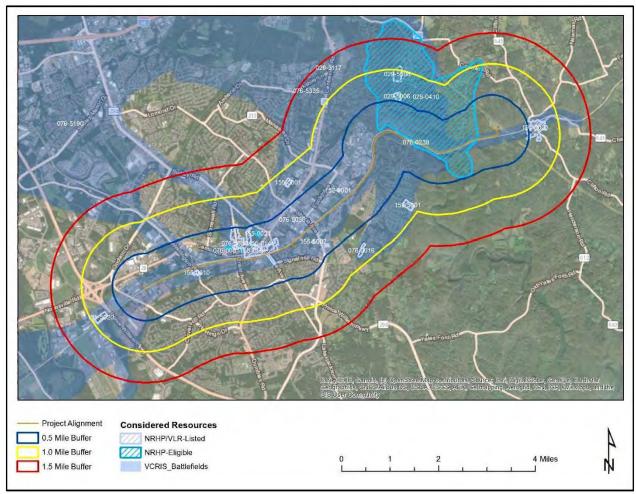
Figure 4-5: Considered architectural resources within their respective tiers around the project area. Source: VCRIS

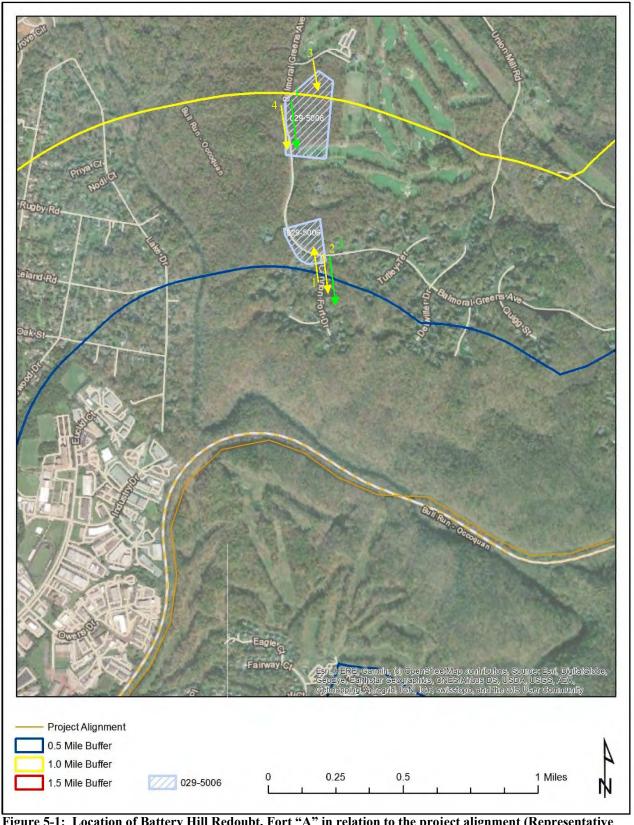
Figure 5-1: Location of Battery Hill Redoubt, Fort "A" in relation to the project alignment (Representative photographs and views towards the project area depicted in yellow, photo simulations depicted in green).

Figure 5-1 depicts the location of Battery Hill Redoubt in relation to the project alignment and viewshed buffers, with the location and direction of all representative photographs and photo simulations. Figures 5-2 through 5-5 are representative photographs of the resource, as well as those taken from locations near the resource towards the project area. Figures 5-6 through 5-11 provide photo simulation from the resource.

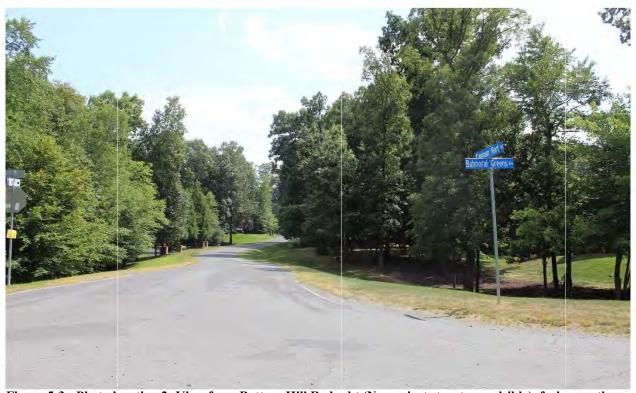
Figure 5-3: Photo location 2- View from Battery Hill Redoubt (No project structures visible), facing south.

Inspection from public ROW in the vicinity of the resource found that none of the existing structures on the project alignment are visible due to topography and vegetation. The landscape between the site and the project alignment slopes steeply down to Bull Run Creek and is thickly wooded. The existing structures within the vicinity to be replaced as part of this project range from 95- to 125-feet in height and the proposed replacement structures will likewise range from 95- to 125-feet in height. As such, the heights of the individual proposed structures may vary slightly from their existing configuration, although none will be any taller than the existing structures. As such, it is anticipated that the intervening topography and vegetation will continue to completely screen visibility of the replacement structures from the Battery Hill Redoubt. This was confirmed

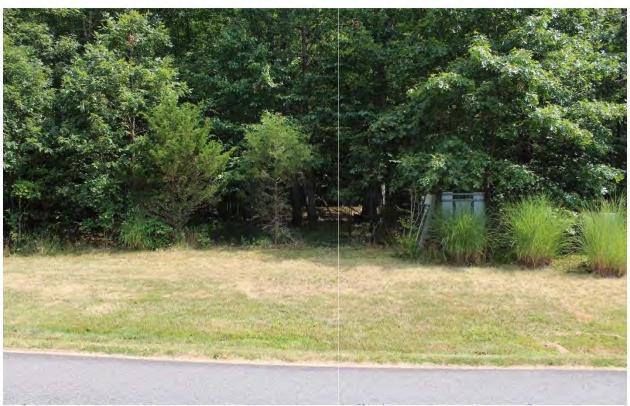
Figure 5-4: Photo location 3- View of earthworks from driveway to Westfields Golf Club (No project structures visible), facing south.

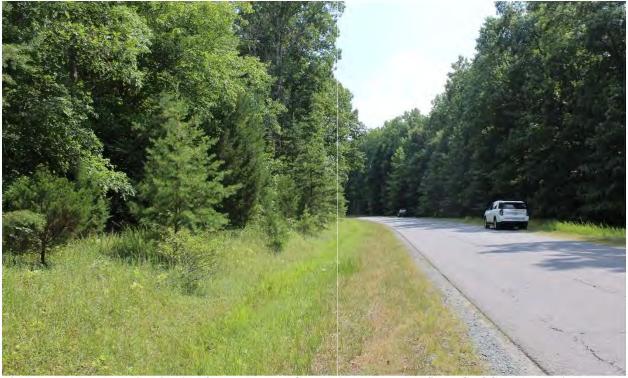
Figure 5-5: Photo location 4- View from Balmoral Greens Avenue at Westfields Golf Club (no project structures visible), facing south.

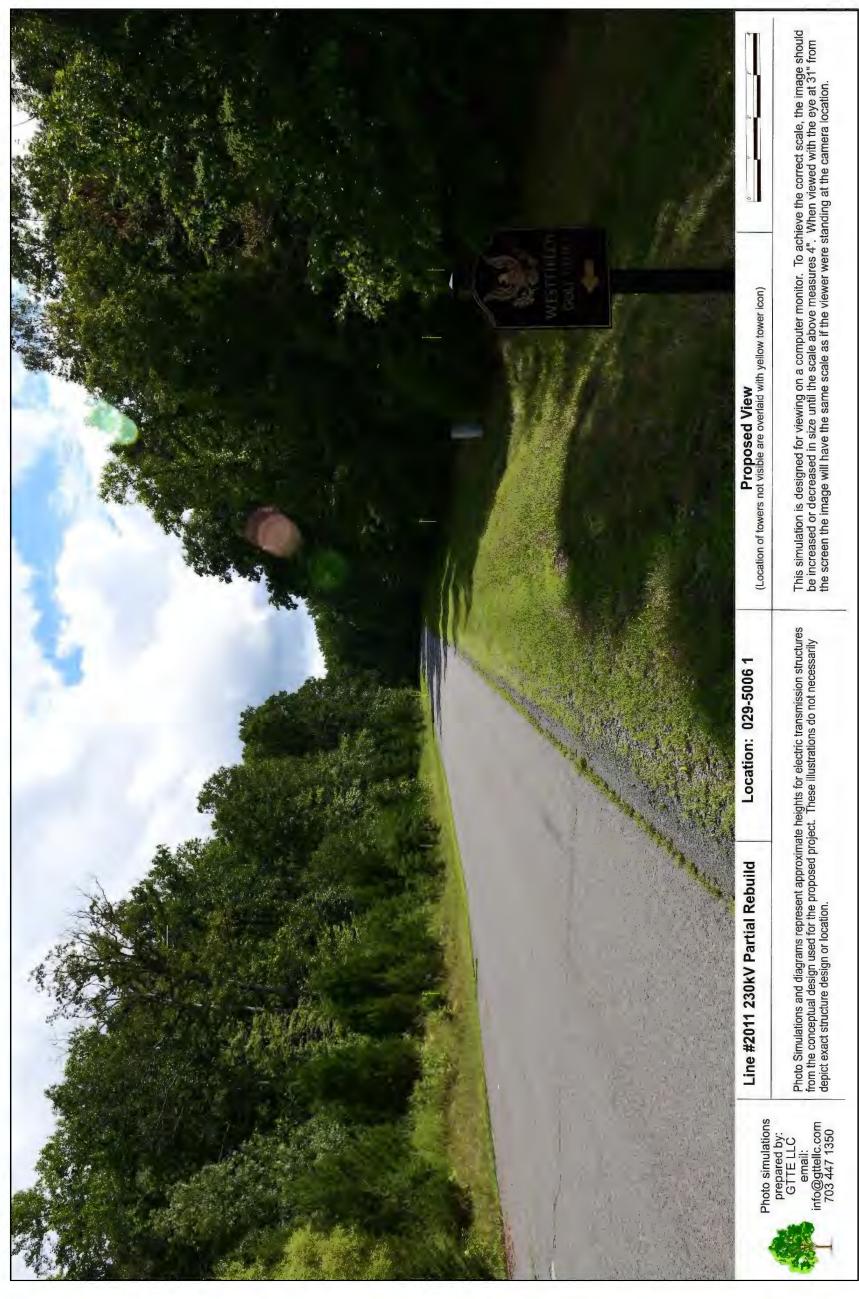
Figure 5-8: Battery Hill Redoubt Simulation 1 - Proposed view from entrance to Westfields Golf Club - (Structures not visible shown in yellow). Source: GTTE, LLC

by photo simulation from multiple vantages that depicts all structures remaining screened beneath the intervening terrain and vegetation. Therefore, the project will not introduce any noticeable change in setting or viewshed of or from the resource which does not include any of the existing project structures, nor will it include views of any replacement structures, and it is therefore D+A's opinion that the Line #2011 230kV Partial Rebuild (Clifton to Winters Branch) Project will pose *no impact* to Battery Hill Redoubt, Fort "A".

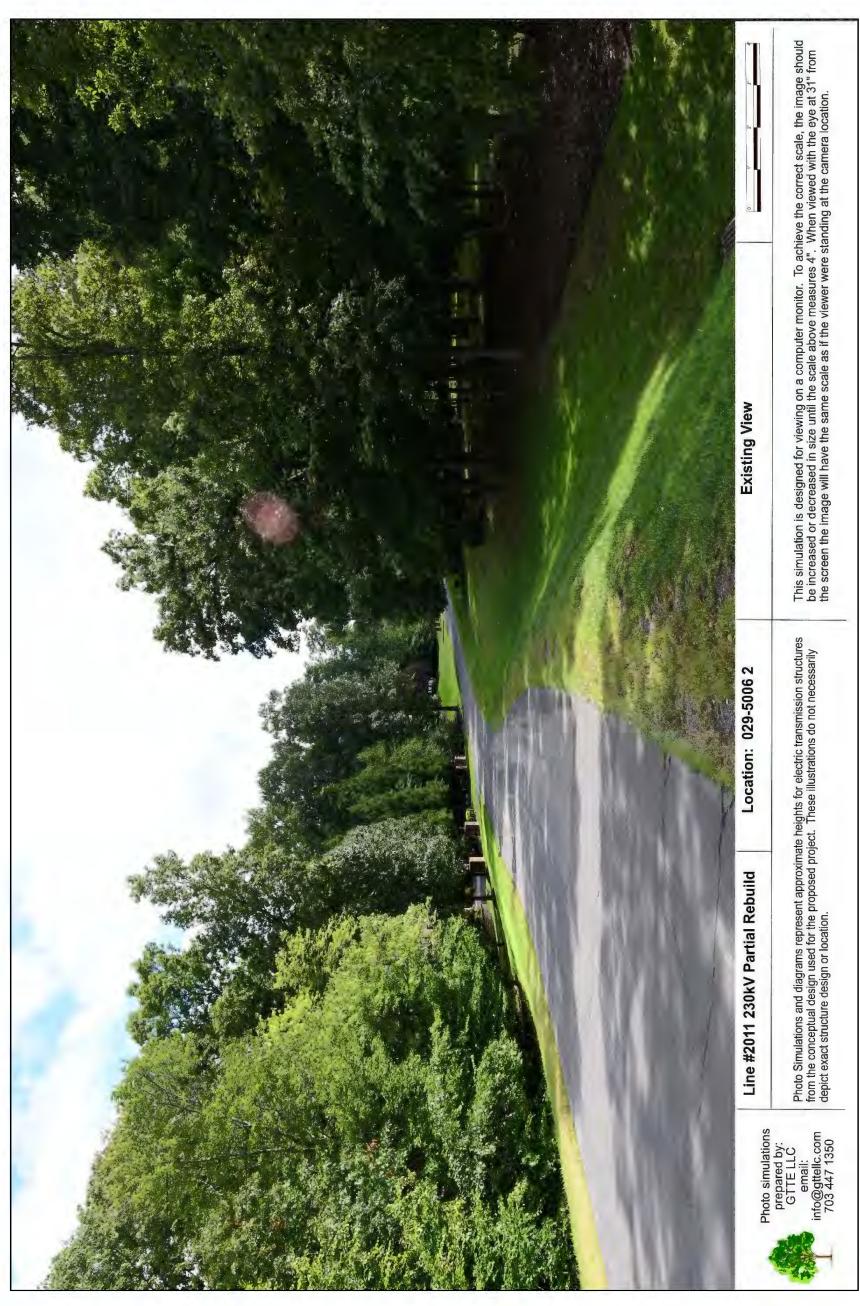
Figure 5-10: Battery Hill Redoubt Simulation 2 – Existing view from Balmoral Greens Avenue. Source: GTTE, LLC
