Application, Appendix, DEQ Supplement, Direct Testimony and Exhibits of Virginia Electric and Power Company

Line #2011 230 kV Partial Rebuild Project

Application No. 323

DEQ Supplement

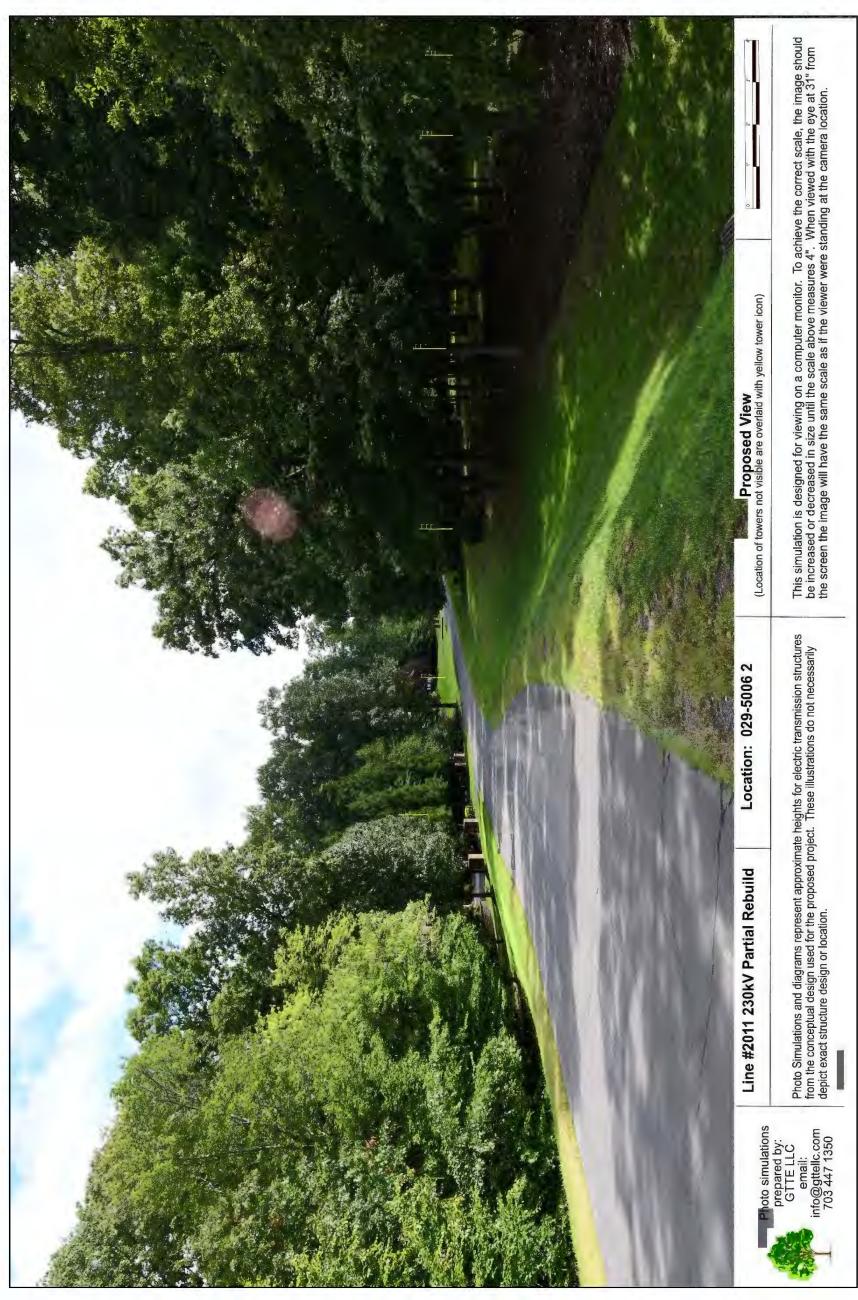
Figure 5-11: Battery Hill Redoubt Simulation 2 – Proposed view from Balmoral Greens Avenue – (Structures not visible shown in yellow). Source: GTTE, LLC

by photo simulation from multiple vantages that depicts all structures remaining screened beneath the intervening terrain and vegetation. Therefore, the project will not introduce any noticeable change in setting or viewshed of or from the resource which does not include any of the existing project structures, nor will it include views of any replacement structures, and it is therefore D+A's opinion that the Line #2011 230kV Partial Rebuild (Clifton to Winters Branch) Project will pose *no impact* to Battery Hill Redoubt, Fort "A".

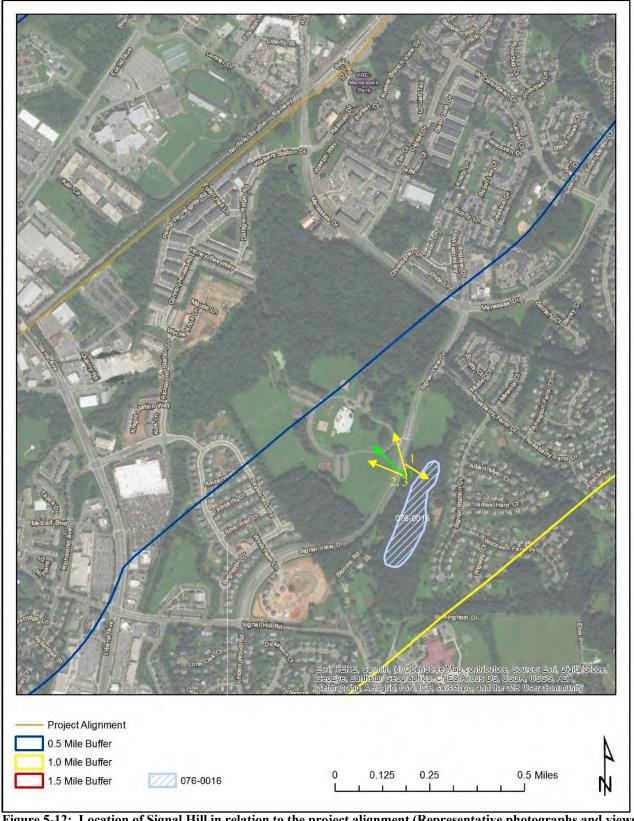
Figure 5-12: Location of Signal Hill in relation to the project alignment (Representative photographs and views towards the project area depicted in yellow, photo simulations depicted in green).

Figure 5-12 depicts the location of Signal Hill in relation to the project alignment and viewshed buffers, with the location and direction of all representative photographs and photo simulations. Figures 5-13 through 5-15 are representative photographs of the resource, as well as those taken from locations near the resource towards the project area. Figures 5-16 through 5-18 provide photo simulation from the resource.

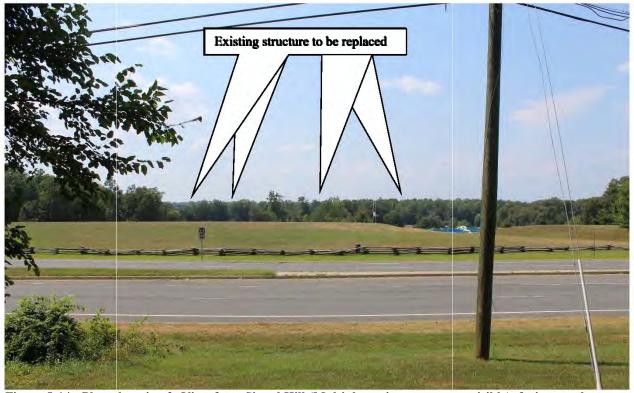
Figure 5-14: Photo location 2- View from Signal Hill (Multiple project structures visible), facing northwest.

Because the structures that are currently visible will generally remain the same height or increase in height by 5 feet or less, the change will not be perceptible at the distance they are set. This was confirmed by photo simulation from the interpretive kiosk that depicts similar visibility of currently visible structures with no new visibility of any structures currently screened. Therefore, the project will not introduce any noticeable change in setting or viewshed of or from the resource which already includes visibility of several structures in the distance, and it is therefore D+A's opinion that the Line #2011 230kV Partial Rebuild (Clifton to Winters Branch) Project will pose no more than a *minimal impact* to Signal Hill.

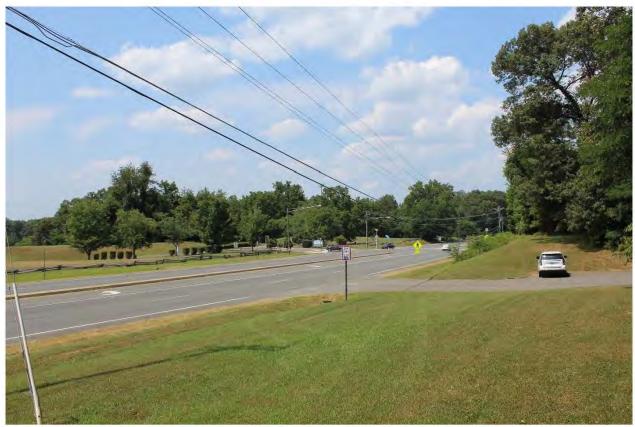
Figure 5-15: Photo location 3- View from Signal Hill (No project structures visible), facing north.

Inspection from the interpretative kiosk pull-off and public ROW in the vicinity of the resource found that several of the existing structures on the project alignment are visible above the treeline in the distance. Much of the landscape between the site and the project alignment is wooded and/or developed which screens views of structures as they extend further to the north and south, however, the large cleared field for the public park directly across the street from the site allow more distant views in that direction where the several visible structures are set. The existing structures within the vicinity to be replaced as part of this project range from 110- to 135-feet in height and the proposed replacement structures will range from 110- to 140-feet in height. As such, the heights of most of the individual proposed structures will remain the same, although some may vary or increase in height slightly from their existing configuration. As such, it is anticipated visibility will remain similar, with structures that are currently visible remaining as such, while the intervening vegetation will continue to screen visibility of those structures that are not currently visible.

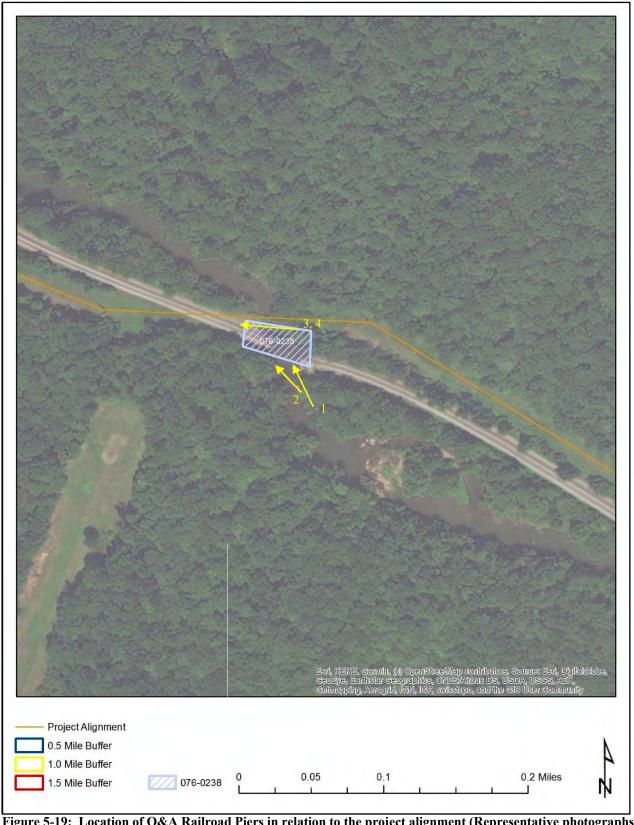
Figure 5-19: Location of O&A Railroad Piers in relation to the project alignment (Representative photographs and views towards the project area depicted in yellow, photo simulations depicted in green).

Figure 5-19 depicts the location of the O&A Railroad Piers in relation to the project alignment and viewshed buffers, with the location and direction of all representative photographs and photo simulations. Figures 5-20 through 5-23 are representative photographs of the resource, as well as those taken from locations near the resource towards the project area.

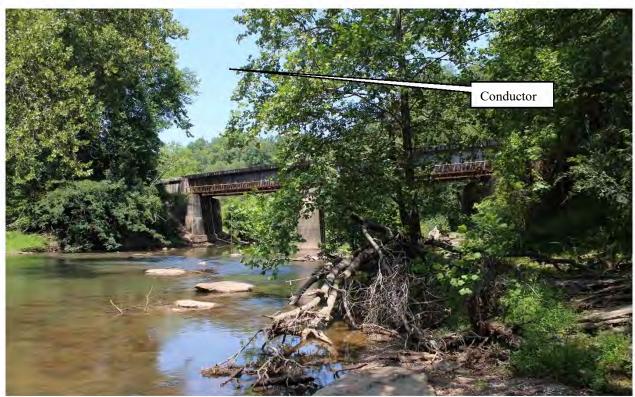
Figure 5-20: Photo location 1- Representative view of existing bridge from hiking trail along Bull Run Creek (conductor visible above bridge but no project structures visible), facing north.

Inspection from the hiking trail in the vicinity of the piers and bridge found that from the south side, the conductor (transmission line) may be seen as it is suspended over the bridge, however, the trees and topography prevent visibility of the existing structures. From the north side of the bridge, two existing structures west of the crossing are visible, however, structures to the east are screened by the bluff bordering the creek and the angle of view. The existing structures in the vicinity of the resource to be replaced as part of this project range from 90- to 125-feet in height and the proposed replacement structures will range from 95- to 125-feet in height. As such, one of the individual proposed structures will be increased in height by 5 feet, while the rest will remain at the same height. As such, it is anticipated visibility will remain similar, with the two structures that are currently visible remaining as such with one slightly taller, while the intervening vegetation will continue to screen visibility of those structures that are not currently visible. Therefore, the project will not introduce any noticeable change in setting or viewshed of or from

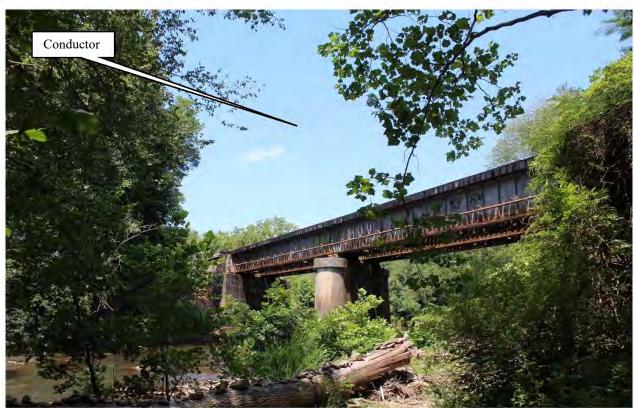
Figure 5-21: Photo location 2- View from trail on south side of bridge (Conductor visible above bridge, but no project structures visible), facing northwest

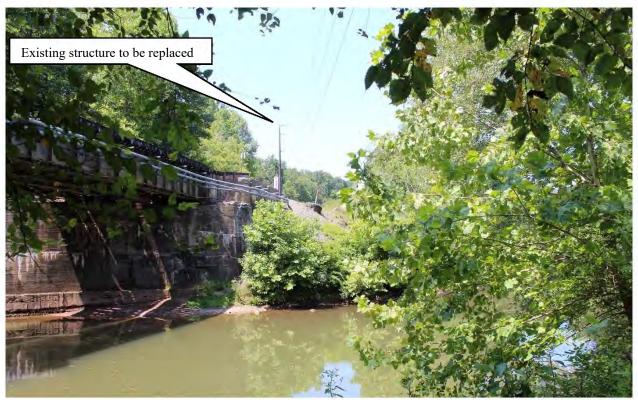
Figure 5-22: Photo location 3- View from trail on north side of bridge (Two project structures visible), facing west.

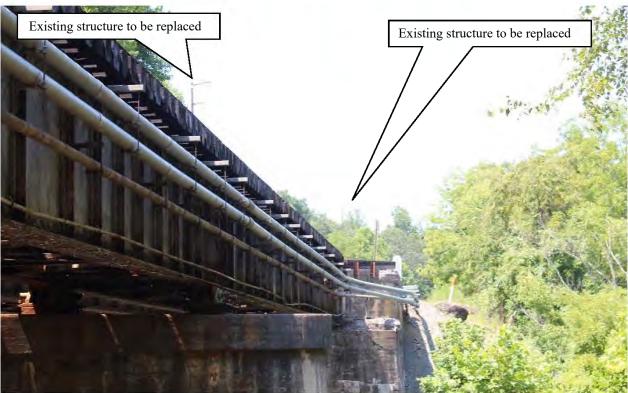
Figure 5-23: Photo location 4- Detail of view from trail on north side of bridge (Two project structures visible), facing west.

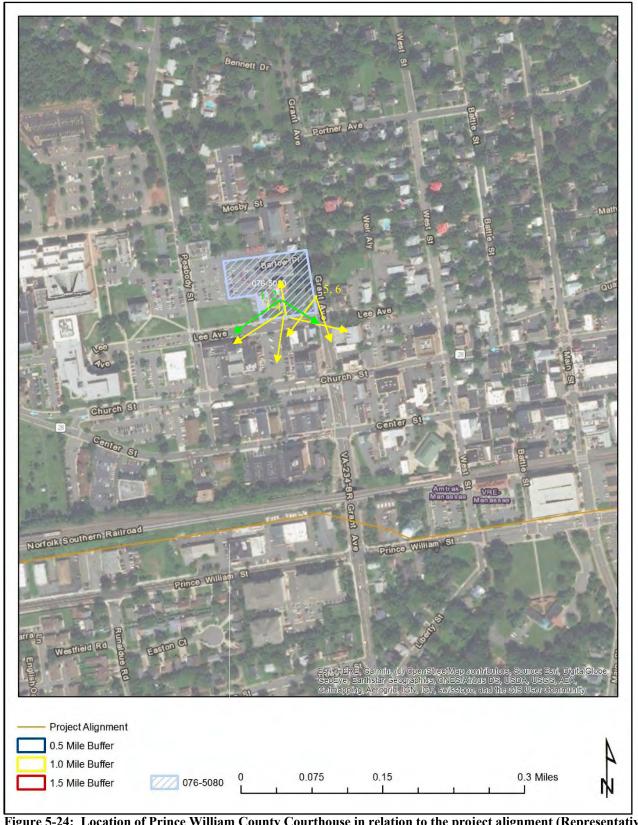
Figure 5-24: Location of Prince William County Courthouse in relation to the project alignment (Representative photographs and views towards the project area depicted in yellow, photo simulations depicted in green).

Figure 5-24 depicts the location of Prince William County Courthouse in relation to the project alignment and viewshed buffers, with the location and direction of all representative photographs and photo simulations. Figures 5-25 through 5-30 are representative photographs of the resource, as well as those taken from locations near the resource towards the project area. Figures 5-31 through 5-36 provide photo simulation from the resource.

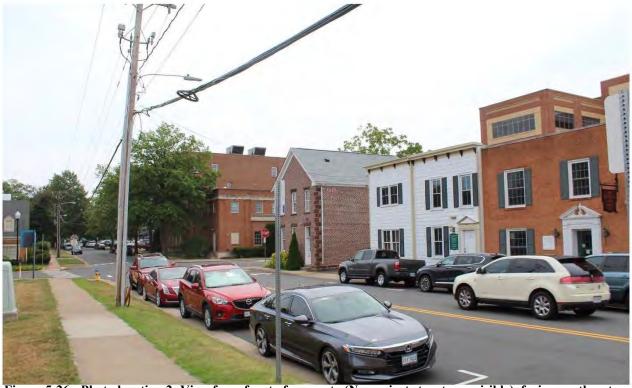
Figure 5-26: Photo location 2- View from front of property (No project structures visible), facing southeast.

Inspection from the roads and sidewalks bordering the property found that several existing structures may be seen through gaps in the adjacent development from discrete vantage points, however, visibility is fleeting and becomes screened with just a slight change in vantage. The most unobstructed views are directly across the street from the front of the building where two existing structures are visible. One of these structures plus an additional structure are also visible from the east side of the building. From this vantage, an existing substation may be seen down the road, however, this will not be rebuilt as part of the project and the adjacent structures leading into the substation are both screened by development. The existing structures in the vicinity of the resource to be replaced as part of this project range from 60- to 129-feet in height and the proposed

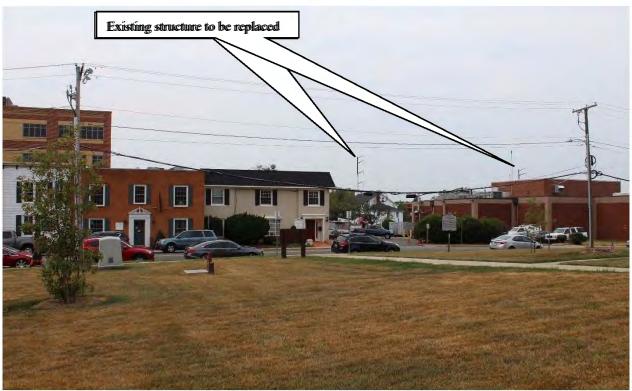
Figure 5-27: Photo location 3- View from front of property (Two project structures visible), facing south.

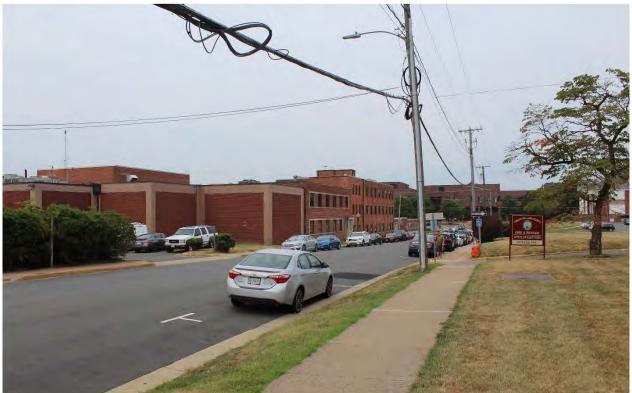
Figure 5-28: Photo location 4- View from front of property (No project structures visible), facing southwest.

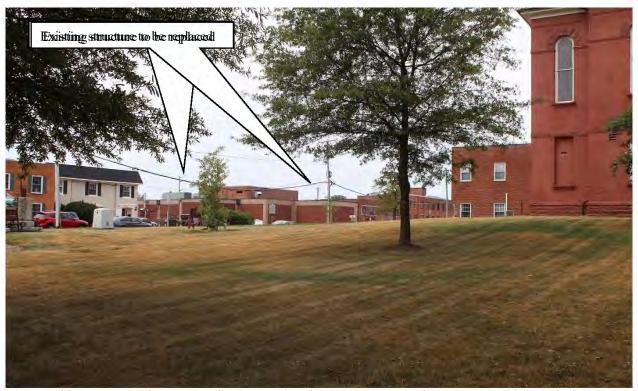
Figure 5-29: Photo location 5- View from west side of property (Two project structures visible), facing southwest.

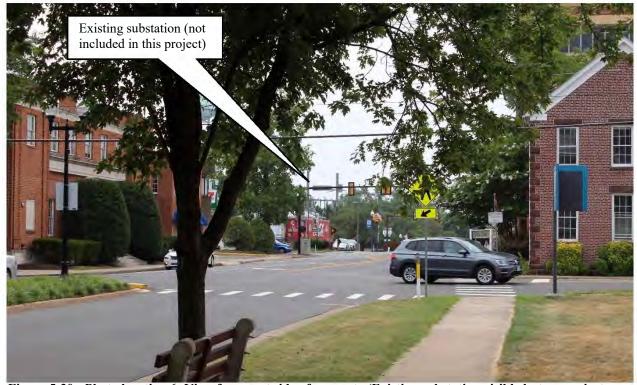
Figure 5-30: Photo location 6- View from east side of property (Existing substation visible but no project structures visible), facing south.

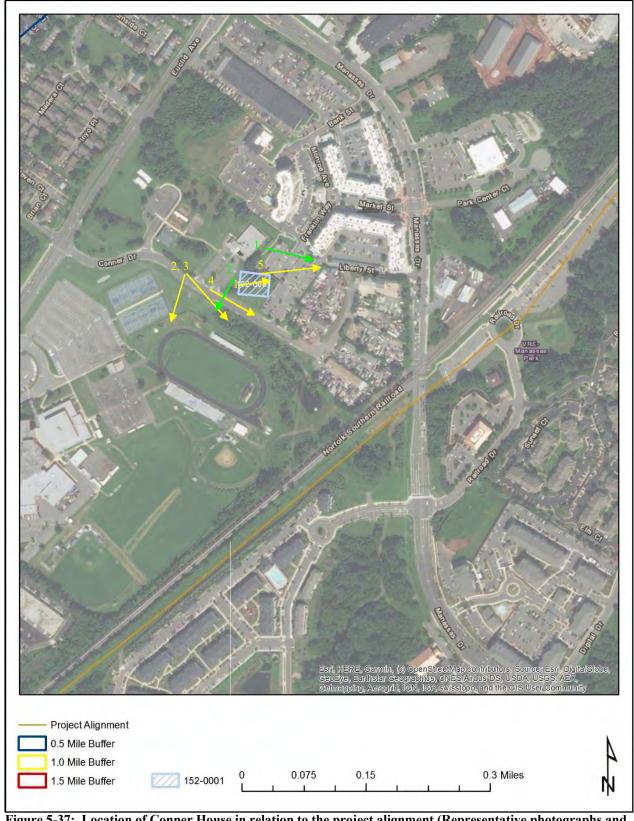
Figure 5-37: Location of Conner House in relation to the project alignment (Representative photographs and views towards the project area depicted in yellow, photo simulations depicted in green).

Figure 5-37 depicts the location of the Conner House in relation to the project alignment and viewshed buffers, with the location and direction of all representative photographs and photo simulations. Figures 5-38 through 5-42 are representative photographs of the resource, as well as those taken from locations near the resource towards the project area. Figures 5-43 through 5-48 provide photo simulation from the resource.

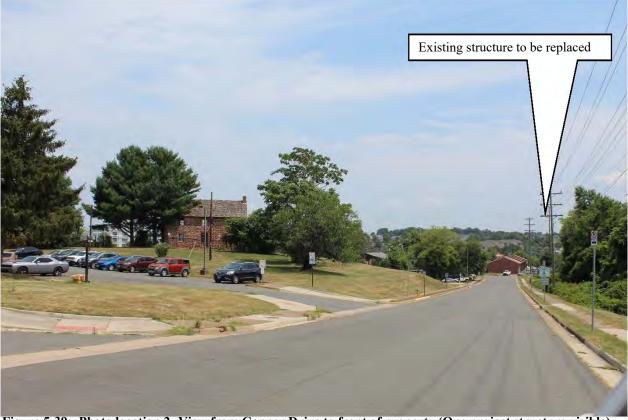
Figure 5-39: Photo location 2- View from Conner Drive to front of property (One project structure visible), facing southeast.

Inspection from Conner Road to the front of the property revealed that several existing structures may be seen downhill to the rear and side of the building, while additional structures can be seen across an open athletic field across the road from the property to the west. Inspection from the homesite found that vegetation in the immediate vicinity screens many of the structures although several may be seen as they extend away to the northeast. The existing structures in the vicinity of the resource to be replaced as part of this project range from 110- to 135-feet in height and the proposed replacement structures will range from 110- to 140-feet in height. As such, several of the individual proposed structures may be increased in height slightly while others will remain the same height. Overall, the tallest replacement structure will be only 5 feet taller than the tallest existing structure. As such, it is anticipated visibility will remain similar, with visibility of several structures across open field and spanning the road in the vicinity. This was confirmed by photo simulation from the property in two directions that depicts a slight change in configuration and visibility of several structures that are already visible with no visibility of any additional structures.

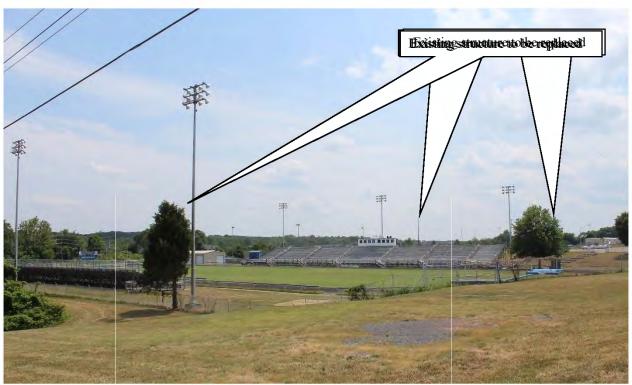
Figure 5-40: Photo location 3- View from Conner Drive to front of property (Several project structures visible), facing south.

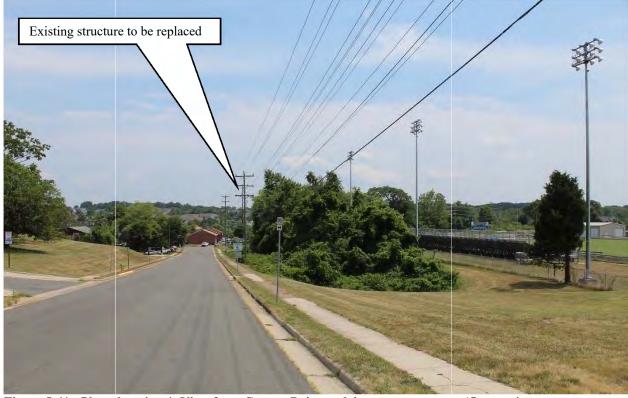
Figure 5-41: Photo location 4- View from Conner Drive at driveway to property (One project structure visible), facing southeast.

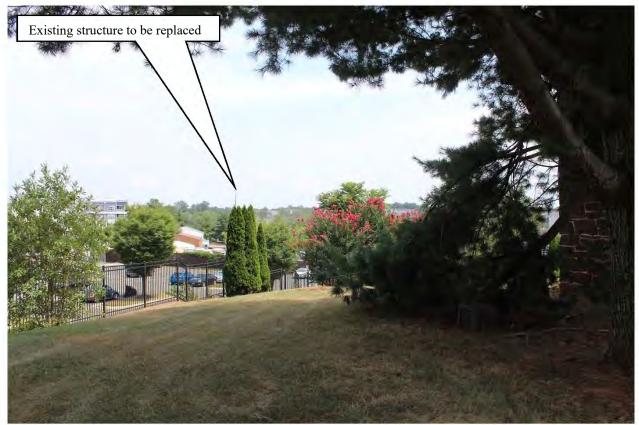
Figure 5-42: Photo location 5- View from side yard of house (One project structure visible), facing northeast.

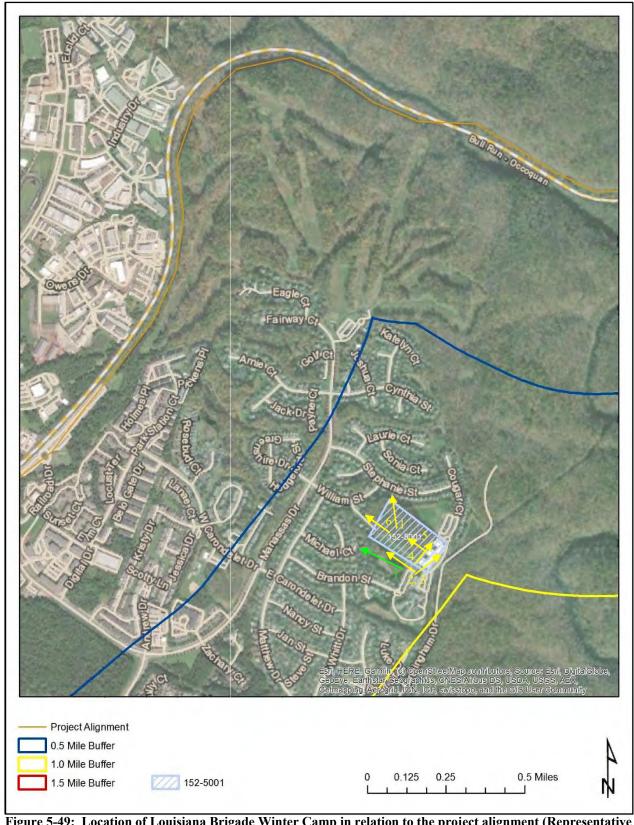
Figure 5-49: Location of Louisiana Brigade Winter Camp in relation to the project alignment (Representative photographs and views towards the project area depicted in yellow, photo simulations depicted in green).

Figure 5-49 depicts the location of the Louisiana Brigade Winter Camp in relation to the project alignment and viewshed buffers, with the location and direction of all representative photographs and photo simulations. Figures 5-50 through 5-55 are representative photographs of the resource, as well as those taken from locations near the resource towards the project area. Figures 5-56 through 5-58 provide photo simulation from the resource.

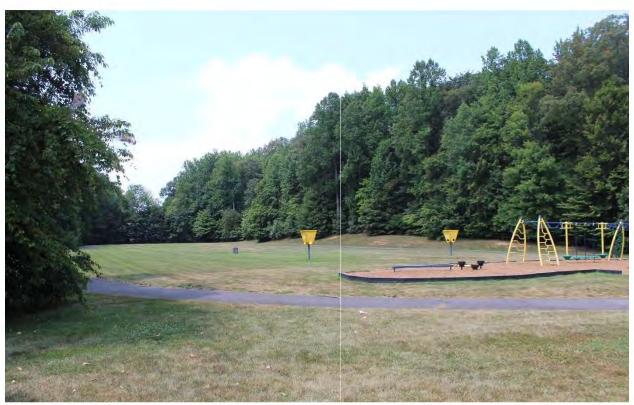
Figure 5-52: Photo location 3- View from recreational field adjacent to wooded preservation area (No project structures visible), facing northwest.

Inspection from the school parking lot and athletic field adjacent to the site found that despite the clearing in this area, none of the existing structures on the project alignment are visible above or through the intervening vegetation and development. Inspection from the walking trails within the preservation area found that the thick woods throughout the site prevent any views beyond the site. The existing structures in the vicinity of the site to be replaced as part of this project range from 120- to 125-feet in height and the proposed replacement structures will likewise range from 120- to 140-feet in height. As such, the heights of the individual proposed structures may vary slightly from their existing configuration, with some remaining in the same height and some increasingly in height slightly. As such, it is anticipated that the intervening topography and vegetation will continue to completely screen visibility of the replacement structures from the Louisiana Brigade Winter Camp site and vicinity. This was confirmed by photo simulation from the field adjacent to

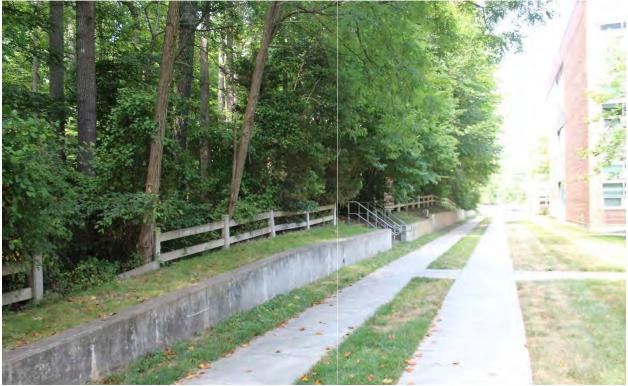
Figure 5-53: Photo location 4- View of entrance to preservation area from school walkway (no project structures visible), facing north.

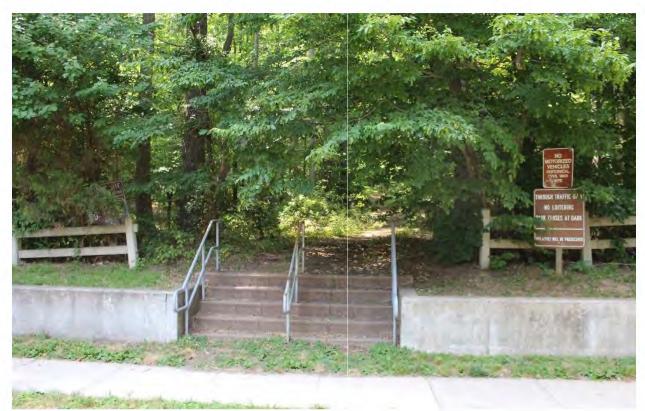
Figure 5-54: Photo location 5- View from entry to walking trails within preservation area (no project structures visible), facing northwest.

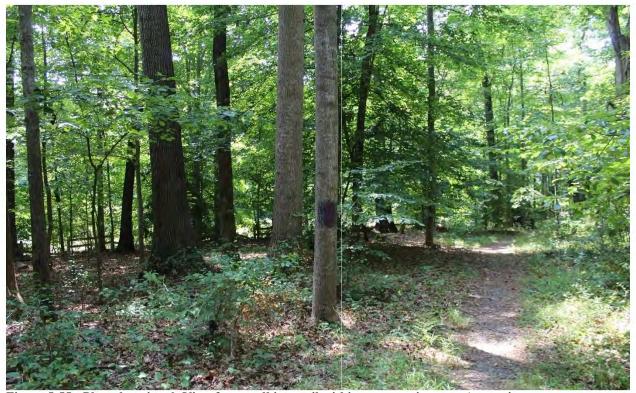
Figure 5-55: Photo location 6- View from walking trail within preservation area (no project structures visible), facing northwest.

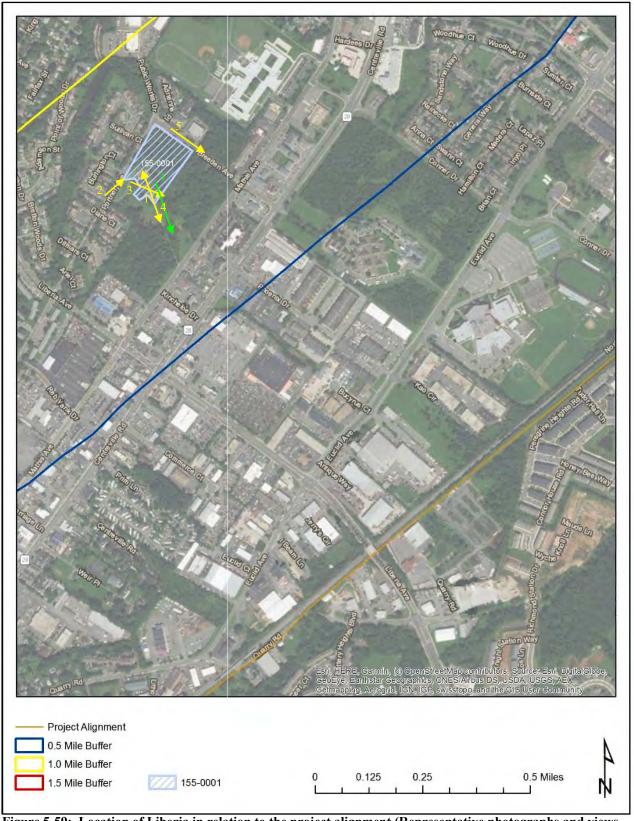
Figure 5-59: Location of Liberia in relation to the project alignment (Representative photographs and views towards the project area depicted in yellow, photo simulations depicted in green).

Figure 5-59 depicts the location of the Liberia property in relation to the project alignment and viewshed buffers, with the location and direction of all representative photographs and photo simulations. Figures 5-60 through 5-64 are representative photographs of the resource, as well as those taken from locations near the resource towards the project area. Figures 5-65 through 5-67 provide photo simulation from the resource.

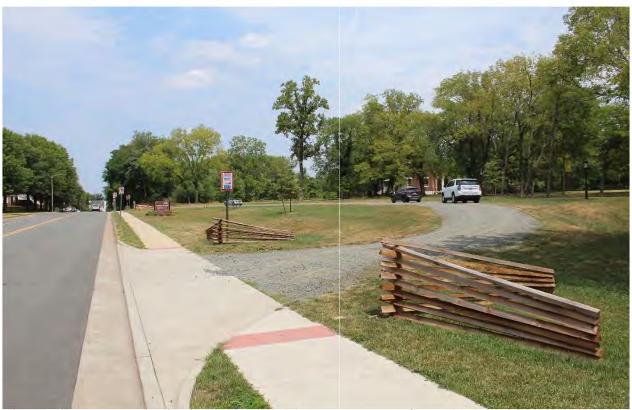
Figure 5-61: Photo location 2- View from Portner Avenue to the rear of the house (No project structures visible), facing northeast.

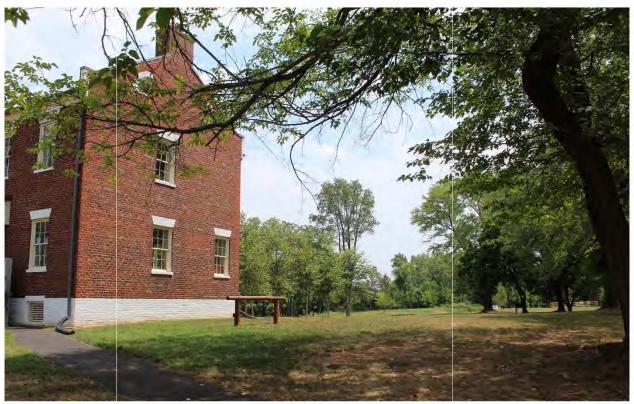
Figure 5-62: Photo location 3- View from side yard of house (No project structures visible), facing east.

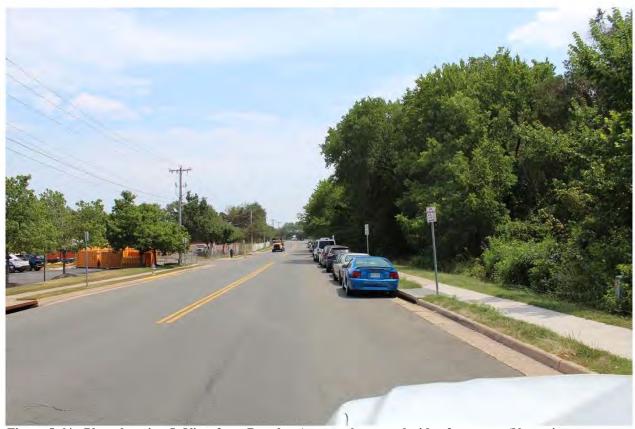
Figure 5-64: Photo location 5- View from Breeden Avenue along north side of property (No project structures visible), facing southeast.

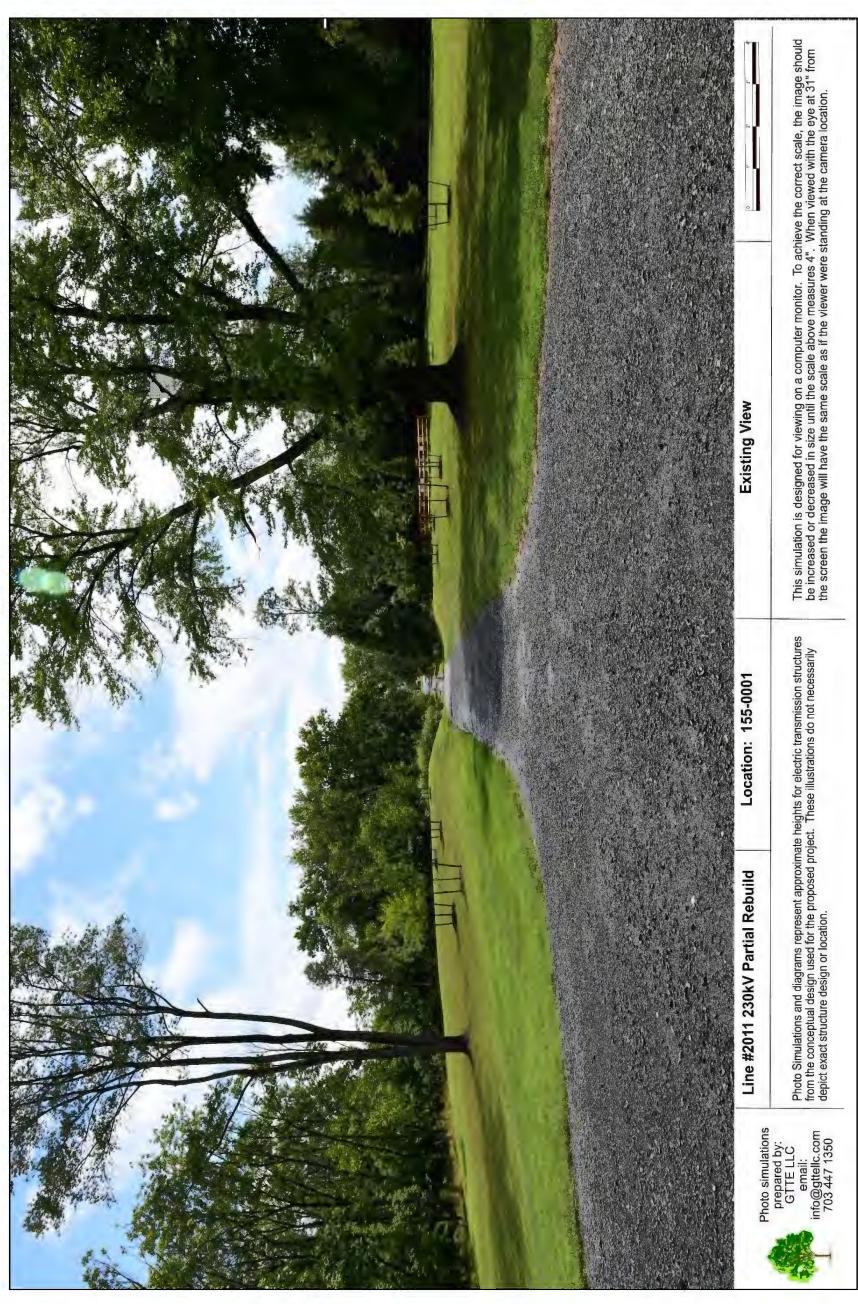
Figure 5-66: Liberia Simulation 1 – Existing view from front of house. Source: GTTE, LLC

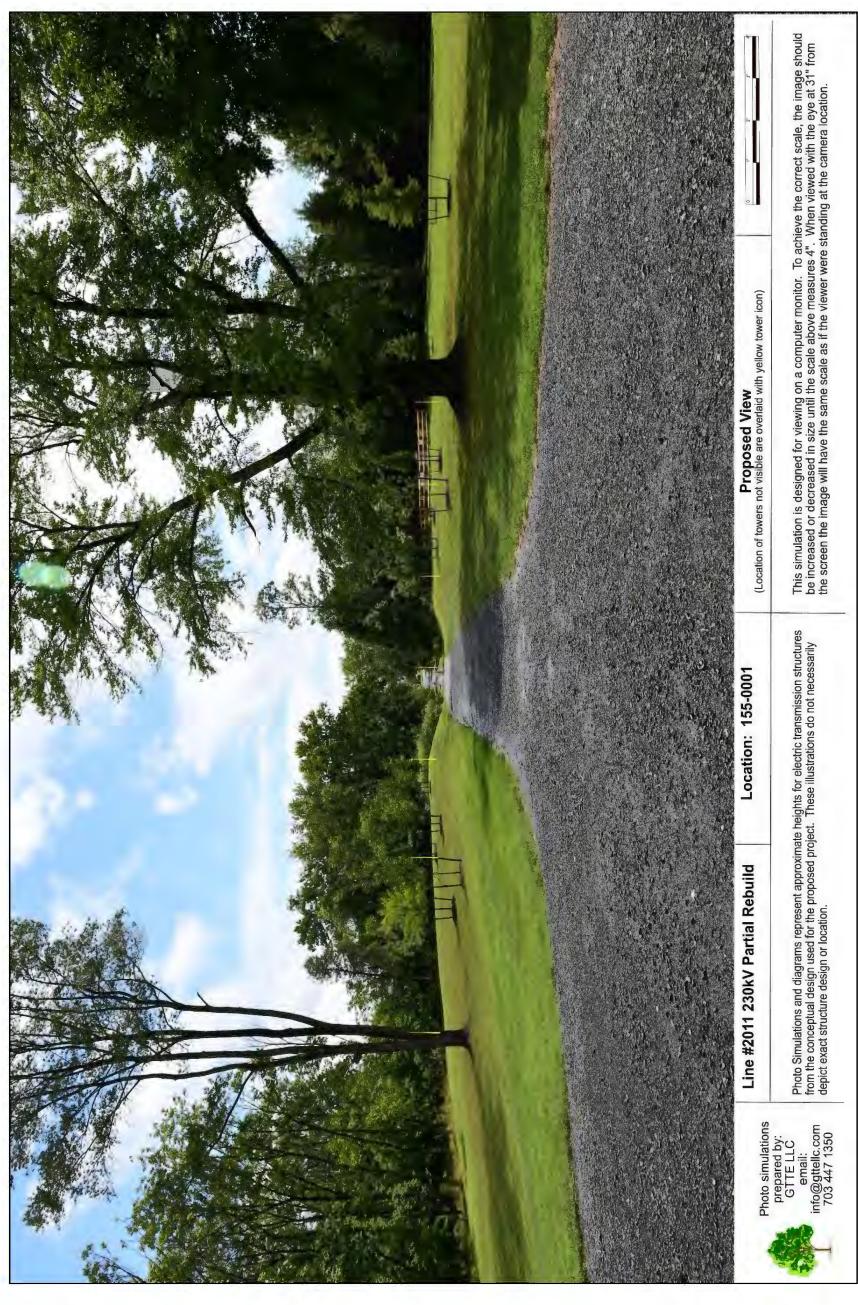
Figure 5-67: Liberia Simulation 1 – Proposed view from front of house – (Structures not visible shown in yellow). Source: GTTE, LLC

proposed replacement structures will range from 115- to 140-feet in height. As such, there will be a slight increase in height for several of the structures, although some individual structures will remain the same height as the existing. Therefore, it is anticipated that the intervening vegetation and development that currently screen the existing structures will continue to completely screen visibility of the replacement structures from the Liberia property and vicinity. This was confirmed by photo simulation from the front of the house that depicts all structures remaining screened beneath the intervening vegetation and development. Therefore, the project will not introduce any noticeable change in setting or viewshed of or from the resource which does not include any of the existing project structures, nor will it include views of any replacement structures, and it is therefore D+A's opinion that the Line #2011 230kV Partial Rebuild (Clifton to Winters Branch) Project will pose *no impact* to Liberia.

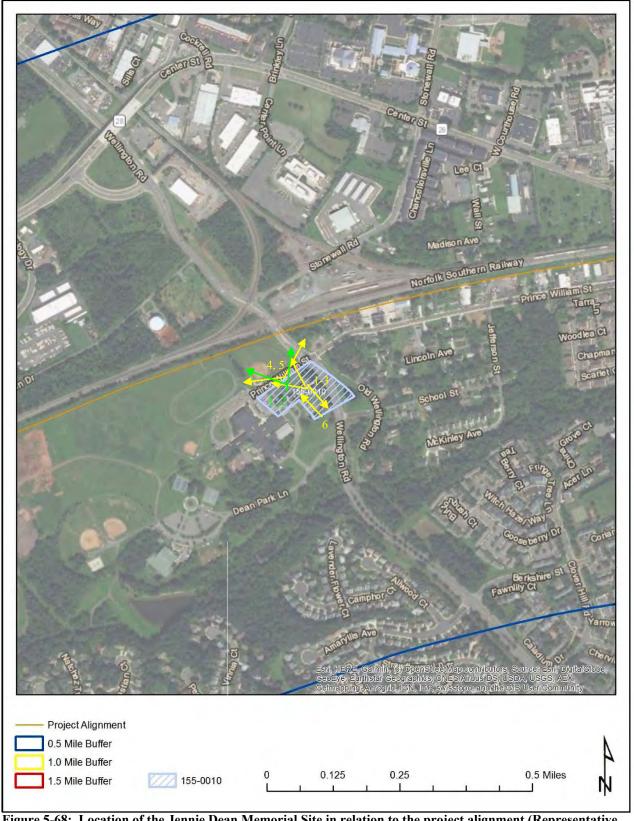
Figure 5-68: Location of the Jennie Dean Memorial Site in relation to the project alignment (Representative photographs and views towards the project area depicted in yellow, photo simulations depicted in green).

Figure 5-68 depicts the location of the Jennie Dean Memorial Site in relation to the project alignment and viewshed buffers, with the location and direction of all representative photographs and photo simulations. Figures 5-69 through 5-74 are representative photographs of the resource, as well as those taken from locations near the resource towards the project area. Figures 5-75 through 5-80 provide photo simulation from the resource.

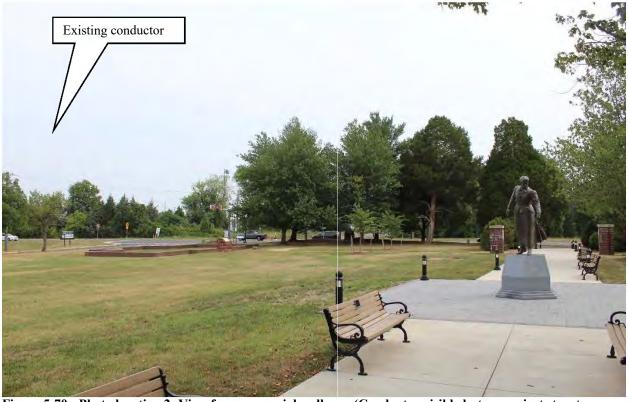
Figure 5-70: Photo location 2- View from memorial walkway (Conductor visible but no project structures visible), facing north.

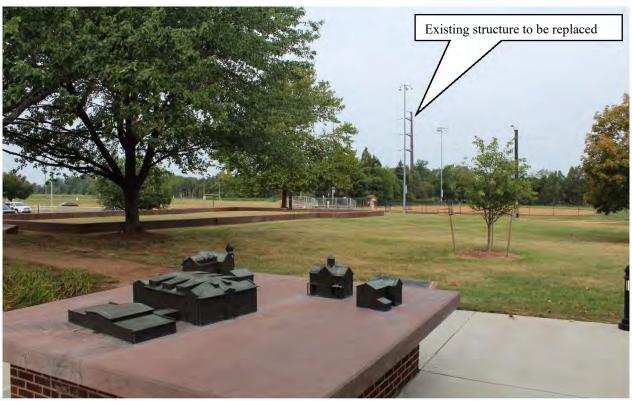
Figure 5-71: Photo location 3- View from interpretive walkway and memorial (Project structure visible), facing northwest.

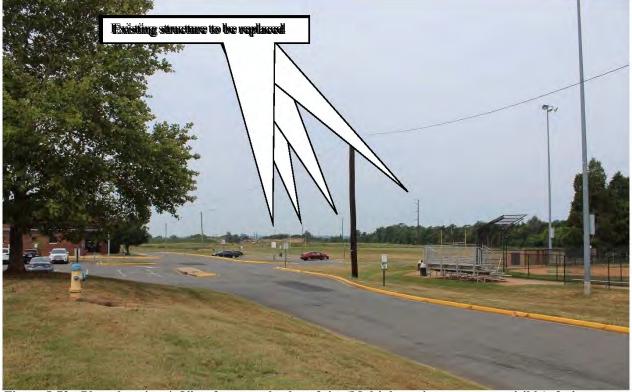
Figure 5-72: Photo location 4- View from north edge of site (Multiple project structures visible), facing northwest.

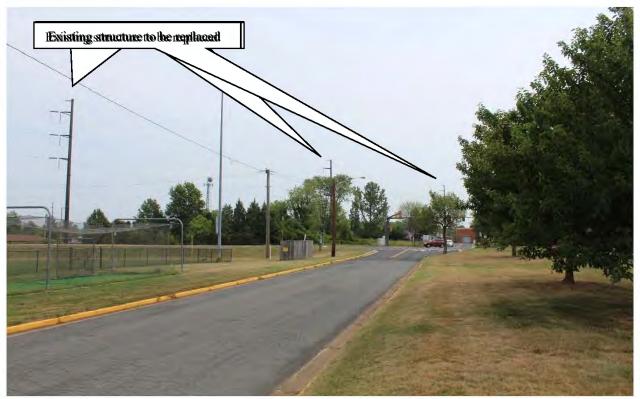
Figure 5-73: Photo location 5- View from north edge of site (Multiple project structures visible), facing northeast.

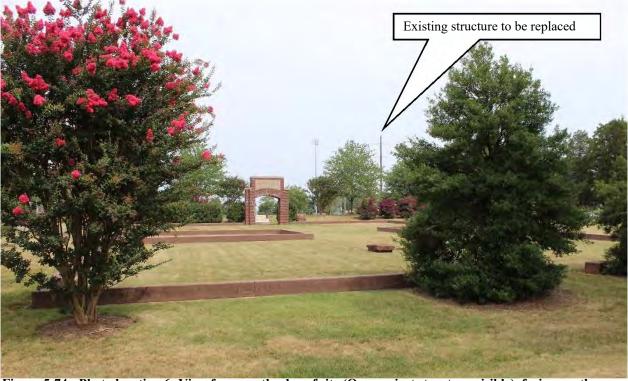
Figure 5-74: Photo location 6- View from south edge of site (One project structure visible), facing north.

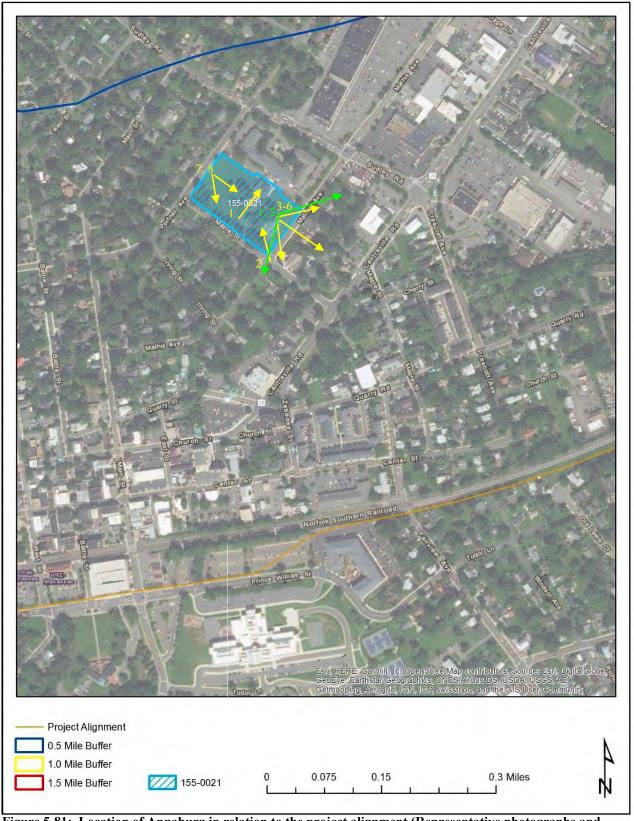
Figure 5-81: Location of Annaburg in relation to the project alignment (Representative photographs and views towards the project area depicted in yellow, photo simulations depicted in green).

Figure 5-81 depicts the location of the Annaburg property in relation to the project alignment and viewshed buffers, with the location and direction of all representative photographs and photo simulations. Figures 5-82 through 5-89 are representative photographs of the resource, as well as those taken from locations near the resource towards the project area. Figures 5-90 through 5-95 provide photo simulation from the resource.

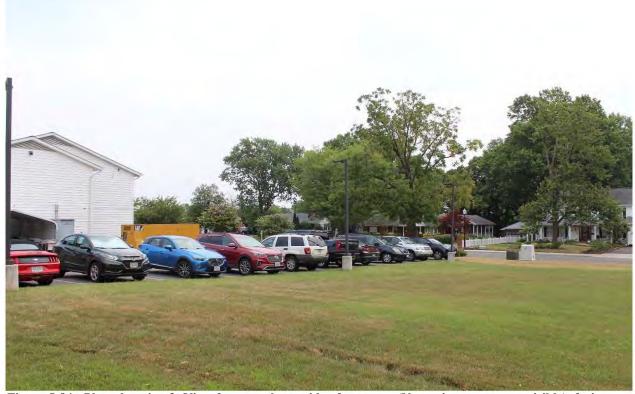
Figure 5-84: Photo location 3- View from southeast side of property (No project structures visible), facing east.

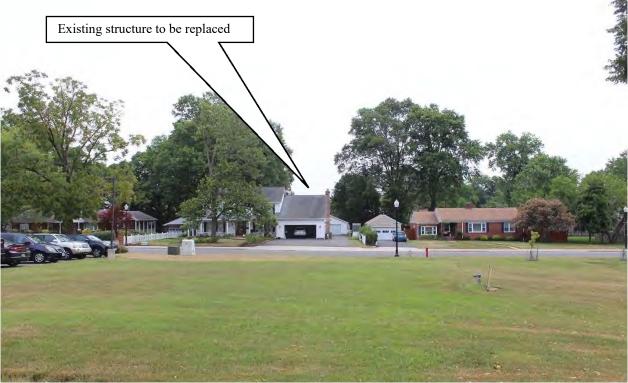
Figure 5-85: Photo location 4- View from southeast side of property (One project structure visible), facing southeast.

Inspection from throughout the homesite and property found that the existing structures are generally screened by the intervening development and vegetation, although a gap in the trees behind a house directly across the street allows visibility of one existing structure. The existing structures in the vicinity of the property to be replaced as part of this project range from 95- to 132-feet in height and the proposed replacement structures will range from 105- to 125-feet in height. The one existing structure currently visible is 116-feet tall and the replacement will be 115-

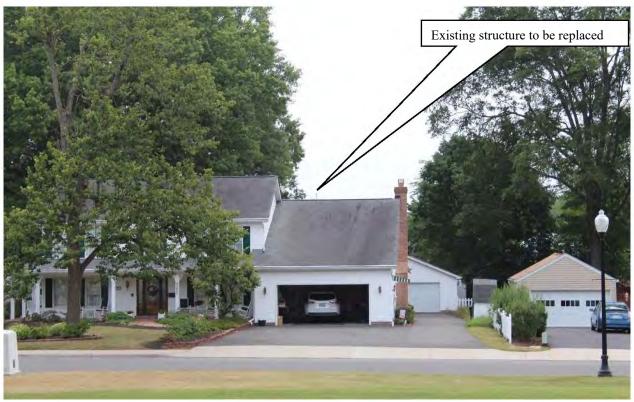
Figure 5-86: Photo location 5- Detail of view from southeast side of property (One project structure visible), facing southeast.

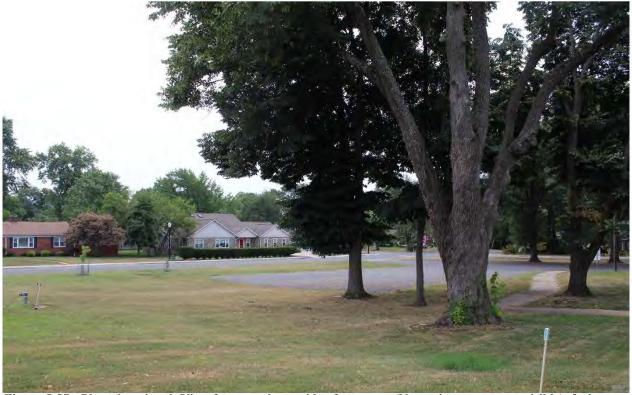
Figure 5-87: Photo location 6- View from southeast side of property (No project structures visible), facing south.

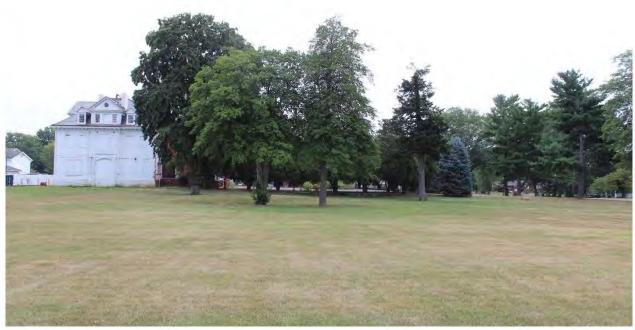
Figure 5-88: Photo location 7- View from northwest side of property (No project structures visible), facing southeast.

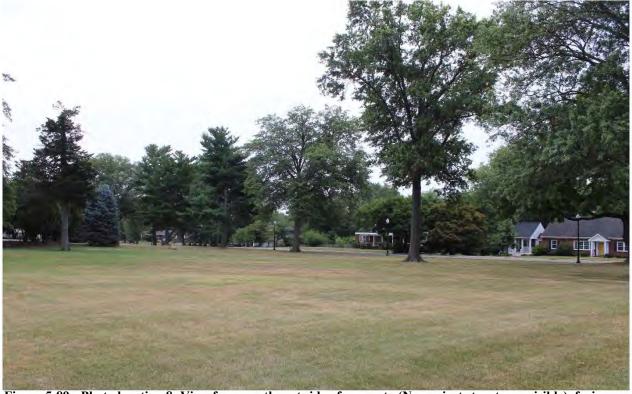
Figure 5-89: Photo location 8- View from northwest side of property (No project structures visible), facing south.

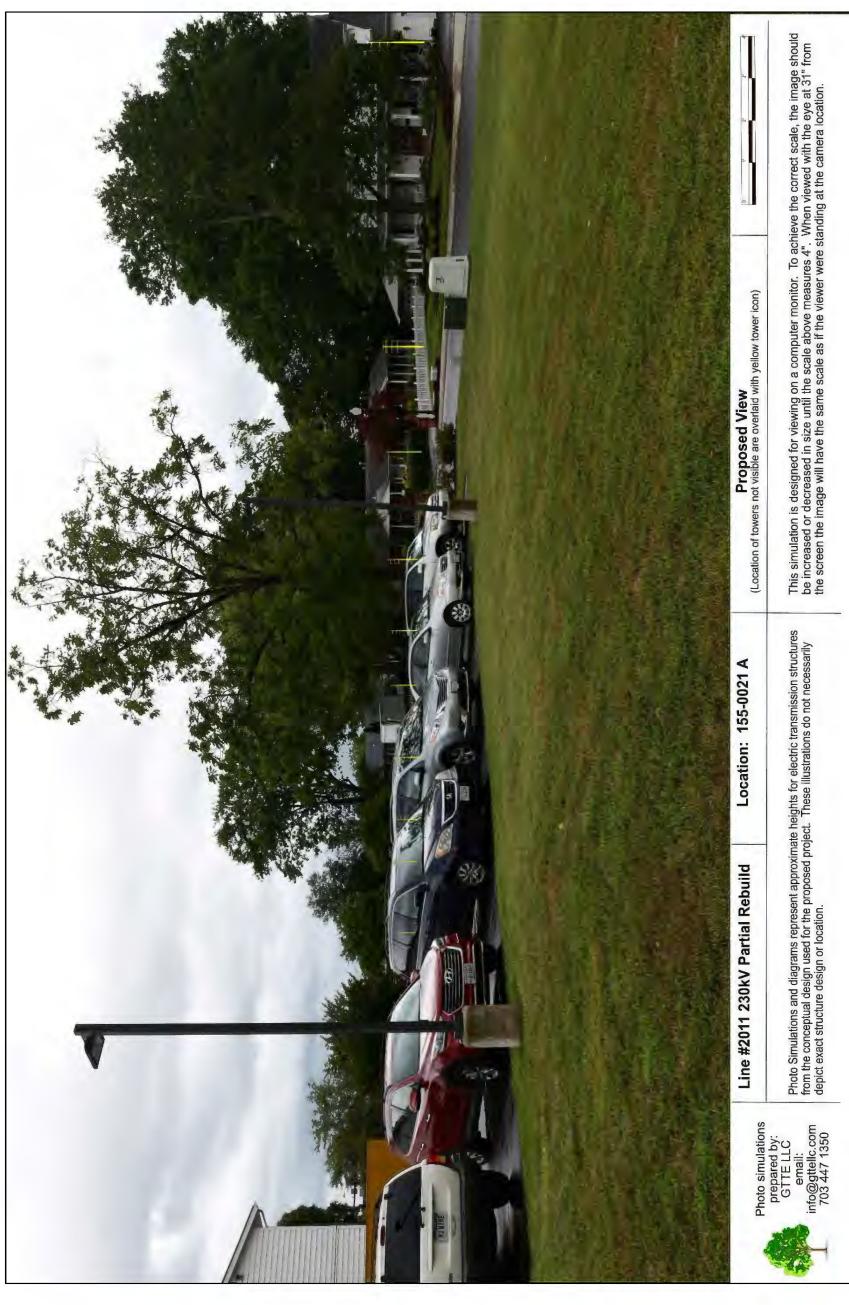
Figure 5-92: Annaburg Simulation 1 - Proposed view from side yard to northeast - (Structures not visible shown in yellow). Source: GTTE, LLC

feet tall. As such, there will be a slight increase in height for several of the structures, while others will remain the same height as the existing, or be decreased in height. The one structure that is currently visible will be decreased in height, and overall, the tallest replacement structure will be 7 feet shorter than the existing tallest structure. Therefore, it is anticipated that the intervening vegetation and development that currently screen the majority of existing structures will continue to do so from the Annaburg property and vicinity, while visibility of the structure that can currently be seen will diminish. This was confirmed by photo simulation from the property in two directions that depicts all structures will remain screened beneath the intervening vegetation and development. Therefore, the project will not introduce any noticeable change in setting or viewshed of or from the resource, and it is therefore D+A's opinion that the Line #2011 230kV Partial Rebuild (Clifton to Winters Branch) Project will pose no more than a *minimal impact* to Annaburg.
