Application, Appendix, DEQ Supplement, Direct Testimony and Exhibits of Virginia Electric and Power Company

Line #2011 230 kV Partial Rebuild Project

Application No. 323

DEQ Supplement

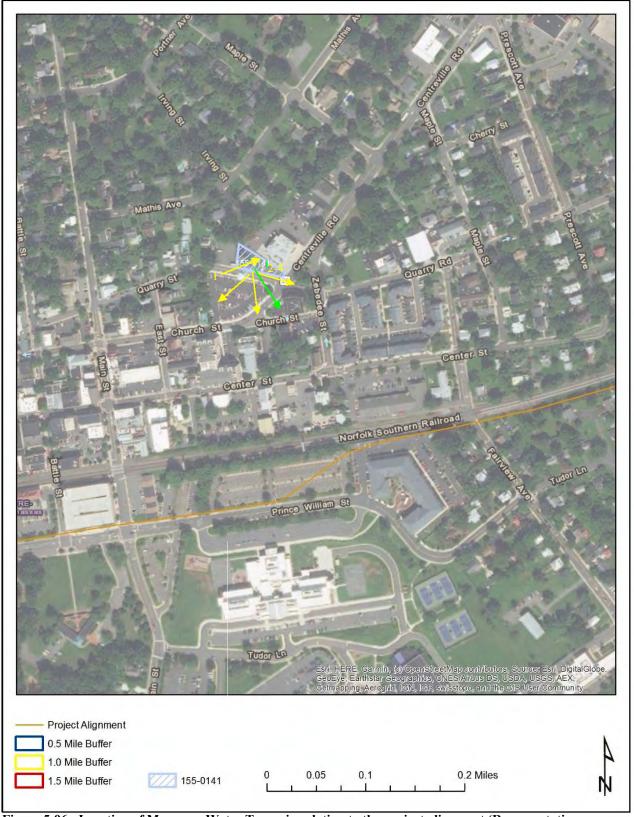
Figure 5-96: Location of Manassas Water Tower in relation to the project alignment (Representative photographs and views towards the project area depicted in yellow, photo simulations depicted in green).

Figure 5-96 depicts the location of the Old Manassas Water Tower property in relation to the project alignment and viewshed buffers, with the location and direction of all representative photographs and photo simulations. Figures 5-97 through 5-100 are representative photographs of the resource, as well as those taken from locations near the resource towards the project area. Figures 5-101 through 5-103 provide photo simulation from the resource.

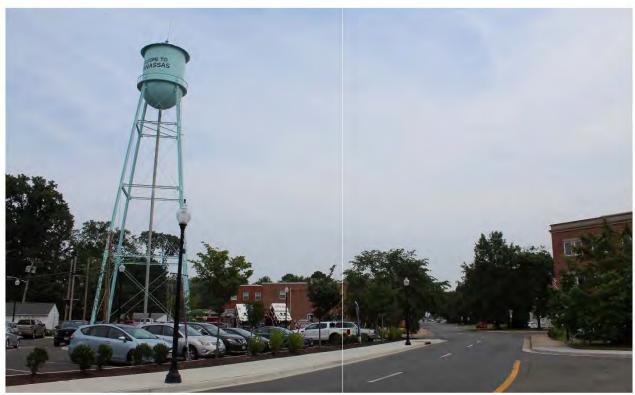
Figure 5-97: Photo location 1- Representative view of water tower and setting, facing northeast.

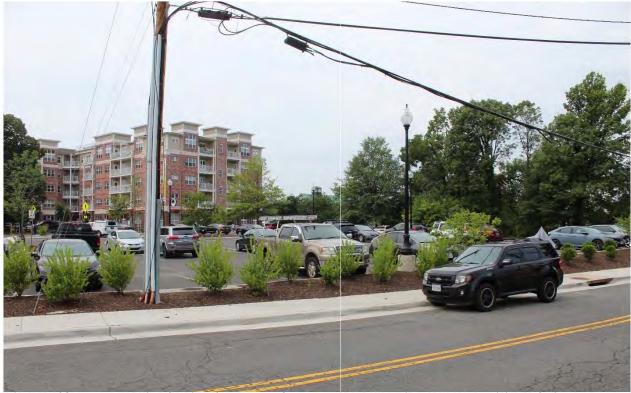
Figure 5-98: Photo location 2- View from base of water tower (No project structures visible), facing southwest.

Inspection from the base of the water tower found that none of the existing structures on the project alignment are visible above or through the intervening development and vegetation. The existing structures in the vicinity of the property to be replaced as part of this project range from 80- to 114-feet in height and the proposed replacement structures will range from 95- to 125-feet in height. As such, there will be an overall increase in height for most of the structures with the tallest replacement structure being roughly 11 feet more than the tallest existing structure. Despite the increase, it is anticipated that the intervening vegetation and development that currently screen the existing structures will continue to provide nearly complete screening of the replacement structures from the Old Manassas Water Tower and vicinity, although there is the chance that individual structures may rise just above these features from discrete vantage points. This was confirmed by photo simulation from the base that revealed all proposed structures will remain just below the

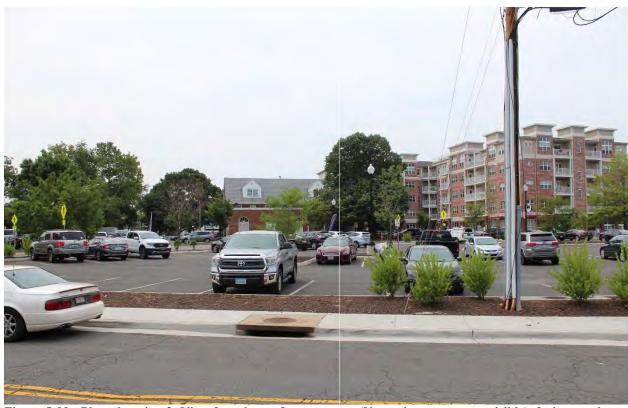
Figure 5-99: Photo location 3- View from base of water tower (No project structures visible), facing south.

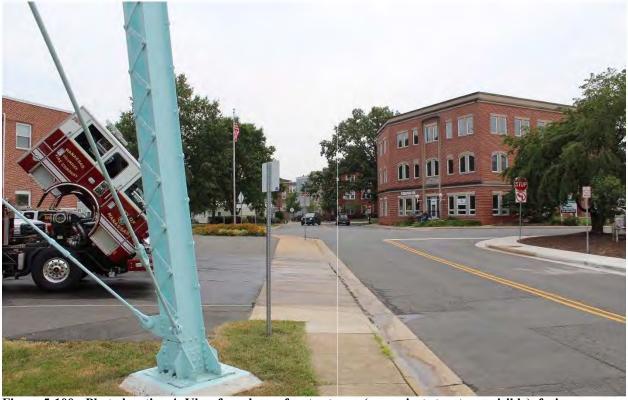
Figure 5-100: Photo location 4- View from base of water tower (no project structures visible), facing northeast.

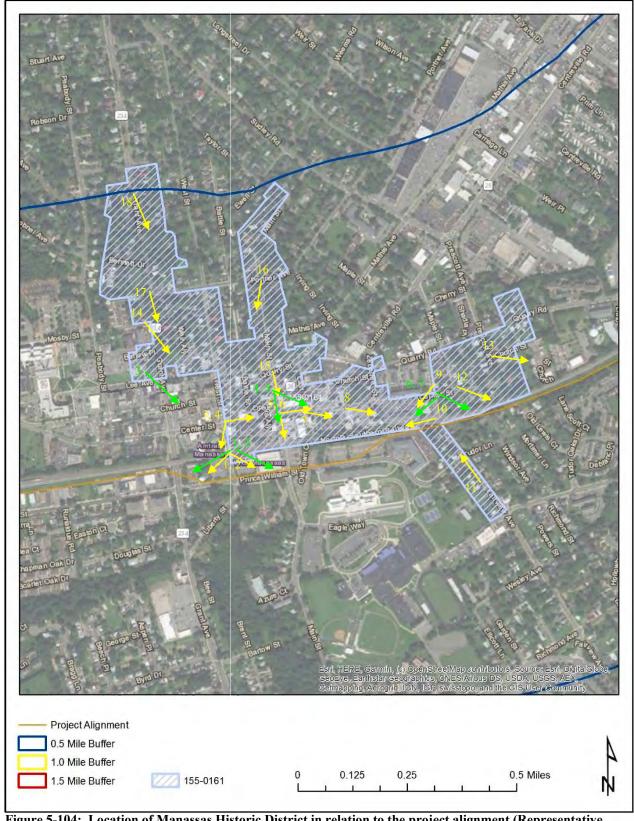
Figure 5-104: Location of Manassas Historic District in relation to the project alignment (Representative photographs and views towards the project area depicted in yellow, photo simulations depicted in green).

Figure 5-104 depicts the location of the Manassas Historic District in relation to the project alignment and viewshed buffers, with the location and direction of all representative photographs and photo simulations. Figures 5-105 through 5-122 are representative photographs of the resource, as well as those taken from locations near the resource towards the project area. Figures 5-123 through 5-143 provide photo simulation from the resource.

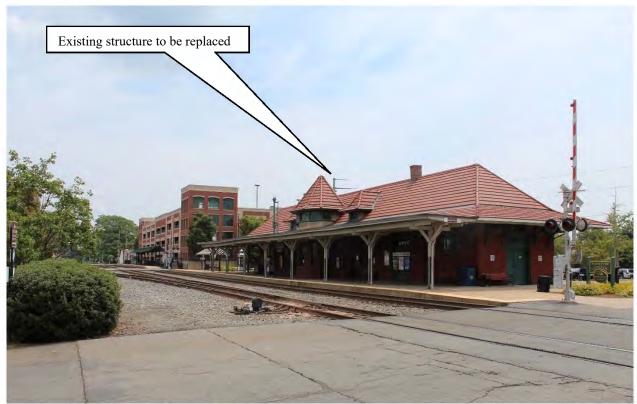
Figure 5-105: Photo location 1- View from Manassas Railroad Station (Project structure visible), facing southeast.

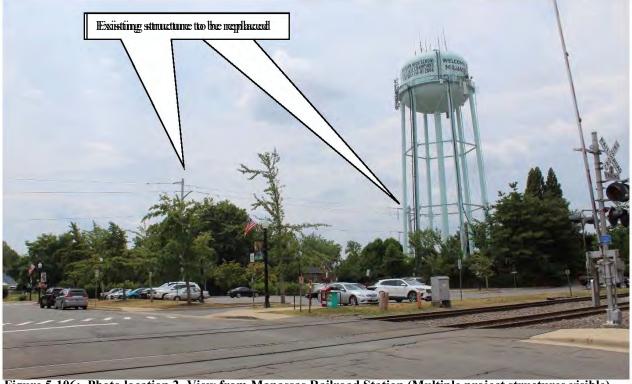
Figure 5-106: Photo location 2- View from Manassas Railroad Station (Multiple project structures visible), facing southwest.

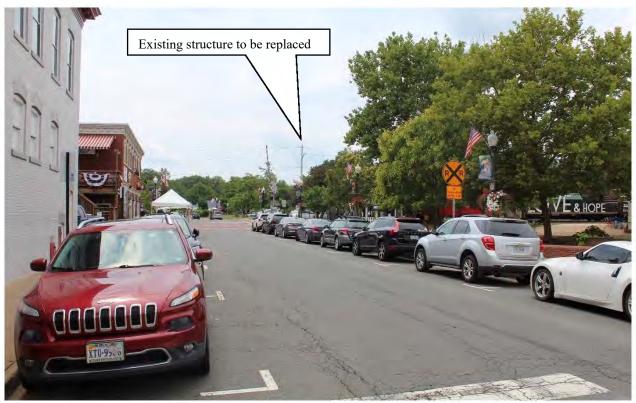
Figure 5-107: Photo location 3- View from West Street at Center Street (Project structure visible), facing south.

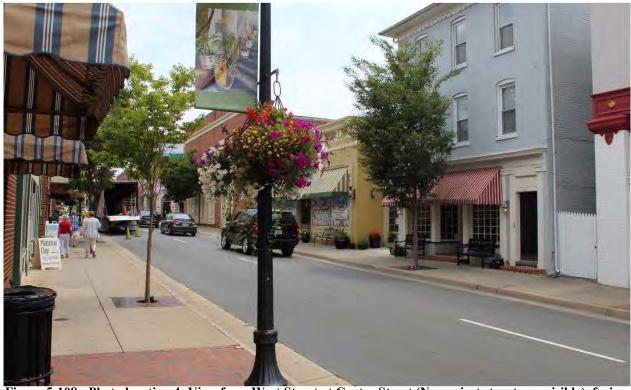
Figure 5-108: Photo location 4- View from West Street at Center Street (No project structures visible), facing southeast.

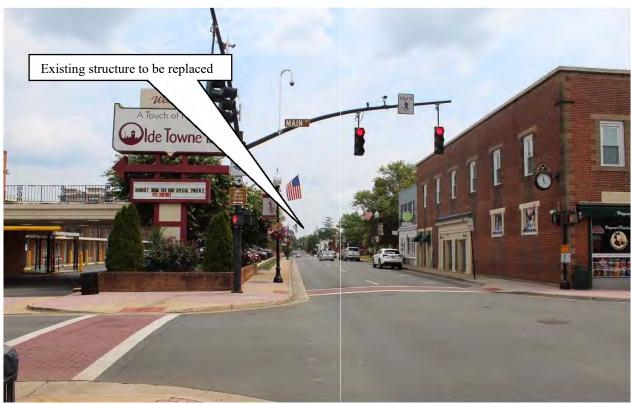
Figure 5-109: Photo location 5- View from Center Street at Main Street (Project structure visible), facing east.

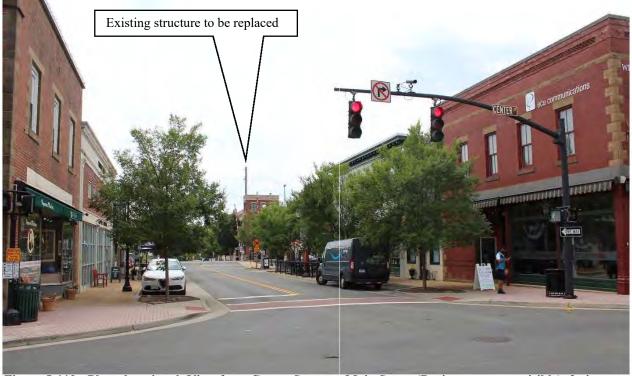
Figure 5-110: Photo location 6- View from Center Street at Main Street (Project structure visible), facing south.

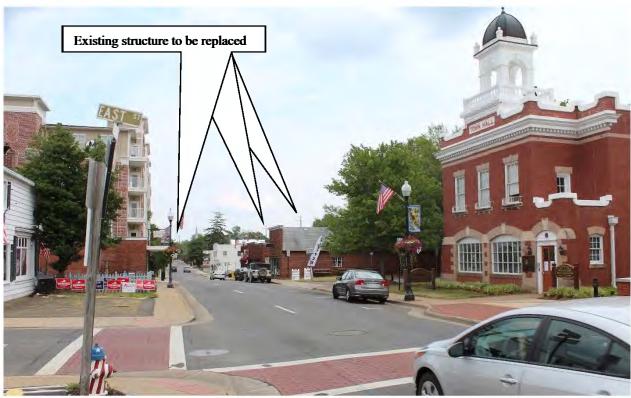
Figure 5-111: Photo location 7- View from Center Street at East Street (Multiple project structures visible), facing east.

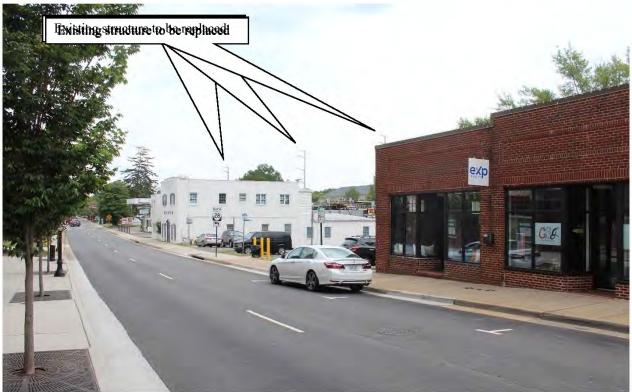
Figure 5-112: Photo location 8- View from Center Street east of East Street (Multiple project structures visible), facing southeast.

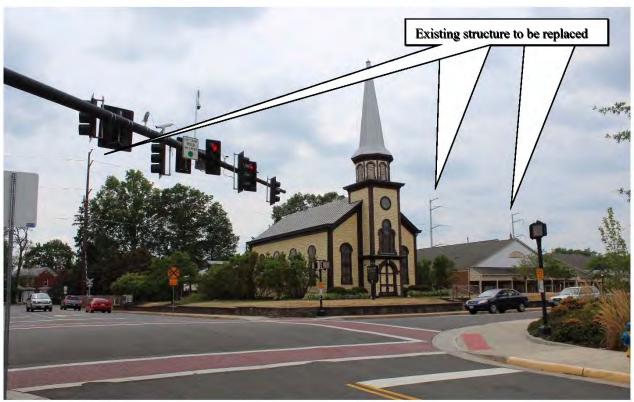
Figure 5-113: Photo location 9- View from Fairview Avenue at Center Street (Multiple project structures visible), facing south.

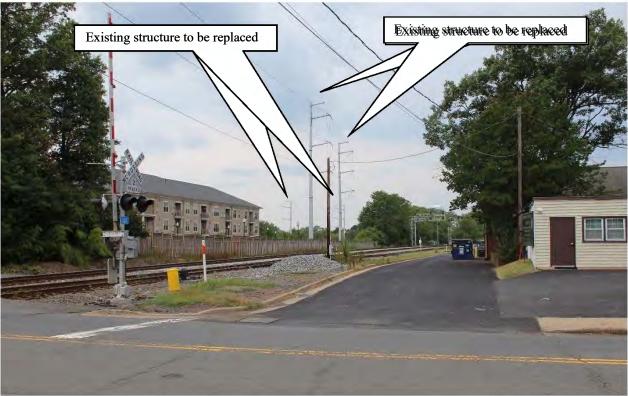
Figure 5-114: Photo location 10- View from Fairview Avenue at railroad crossing (Multiple project structures visible), facing west.

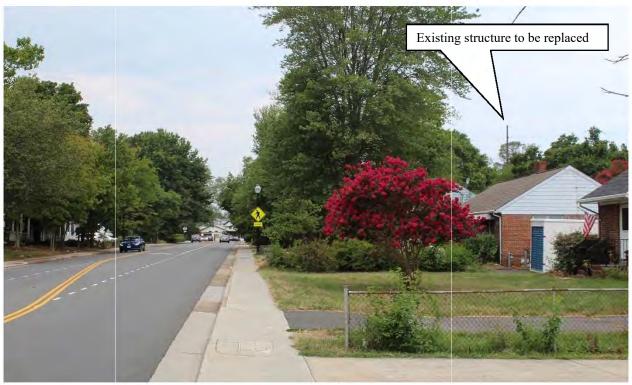
Figure 5-115: Photo location 11- View from Fairview Avenue south of railroad (Project structure visible), facing north.

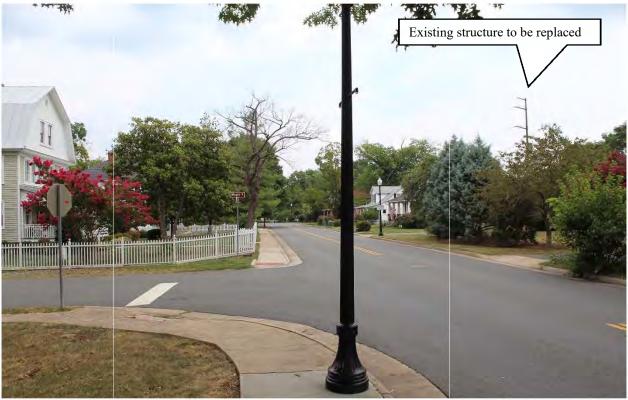
Figure 5-116: Photo location 12- View from Center Street at Maple Street (Project structure visible), facing east.

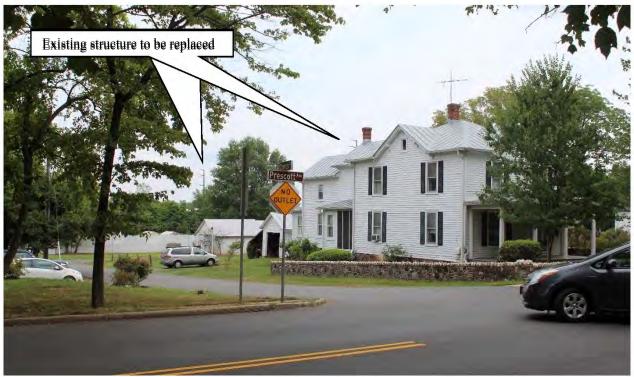
Figure 5-117: Photo location 13- View from Prescott Avenue at Church Street (Multiple project structures visible), facing south.

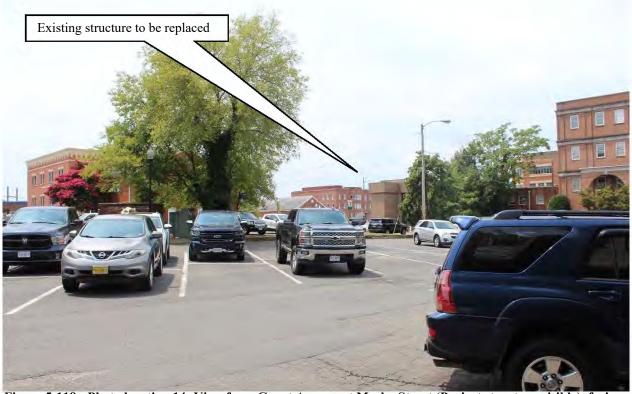
Figure 5-118: Photo location 14- View from Grant Avenue at Mosby Street (Project structure visible), facing south.

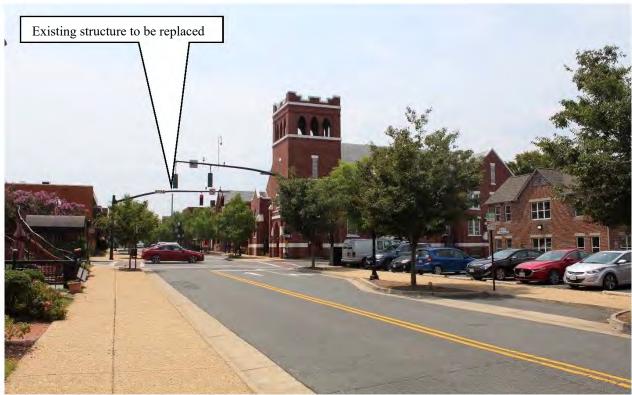
Figure 5-119: Photo location 15 - View from Main Street at Church Street (Project structure visible), facing south.

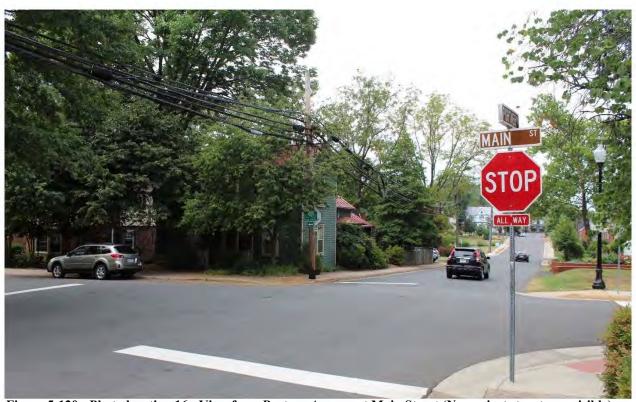
Figure 5-120: Photo location 16 - View from Portner Avenue at Main Street (No project structures visible), facing south.

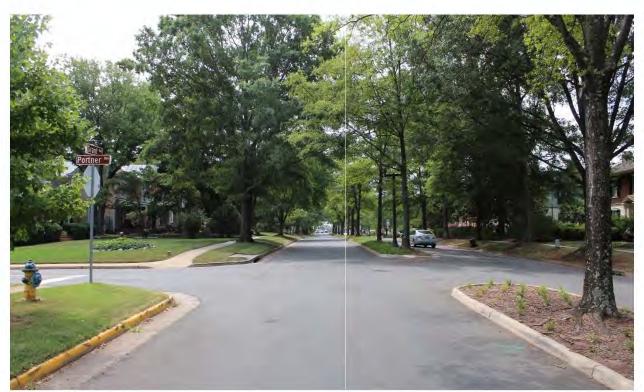
Figure 5-121: Photo location 17- View from Grant Avenue at Portner Avenue (No project structures visible), facing south.

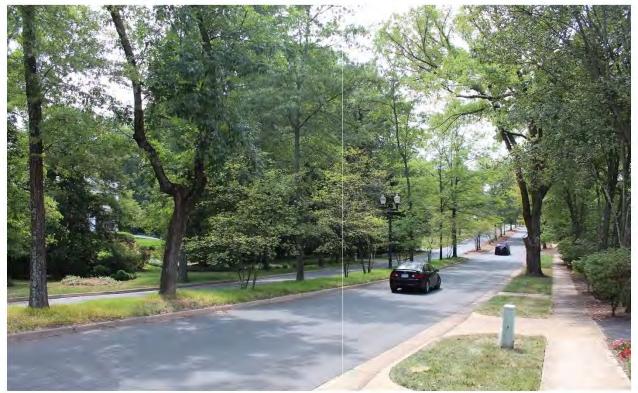
Figure 5-122: Photo location 18- View from Grant Avenue at north edge of historic district (No project structures visible), facing south.

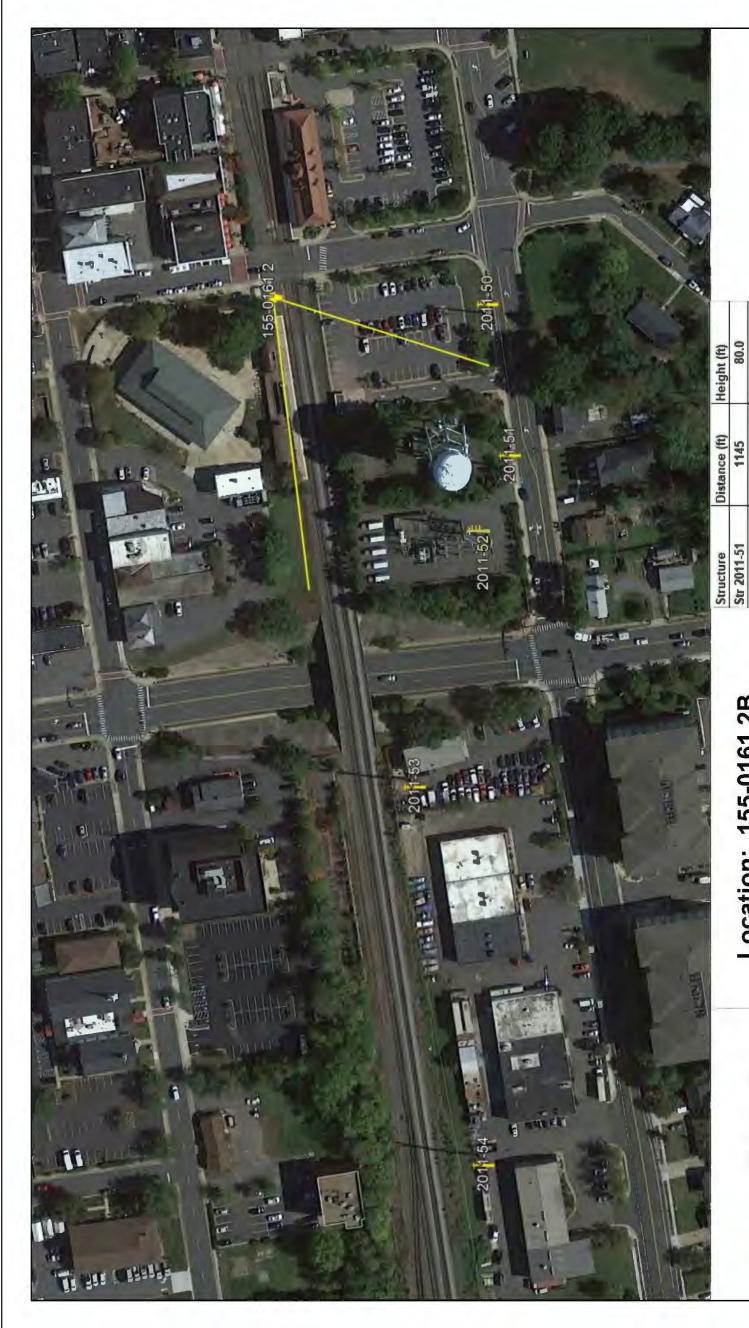
Location: 155-0161 2B

Figure 5-126: Manassas Historic District Simulation 2 – Simulation location, direction of view, and structures modeled Manassas Rail Depot looking west. Source: GTTE, LLC email: info@gttellc.com 703 447 1350

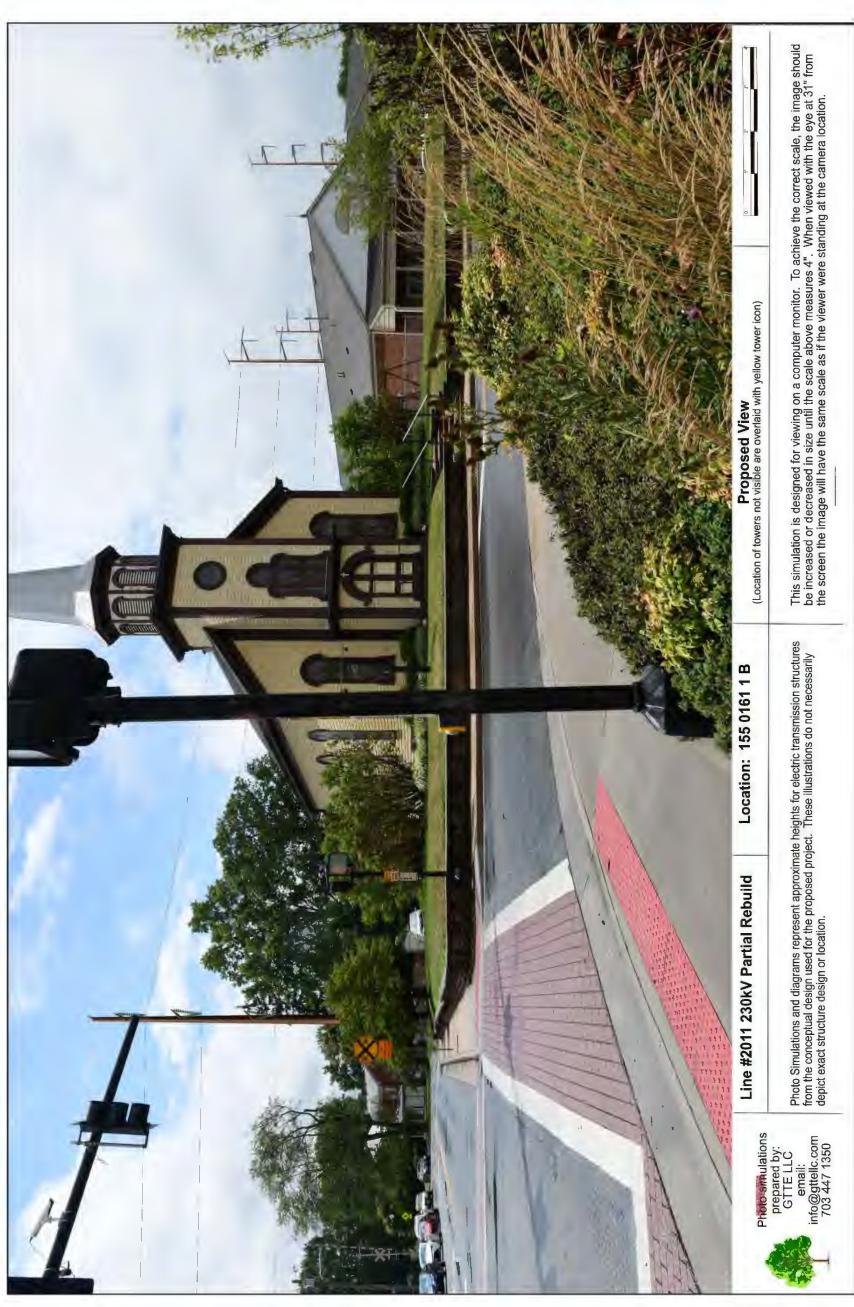
Figure 5-143: Manassas Historic District Simulation 7 - Proposed view from intersection of Center Street and Fairview Avenue - (Visible structures shown as they would appear). Source: GTTE, LLC

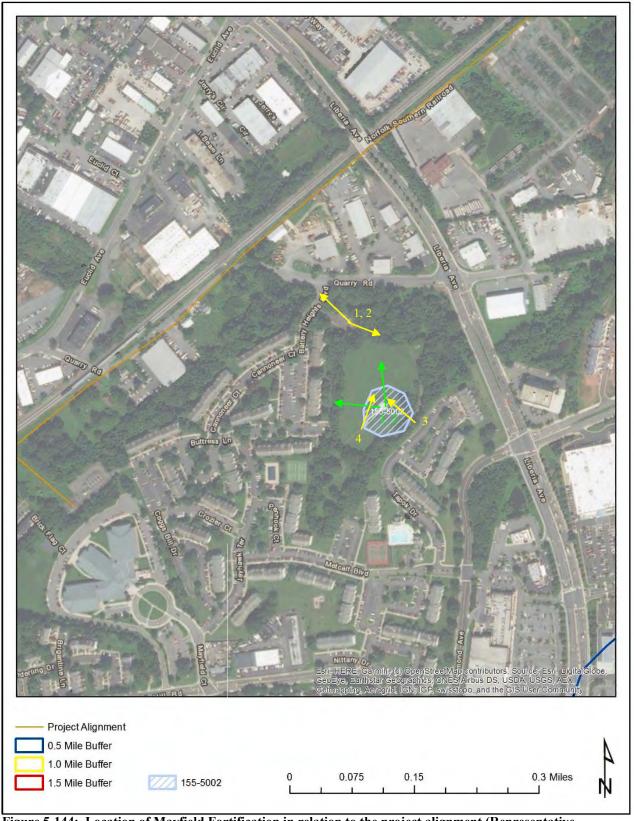
Figure 5-144: Location of Mayfield Fortification in relation to the project alignment (Representative photographs and views towards the project area depicted in yellow, photo simulations depicted in green).

Figure 5-144 depicts the location of Mayfield Fortification in relation to the project alignment and viewshed buffers, with the location and direction of all representative photographs and photo simulations. Figures 5-145 through 5-148 are representative photographs of the resource, as well as those taken from locations near the resource towards the project area. Figures 5-149 through 5-154 provide photo simulation from the resource.

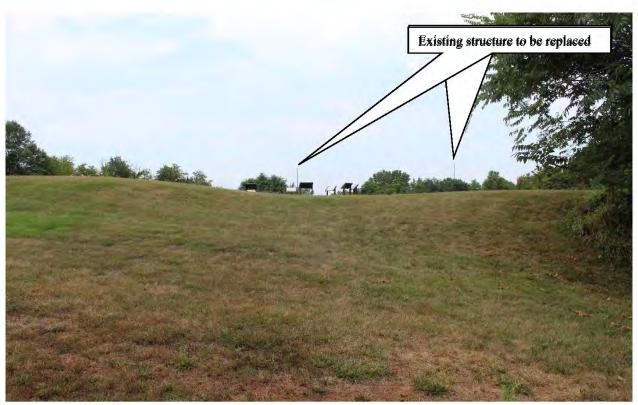
Figure 5-147: Photo location 3- View from trail approaching interpretative area (Multiple project structures visible), facing northwest.

Inspection from the parking area found that the thick vegetation and dense development patterns in the area inhibit distant views in the direction of the project and no existing structures can be seen. Inspection from along the walkway to the ridgetop and interpretive area found that several existing structures become visible from the cleared and more elevated areas, and multiple existing structures can be seen extending to the west and north of the site from the interpretive kiosks. The existing structures within the vicinity to be replaced as part of this project range from 107- to 130-feet in height and the proposed replacement structures will range from 115- to 130-feet in height. As such, the overall height will not increase, and while the heights of most of the individual proposed structures will remain the same, some may vary or increase in height slightly from their existing configuration. As such, it is anticipated visibility will remain similar, with structures that are currently visible remaining as such, while the intervening vegetation will continue to screen

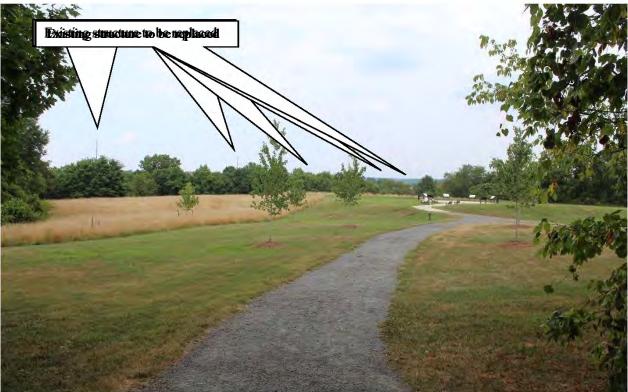
Figure 5-148: Photo location 4- View from ridgetop near interpretative area (Multiple project structures visible), facing north.

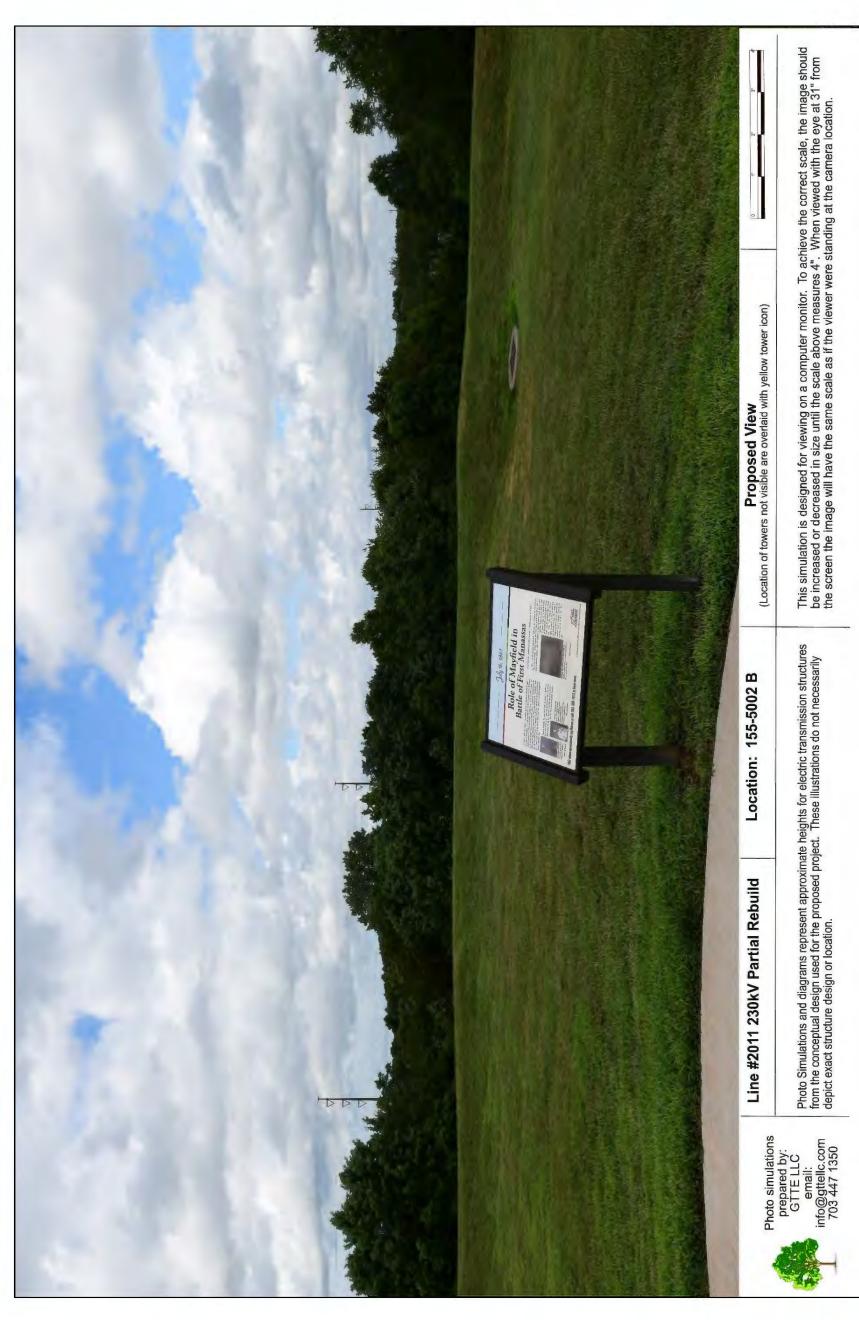
Figure 5-154: Mayfield Fortification Simulation 2 – Proposed view from interpretive kiosk looking north – (Visible structures shown as they would appear). Source: GTTE, LLC

visibility of those structures that are not currently visible. Because the structures that are currently visible will generally remain the same height and configuration, the change will not be perceptible at the distance they are set. This was confirmed by photo simulation in two directions that revealed unchanged visibility of structures currently visible with the addition of a small portion of the top of one additional structure above the treeline in the distance that is currently screened. Therefore, the project will not introduce any noticeable change in setting or viewshed of or from the resource which already includes visibility of multiple structures, and it is therefore D+A's opinion that the Line #2011 230kV Partial Rebuild (Clifton to Winters Branch) Project will pose no more than a *minimal impact* to the Mayfield Fortification.

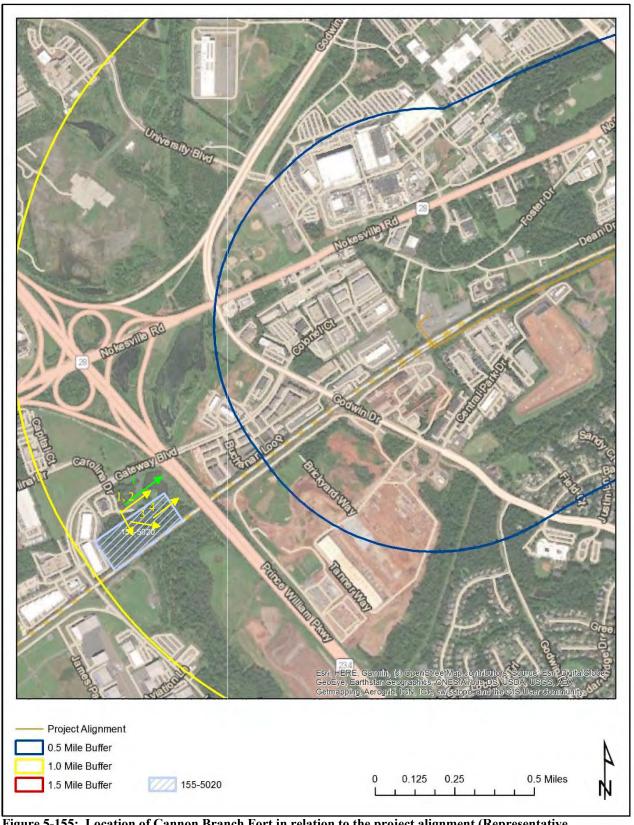
Figure 5-155: Location of Cannon Branch Fort in relation to the project alignment (Representative photographs and views towards the project area depicted in yellow, photo simulations depicted in green).

Figure 5-155 depicts the location of the Cannon Branch Fort in relation to the project alignment and viewshed buffers, with the location and direction of all representative photographs and photo simulations. Figures 5-156 through 5-159 are representative photographs of the resource, as well as those taken from locations near the resource towards the project area. Figures 5-160 through 5-162 provide photo simulation from the resource.

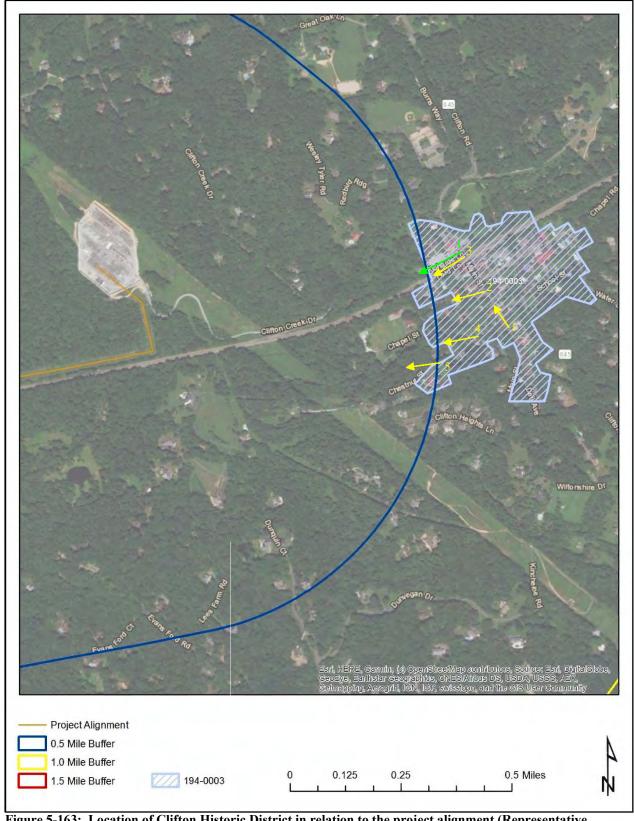
Figure 5-163: Location of Clifton Historic District in relation to the project alignment (Representative photographs and views towards the project area depicted in yellow, photo simulations depicted in green).

Figure 5-163 depicts the location of the Clifton Historic District in relation to the project alignment and viewshed buffers, with the location and direction of all representative photographs and photo simulations. Figures 5-164 through 5-168 are representative photographs of the district, as well as those taken from locations throughout the district towards the project area. Figures 5-169 through 5-171 provide photo simulation from the district.

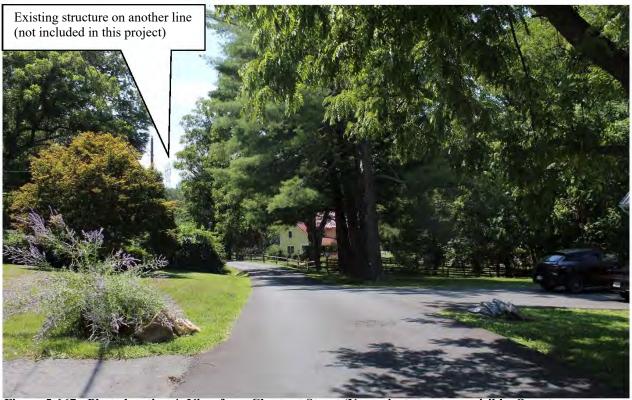
Figure 5-167: Photo location 4- View from Chestnut Street (No project structures visible. One structure on another line not included in this project is visible), facing west.

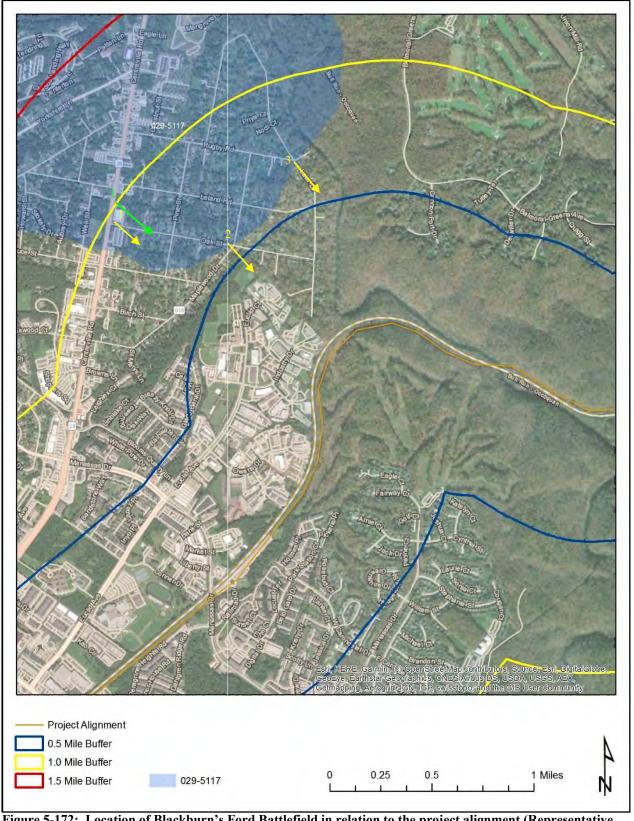
Figure 5-172: Location of Blackburn's Ford Battlefield in relation to the project alignment (Representative photographs and views towards the project area depicted in yellow, photo simulations depicted in green).

Figure 5-172 depicts the boundaries of the Blackburn's Ford Battlefield in relation to the project area and viewshed buffers, with the location and direction of all representative photographs and photo simulations. Figures 5-173 through 5-178 are representative photographs of the battlefield, as well as those taken from locations within and near the battlefield towards the project area. Figures 5-179 through 5-181 provide photo simulation from the battlefield.

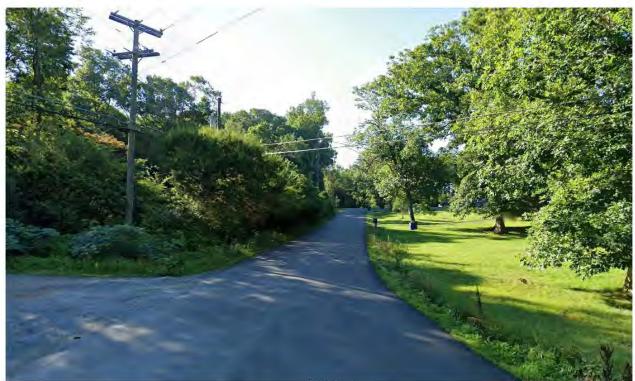
Figure 5-175: Photo location 3- View intersection of Rugby Road and Lake Drive (No project structures visible), facing southeast.

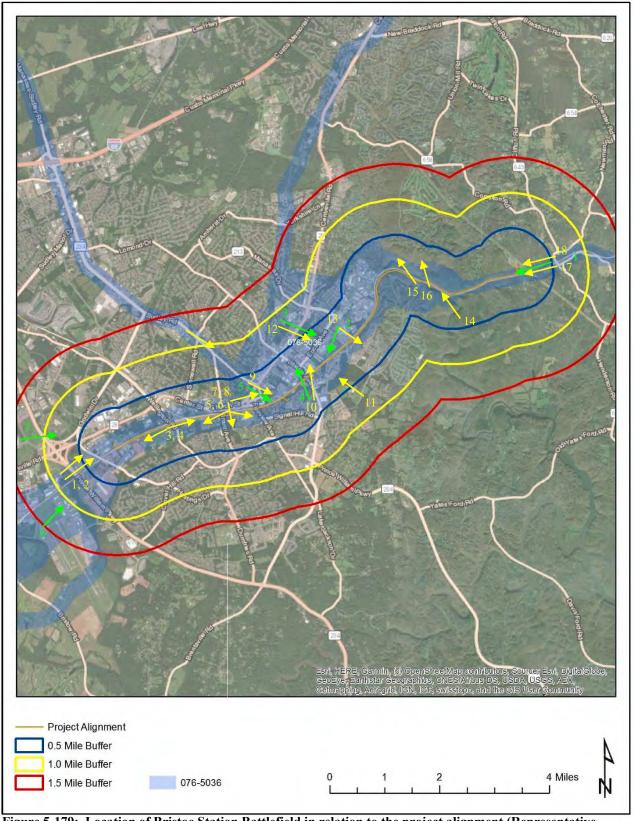
Figure 5-179: Location of Bristoe Station Battlefield in relation to the project alignment (Representative photographs and views towards the project area depicted in yellow, photo simulations depicted in green).

Figure 5-179 depicts the boundaries of the Bristoe Station Battlefield in relation to the project area and viewshed buffers, with the location and direction of all representative photographs and photo simulations. Figures 5-180 through 5-197 are representative photographs of the battlefield, as well as those taken from locations within and near the battlefield towards the project area. Figures 5-198 through 5-218 provide photo simulation from the resource.

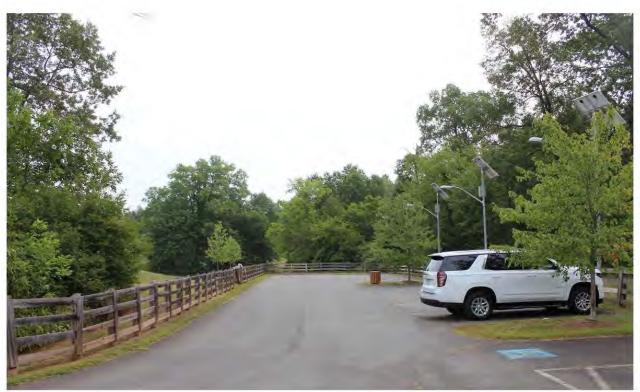
Figure 5-180: Photo location 1- View from Cannon Branch Fort parking lot (No project structures visible), facing east.

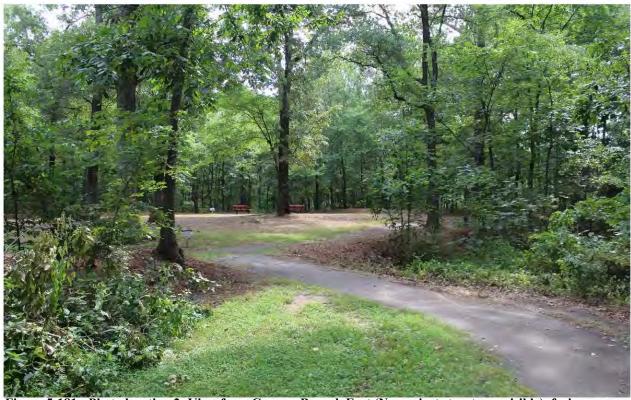
Figure 5-181: Photo location 2- View from Cannon Branch Fort (No project structures visible), facing southeast.

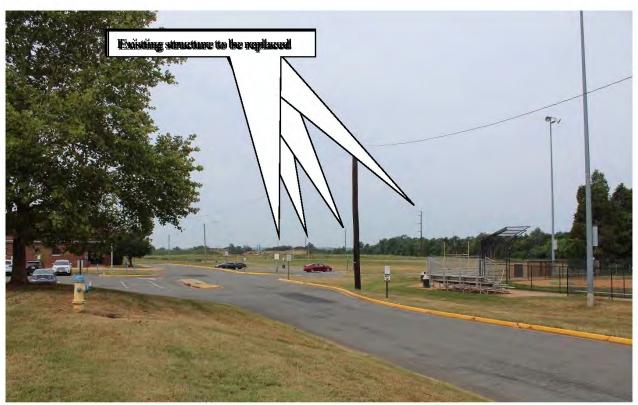
Figure 5-182: Photo location 3- View from Jennie Dean Memorial Site (Multiple project structures visible), facing northwest.

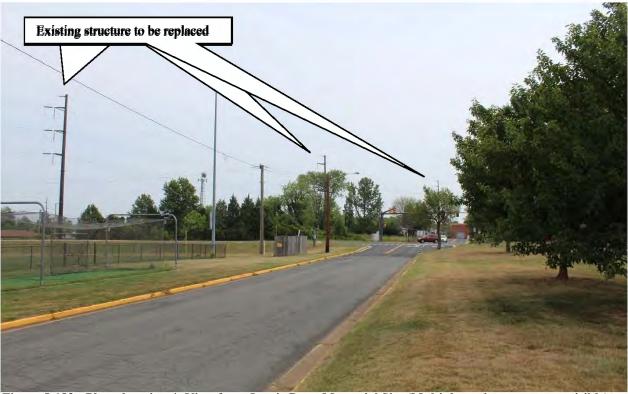
Figure 5-183: Photo location 4- View from Jennie Dean Memorial Site (Multiple project structures visible), facing northeast.

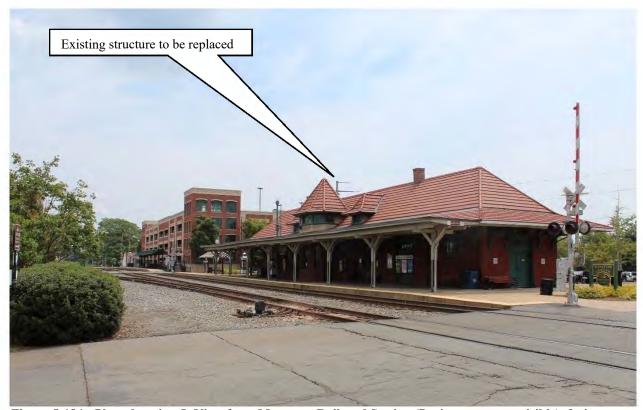
Figure 5-184: Photo location 5- View from Manassas Railroad Station (Project structure visible), facing southeast.

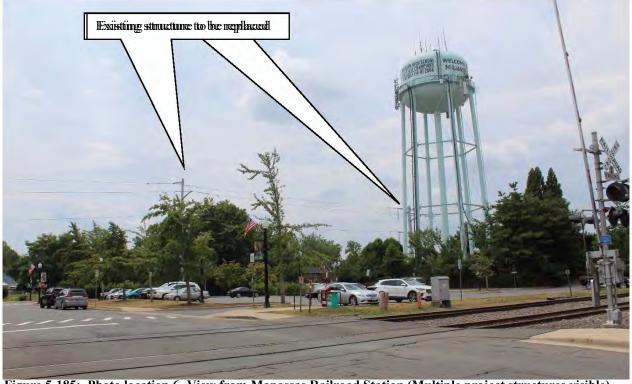
Figure 5-185: Photo location 6- View from Manassas Railroad Station (Multiple project structures visible), facing southwest.

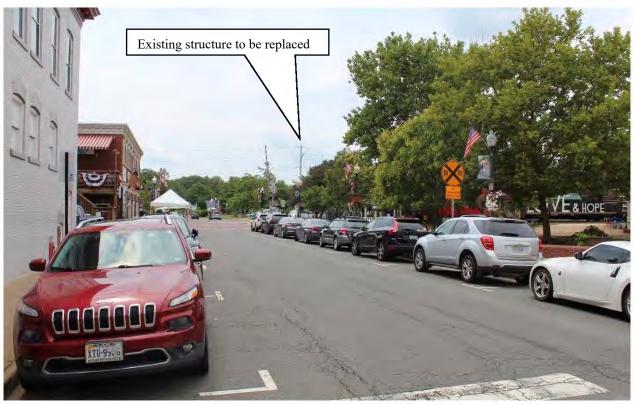
Figure 5-186: Photo location 7- View from West Street at Center Street (Project structure visible), facing south.

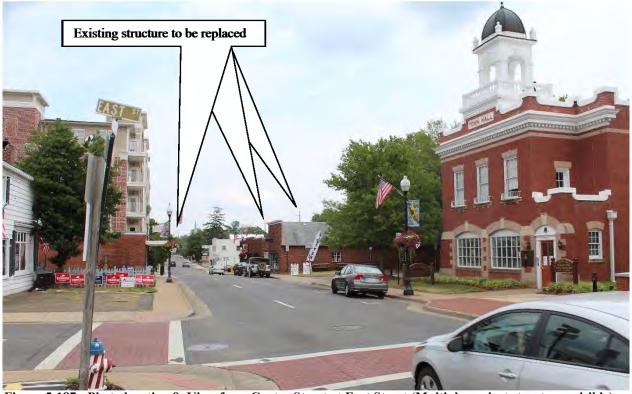
Figure 5-187: Photo location 8- View from Center Street at East Street (Multiple project structures visible), facing east.

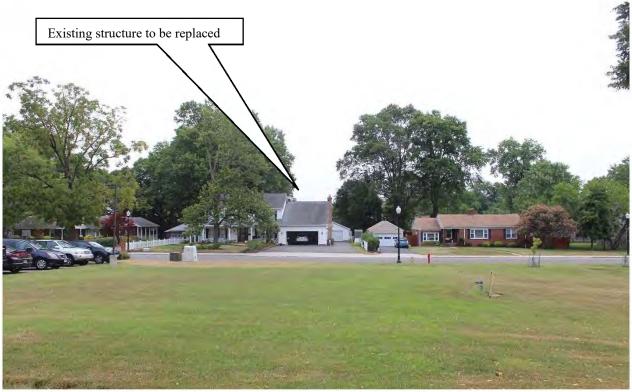
Figure 5-188: Photo location 9- View from Annaburg (One project structure visible), facing southeast.

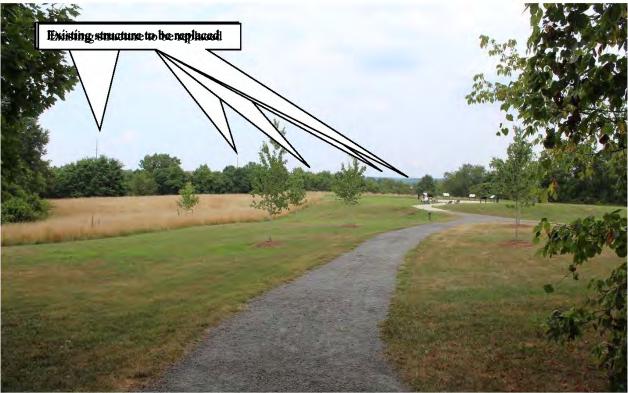
Figure 5-189: Photo location 10- View from Mayfield Fortification near interpretative area (Multiple project structures visible), facing north.

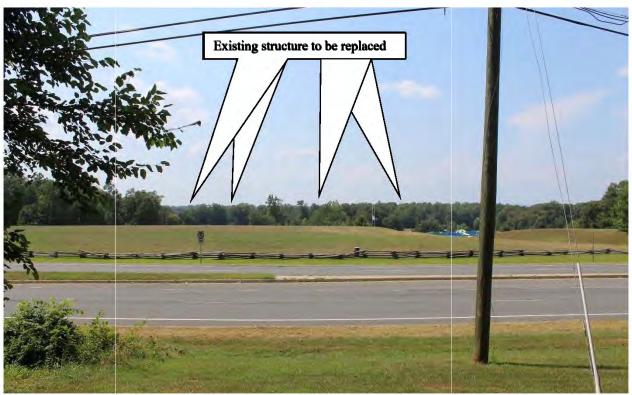
Figure 5-190: Photo location 11- View from Signal Hill (Multiple project structures visible), facing northwest.

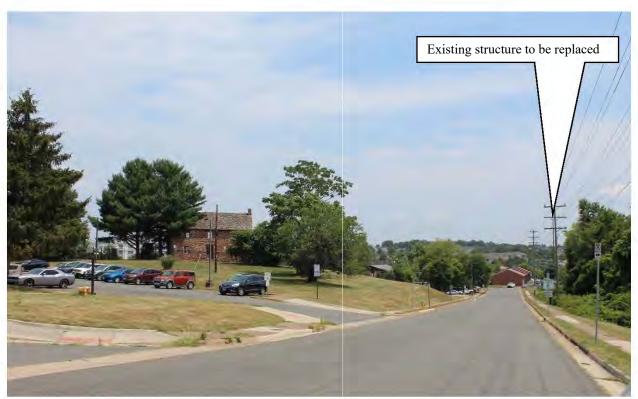
Figure 5-192: Photo location 13- View from Conner House (One project structure visible), facing southeast.

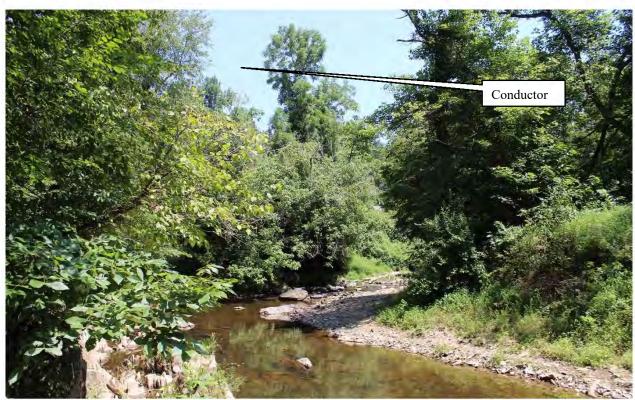
Figure 5-194: Photo location 15- View from Hemlock Overlook Regional Park (No project structures visible, but a length of conductor is visible), facing north.

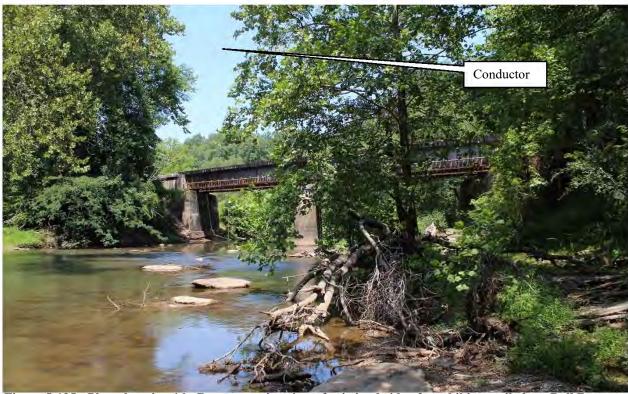
Figure 5-195: Photo location 16 - Representative view of existing bridge from hiking trail along Bull Run Creek (Conductor visible above bridge but no project structures visible), facing north.

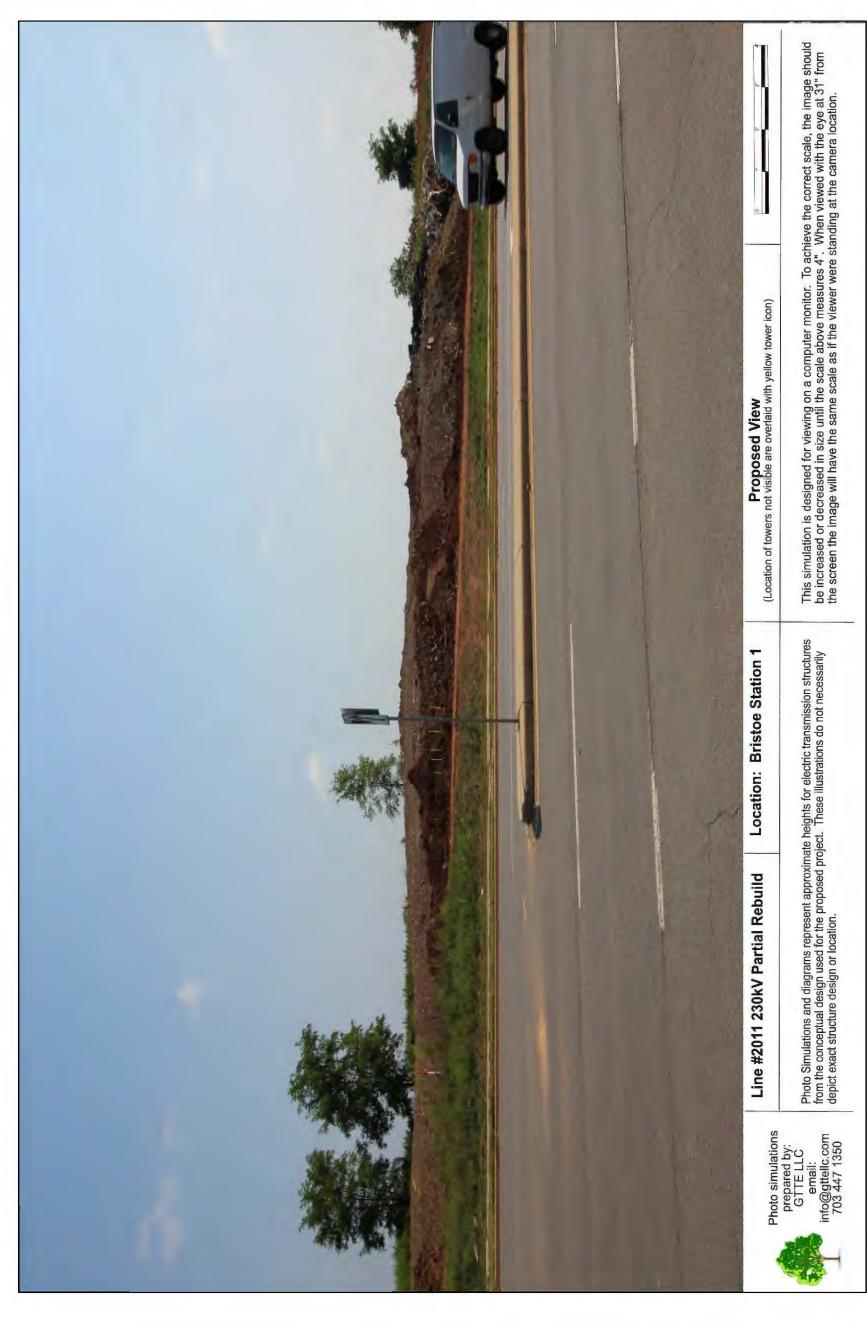
Figure 5-218: Bristoe Station Battlefield Simulation 7 - Proposed view from Hornbaker Road - (Structures not visible shown in yellow). Source: GTTE, LLC

Figure 5-217: Bristoe Station Battlefield Simulation 7 – Existing view from Hornbaker Road.
Source: GTTE, LLC5-216
Figure 5-218: Bristoe Station Battlefield Simulation 7 – Proposed view from Hornbaker Road –
(Structures not visible shown in yellow). Source: GTTE, LLC
Figure 5-219: Location of Second Manassas Battlefield in relation to the project alignment
(Representative photographs and views towards the project area depicted in yellow, photo
simulations depicted in green).
Figure 5-220: Photo location 1- View from Wellington Road at Godwin Drive (No project
structures visible), facing southeast
Figure 5-221: Photo location 2- View from Nokesville Road overpass of Wellington Road
(Multiple project structures visible), facing southeast
Figure 5-222: Photo location 3- View from Grant Avenue near Sudley Road (No project
structures visible), facing south.
Figure 5-223: Photo location 4- View from Grant Avenue at Portner Avenue (No project

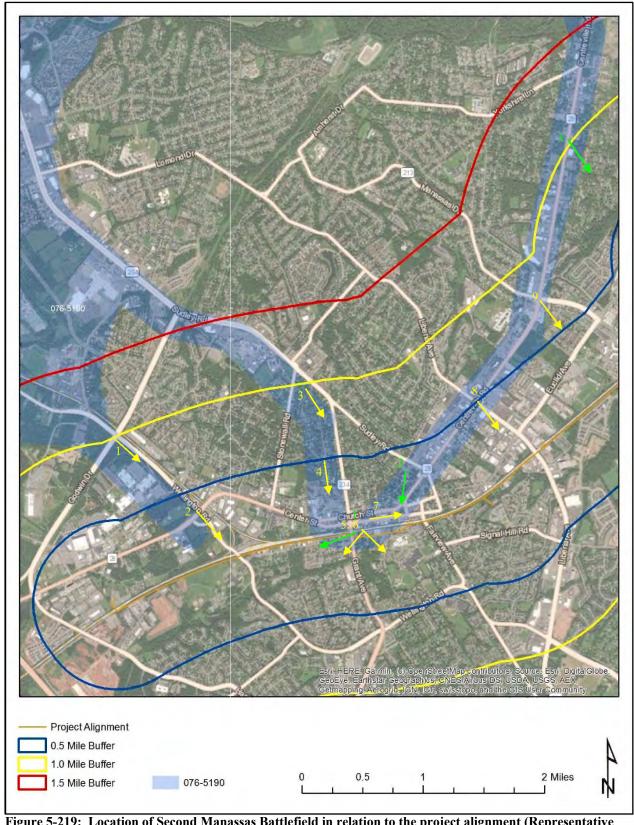
Figure 5-219: Location of Second Manassas Battlefield in relation to the project alignment (Representative photographs and views towards the project area depicted in yellow, photo simulations depicted in green).

Figure 5-219 depicts the boundaries of the Second Manassas Battlefield in relation to the project area and viewshed buffers, with the location and direction of all representative photographs and photo simulations. Figures 5-220 through 5-228 are representative photographs of the battlefield, as well as those taken from locations within and near the battlefield towards the project area. Figures 5-229 through 5-237 provide photo simulation from the resource.
