Application, Appendix, DEQ Supplement, Direct Testimony and Exhibits of Virginia Electric and Power Company

Line #2011 230 kV Partial Rebuild Project

Application No. 323

DEQ Supplement

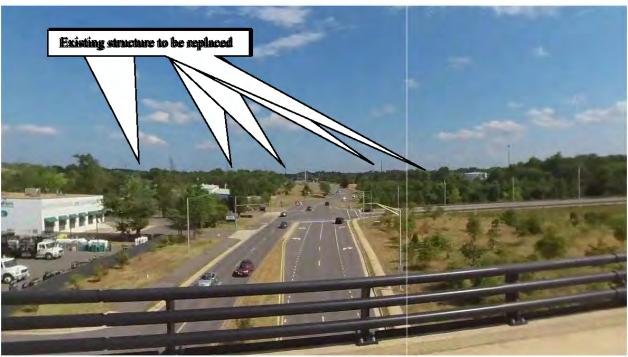
Figure 5-221: Photo location 2- View from Nokesville Road overpass of Wellington Road (Multiple project structures visible), facing southeast.

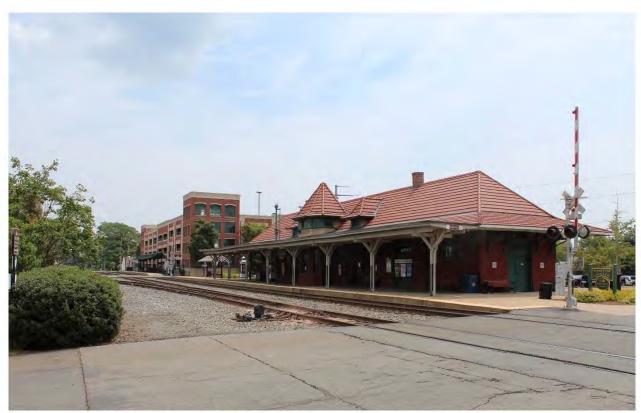
Figure 5-224: Photo location 5- View from Manassas Railroad Station (Project structure visible), facing southeast.

structures visible), facing south.
Figure 5-224: Photo location 5- View from Manassas Railroad Station (Project structure
visible), facing southeast
Figure 5-225: Photo location 6- View from Manassas Railroad Station (Multiple project
structures visible), facing southwest
Figure 5-226: Photo location 7- View from Center Street at East Street (Multiple project
structures visible), facing east
Figure 5-227: Photo location 8- View from Centerville Road at Liberia Road (One project
structure visible), facing southeast
Figure 5-228: Photo location 9- View from Centerville Road at Manassas Drive (No project
structures visible. Multiple structures on another line not included in this project area visible),
facing southeast
Figure 5-229: Second Manassas Battlefield Simulation 1 – Simulation location, direction of
view, and structures modeled from Manassas Rail Depot. Source: GTTE, LLC5-227
Figure 5-230: Second Manassas Battlefield Simulation 1 – Existing view from Manassas Rail

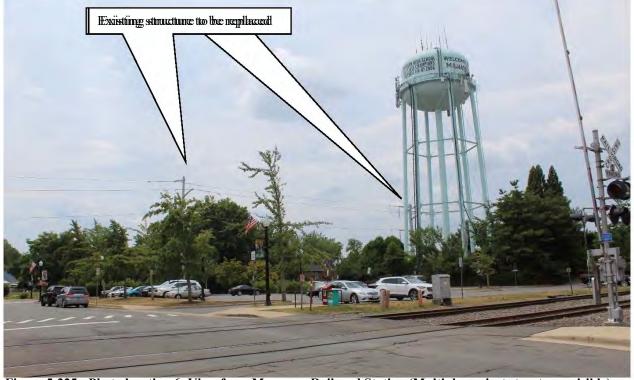
Figure 5-225: Photo location 6- View from Manassas Railroad Station (Multiple project structures visible), facing southwest.

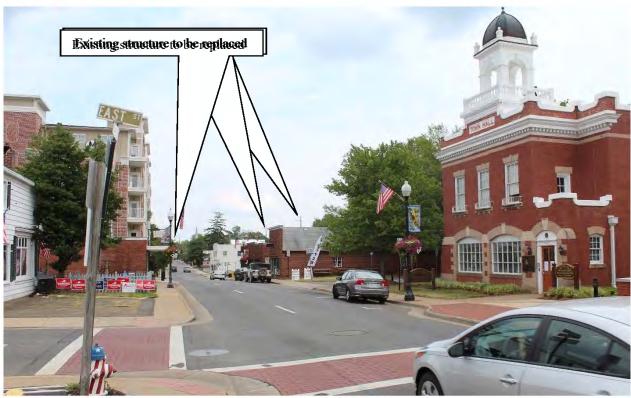
Figure 5-226: Photo location 7- View from Center Street at East Street (Multiple project structures visible), facing east.

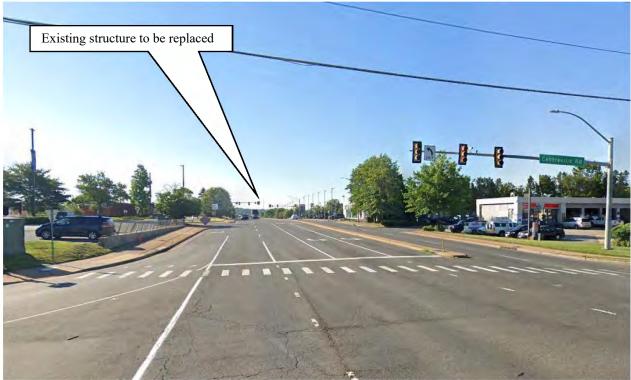
Figure 5-227: Photo location 8- View from Centerville Road at Liberia Road (One project structure visible), facing southeast.

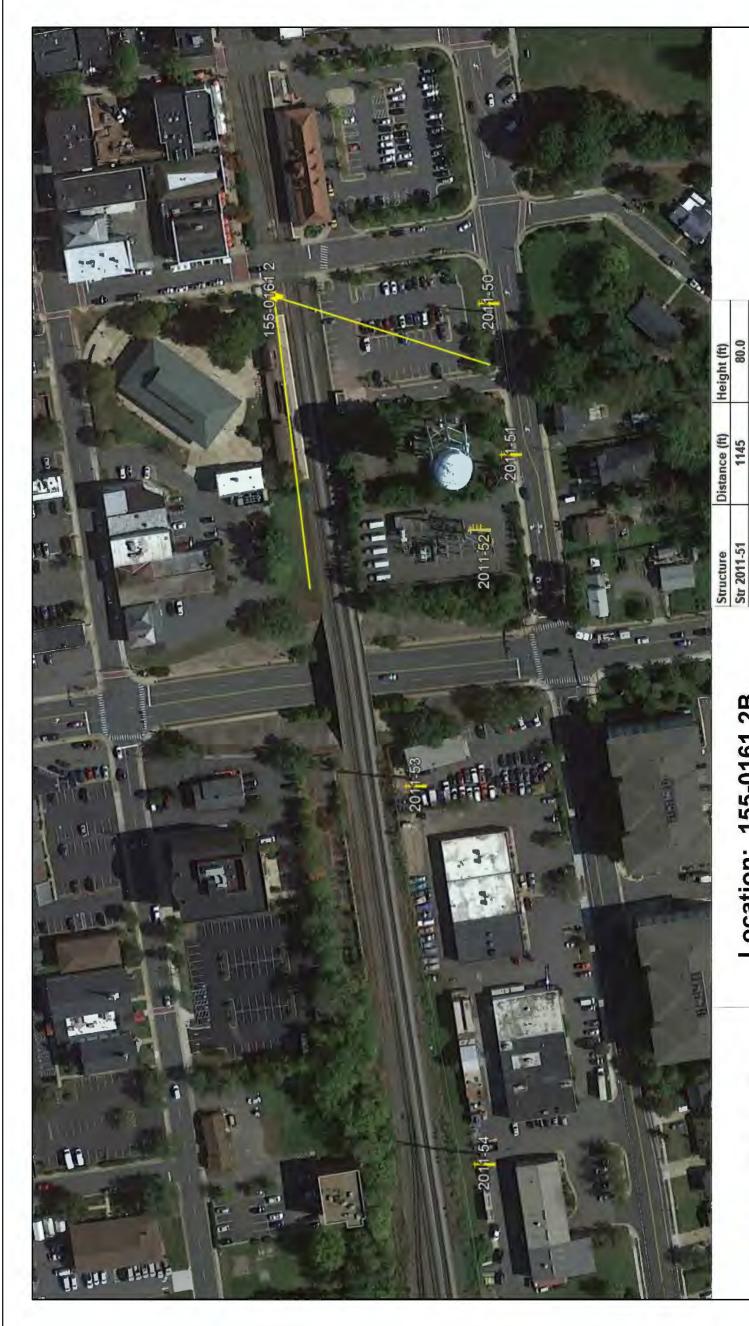
105.0 120.0 125.0 120.0 125.0

Str 2011-58 3358 120.0
Simulation 1 – Simulation location, direction of view, and structures modeled from Manassas Rail Depot. Source: GTTE, LLC Figure 5-229: Second Manassas Battlefield

Figure 5-219 depicts the boundaries of the Second Manassas Battlefield in relation to the project area and viewshed buffers, with the location and direction of all representative photographs and photo simulations. Figures 5-220 through 5-228 are representative photographs of the battlefield, as well as those taken from locations within and near the battlefield towards the project area. Figures 5-229 through 5-237 provide photo simulation from the resource.

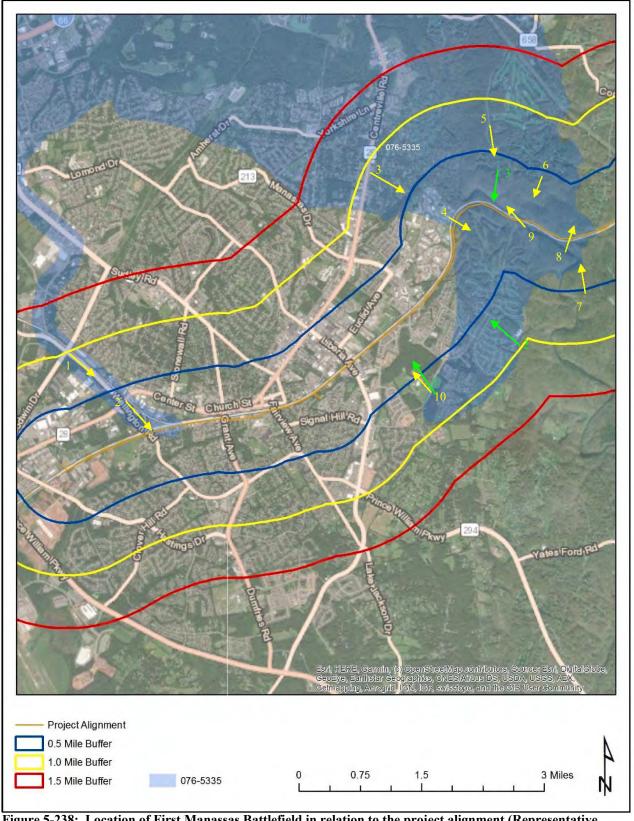
Figure 5-238: Location of First Manassas Battlefield in relation to the project alignment (Representative photographs and views towards the project area depicted in yellow, photo simulations depicted in green).

Figure 5-238 depicts the boundaries of the First Manassas Battlefield in relation to the project area and viewshed buffers, with the location and direction of all representative photographs and photo simulations. Figures 5-239 through 5-248 are representative photographs of the battlefield, as well as those taken from locations within and near the battlefield towards the project area. Figures 5-249 through 5-257 provide photo simulation from the resource.

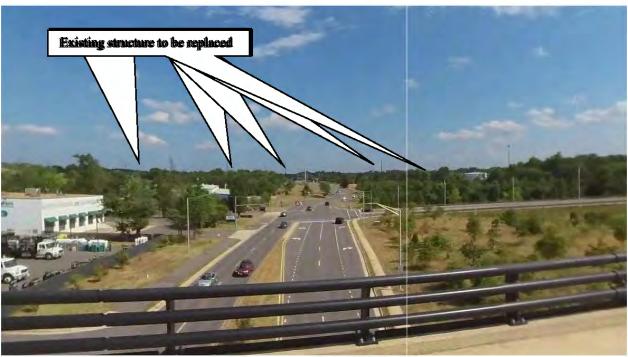
Figure 5-240: Photo location 2- View from Nokesville Road overpass of Wellington Road (Multiple project structures visible), facing southeast.

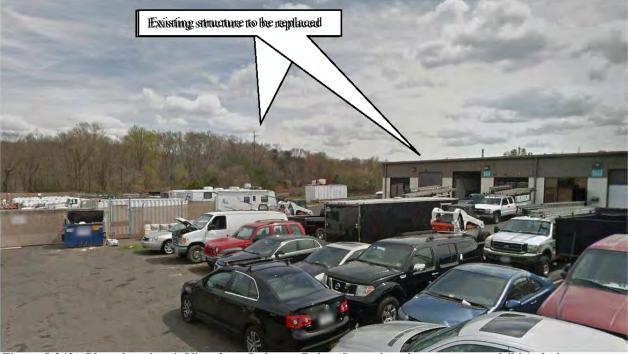
Figure 5-242: Photo location 4- View from Industry Drive (Several project structures visible), facing southeast.

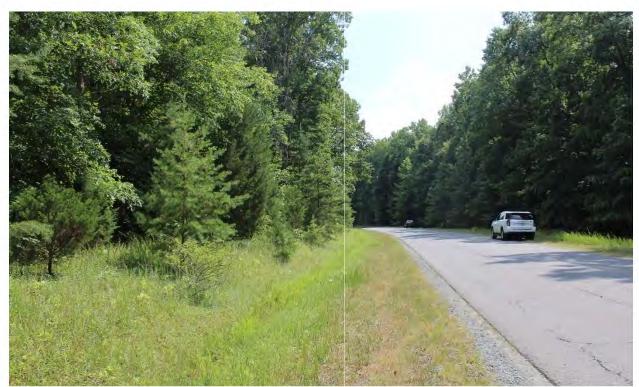
Figure 5-243: Photo location 5- View from Batter Hill Redoubt (Project structure visible), facing south.

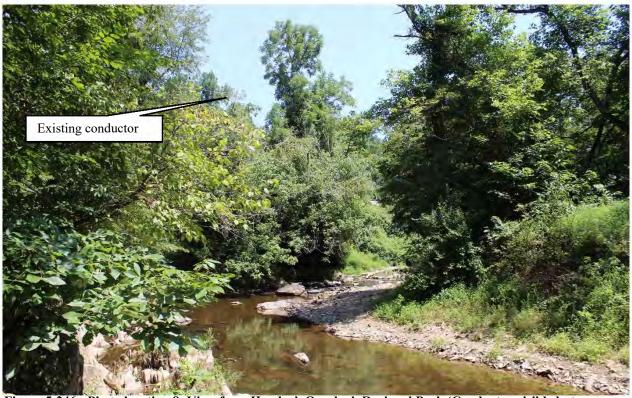
Figure 5-246: Photo location 8- View from Hemlock Overlook Regional Park (Conductor visible but no project structures visible), facing north.

structures visible), facing north
Figure 5-246: Photo location 8- View from Hemlock Overlook Regional Park (Conductor
visible but no project structures visible), facing north
Figure 5-247: Photo location 9- View from O&A Railroad Bridge in Hemlock Regional Park
(Existing conductor visible but no project structures visible), facing northwest5-244
Figure 5-248: Photo location 10- View from Louisiana Brigade Winter Camp (No project
structures visible), facing northwest
Figure 5-249: First Manassas Battlefield Simulation 1 – Simulation location, direction of view,
and structures modeled from Signal Hill. Source: GTTE, LLC5-245
Figure 5-250: First Manassas Battlefield Simulation 1 – Existing view from Signal Hill. Source:
GTTE, LLC
Figure 5-251: First Manassas Battlefield Simulation 1 – Proposed view from Signal Hill –
(Visible structures shown as they would appear. Structures not visible shown in yellow). Source:

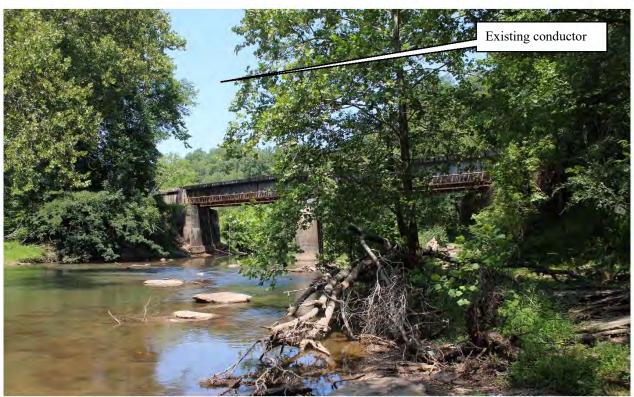
Figure 5-247: Photo location 9- View from O&A Railroad Bridge in Hemlock Regional Park (Existing conductor visible but no project structures visible), facing northwest.

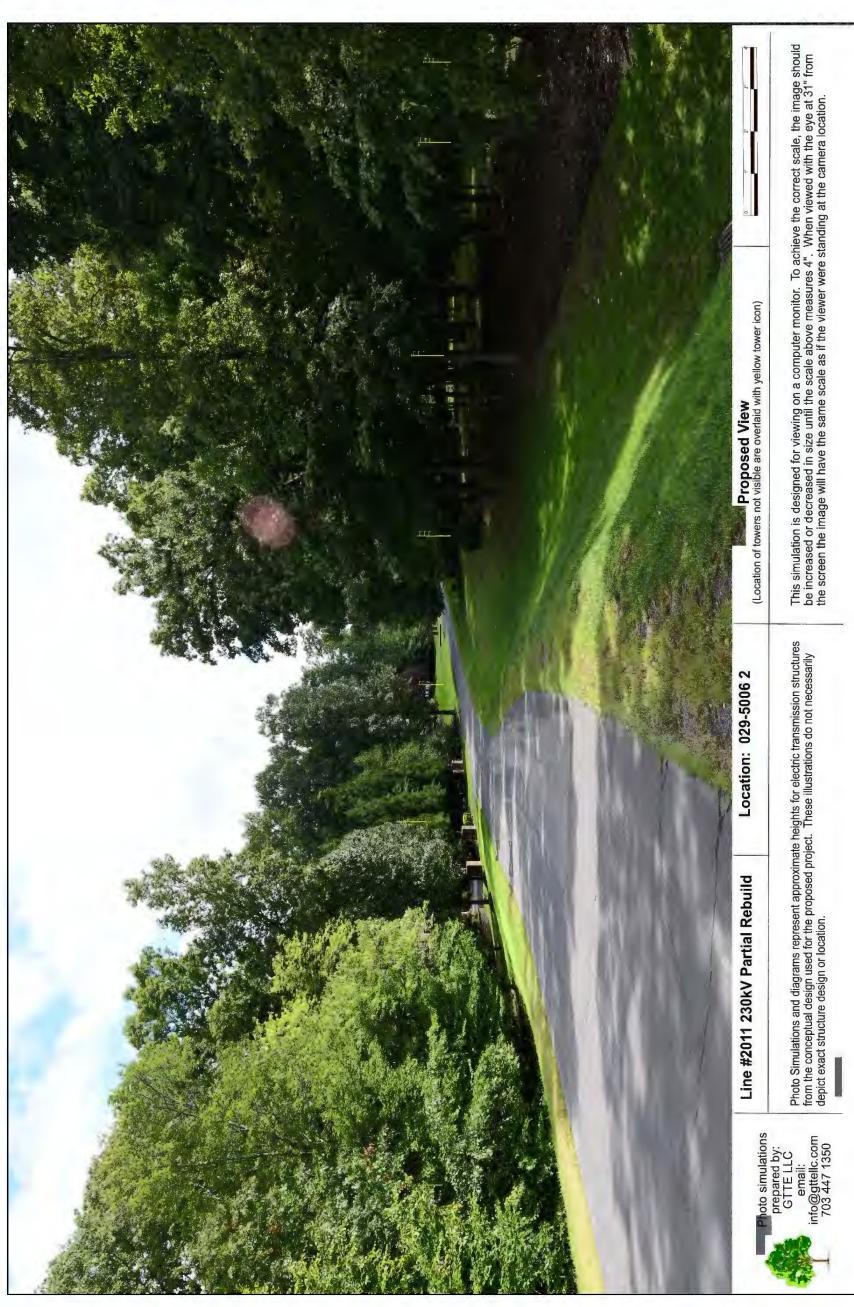
Figure 5-257: First Manassas Battlefield Simulation 3 – Proposed view from Battery Hill Redoubt – (Structures not visible shown in yellow). Source: GTTE, LLC

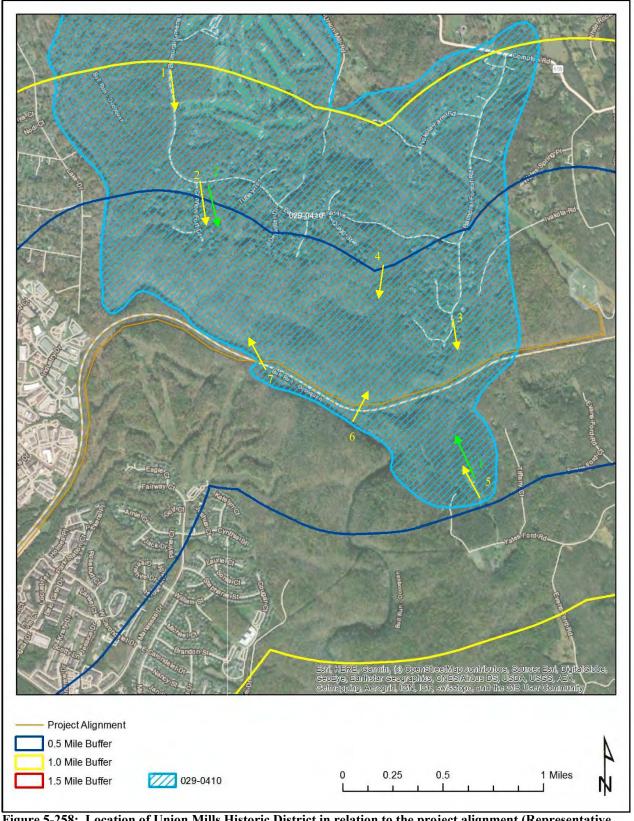
Figure 5-258: Location of Union Mills Historic District in relation to the project alignment (Representative photographs and views towards the project area depicted in yellow, photo simulations depicted in green).

Figure 5-258 depicts the location of Union Hills Historic District in relation to the project alignment and viewshed buffers, with the location and direction of all representative photographs and photo simulations. Figures 5-259 through 5-265 are representative photographs of the district, as well as those taken from locations within the district boundaries towards the project area. Figures 5-266 through 5-271 provide photo simulation from the district.

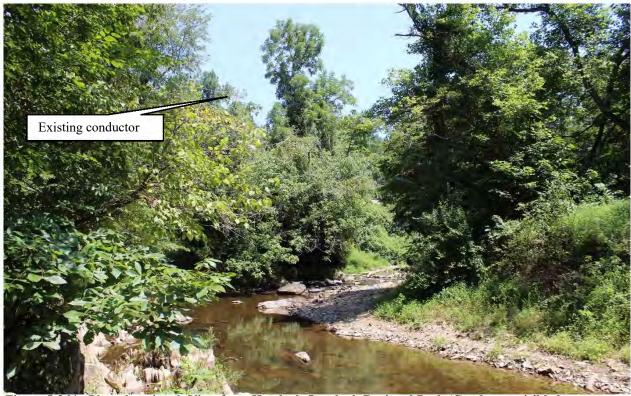
Figure 5-264: Photo location 6- View from Hemlock Overlook Regional Park (Conductor visible but no project structures visible), facing north.

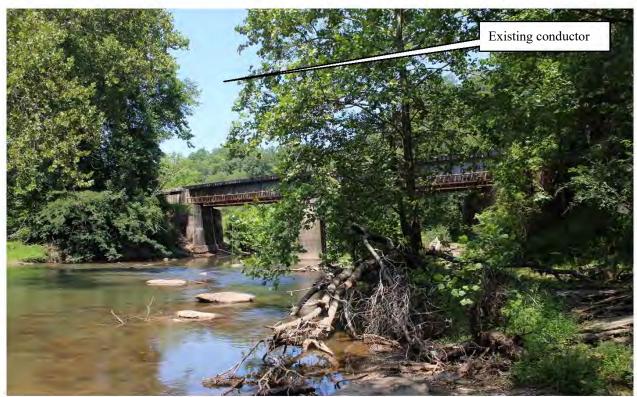
Figure 5-265: Photo location 7- View from O&A Railroad Bridge in Hemlock Regional Park (Existing conductor visible but no project structures visible), facing northwest.

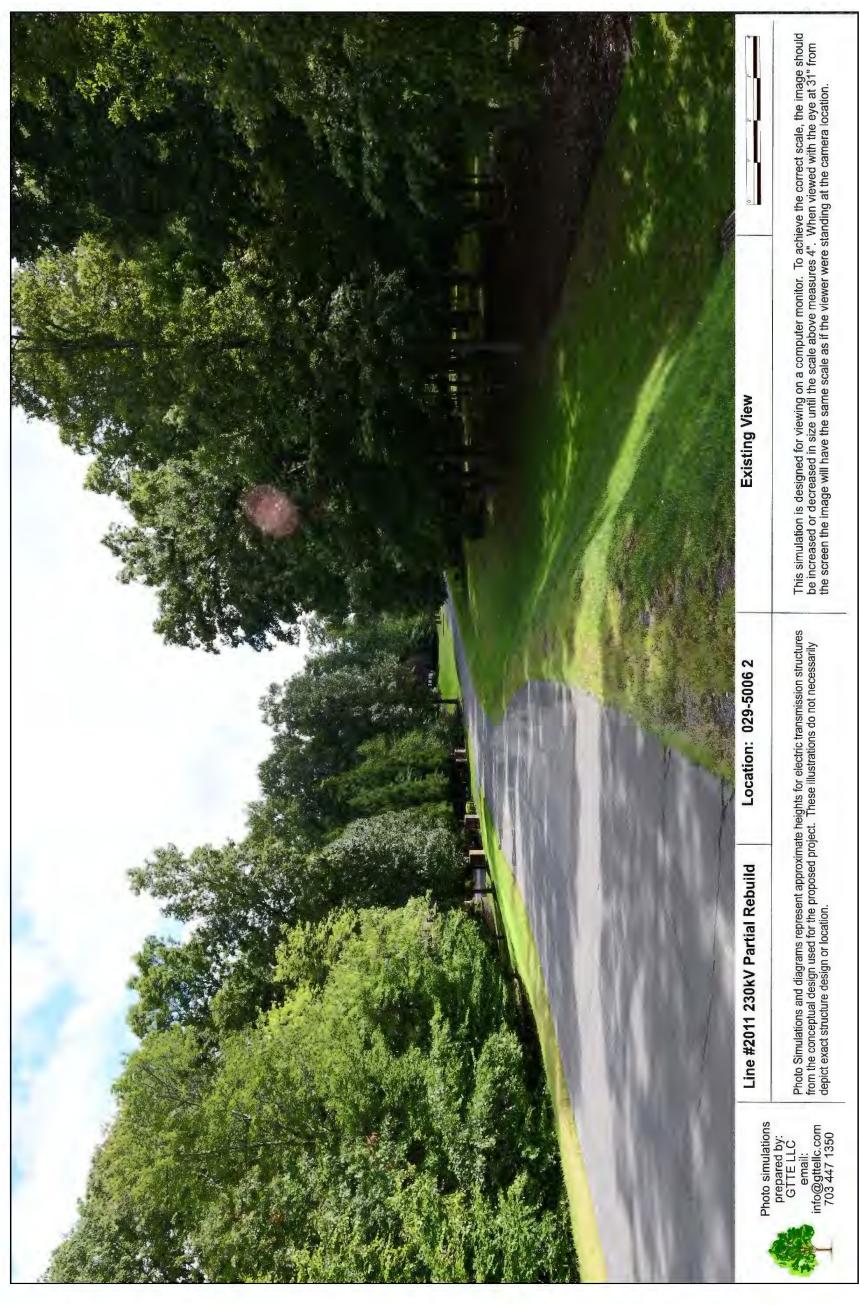
Figure 5-270: Union Mills Historic District Simulation 2 – Existing view from Balmoral Greens Avenue. Source: GTTE, LLC

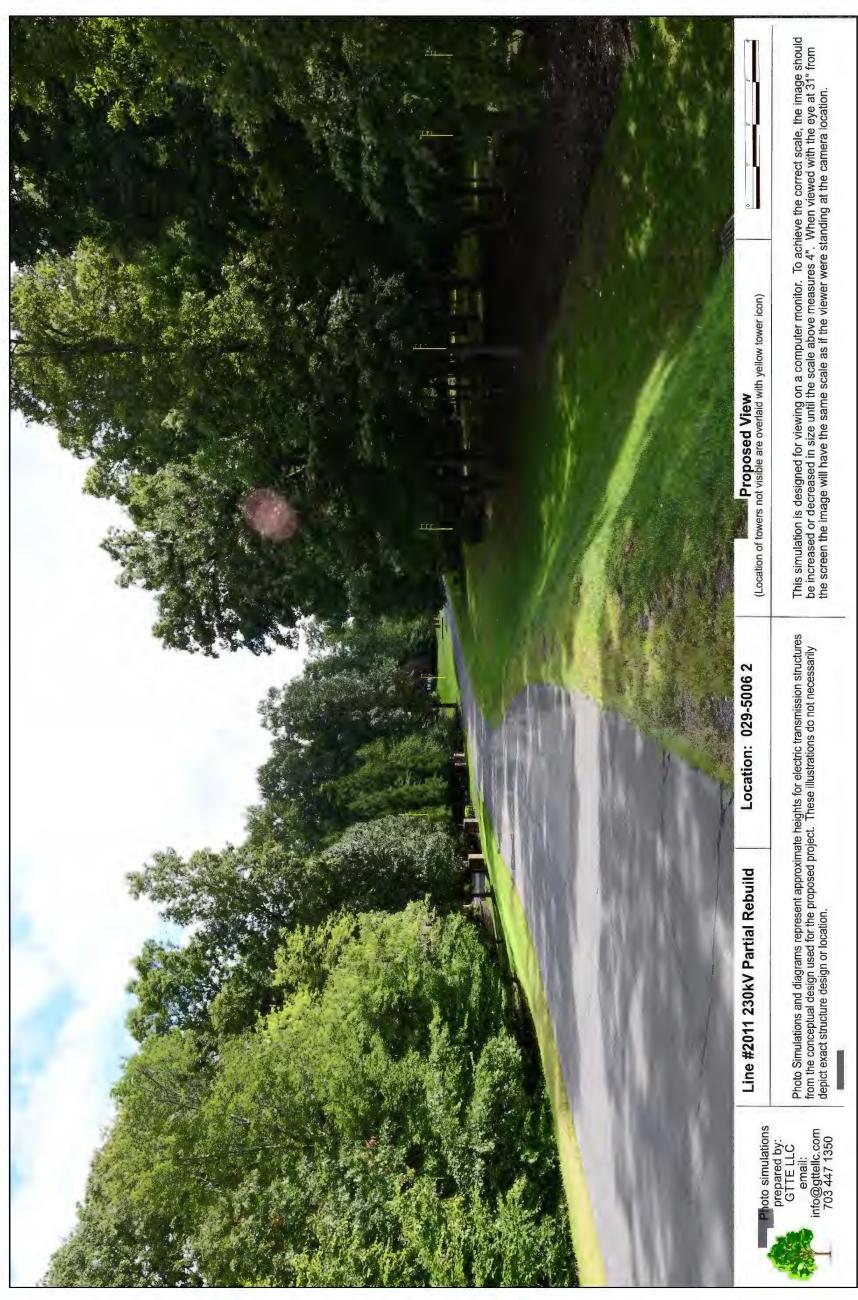
Simulation 2 - Proposed view from Balmoral Greens Avenue - (Structures not visible shown in yellow). Source: GTTE, LLC Figure 5-271: Union Mills Historic District

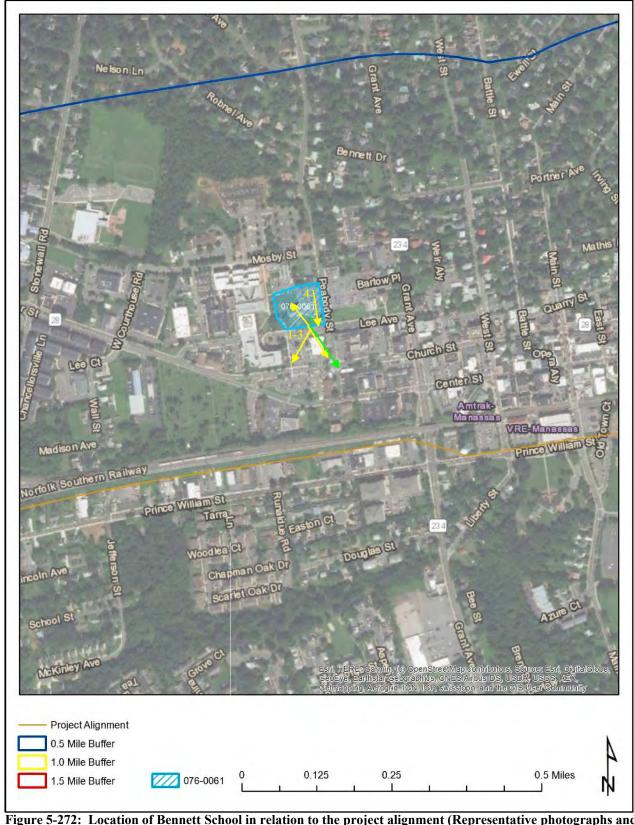
Figure 5-272: Location of Bennett School in relation to the project alignment (Representative photographs and views towards the project area depicted in yellow, photo simulations depicted in green).

Figure 5-272 depicts the location of Bennett School in relation to the project alignment and viewshed buffers, with the location and direction of all representative photographs and photo simulations. Figures 5-273 through 5-276 are representative photographs of the resource, as well as those taken from locations near the resource towards the project area. Figures 5-277 through 5-279 provide photo simulation from the resource.

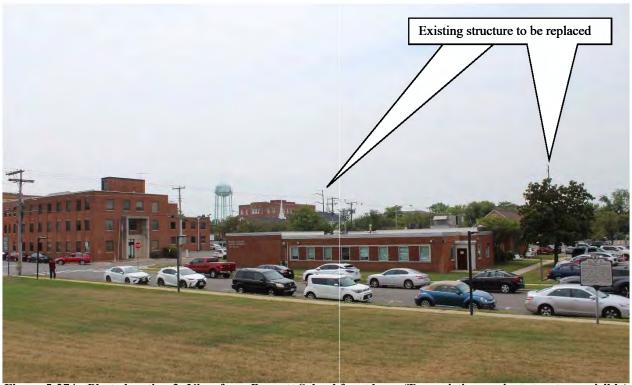
Figure 5-274: Photo location 2- View from Bennett School front lawn (Two existing project structures visible), facing southeast.

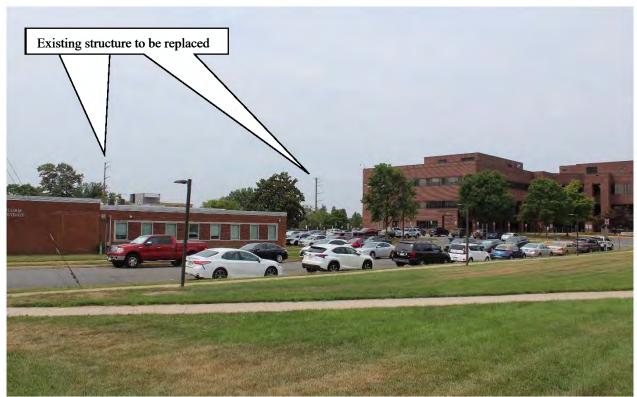
Figure 5-275: Photo location 3- View from Bennett School front lawn (Two existing project structures visible), facing southwest.

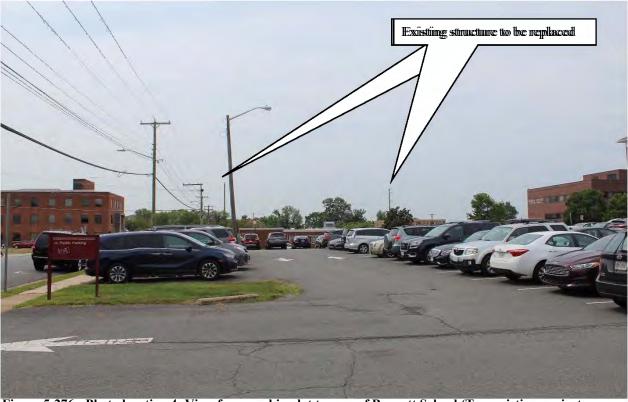
Figure 5-276: Photo location 4- View from parking lot to rear of Bennett School (Two existing project structures visible), facing south.

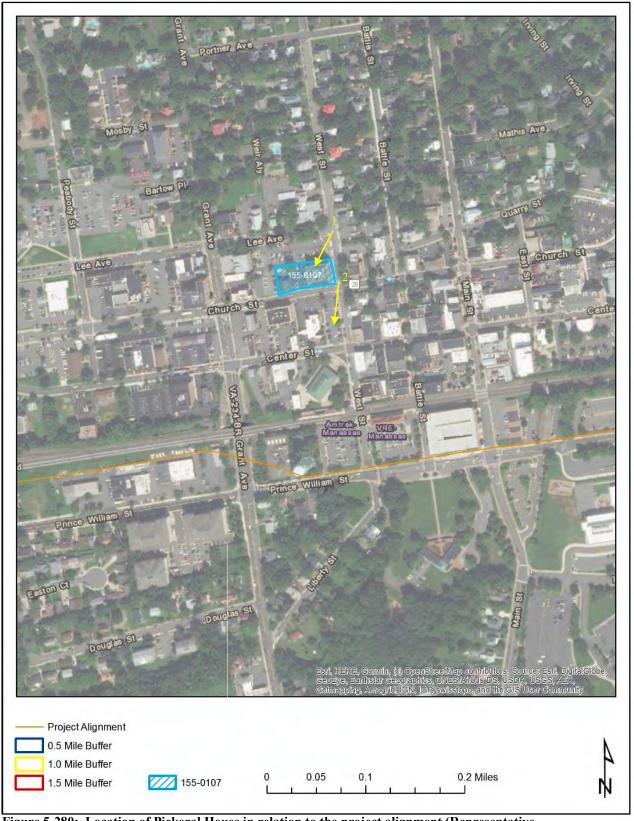
Figure 5-280: Location of Pickeral House in relation to the project alignment (Representative photographs and views towards the project area depicted in yellow, photo simulations depicted in green).

Figure 5-280 depicts the location of the Pickeral House site in relation to the project alignment and viewshed buffers, with the location and direction of all representative photographs and photo simulations. Figures 5-281 and 5-282 are representative photographs of the site, as well as those taken from locations near the site towards the project area.

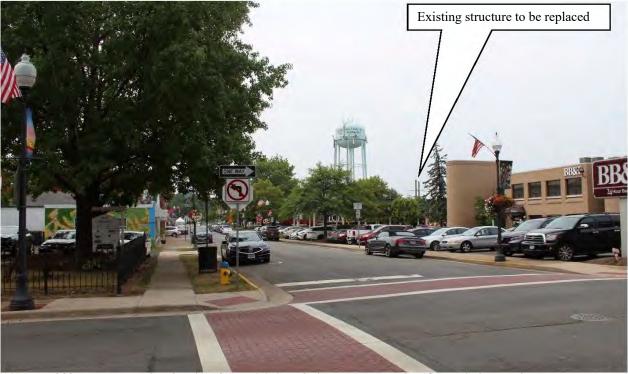
Figure 5-282: Photo location 2- View from vicinity of Pickeral House site (One existing project structure visible), facing south.

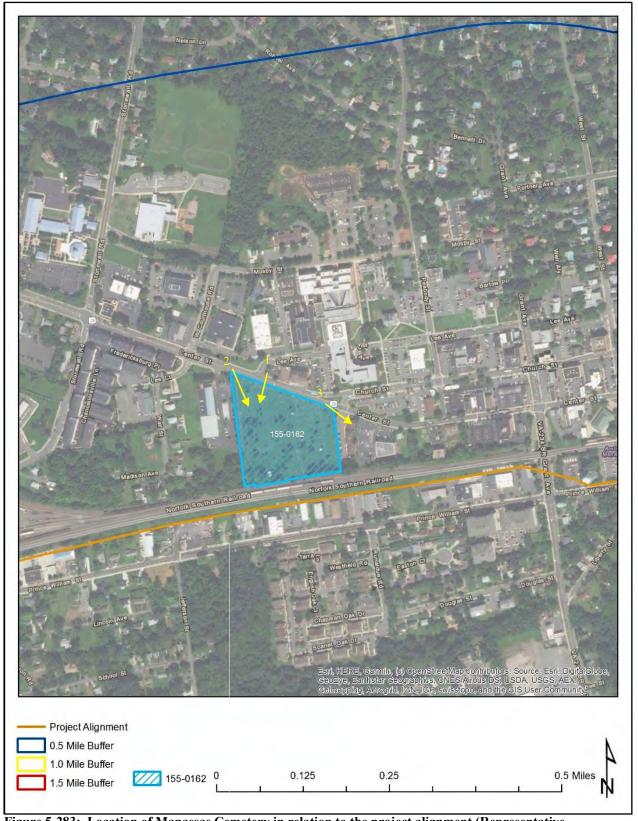
Figure 5-283: Location of Manassas Cemetery in relation to the project alignment (Representative photographs and views towards the project area depicted in yellow, photo simulations depicted in green).

Figure 5-283 depicts the location of Manassas Cemetery in relation to the project alignment and viewshed buffers, with the location and direction of all representative photographs and photo simulations. Figures 5-284 through 5-286 are representative photographs of the resource, as well as those taken from locations near the resource towards the project area.

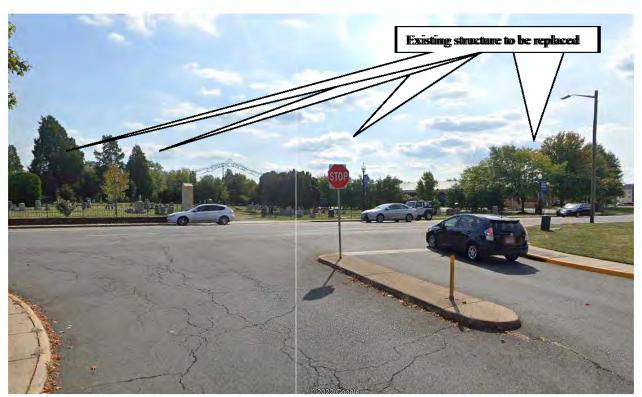
Figure 5-284: Photo location 1- Representative view of gate to cemetery (One project structure visible), facing south.

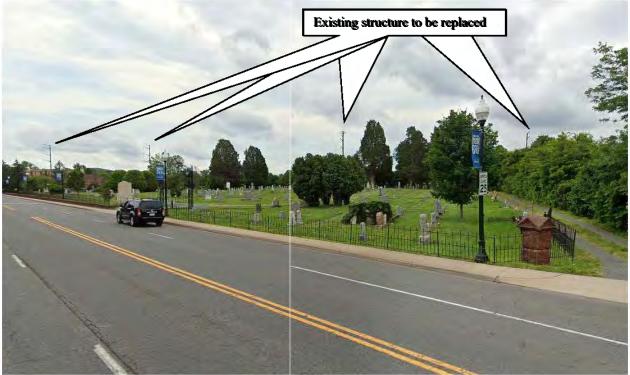
Figure 5-285: Photo location 2- View from west end of cemetery (Multiple existing project structures visible), facing southeast.

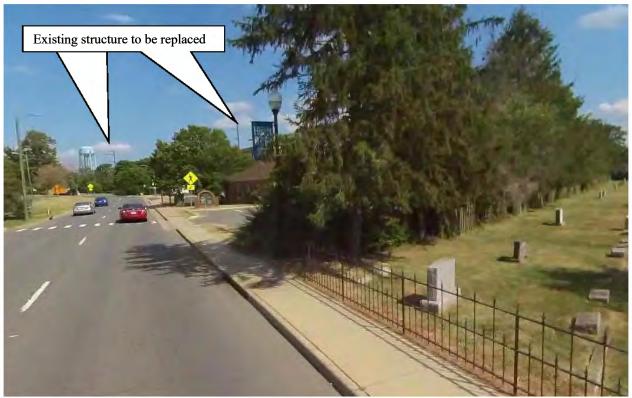
Figure 5-286: Photo location 3- View from east end of cemetery (Two existing project structures visible), facing southeast.
